Dec 1st, 2025

2136 Silver Dr., Arnold, CA, 95223

# Home Inspection Report

Sandra Lattin / Streamline Inspections

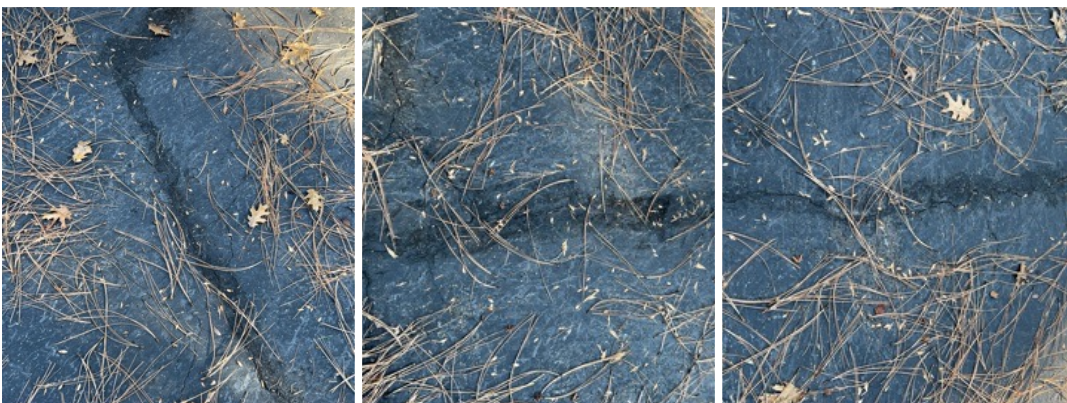
Cracks present in asphalt, previous sealants present.

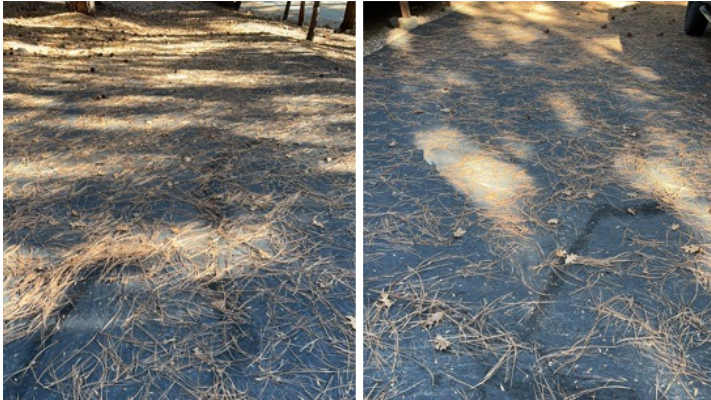
Due to pine needles the comments reflect only the visible portion of the driveway

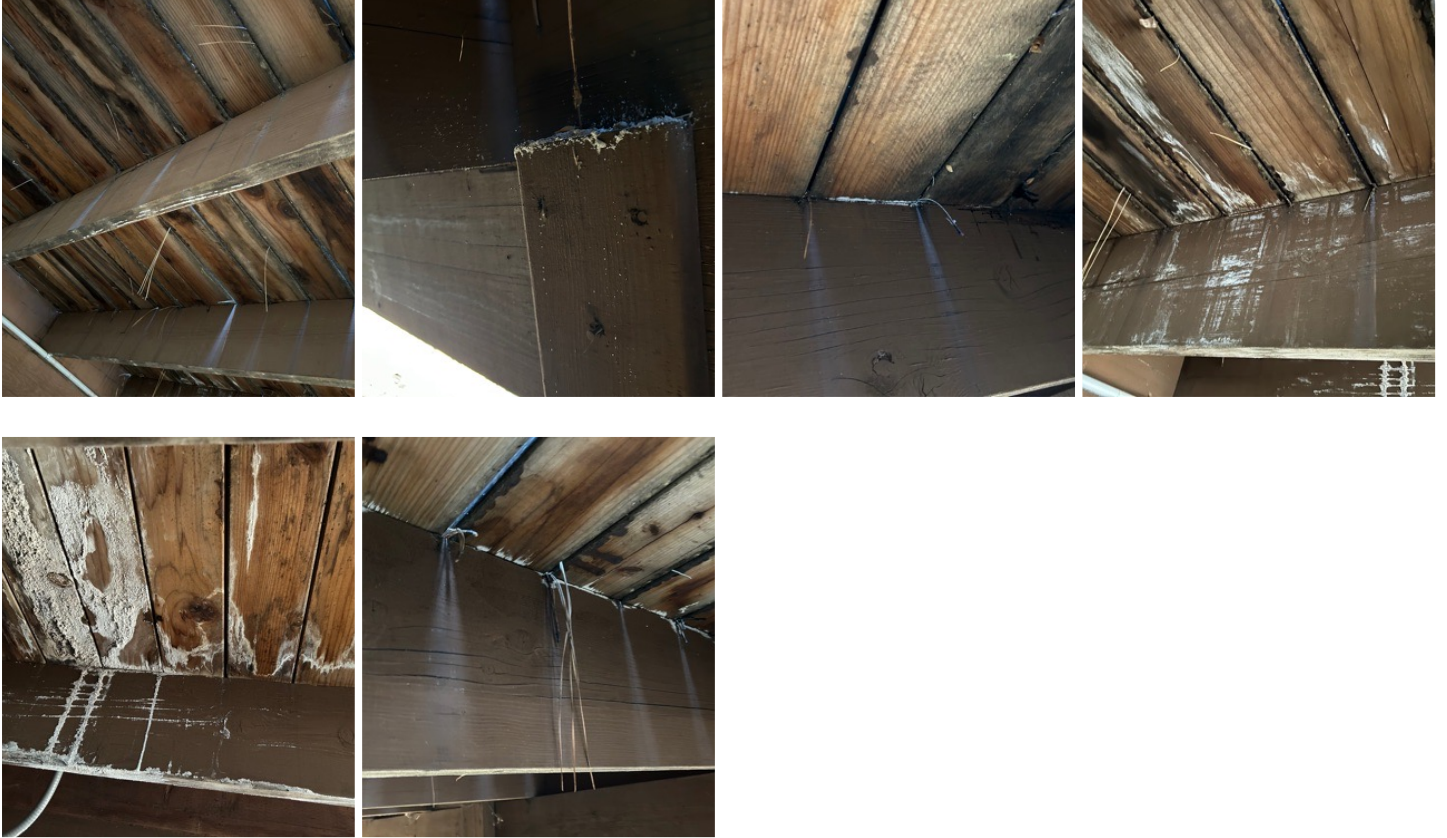
Organic surface fungus noted at deck wood members.

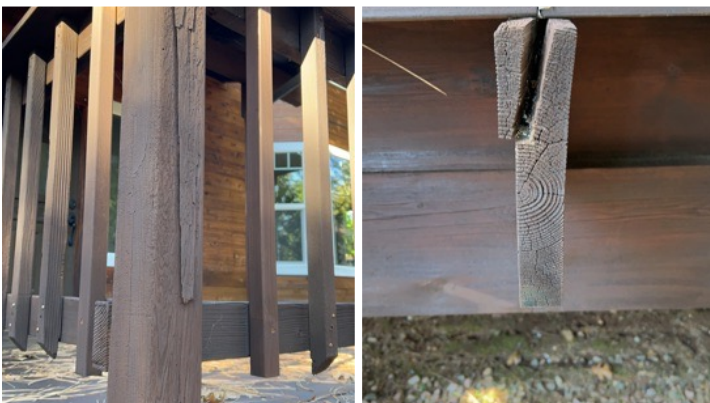
Splits/cracks were noted in wood members.

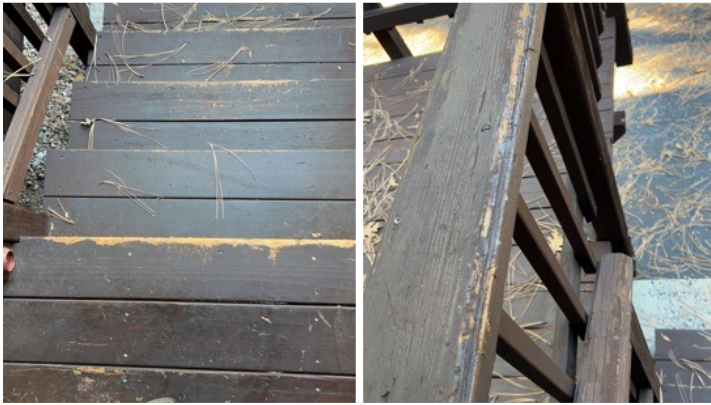
Recommend maintaining paint/stain at deck surface.

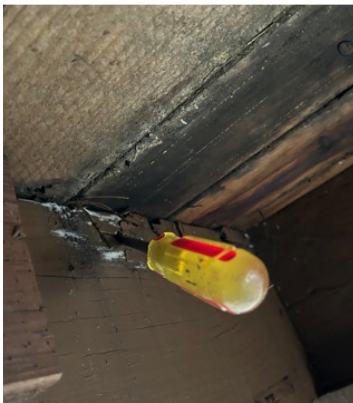
Wood deterioration is present

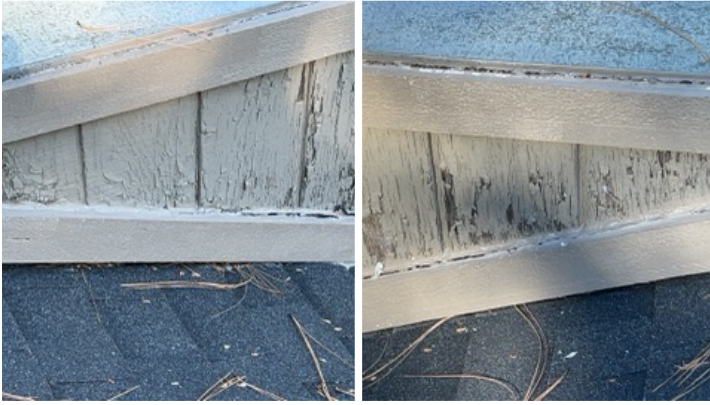
Delamination noted at wood siding.

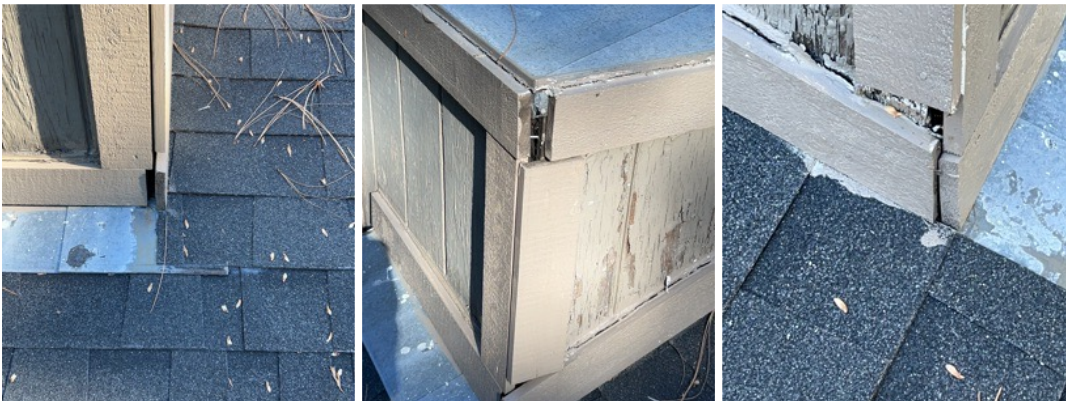
Missing trim.

Portions of the trim was noted to be missing.

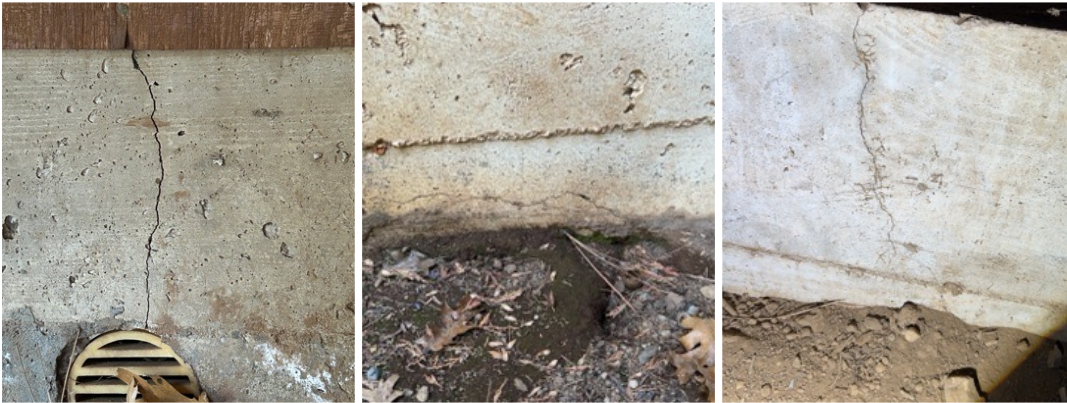
Minor cracks present.

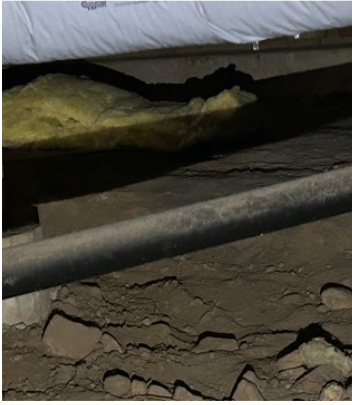
Fallen insulation noted.

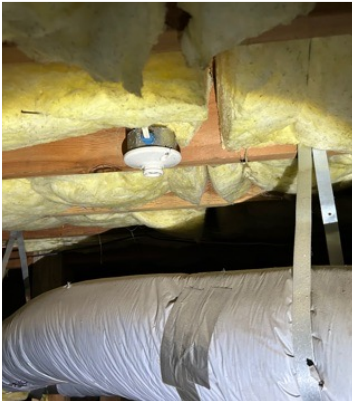
Light fixture not functional at time of inspection; missing bulb.

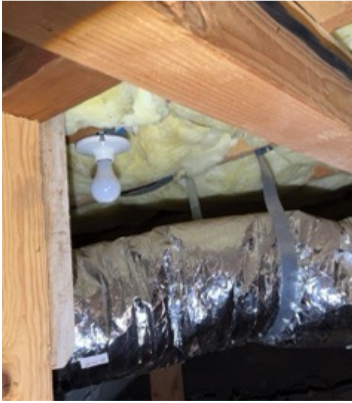
Light fixture not functional; possibly burnt out bulb.

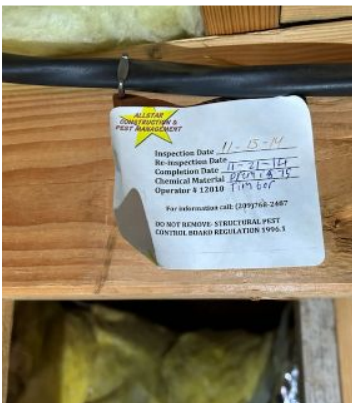
Chemical tag posted for chemical application on 11/15/2014. Chemical label indicated re-application needed after 5 years. No current evidence of wood destroying insects noted.

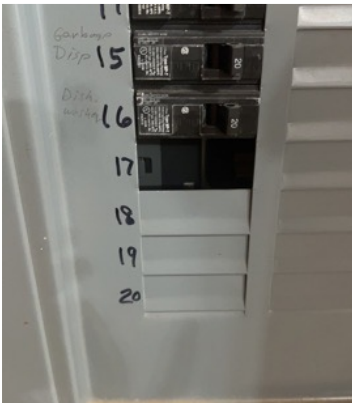
Open 'knock-out' hole- insert 'blank-out' cap to close off opening

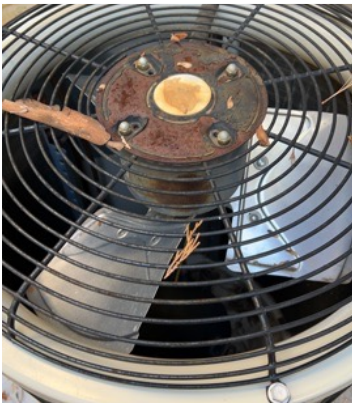
Exterior box has surface rust.

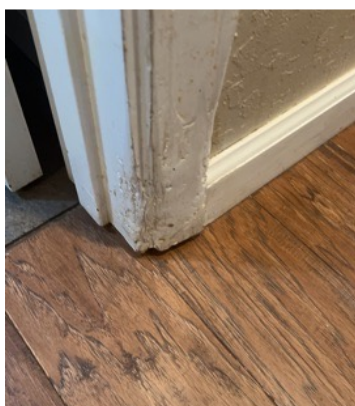
Cosmetic blemishes/damage was noted at hallway trim.

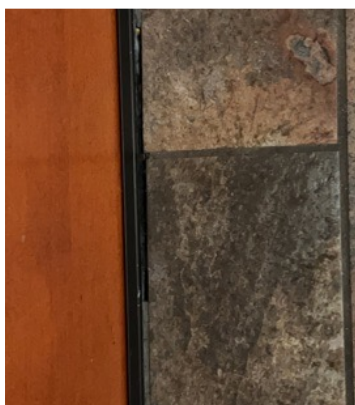
A void was noted between the entry door threshold and tile flooring.

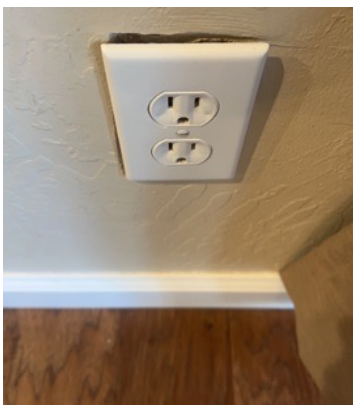
Loose switch or outlet should be resecured

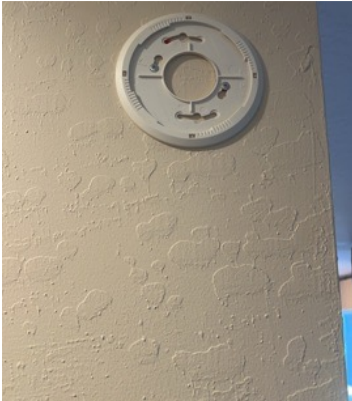
Smoke detectors are required to be installed on each level of interior living space.

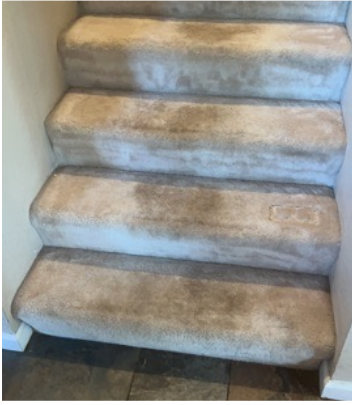
Carpet was noted to be stained/soiled.

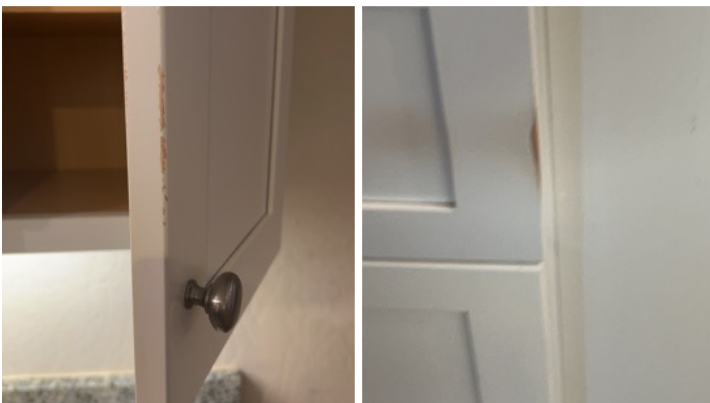
Cosmetic blemishes noted at kitchen cabinets.

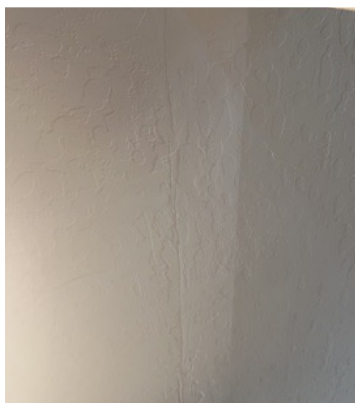
Cracks present

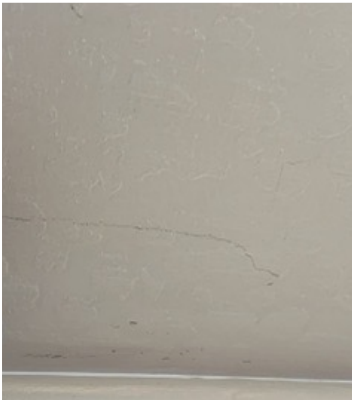
Cracks present at sheetrock

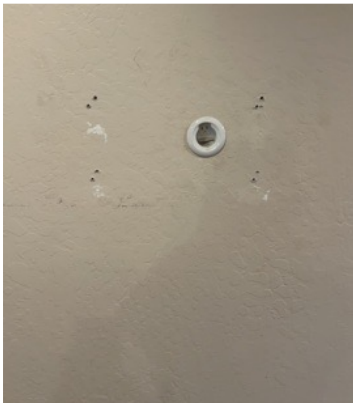
cosmetic damage was noted at walls.

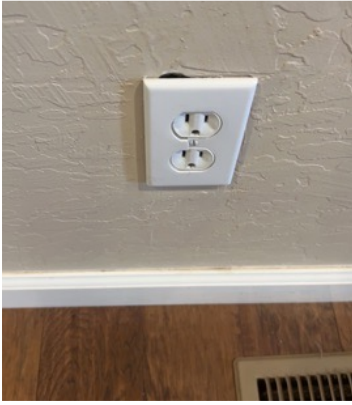
The electrical cover plate is loose.

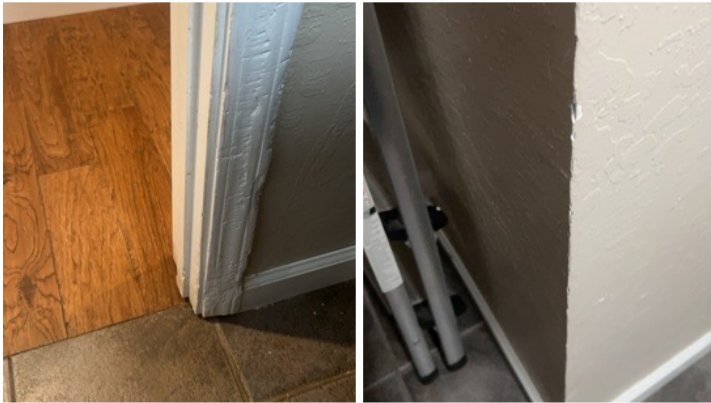
Cosmetic blemishes/damage was noted at laundry room, trim and walls.

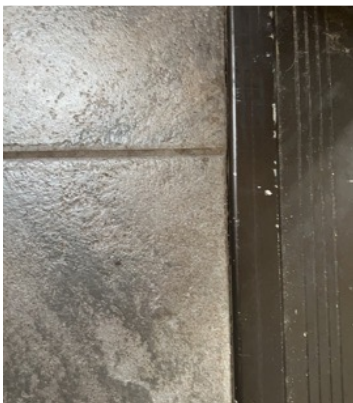
A void was noted between the door threshold and tile flooring.

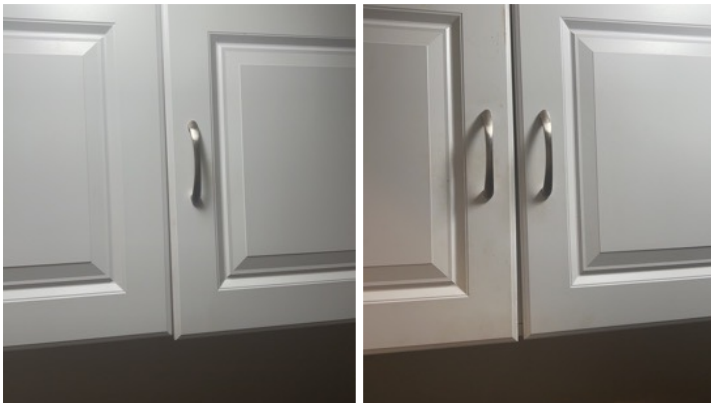
Cabinet doors are in need of adjustment.

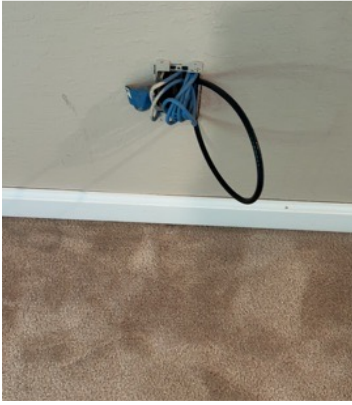
Install missing junction box cover plates

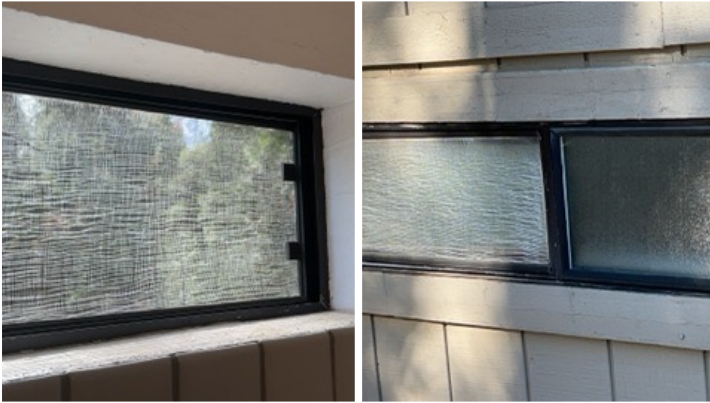
Sun damage was noted at screen.

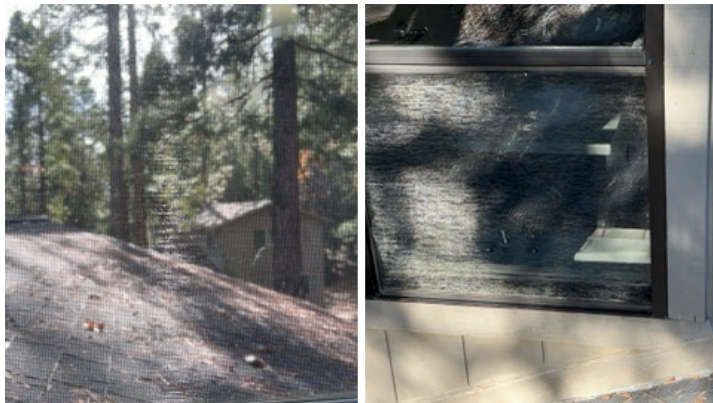
Sun damage was noted at screen.

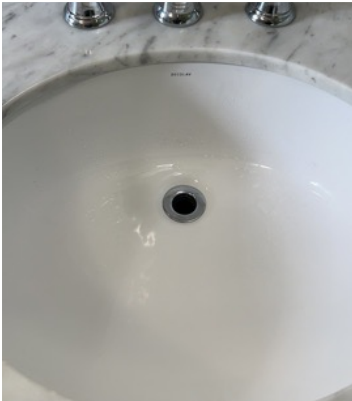
Missing drain stopper noted.

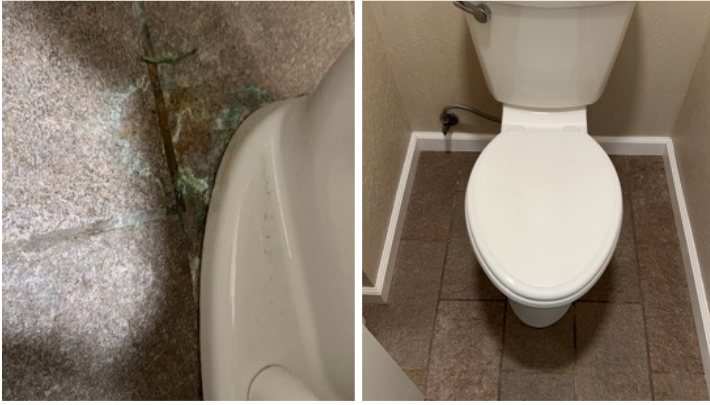
The toilet is loose at the floor and may require replacement of the wax seal

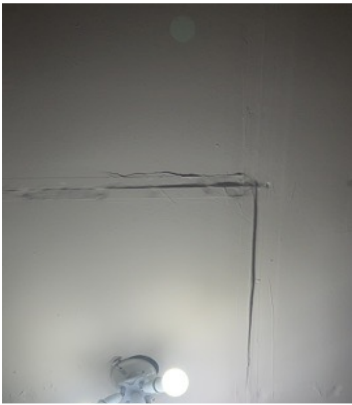
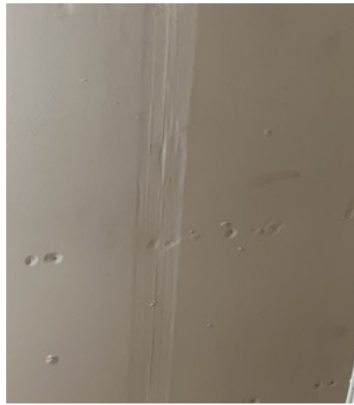
Visible tape joints.

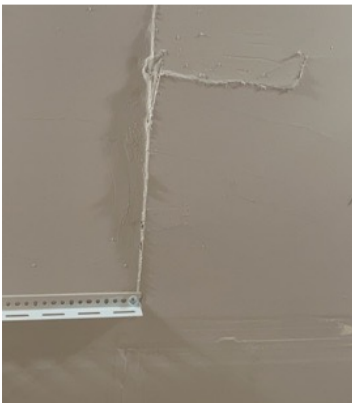
Cracks present

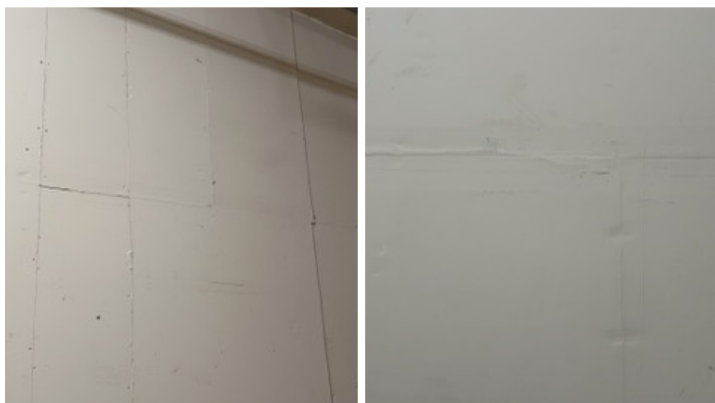
Visible tape joints.

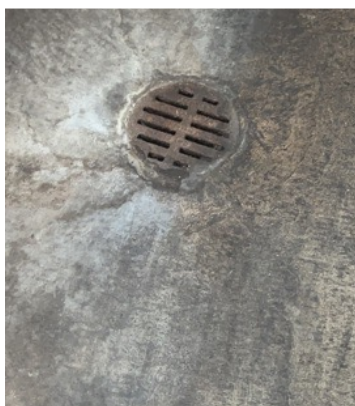
A drain has been installed in concrete slab.

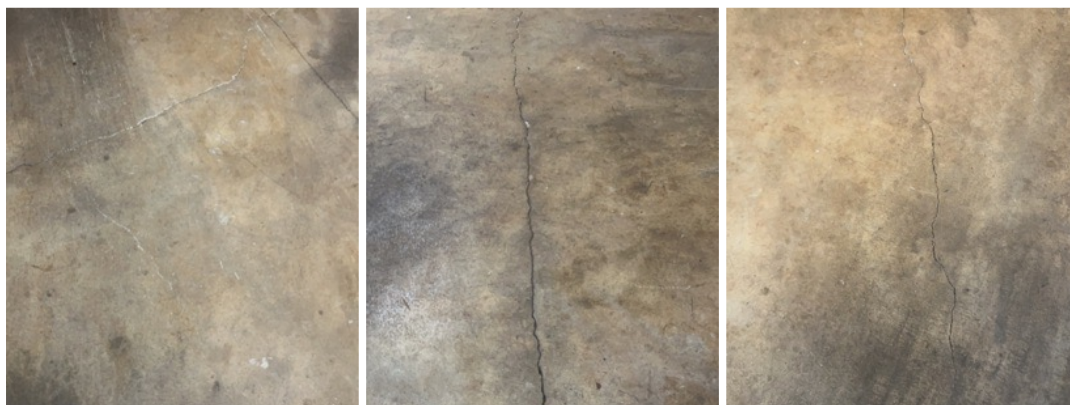
Cracks noted.

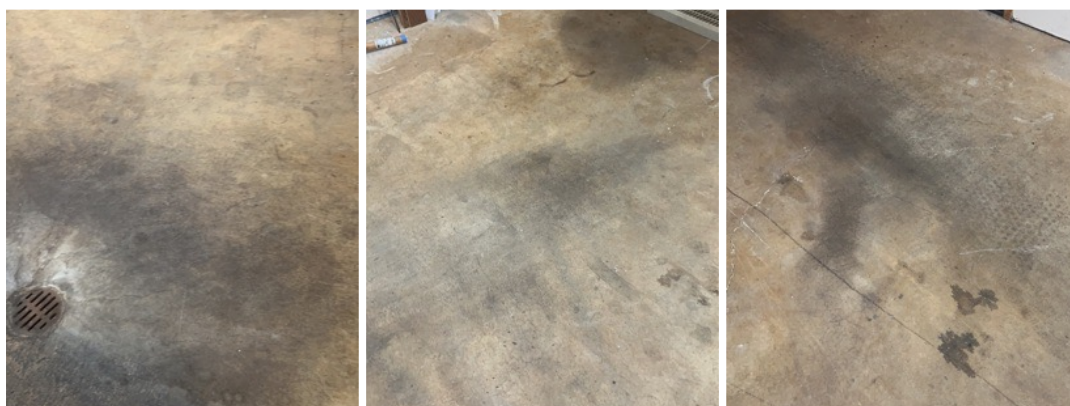
Staining noted

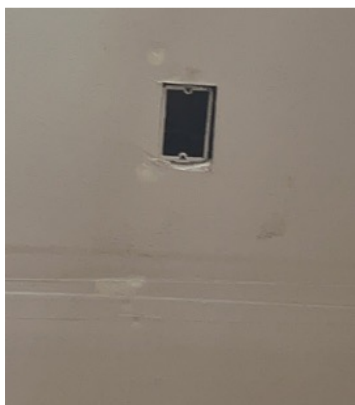
Install missing cover plate.

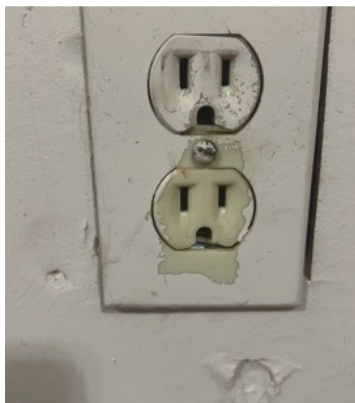
Ground portion of receptacle is broken; this does not affect the functionality of the outlet.

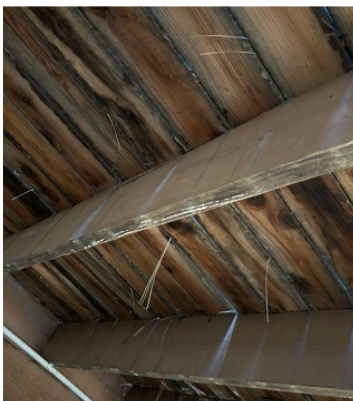
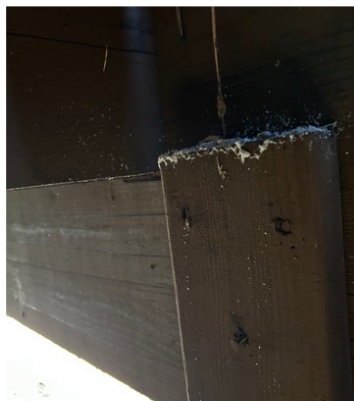
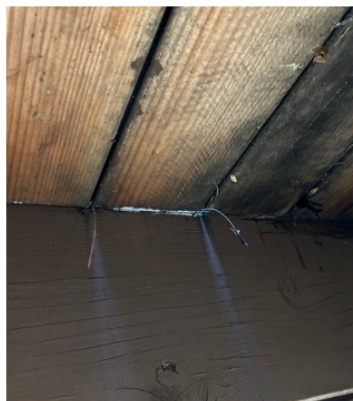
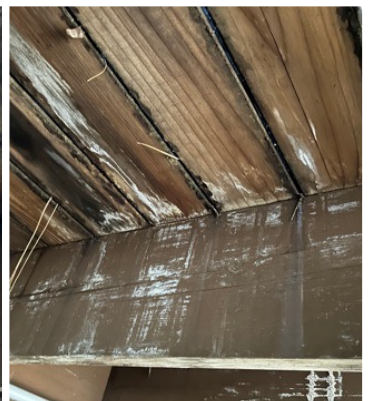
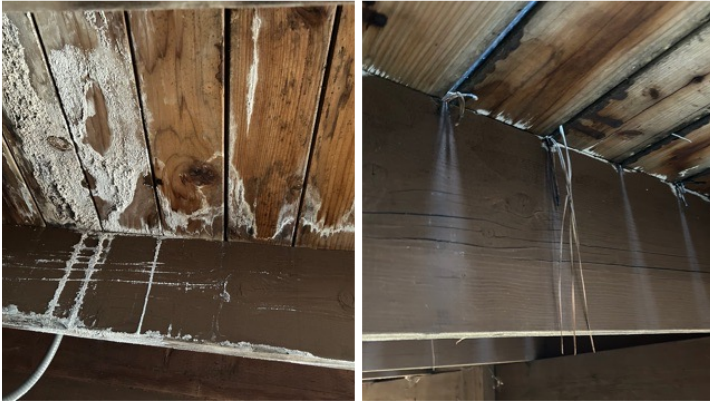
Organic surface fungus noted at deck wood members.

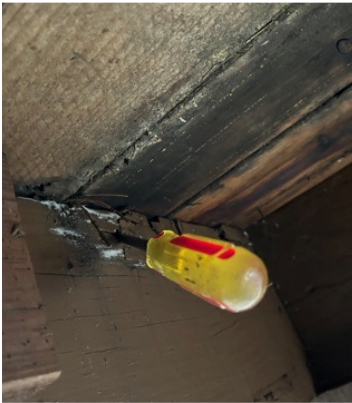
Wood deterioration is present

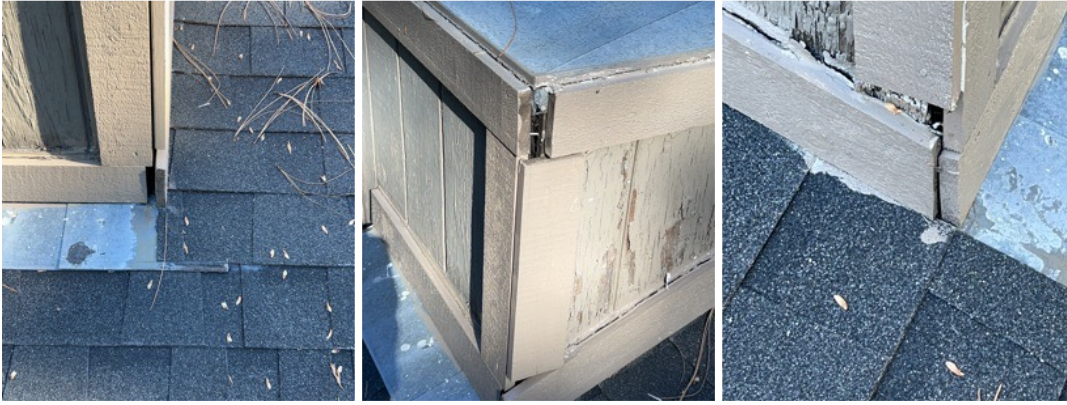
Missing trim.

Portions of the trim was noted to be missing.

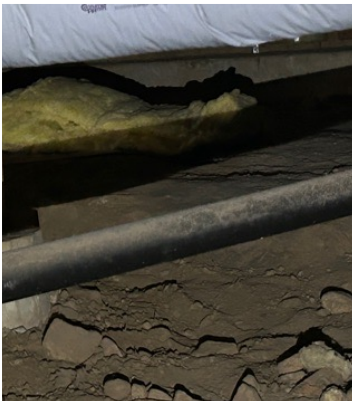
Fallen insulation noted.

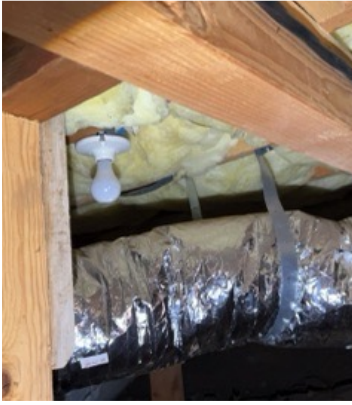
Light fixture not functional; possibly burnt out bulb.

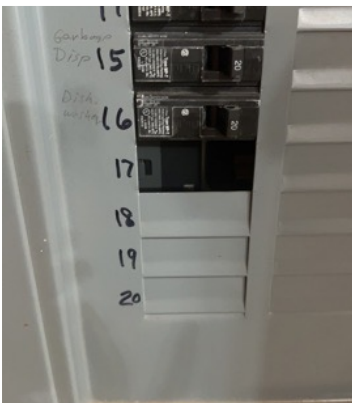
Open 'knock-out' hole- insert 'blank-out' cap to close off opening

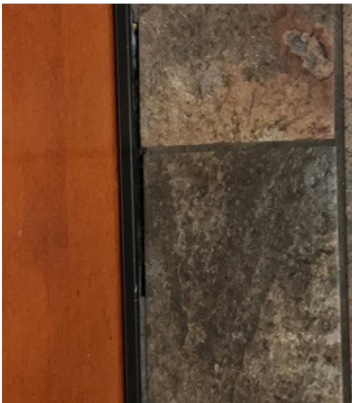
A void was noted between the entry door threshold and tile flooring.

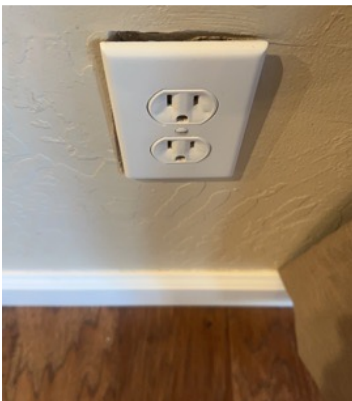
Loose switch or outlet should be resecured

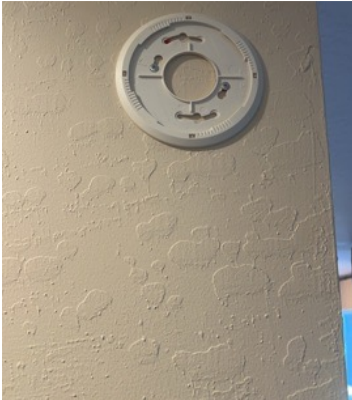
Smoke detectors are required to be installed on each level of interior living space.

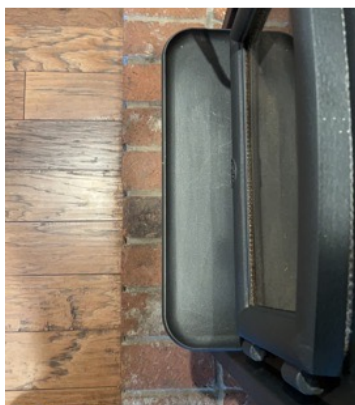
(Any firebox less than six feet in square footage must have a hearth extending forth by a minimum of 16 inches. This hearth must also span eight inches on either side of the firebox.  
Hearths measuring over six square feet must include a hearth that juts forward at least 20 inches and extends 12 inches to each side. The building materials permissible for a California fireplace hearth include:  
- Brick  
- Concrete  
- Quarry  
- Tile  
- Marble  
- Slate  
- Stone  
- Terrazzo)

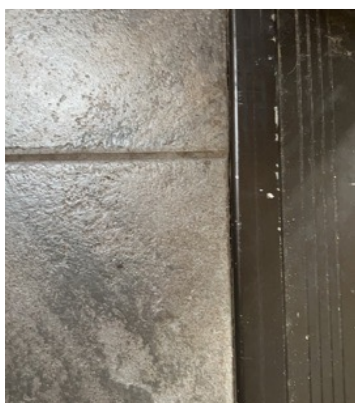
A void was noted between the door threshold and tile flooring.

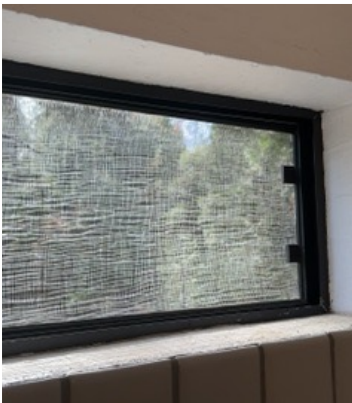
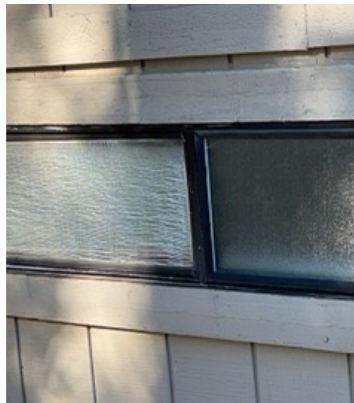
Sun damage was noted at screen.

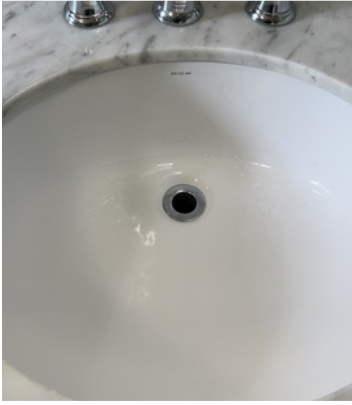
Missing drain stopper noted.

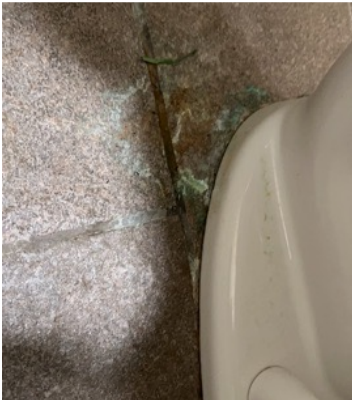
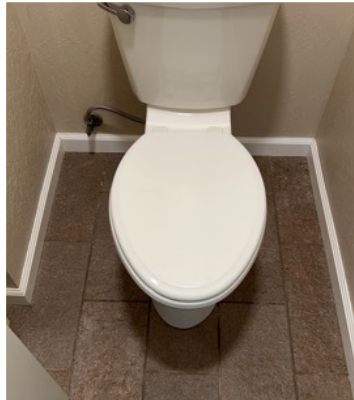
The toilet is loose at the floor and may require replacement of the wax seal

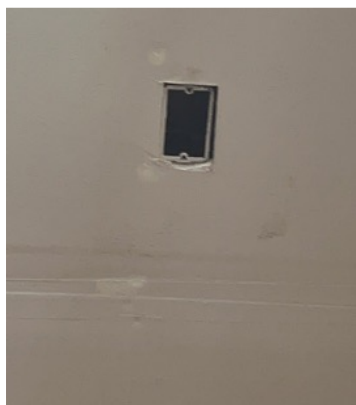
Install missing cover plate.

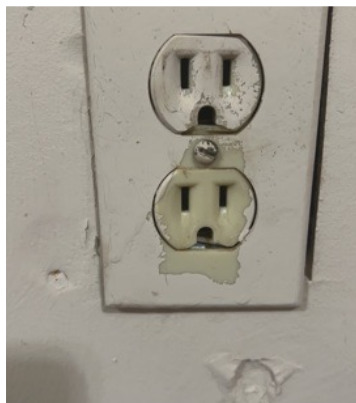
Ground portion of receptacle is broken; this does not affect the functionality of the outlet.
