WOOD DESTROYING PESTS AND ORGANISMS INSPECTION REPORT

BUILDING NO. 29803	STREET, CITY, STATE, ZIP Mono Trail , Cold Springs CA 95335	Date of Inspection 5/13/2025	No. of Pages 7
------------------------------	---	--	--------------------------

General Description: TWO STORY SINGLE FAMILY RESIDENCE OCCUPIED	Inspection Tag Posted: SUBSTRUCTURE AREA
Other Tags Posted:

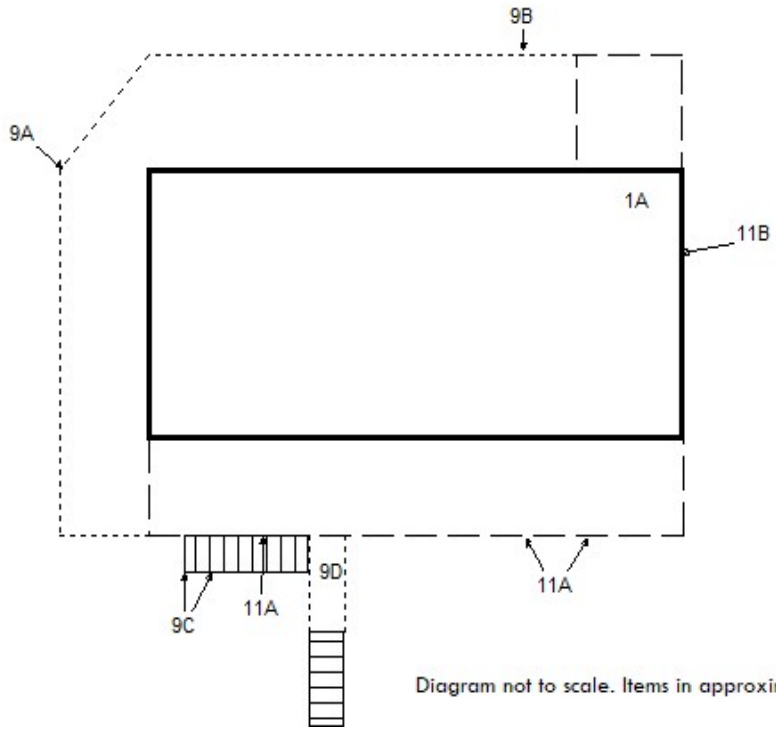
ITEM 1A A plumbing leak was noted at the water heater supply lines above the water heater.

ITEM 9A Fungus damage/wood rot was noted at the railing top cap.

ITEM 9B Fungus damage/wood rot was noted at the upper rim joist at the rear deck.

ITEM 9C Soil/debris build up was noted around the lower staircase.

ITEM 9D Fungus damage/wood rot was noted at the joist/girder at the front deck structure.

ITEM 11A Damaged/delaminated siding was noted at areas of the front roof sheathing.

ITEM 11B Wood pecker damage was noted at the upper siding at the right side of the home.

RECOMMENDATION Employ a licensed plumber to repair the leak as necessary.

RECOMMENDATION Remove the damaged wood members for further inspection. If no further damage is present, replace with new material.

RECOMMENDATION This area was not fully visible/accessible for inspection due to height. Further inspection is required by the contractor with a ladder to inspect the post the rim joist is attached to and give a proper estimate for repairs.

RECOMMENDATION Employ proper trades to remove all debris around the staircase to prevent moisture damage. A supplemental report will be given if additional damage is found.

RECOMMENDATION Employ a licensed roofing contractor for evaluation and repairs to affected areas.

RECOMMENDATION Employ a licensed painting contractor to seal the void as necessary.
