WOOD DESTROYING PESTS AND ORGANISMS INSPECTION REPORT

Building No. 5343	Street Janisann ave	City Culver City	ZIP 90230	Date of Inspection 04/04/2024	Number of Pages 4
----------------------	------------------------	---------------------	--------------	----------------------------------	----------------------

Hammer Pest Control 1455 N Monterey Pass Road Suite 102 Monterey Park CA 91754 (323) 318-2477 email@hammerpestcontrol.com Fax (323) 318-2474	Report # : 13412 Registration # : PR7795 Escrow # : <input type="checkbox"/> CORRECTED REPORT
--	--

GENERAL DESCRIPTION: One story building, stucco, gable comp roof, detached garage, occupied	Inspection Tag Posted: Attic Other Tags Posted:
---	---

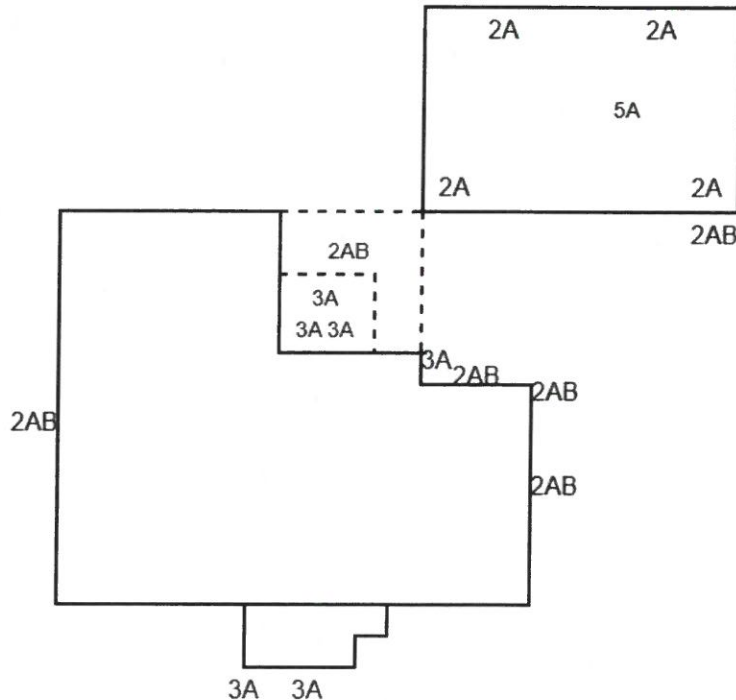
Diagram Not To Scale

FINDINGS - Drywood termites found at rafter tails, garage framing, shed studs (back of garage), deck flooring

FINDING - Drywood termite damage found at 2x4 rafter tails, deck flooring

FINDING - Dry rot fungus damage found at window framing, shed door, water heater box cover, deck flooring

RECOMMENDATION - Fumigate the structure for the control of wood destroying beetles. Owner or agent to prepare the structure for fumigation as per list of instructions to be furnished by this company. The structure must be vacated until released for re-entry by the licensed fumigator.

Recommendation: Repair/Replace damaged wood work. If damage extends into inaccessible areas, a supplemental report will be issued along with new estimates if within the scope of this company's operation.
