## Home Inspection Report

**7 Chopin Court, Rancho Mirage**

This is a supplemental to our original report no.584647 dated 2/26/2022 and should be made a part thereof.

### **SUPPLEMENTAL INSPECTION**

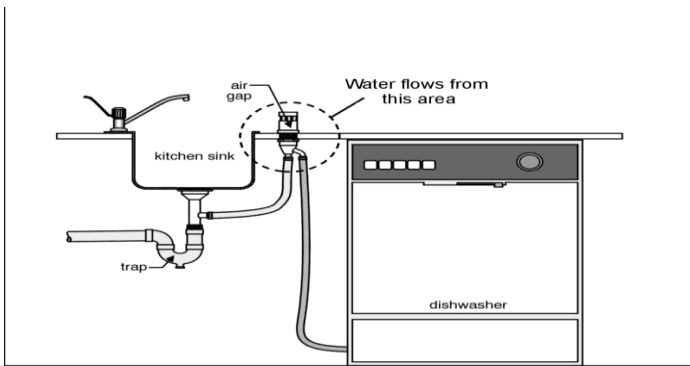
Illustration 9F

- ! 7. The air-gap or its connection to the disposal, appears to be restricted, causing water to flow out of the air-gap during the drain cycle of the dishwasher. We recommend that the drain system be cleaned or modified to correct this deficiency. (See Illustration 9F) (See Photo 4)

Clogged or restricted air gap

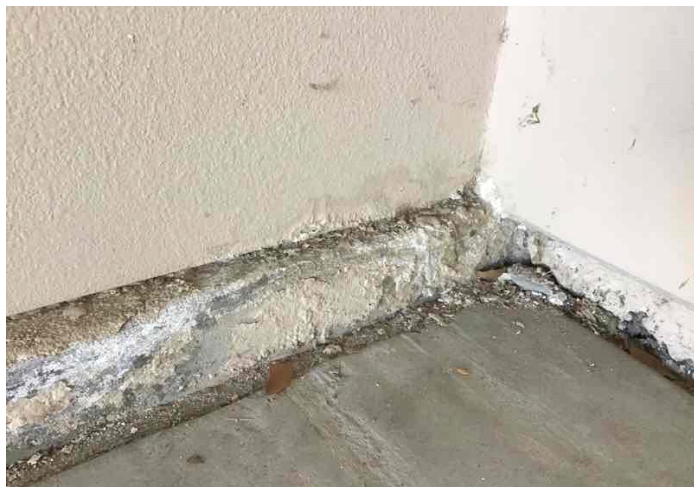
Photo 01

- ! 3. The wall at the garage next to the garage man door shows evidence of water stains. It is recommended that the source of the moisture be identified and corrected and the surface be repaired and refinished to restore its appearance. (See Photo 1)

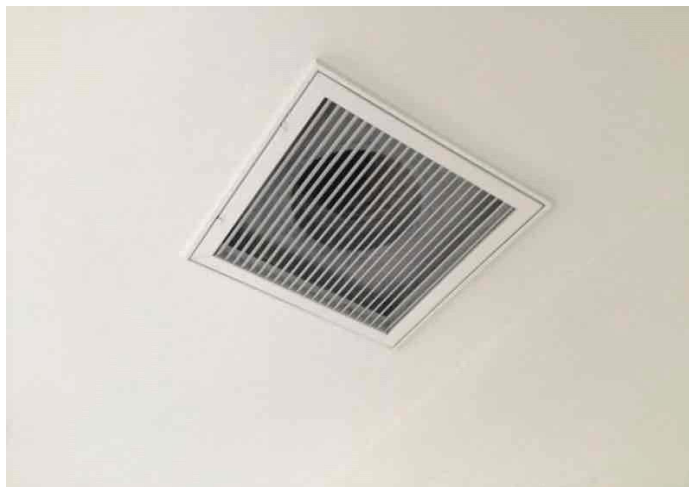
Photo 02

- !** 1. The missing furnace air filter should be replaced. This will help keep dust from re-entering the occupied interior and help keep the blower and duct work clean. (See Photo 2)

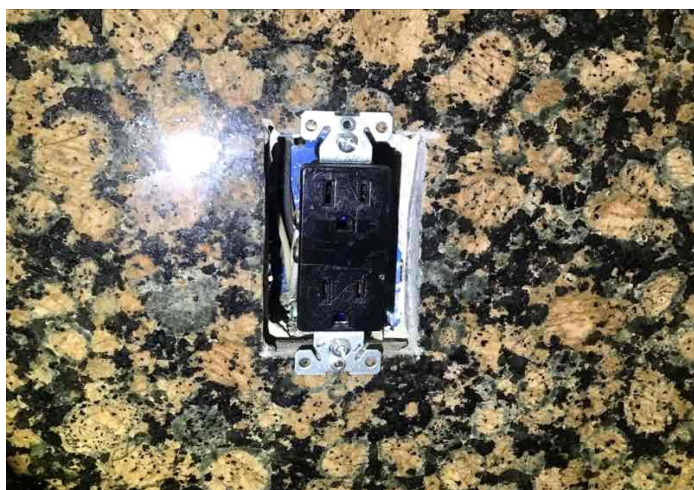
Photo 03

- ! 1. Exposed electric connections or open junction boxes at the left side attic should be corrected. All electric connections should be made inside approved junction boxes fitted with proper cover plates. (See Photo 6)
- ! 2. The missing outlet cover plates at the kitchen should be replaced. Based upon our inspection of a representative number of outlets we recommend checking every outlet to make sure they all have covers. (See Photo 3)

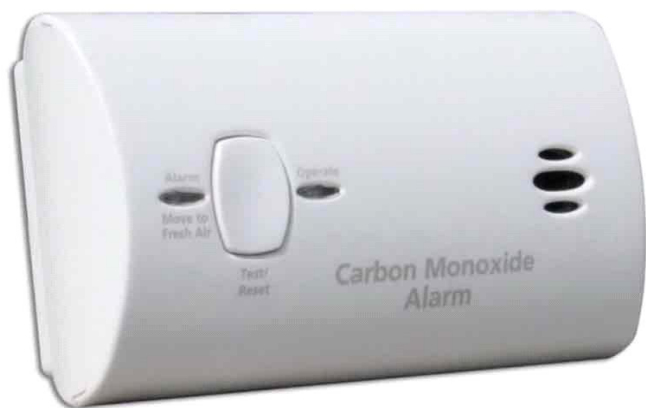
Photo 05

- ! 2. California law requires that all homes have a State Fire Marshall approved Carbon Monoxide Detector be installed outside of the sleeping areas in the hallway and on each level of the home including basements. At the time of this inspection a Carbon Monoxide Detector could not be located. We recommend consulting with the owner to see if a Carbon Monoxide Detector exists and if not they should be installed in all required locations. (See Photo 5)

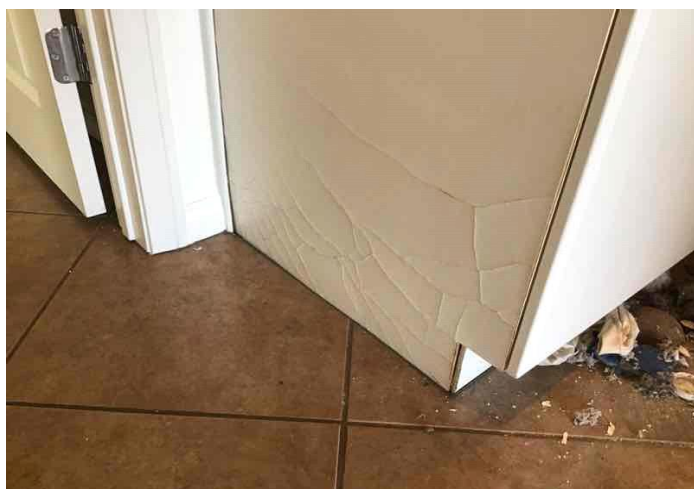
Photo 07

- ! 1. The base and/or side of the laundry cabinet sink shelf is deteriorated. We recommend the advice and services of a licensed pest control operator for investigation and possible repair of this condition. (See Photo 7)
