Kevin Kelpin  
7177 Sunny Place  
Yucca Valley, CA 92284

Date of Inspection: 3/20/2025 - 2:00pm

Inspection type: General Home Inspection

Year Built: 1963

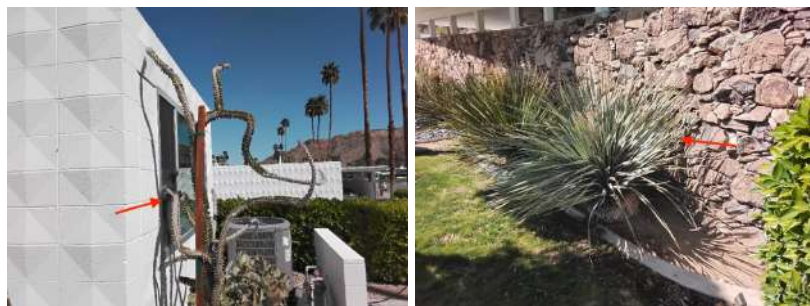
**Trees and shrubs are rubbing against the house in a few areas on the south side.** Note: Trees and shrubs that are in direct contact with the home can cause damage to the house, introduce moisture and will attract insect/vermin activity. Recommend licensed landscaping contractor trim/remove.

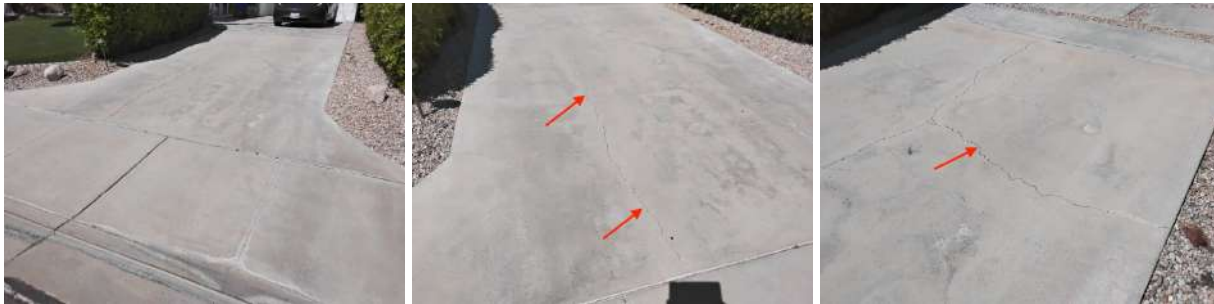
Cracks were observed in the driveway. Recommend handyman seal cracks with a masonry sealant to avoid water penetration and future settling and/or heaving.

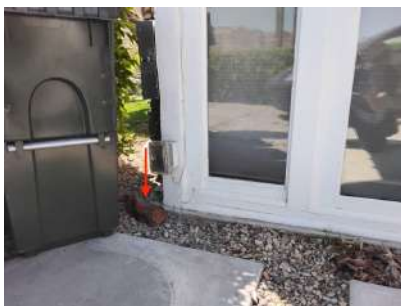
Low Spot - South

Water should always be diverted away from the house and foundation. There are low spots and evidence of pooling next to the house and foundation in a few areas around the home. All 3 gutter downspouts terminate next to the house and foundation. It is recommended that all downspouts have a splash block or extension for proper diversion away from the house and foundation. Recommend licensed landscaping contractor correct and maintain proper drainage and sloped grading away from the home in all areas.

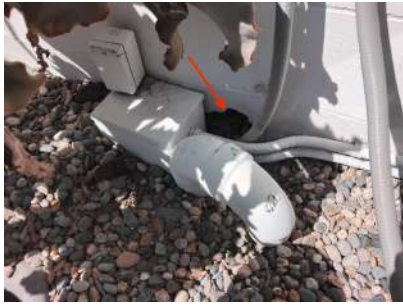
Unsealed Hole - South

There is an unsealed hole at the siding on the south side. There is an unsealed wall penetration at the spigot on the north side. It is recommended that all wall penetrations are properly sealed to avoid water penetration and pest intrusion. Recommend handyman repair.

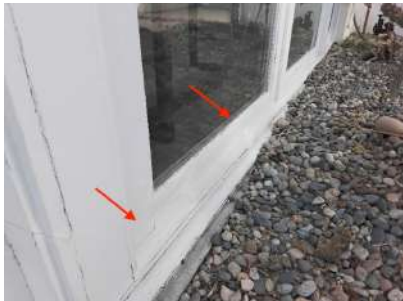
Paint was peeling at the window trim/frames around the addition. Recommend qualified professional repaint to avoid water penetration and potential dry rot.

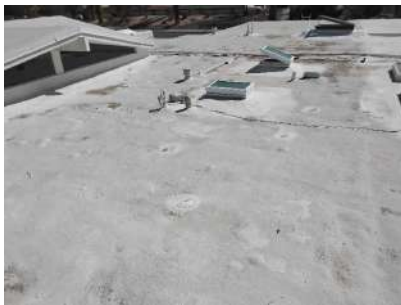
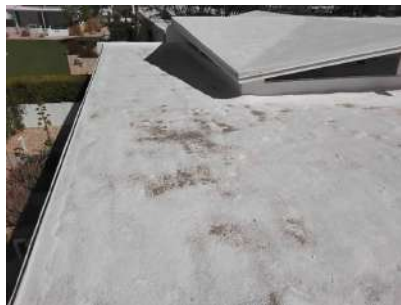
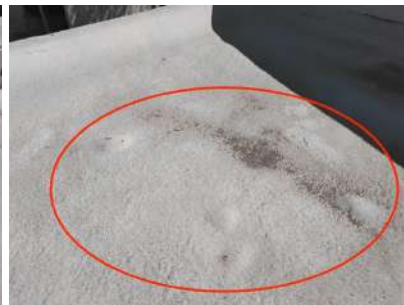
Blistering

**SPF (Spray Polyurethane Foam)** - The exact age of the roof could not be determined at time of inspection, but appears to be approximately 20-25 years old. **The overall condition of the roof was not satisfactory.** There are blisters and holes in the foam throughout, indicating the roofing is at the end of its service life and needs to be replaced. Patchwork was observed in several areas throughout. The elastomeric sealer is cracking/deteriorating and leaving the foam layer exposed in several areas throughout. Recommend licensed roofing contractor evaluate further/repair/replace as needed to avoid water penetration.

**Note: The typical life span of SPF (Spray Polyurethane Foam) roofs is approximately 20-30 years, depending on installation, elemental factors and maintenance. It is recommended that spray foam roofs be re-coated with an elastomeric sealer once every 5-10 years to prevent deterioration and preserve the foam layer.**

- 1) ROOF – Roof Covering: Elastomeric copolymer coating applied 1/13/2026 (see materials)
- 2) PLUMBING – Water Heater: According to RotoCo Plumbing Company, separate drainage for each piece of equipment is considered optional for older homes. We received a quote of \$3272 (see materials) to separate TRP valve drainage to the outside of the home, recommended only if the room is kept as enclosed living space. If the room is converted back to a carport, separated drainage (if desired) can be accomplished much less expensively by simply draining onto parking slab outside the utility room door.

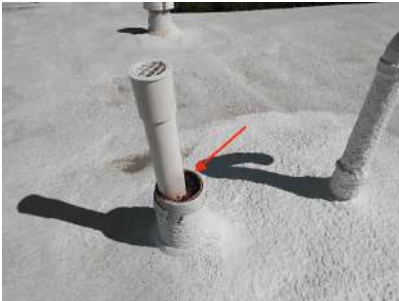
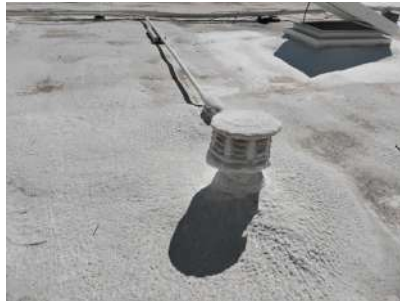
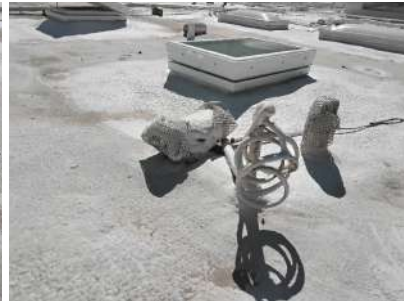
Inadequate Seal/Waterproofing

The water heater vent is without proper waterproofing/flashings. Recommend licensed roofing contractor repair to avoid water penetration.

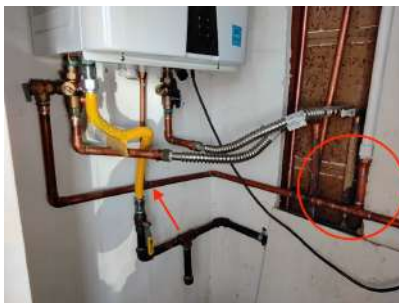
Inadequate TPR Valve Extension

The water heater was manufactured in 2017. The unit was producing hot water at time of inspection. No gas leaks detected. **The TPR (Temperature Pressure Relief) valve extension is improperly installed with T-fittings and serves multiple drains.** Per CPC code, TPR valve extensions shall not have T-fittings, and shall not connect to piping serving any other relief device or equipment (must be installed independently). Recommend licensed plumbing contractor repair.

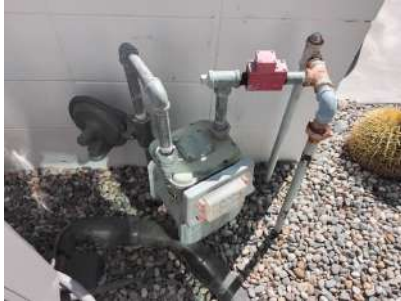
Rust On Pipes and Fittings

The gas meter was located on the south side of the home. Seismic shutoff valve was present. **There was rust/corrosion on the gas line piping and fittings.** Recommend handyman paint with a UV protective paint to avoid further rust/corrosion and potential leaks.

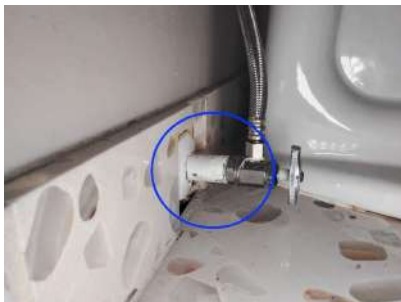
Galvanized Piping

**Galvanized piping was observed in visible areas of the home (toilet supply lines). Note: Galvanized pipes are subject to deterioration from the inside out. This type of piping often clogs or rusts out around 40-50 years of age and will need repair or replacement at that time. No evidence of leaks were observed at time of inspection.**

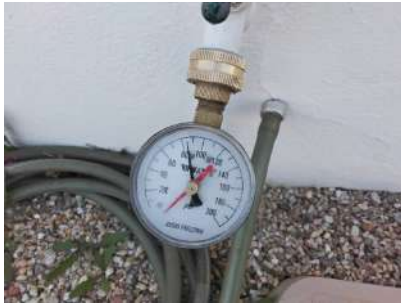
85 psi

**The water pressure for the home was tested at 85-90 psi on 2 separate spigots.** Normal water pressure for a residential home is generally between 40 and 60 psi. Anything above 80 psi can potentially put undue

stress on pipes, fixtures and appliances. Note: Pressure regulator was absent at the water main shutoff. Recommend licensed plumbing contractor install pressure regulator and adjust pressure for the home.

NOTE: Though not listed as defect, we added a recommended water pressure regulator at the point at which water enters the home (see “Water Pressure” page 15).

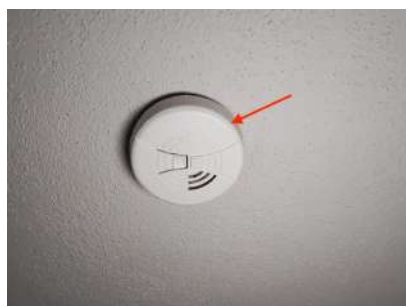
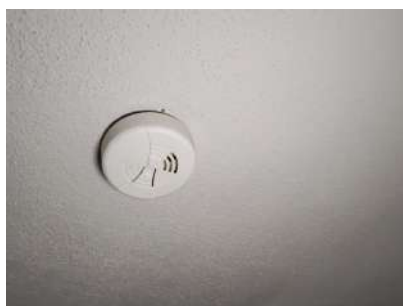
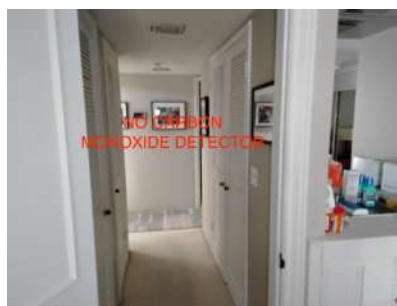
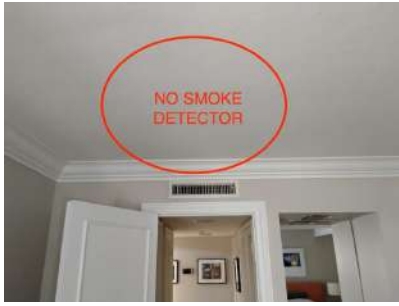
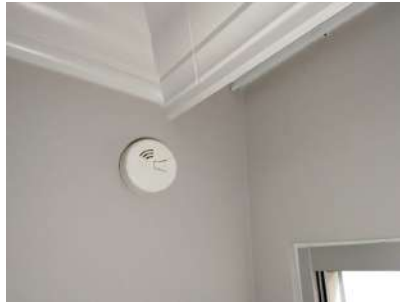
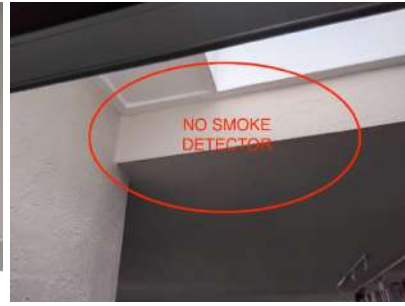
The smoke detector in the hallway was non-operational. Smoke detectors were absent in the primary bedroom and office. Carbon monoxide detector was absent in the hallway. All detectors appear to be outdated (over 10 years old). Per ICC code and California statute, smoke alarms are required in all bedrooms and hallways, on every level of the home. Carbon monoxide detectors are required in each hallway. Note: Full examination and date of each detector is outside the scope of inspection. Smoke detectors should be replaced at least every 10 years due to wear and tear on the sensors and corrosion on the electrical components. All smoke alarms solely powered by a battery are required to feature a non-replaceable, non-removable battery that is capable of powering the smoke alarm for a minimum of 10 years. Recommend installing all detectors to the specified requirements.

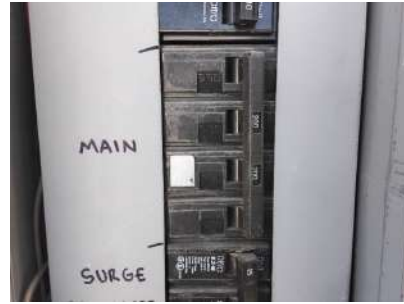
Inadequate Dead Front Cover

Numerous circuits are missing labels. Main service disconnect was present (200amp). The dead front cover is a make shift installation (not from electrical manufacturer), leaving gaps and exposed wires accessible.

Recommend replacing dead front cover with an exact duplicate from the same manufacturer to comply with the UL rating. There was rust on the ground/neutral bus bar inside the panel. Note: Corrosion inside a panel is an indication of unwanted moisture and can lead to poor connections and overheating. Recommend licensed electrician repair noted items and clearly label all circuits.

- 3) PLUMBING – Gas Lines: This issue was not replicated by the gas company. (see materials)
- 4) ELECTRICAL – Main Panel: Circuits labeled, front cover repaired, re-inspected after work completed by Home Team Electric Co. on 12/23/2025 which provided a one-year warranty including discounted hourly rate and free inspections (see materials).

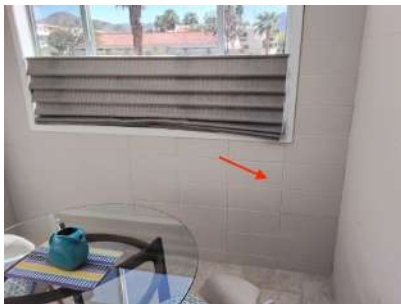
Evidence Of Leakage - Dining Room

There is evidence of leakage at the dining room window. The window in the office is missing a window latch/handle. Recommend licensed window professional repair noted items.

- 6) INTERIOR – Windows: Breakfast room window re-sealed with heavy-duty polyurethane sealant by Desert View Window and Glass Co 1/12/2026.
- 7) INTERIOR – Moisture and Mildew: Verified with gardener there are no irrigation devices outdoors in the area adjacent to the wall.

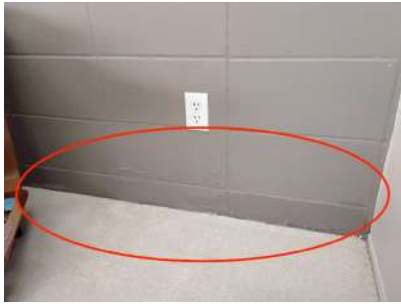
Water Damage - Living Room (East Wall)

There is evidence of water damage (efflorescence) at the bottom of the block wall in the living room (east side). High moisture levels were detected at time of inspection. Recommend licensed building contractor evaluate further. Note: Poor grading was observed at the exterior of this wall. Recommend licensed landscaping contractor correct grading to ensure proper water diversion away from the house and foundation.

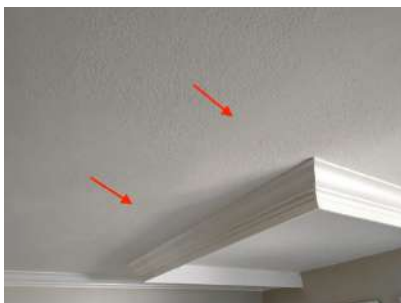
Patchwork - Primary Bedroom

Hairline cracks, blemishes + evidence of patchwork were observed at the ceilings in the primary bedroom and kitchen. Water stains were observed in the guest bedroom closet. No moisture was detected at time of inspection. Note: Hairline cracks are typically caused by normal settlement and thermal expansion. Cracks less than 1/8-inch thick are considered stress cracks and are typically harmless. Recommend qualified professional repair/repaint.

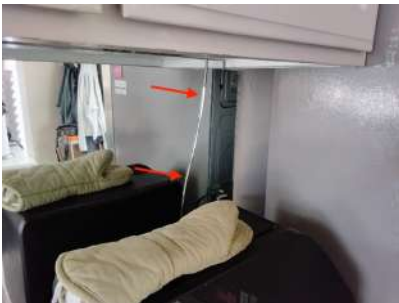
The mirror at the kitchen backsplash is cracked/broken. Recommend licensed glass contractor replace.

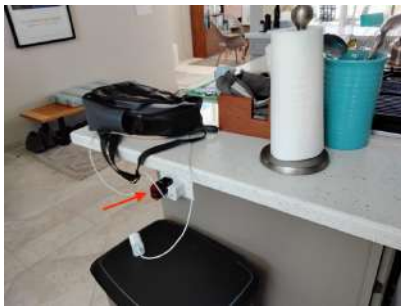
Non-GFCI

Both outlets at the kitchen island are without GFCI protection. Per current NEC code, all outlets serving kitchen countertops are required to have GFCI protection (including islands). Recommend licensed electrician replace.

- 9) KITCHEN – Receptacles: Power receptacles on the island were repaired by Home Team Electric.
- 10) LAUNDRY – Washer/Dryer: A new washer/dryer was installed 1/13/2026, incorporating an improved ventilation system.

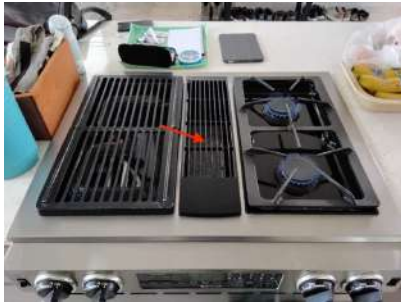
The downdraft range vent fan was abnormally noisy at time of inspection. Recommend qualified professional repair.

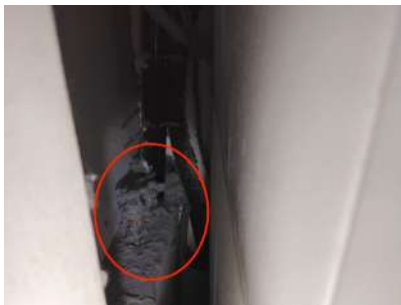
Lint Buildup

The washer and dryer were operational at time of inspection. No leaks were detected at the plumbing valves. There was excessive lint buildup behind the units, indicating a poor dryer vent connection or clogged dryer vent duct (safety hazard).

**Note:** Clogged dryer vents are one of the leading causes of house fires. Recommend qualified professional evaluate further/repair. Recommend periodic monitoring and cleaning of the dryer vent duct for safety.

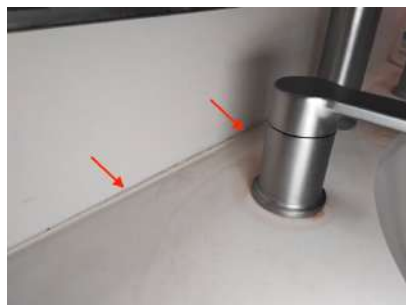
The caulking was cracked/deteriorating at the backsplash in the guest bathroom. Recommend qualified professional re-caulk to avoid water penetration behind sink cabinet.
