# CHOICE HOME INSPECTIONS

## SEWER LATERAL INSPECTION

16519 Gabarda Rd  
San Diego, CA 92128

08/24/2026

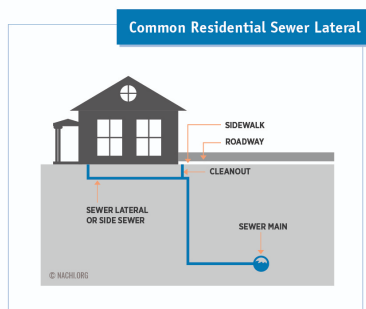
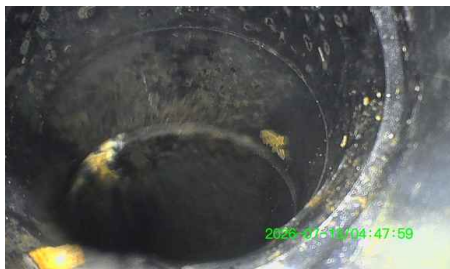
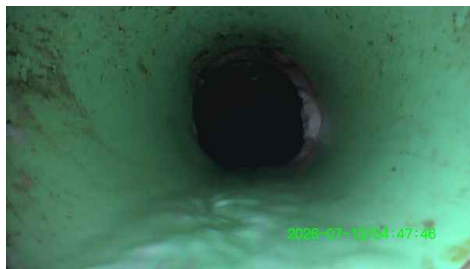
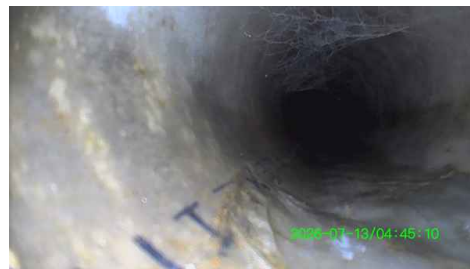
ABS, SDR (PVC), CIP (Cured in Place Pipe)
