# WOOD DESTROYING PESTS AND ORGANISMS INSPECTION REPORT

BUILDING NO. <b>2301</b>	STREET, CITY, STATE, ZIP <b>PLUM ST, POINT LOMA CA 92106</b>	Date of Inspection <b>1/14/2025</b>	No. of Pages <b>11</b>
  <b>10107 Prospect Avenue, Suite B Santee, CA 92071 Tel: (877) 300-6483 Fax: (619) 542-8584 Web: www.xtermite.com</b>		 	
Firm Registration No. <b>PR 3336</b>	Report No. <b>113037</b>	Escrow No.	
Ordered By: LYNN GRIMM 2301 PLUM ST POINT LOMA, CA 92106 858 922 8085	Property Owner/Party of Interest LYNN GRIMM 2301 PLUM ST POINT LOMA, CA 92106 POINTLOMAGRIMMS@GMAIL.COM 858 922 8085	Report Sent To: LYNN GRIMM 2301 PLUM ST POINT LOMA, CA 92106 POINTLOMAGRIMMS@GMAIL.COM 858 922 8085	
COMPLETE REPORT <input type="checkbox"/> LIMITED REPORT <input checked="" type="checkbox"/> SUPPLEMENTAL REPORT <input type="checkbox"/> REINSPECTION REPORT <input type="checkbox"/>			
General Description: 1 Story Single Family Residence, Attic, Sub Area, Furnished / Occupied, With A Detached Garage.		Inspection Tag Posted: Garage  Other Tags Posted: None Noted

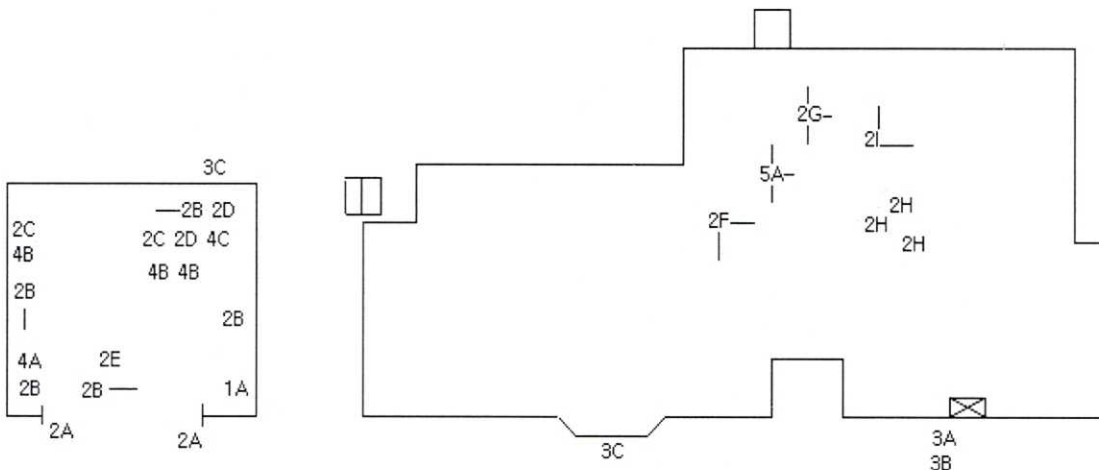
THE DIAGRAM IS NOT TO SCALE

- ITEM 1A FINDING: Subterranean termite infestation(s) was noted at the garage wall framing (approx. 10 ft.).  
RECOMMENDATION: Treat infested area as necessary (trench and treat and/or drill through concrete slab and pressure inject) the ground directly below infestation(s). Treat with Dominion 2L Insecticide (Active ingredient: Imidacloprid), for the control of subterranean termites. Remove or destroy accessible termite tubes/tunnels. Seal drill holes with concrete.

- ITEM 2A FINDING: Evidence of drywood termite infestations was noted at the garage door jamb (approx. 2x6x6 ft.).  
RECOMMENDATION: Exterminate the drywood termites by drilling small holes into the infested wood member and injecting XT-2000 Orange Oil Plus (Active Ingredient: d-Limonene), into the termite channels. XT-2000 Orange Oil Plus is a by-product of the citrus rind, natural in origin, and biodegradable. d-Limonene does not contain and is not manufactured with any of the Class I or II Ozone-Depleting substances listed under the United States Clean Air Act of 1990. This Company will patch all injection holes, cover or remove accessible termite evidence. Painting and/or repairs to wall coverings, paneling, paint are not included in this estimate.

- ITEM 2B FINDING: Evidence of drywood termite infestations was noted at the garage top plate (approx. 2x4x8 ft.).  
RECOMMENDATION: Exterminate the drywood termites by drilling small holes into the infested wood member and injecting XT-2000 Orange Oil Plus (Active Ingredient: d-Limonene), into the termite channels. XT-2000 Orange Oil Plus is a by-product of the citrus rind, natural in origin, and biodegradable. d-Limonene does not contain and is not manufactured with any of the Class I or II Ozone-Depleting substances listed under the United States Clean Air Act of 1990. This Company will patch all injection holes, cover or remove accessible termite evidence. Painting and/or repairs to wall coverings, paneling, paint are not included in this estimate.

- ITEM 2C FINDING: Evidence of drywood termite infestations was noted at the garage ceiling rafter (approx. 2x4x8 ft.).  
RECOMMENDATION: Exterminate the drywood termites by drilling small holes into the infested wood member and injecting XT-2000 Orange Oil Plus (Active Ingredient: d-Limonene), into the termite channels. XT-2000 Orange Oil Plus is a by-product of the citrus rind, natural in origin, and biodegradable. d-Limonene does not contain and is not manufactured with any of the Class I or II Ozone-Depleting substances listed under the United States Clean Air Act of 1990. This Company will patch all injection holes, cover or remove accessible termite evidence. Painting and/or repairs to wall coverings, paneling, paint are not included in this estimate.

- ITEM 2D FINDING: Evidence of drywood termite infestations was noted at the garage wall slat (approx. 1x4x8 ft.).  
RECOMMENDATION: Exterminate the drywood termites by drilling small holes into the infested wood member and injecting XT-2000 Orange Oil Plus (Active Ingredient: d-Limonene), into the termite channels. XT-2000 Orange Oil Plus is a by-product of the citrus rind, natural in origin, and biodegradable. d-Limonene does not contain and is not manufactured with any of the Class I or II Ozone-Depleting substances listed under the United States Clean Air Act of 1990. This Company will patch all injection holes, cover or remove accessible termite evidence. Painting and/or repairs to wall coverings, paneling, paint are not included in this estimate.

- ITEM 2E FINDING: Evidence of drywood termite infestations was noted at the garage wall block (approx. 2x4x1 ft.).  
RECOMMENDATION: Exterminate the drywood termites by drilling small holes into the infested wood member and injecting XT-2000 Orange Oil Plus (Active Ingredient: d-Limonene), into the termite channels. XT-2000 Orange Oil Plus is a by-product of the citrus rind, natural in origin, and biodegradable. d-Limonene does not contain and is not manufactured with any of the Class I or II Ozone-Depleting substances listed under the United States Clean Air Act of 1990. This Company will patch all injection holes, cover or remove accessible termite evidence. Painting and/or repairs to wall coverings, paneling, paint are not included in this estimate.

- ITEM 2F FINDING: Evidence of drywood termite infestations was noted at the attic window frame (approx. 1x3x2 ft.).  
RECOMMENDATION: Exterminate the drywood termites by drilling small holes into the infested wood member and injecting XT-2000 Orange Oil Plus (Active Ingredient: d-Limonene), into the termite channels. XT-2000 Orange Oil Plus is a by-product of the citrus rind, natural in origin, and biodegradable. d-Limonene does not contain and is not manufactured with any of the Class I or II Ozone-Depleting substances listed under the United States Clean Air Act of 1990. This Company will patch all injection holes, cover or remove accessible termite evidence. Painting and/or repairs to wall coverings, paneling, paint are not included in this estimate.

- ITEM 2G FINDING: Evidence of drywood termite infestations was noted at the attic wall trim (approx. 1x2x3 ft.).  
RECOMMENDATION: Exterminate the drywood termites by drilling small holes into the infested wood member and injecting XT-2000 Orange Oil Plus (Active Ingredient: d-Limonene), into the termite channels. XT-2000 Orange Oil Plus is a by-product of the citrus rind, natural in origin, and biodegradable. d-Limonene does not contain and is not manufactured with any of the Class I or II Ozone-Depleting substances listed under the United States Clean Air Act of 1990. This Company will patch all injection holes, cover or remove accessible termite evidence. Painting and/or repairs to wall coverings, paneling, paint are not included in this estimate.

- ITEM 2H FINDING: Evidence of drywood termite infestations was noted at the attic framing (approx. 2x4x8 ft.).  
RECOMMENDATION: Exterminate the drywood termites by drilling small holes into the infested wood member and injecting XT-2000 Orange Oil Plus (Active Ingredient: d-Limonene), into the termite channels. XT-2000 Orange Oil Plus is a by-product of the citrus rind, natural in origin, and biodegradable. d-Limonene does not contain and is not manufactured with any of the Class I or II Ozone-Depleting substances listed under the United States Clean Air Act of 1990. This Company will patch all injection holes, cover or remove accessible termite evidence. Painting and/or repairs to wall coverings, paneling, paint are not included in this estimate.

- ITEM 2I FINDING: Evidence of drywood termite infestations was noted at the attic baseboard (approx. 1x3x8 ft.).  
RECOMMENDATION: Exterminate the drywood termites by drilling small holes into the infested wood member and injecting XT-2000 Orange Oil Plus (Active Ingredient: d-Limonene), into the termite channels. XT-2000 Orange Oil Plus is a by-product of the citrus rind, natural in origin, and biodegradable. d-Limonene does not contain and is not manufactured with any of the Class I or II Ozone-Depleting substances listed under the United States Clean Air Act of 1990. This Company will patch all injection holes, cover or remove accessible termite evidence. Painting and/or repairs to wall coverings, paneling, paint are not included in this estimate.

- ITEM 3A FINDING: Dryrot damage was noted at the eave sheathing. A lack of protective sealant appears to be the cause.  
RECOMMENDATION: Repair source of dryrot condition, remove and replace all dryrot damaged wood. All wood infested with dryrot may not be wood filled and must be removed. If damage leads into inaccessible areas, further inspection by a licensed termite company (Xtermite, Inc. or otherwise) must be performed. Xtermite, Inc. is not responsible or liable for the workmanship of others. Referred to the Owner or Owner's Contractor(s) at this time.

- ITEM 3B FINDING: Dryrot damage was noted at the rafter tail. A lack of protective sealant appears to be the cause.  
RECOMMENDATION: Repair source of dryrot condition, remove and replace all dryrot damaged wood. All wood infested with dryrot may not be wood filled and must be removed. If damage leads into inaccessible areas, further inspection by a licensed termite company (Xtermite, Inc. or otherwise) must be performed. Xtermite, Inc. is not responsible or liable for the workmanship of others. Referred to the Owner or Owner's Contractor(s) at this time.

- ITEM 3C FINDING: Dryrot damage was noted at the window sill. A lack of protective sealant appears to be the cause.  
RECOMMENDATION: Repair source of dryrot condition, remove and replace all dryrot damaged wood. All wood infested with dryrot may not be wood filled and must be removed. If damage leads into inaccessible areas, further inspection by a licensed termite company (Xtermite, Inc. or otherwise) must be performed. Xtermite, Inc. is not responsible or liable for the workmanship of others. Referred to the Owner or Owner's Contractor(s) at this time.

- ITEM 4A FINDING: Drywood termite damaged wood noted at the garage top plate.  
RECOMMENDATION: Repair or remove and replace all drywood termite damaged wood. Structurally weakened wood may not be wood filled. If damage leads into inaccessible areas, further inspection by licensed termite company (Xtermite, Inc. or otherwise) must be performed. Xtermite, Inc. is not liable or responsible for the workmanship of others. Referred to the Owner or Owner's Contractor(s) at this time.

- ITEM 4B FINDING: Drywood termite damaged wood noted at the garage ceiling rafter.  
RECOMMENDATION: Repair or remove and replace all drywood termite damaged wood. Structurally weakened wood may not be wood filled. If damage leads into inaccessible areas, further inspection by licensed termite company (Xtermite, Inc. or otherwise) must be performed. Xtermite, Inc. is not liable or responsible for the workmanship of others. Referred to the Owner or Owner's Contractor(s) at this time.

- ITEM 4C FINDING: Drywood termite damaged wood noted at the garage wall slat.  
RECOMMENDATION: Repair or remove and replace all drywood termite damaged wood. Structurally weakened wood may not be wood filled. If damage leads into inaccessible areas, further inspection by licensed termite company (Xtermite, Inc. or otherwise) must be performed. Xtermite, Inc. is not liable or responsible for the workmanship of others. Referred to the Owner or Owner's Contractor(s) at this time.
