## Home and Sewer Line Inspection - Dec 06, 2024

8494 Hillcrest Avenue  
La Mesa, CA 91941

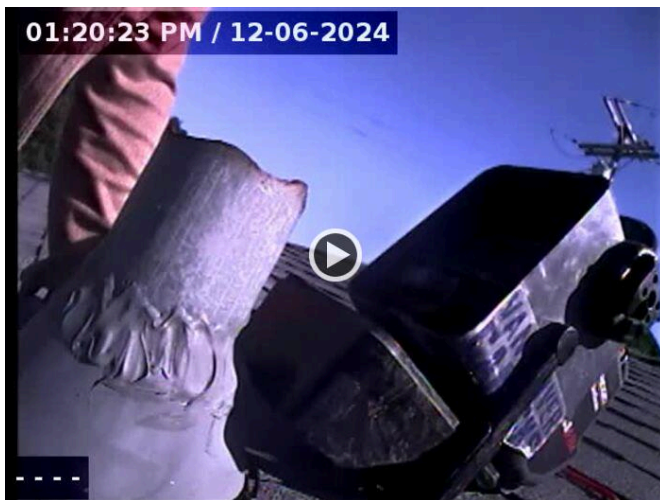
We entered the main waste line through the 3" plumbing vent stack located at the roof. We were unable to push past the first turn due to heavy scaling and flaking to the pipe. We were also unable to open up the plumbing clean outs located in the garage and crawl space areas due the caps being corroded and heavily glued on. We recommend seeking a licensed plumbing professional to open the clean outs and to re-cap them as necessary for future service-related issues. Due to the heavy amount of scaling and flaking we recommend having a plumber hydro jet to clear the line and to have the pipe re scoped to the city lateral to determine if there are any damages present.
