# Confidential Inspection Report

LOCATED AT:  
74 Via Marisma  
Camarillo, CA 93012

INSPECTED ON:  
Tuesday, June 4, 2024

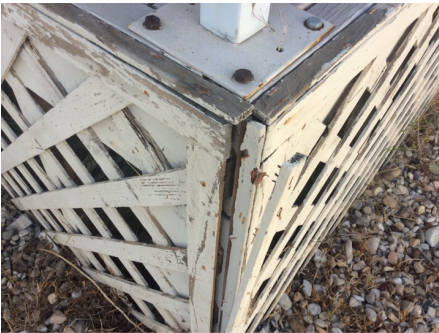
**s-15:** The exterior woodwork exhibits worn and missing caulk and paint which protects against the environment. Recommend preventive maintenance as required.

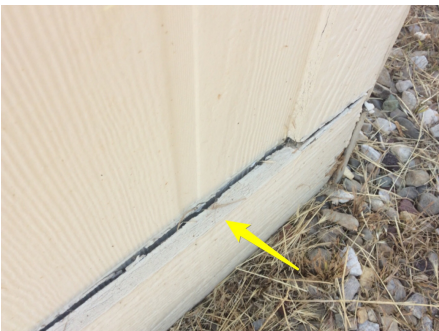
**s-16:** If caulking is needed for maintenance, or in preparation for the next paint job, we suggest a high quality urethane sealant such as 'Sikaflex'. Latex, butyl, oil based, silicone or 'architectural grade' sealants should be avoided on the exterior.

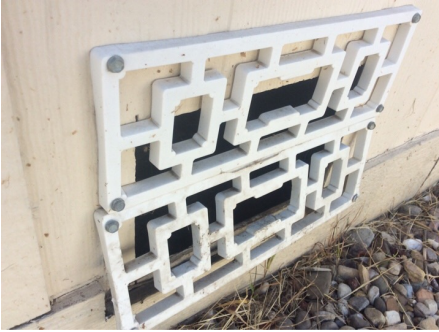
**SFTY** s-18: Damaged vent screen at the .... will allow rodent entry. Recommend repair.

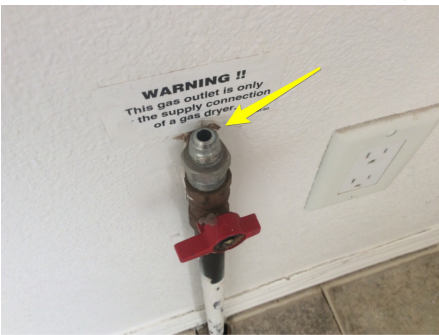
**SFTY** s-28: There is an uncapped gas valve in the the laundry area. If it remains unused, we recommend it be capped to reduce the chance of gas leakage.

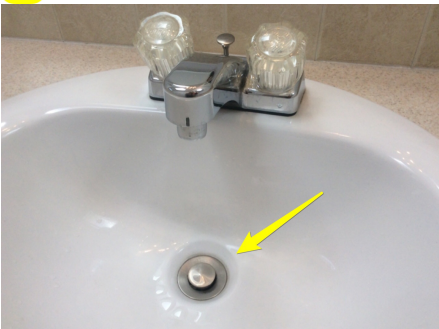
**WRKG** s-96: The sink drain stopper is not functional. Recommend this be corrected.

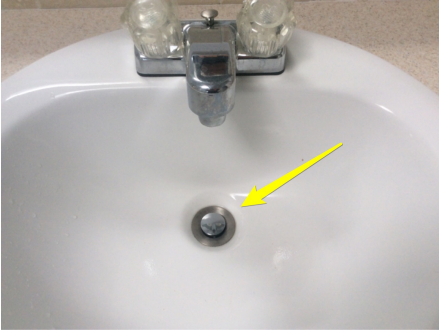
**MANT** s-116: The left drain is slow. Recommend this be corrected.

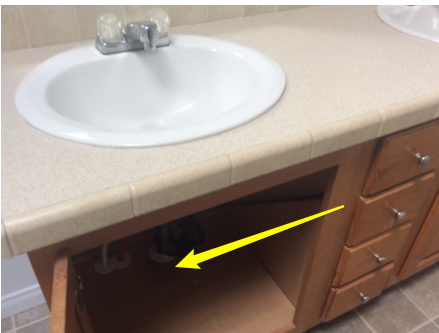
**MANT** s-118: The left sink drain plumbing is leaking. This should be repaired by a licensed plumber. There is likely to be moisture related damage below this area.

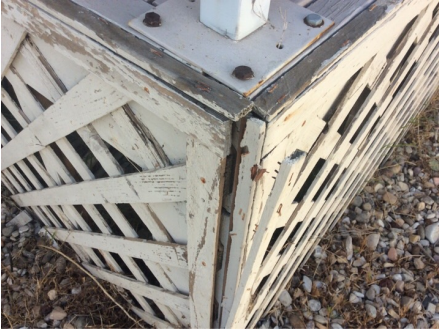
**MANT 15:** The exterior woodwork exhibits worn and missing caulk and paint which protects against the environment. Recommend preventive maintenance as required.

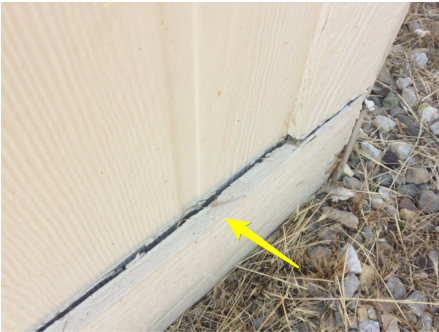
**MANT 16:** If caulking is needed for maintenance, or in preparation for the next paint job, we suggest a high quality urethane sealant such as 'Sikaflex'. Latex, butyl, oil based, silicone or 'architectural grade' sealants should be avoided on the exterior.

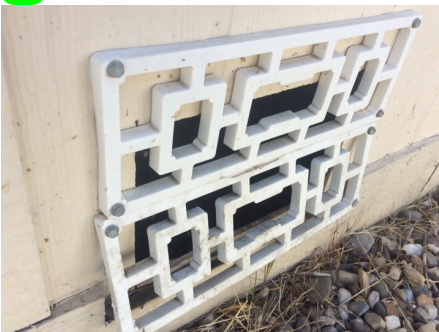
**SFTY 18:** Damaged vent screen at the .... will allow rodent entry. Recommend repair.

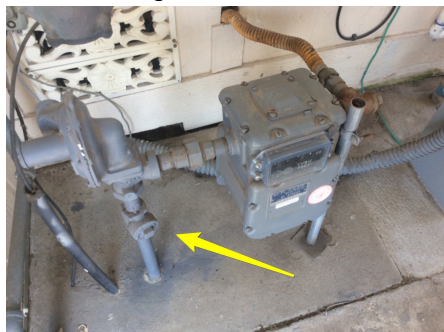
**25:** The gas meter is outside on the right side of the building. The main gas supply shutoff valve is located on the riser pipe between the ground and the meter. This valve should be turned 90 degrees (either way) in order to shut off the gas.

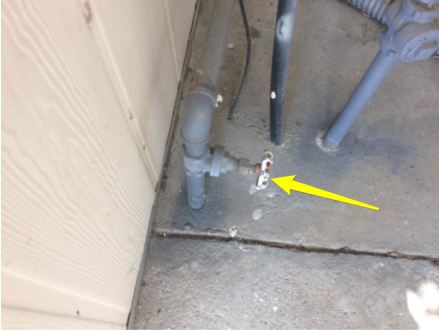
**27:** The gas piping appears to be properly installed and in serviceable condition. We detected no evidence of leakage at any of the exposed gas piping. Pressure testing may reveal leaks, but this procedure is beyond the scope of our inspection.

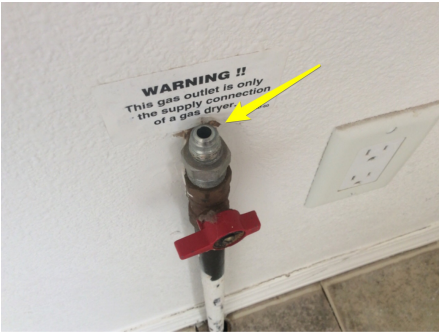
**SFTY 28:** There is an uncapped gas valve in the the laundry area. If it remains unused, we recommend it be capped to reduce the chance of gas leakage.

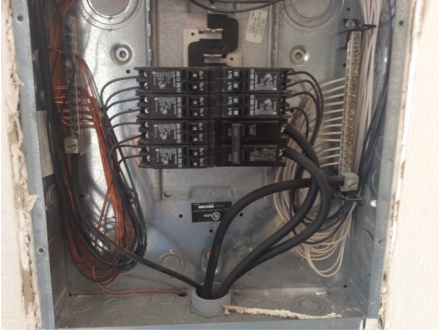
31: A subpanel is located in the laundry room.

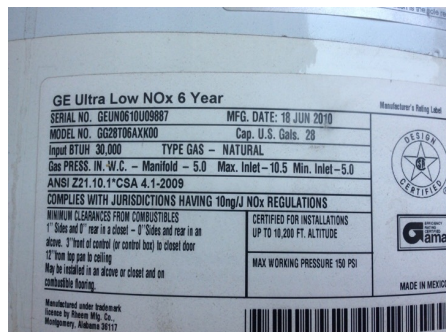
50: This water heater was manufactured in 2010 and has a 28 gallon capacity.

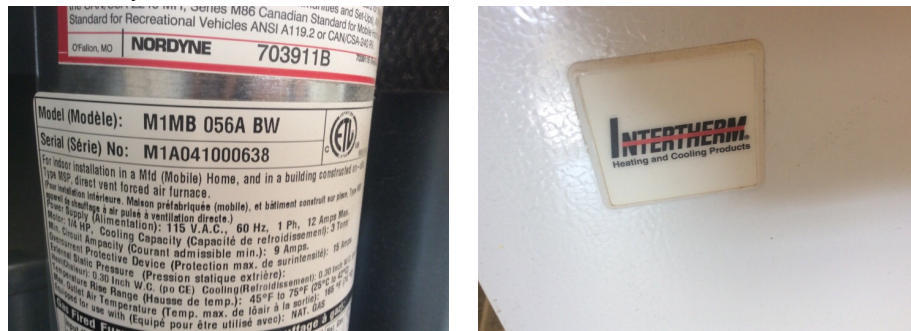
**63:** This system was manufactured in 2004.

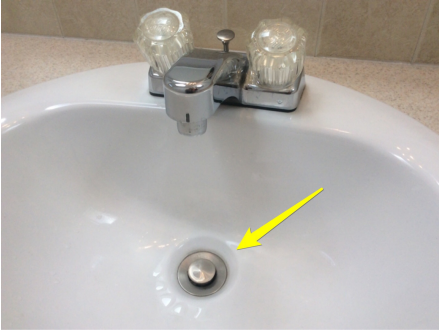
**WRKG** 96: The sink drain stopper is not functional. Recommend this be corrected.

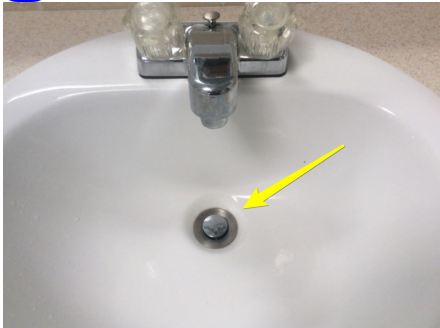
**MANT 116:** The left drain is slow. Recommend this be corrected.

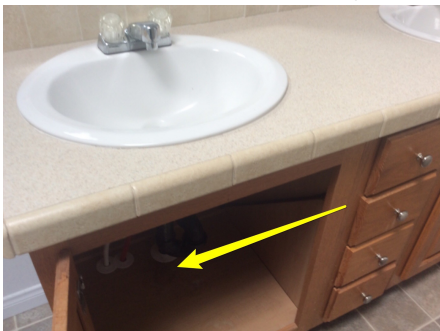
**MANT 118:** The left sink drain plumbing is leaking. This should be repaired by a licensed plumber. There is likely to be moisture related damage below this area.

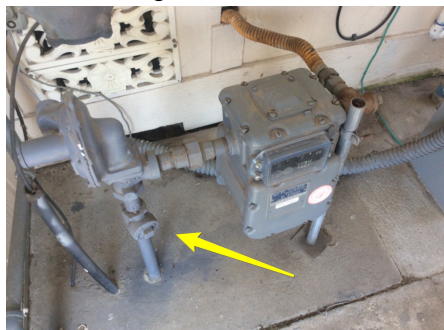
**1:** The gas meter is outside on the right side of the building. The main gas supply shutoff valve is located on the riser pipe between the ground and the meter. This valve should be turned 90 degrees (either way) in order to shut off the gas.
