October 25, 2023

File No. 3119-31

SUBJECT: **GEOLOGICAL REVIEW OF SITE CONDITIONS**
709 Paseo Del Mar, Palos Verdes Estates, CA 90274

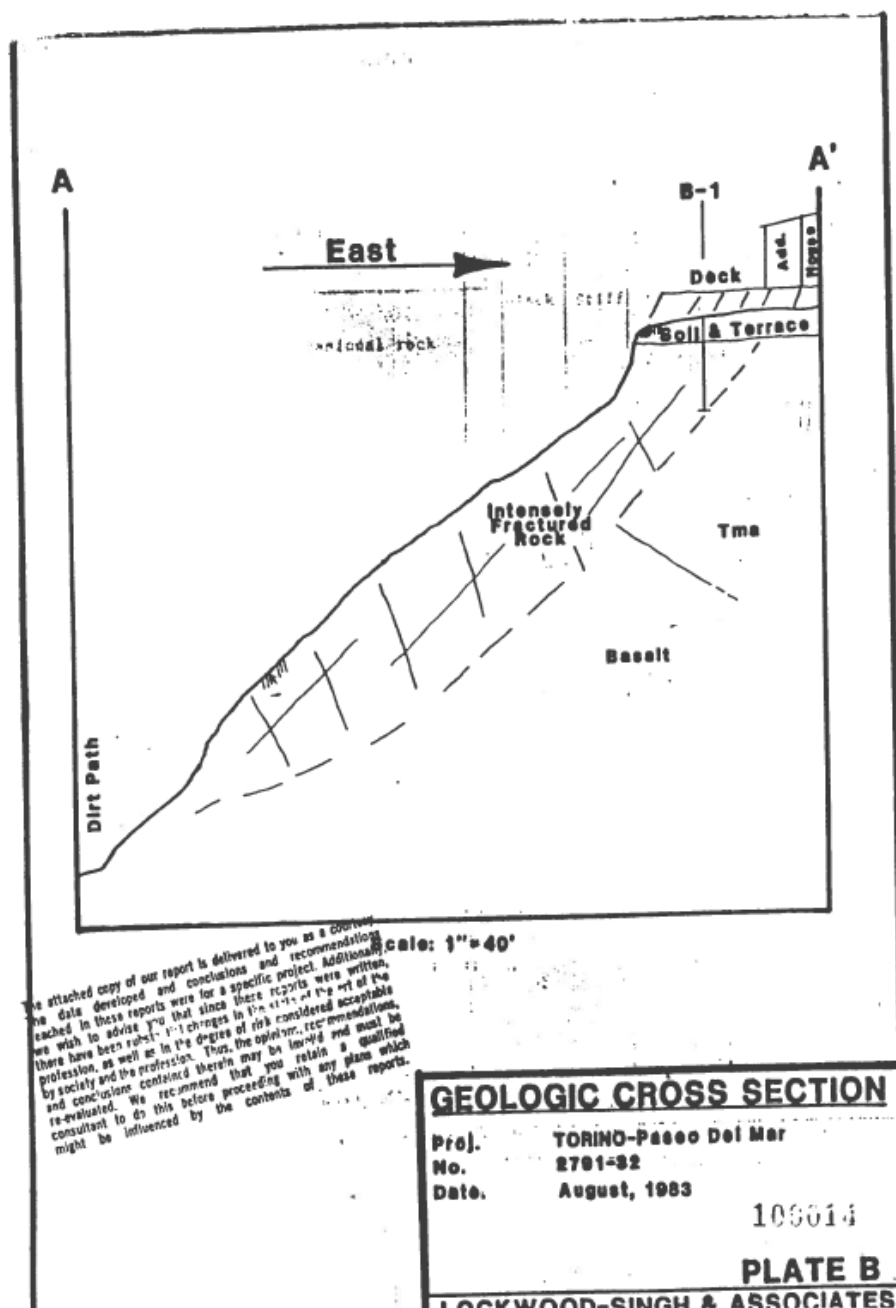
Figure 4. Cross section A-A' from LSA (1983) which illustrates the geology below the western portion of the project site adjacent to the house. The site is underlain by topsoil/marine terrace deposits, sedimentary, and igneous bedrock.

According to LSA, approximately eight feet of topsoil and terrace overlay intensely fractured bedrock that was in turn underlain by sedimentary bedrock of the Monterey Formation above basalt bedrock.

LSA stated that no slide planes or landslide material was observed and recommended that the existing deck be removed and that a new deck along with the house addition be founded on caissons that were a minimum of 2 feet in diameter and 30 feet in depth.

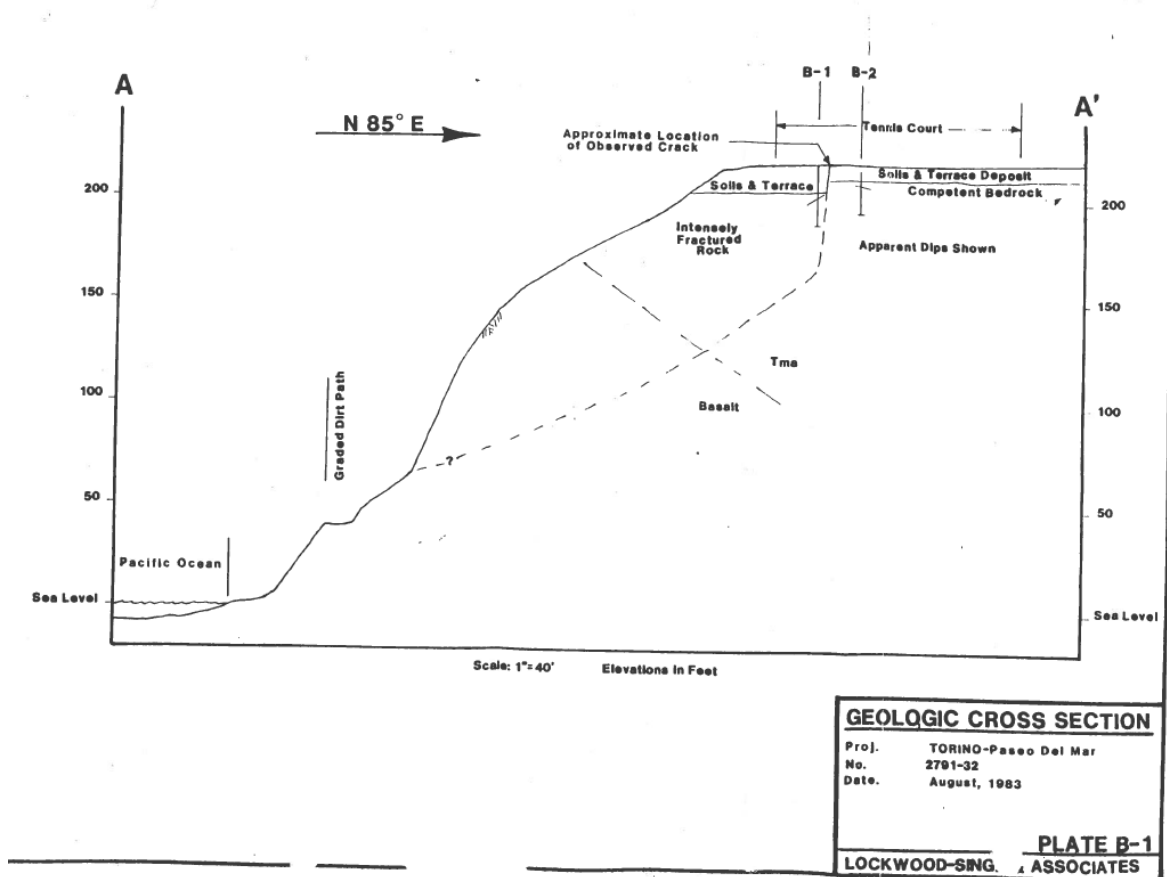
LSA issued an additional report regarding distress to the tennis court. According to LSA the portion of the tennis court located 10 to 20 feet from the top of the descending slope had distress consisting of cracks and vertical offset of several inches. Two borings were drilled in the vicinity of the tennis court and landslide affected bedrock to a depth of 30 feet was observed within a boring located closest to the slope. A similar repair recommendation was provided except that LSA recommended that caissons be a minimum of 2.5 feet in diameter, 40 feet deep and that the row of caissons be located entirely along the west side of the deck to a depth of 40 feet. A cross section from the report is included as Figure 5.

Figure 5. Cross section A-A' from LSA (1983) which illustrates the geology below the tennis court.

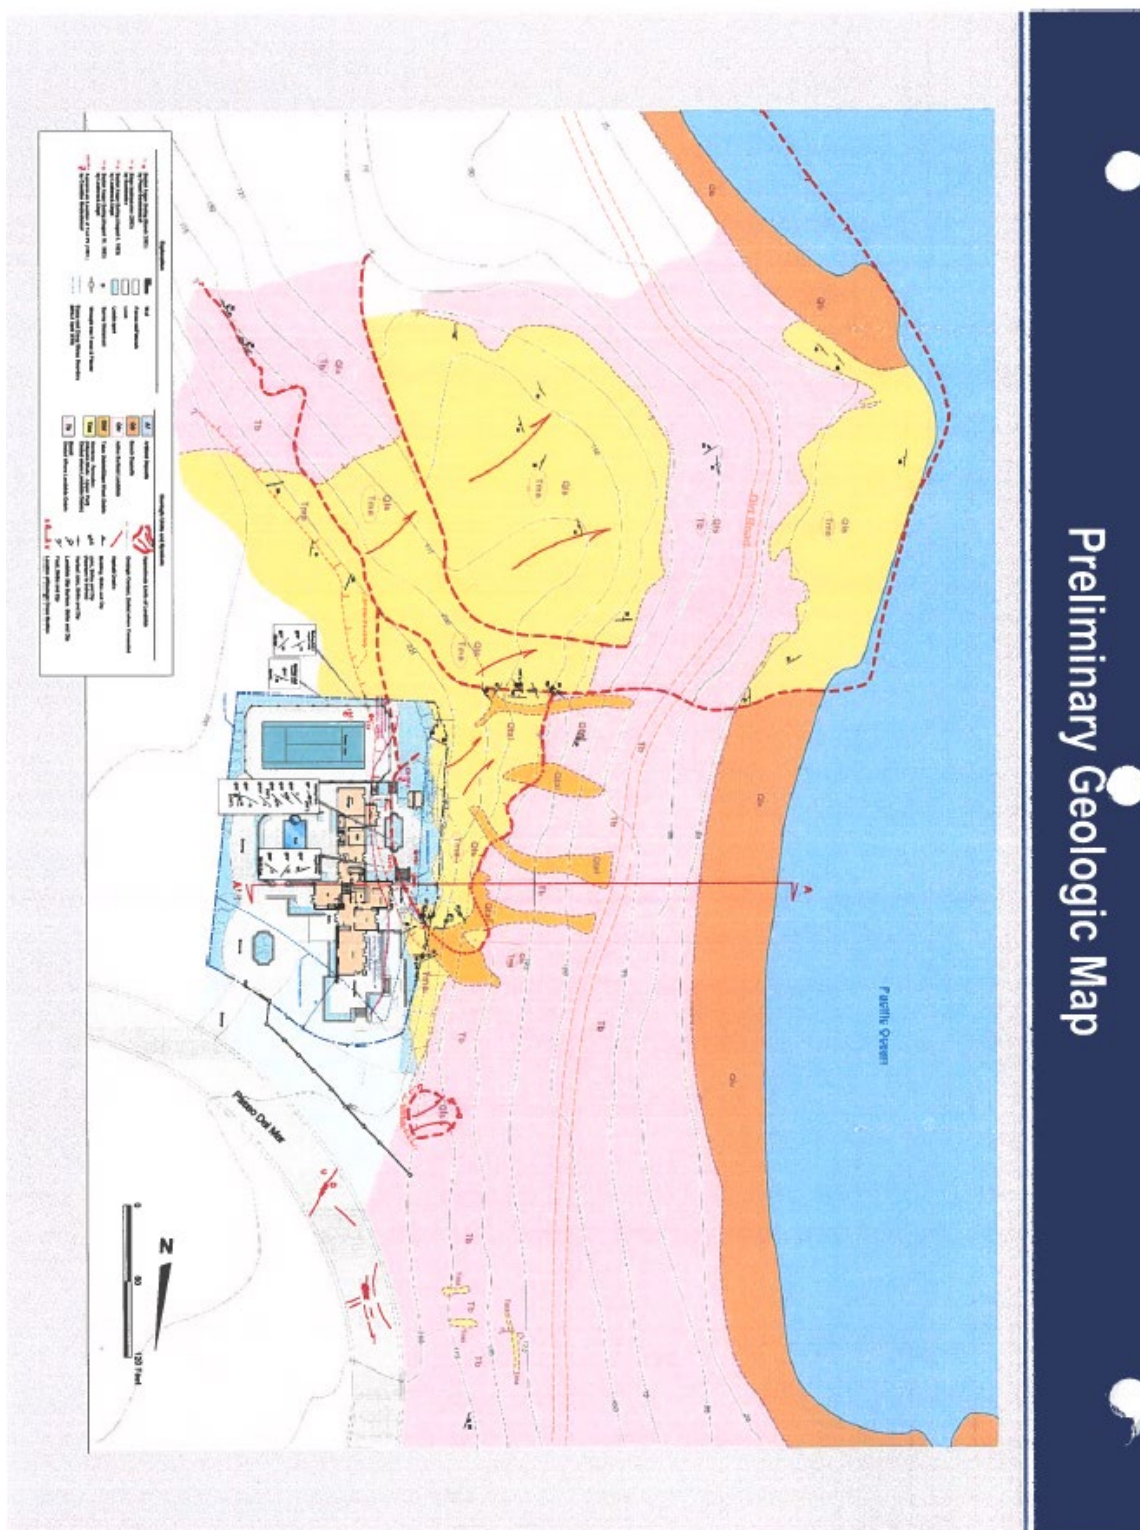
A geologic map of the area, included as Figure 6 indicates that slumps and landslide masses are located close to and also on the property.

Figure 6. A preliminary geologic map of the area. The yellow area depicts landslides. Note a portion of the slides, as outlined by the red dashed lines, extend onto the building pad.

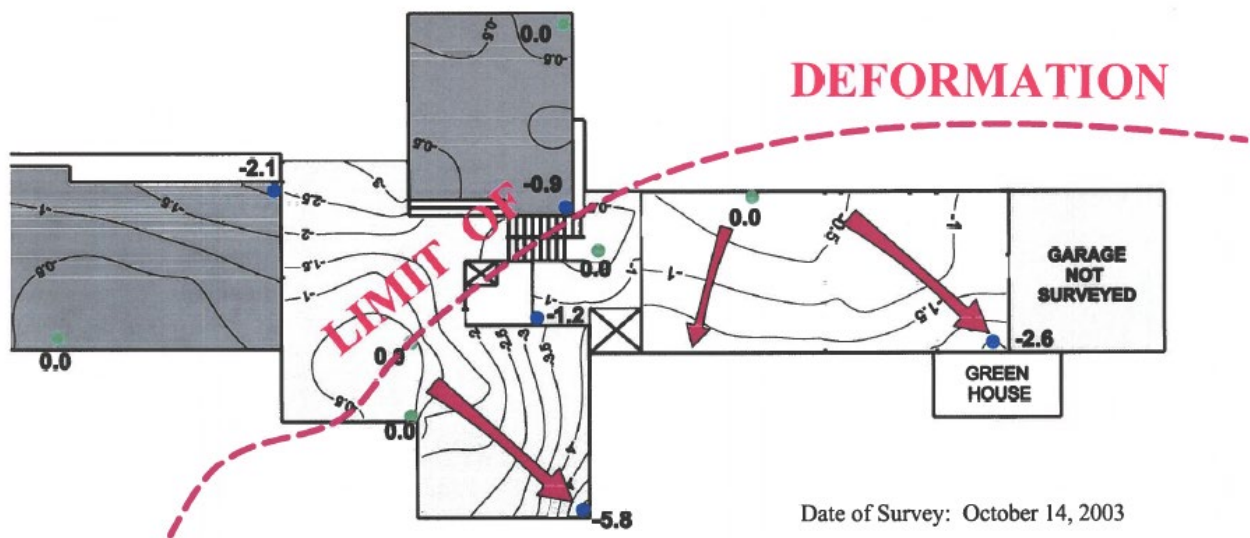
Several floor level surveys (manometers) were conducted on the home and it appears that both the plaintiffs and the defense determined that a portion of the home was affected by movement of the hillside. Figure 7 is a copy of a manometer survey with a line depicting the extent of deformation into the home prepared by the plaintiffs and Figure 8 is the affected area as determined by the defense. Note that the area affected by the slope movement is further into the home as determined by the plaintiffs than by the defense.

Figure 7. The manometer survey prepared for the Plaintiff. The ocean is located at the bottom of the figure. The red line supposedly depicts the portion of the house that has been affected by slope movement. Arrows depict the direction of tilt from deformation.

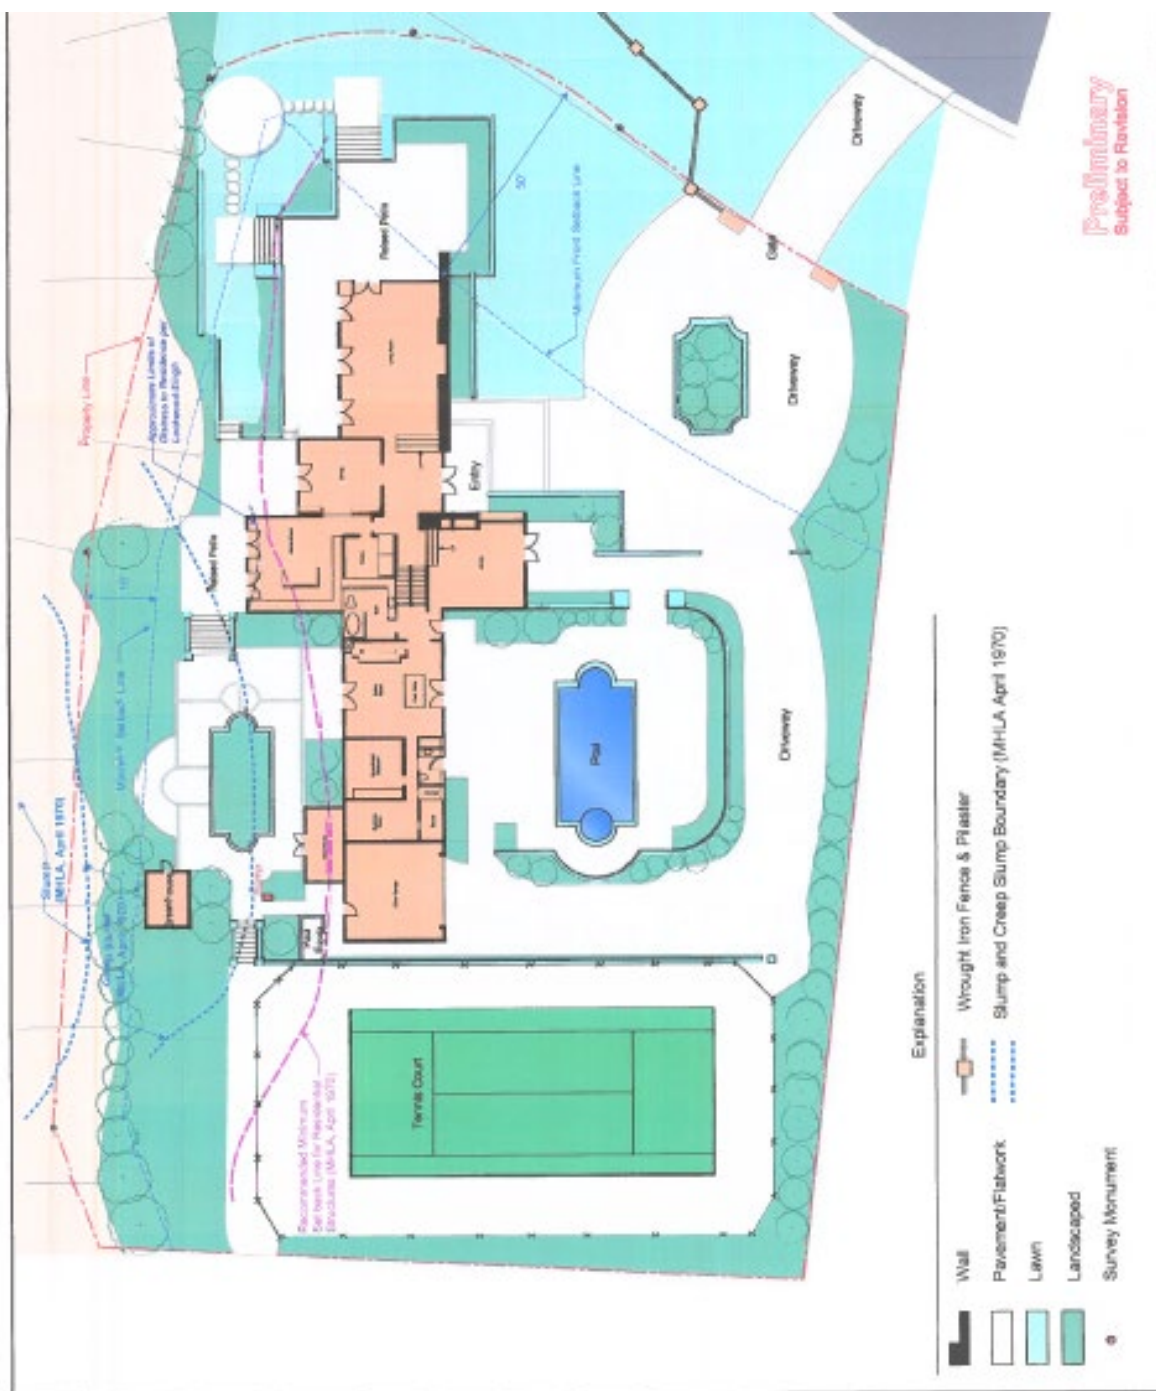
Figure 8. The affected area, as determined by the Defense. The ocean is located to the left of the figure. The purple line supposedly depicts the portion of the house that has been affected by slope movement. Note that it partially extends into the kitchen.

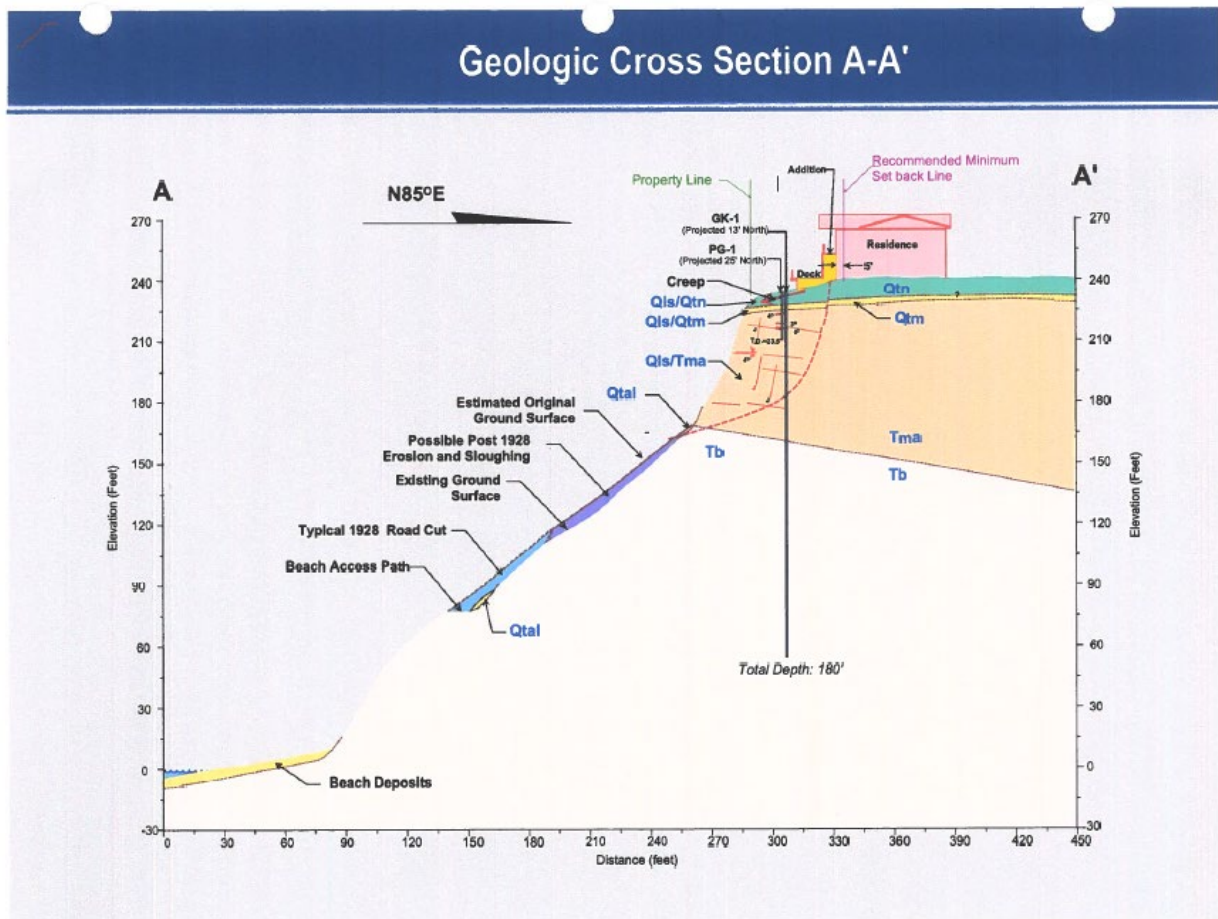
Figures 9 and 10 are cross sections prepared by the defense and plaintiff. The cross sections are similar except that the plaintiffs indicate the underlying landslide material affects more of the house than the defense does.

Figure 9. Cross section from the defense showing the landslide (red dashed line) that extends up to the edge of the house.

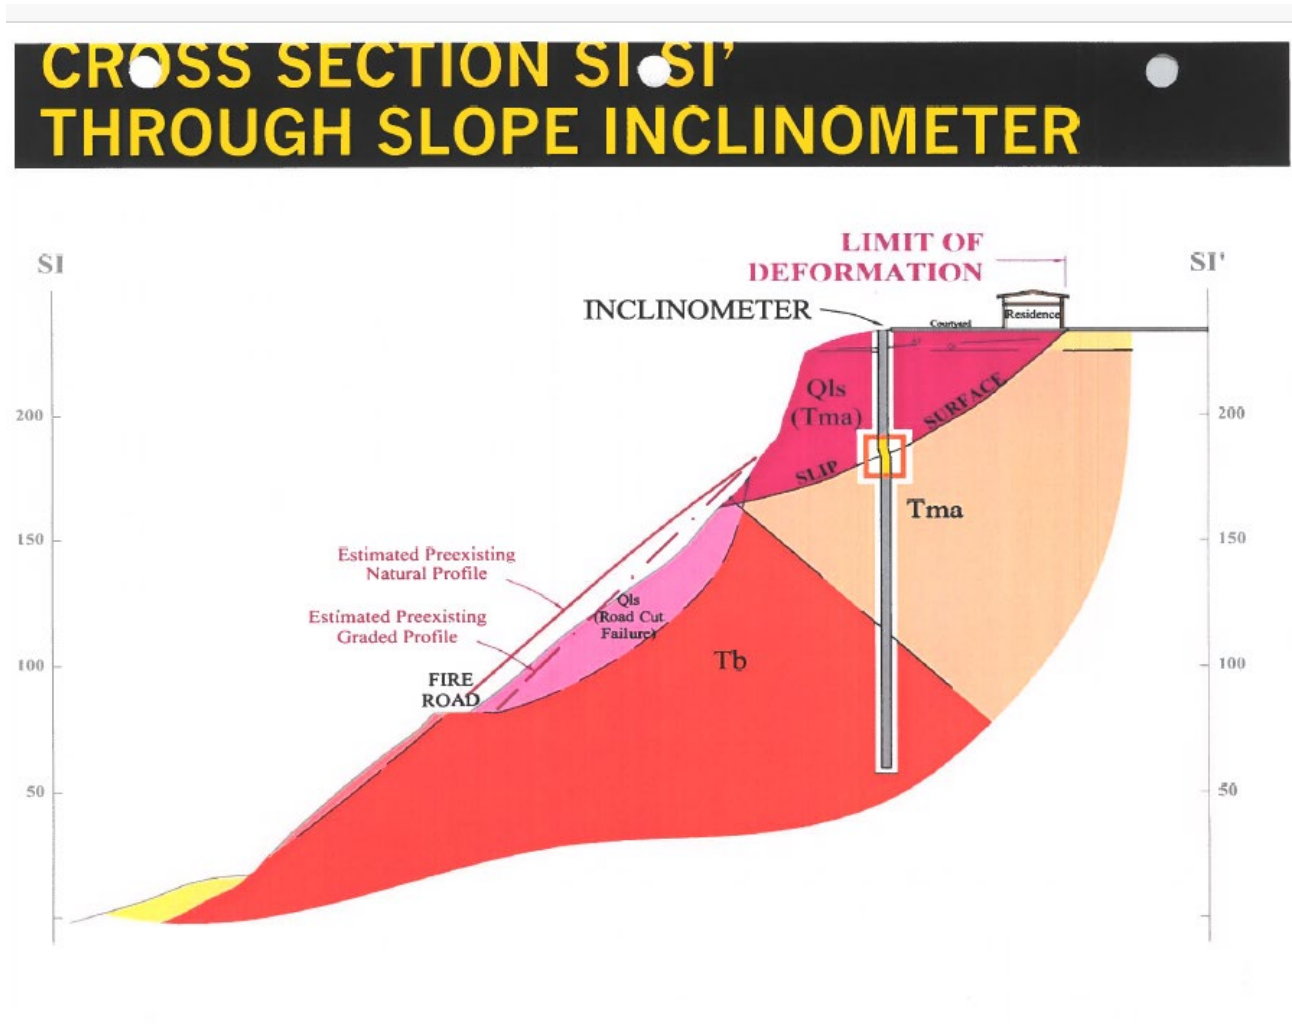
Figure 10. Cross section by Plaintiffs showing that the landslide (Qls material) extends under the home.
