## Home Inspection Report

**23264 Seminole Dr**

**Columbia, CA 95310**

Inspected on Mon, Oct 5 2026 at 12:00PM

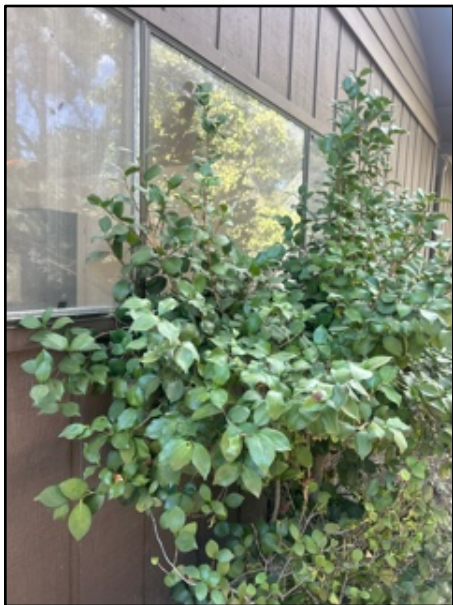
Figure 2-1

Comment 2:  
The shrubs are growing too close to the house and need to be trimmed. This will prevent moisture intrusion behind the exterior covering.

- 1) Comment 2: The shrubs are growing too close to the house and need to be trimmed. This will prevent moisture intrusion behind the exterior covering.

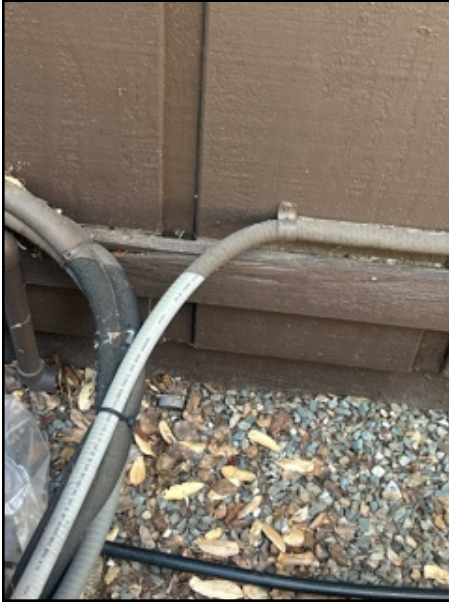
Figure 3-1

**Comment 3:**  
Wood deterioration was noted at the siding at the right side of the structure. Recommend repairing or replacing all affected materials as needed.

- 2) Comment 3: Wood deterioration was noted at the siding at the right side of the structure. Recommend repairing or replacing all affected materials as needed.

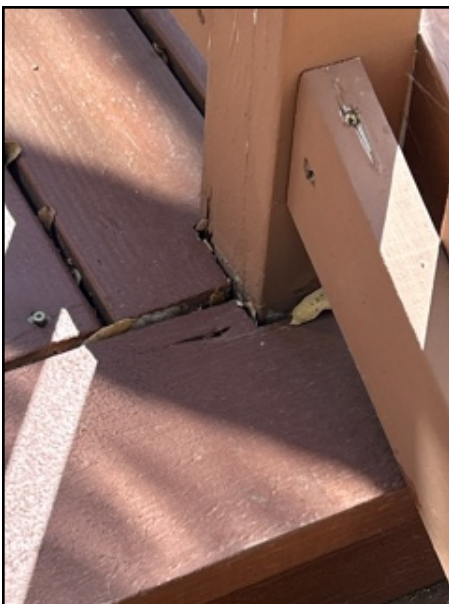
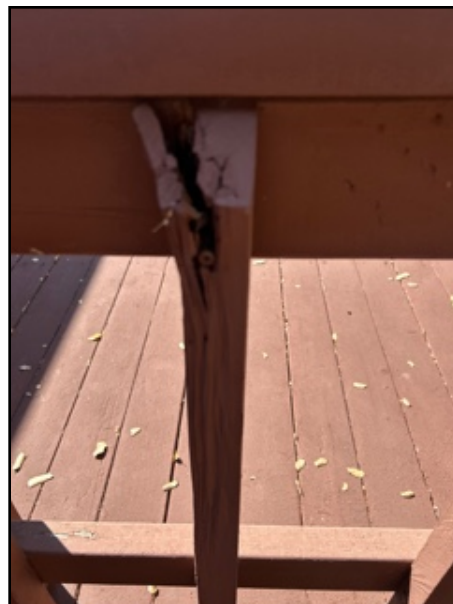
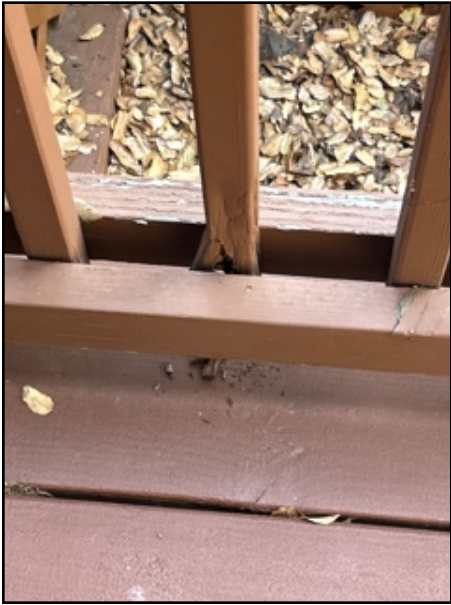
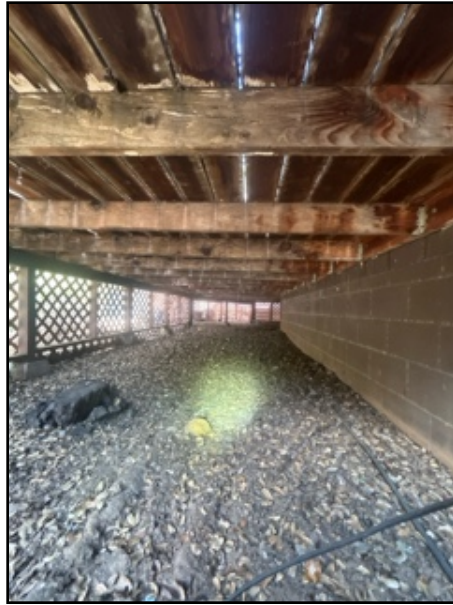
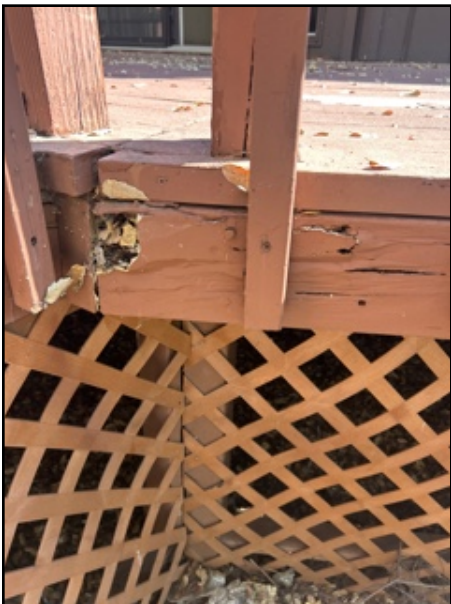
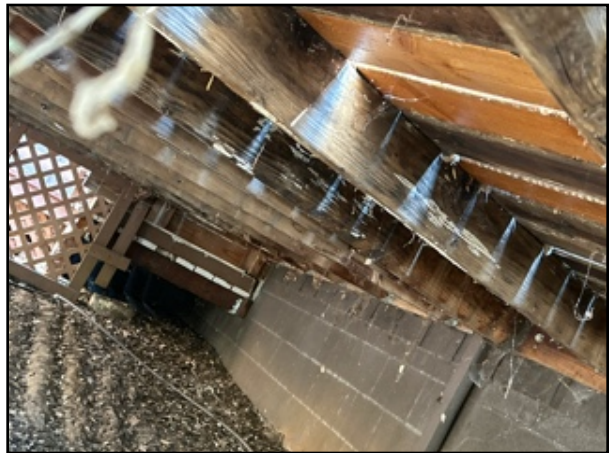
**Comment 4:**  
Wood deterioration was noted at numerous areas of the rear deck. Recommend having this reviewed for repairs or replacement by a licensed contractor.

- 3) Comment 4: Wood deterioration was noted at numerous areas of the rear deck. Recommend having this reviewed for repairs or replacement by a licensed contractor.

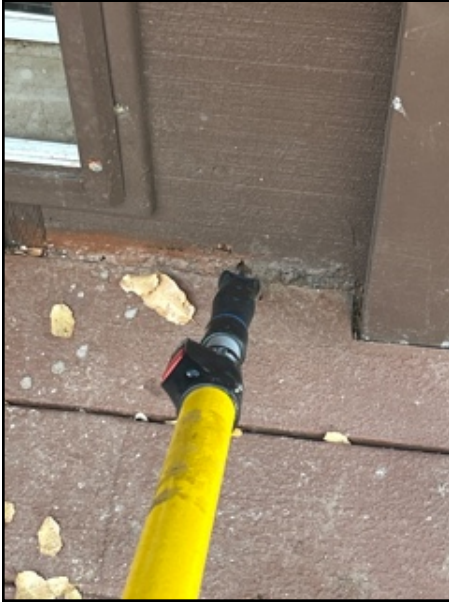
Figure 5-1

Wood deterioration was noted at the siding at the rear deck line. Recommend repairing or replacing all affected materials as needed.

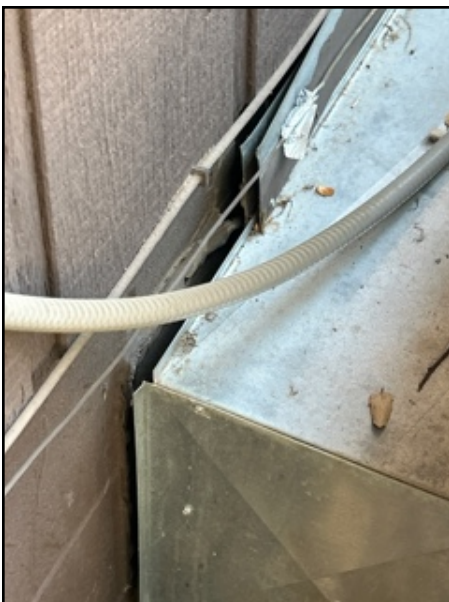
Figure 6-1

The HVAC plenum was not sealed to the siding. Recommend repairs to prevent moisture damage to wood members

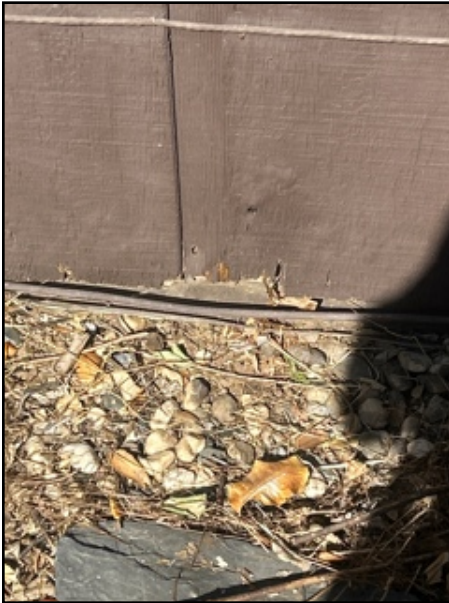
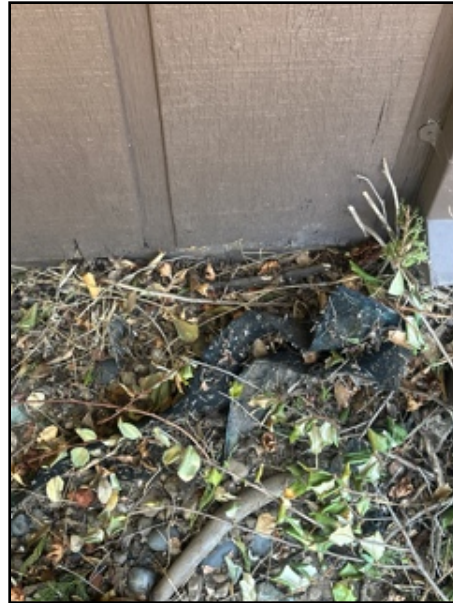
Wood deterioration was noted at areas of the lower siding at the left and front side of the structure. Recommend repairing or replacing all affected materials as needed.

- 6) Comment 7: Wood deterioration was noted at areas of the lower siding at the left and front side of the structure. Recommend repairing or replacing all affected materials as needed.

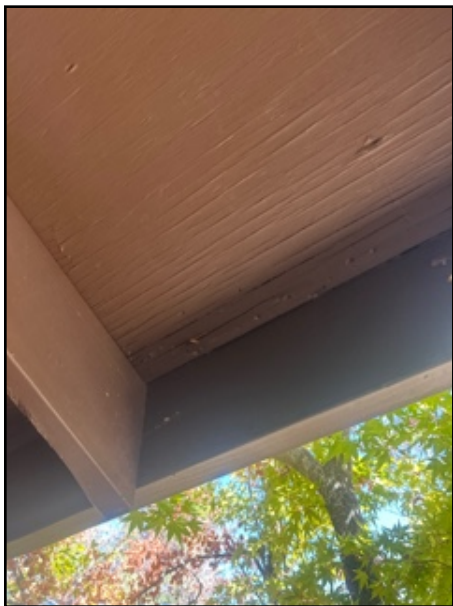
Figure 8-1

Wood deterioration was noted at areas of the roof sheathing at the front of the structure. Recommend repairing or replacing all affected materials as needed.

- 7) Comment 8: Wood deterioration was noted at areas of the roof sheathing at the front of the structure. Recommend repairing or replacing all affected materials as needed.

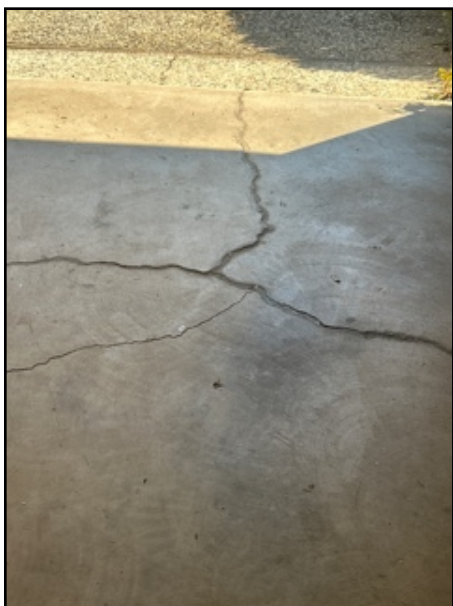
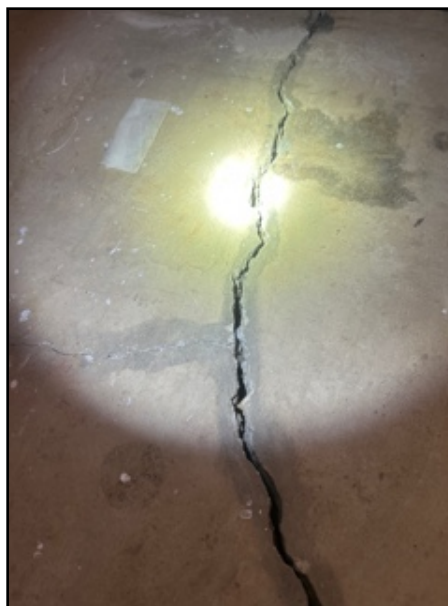
**Comment 9:**  
Concrete cracking and deflection were noted at the garage slab. Recommend having this review for repairs by proper trades.

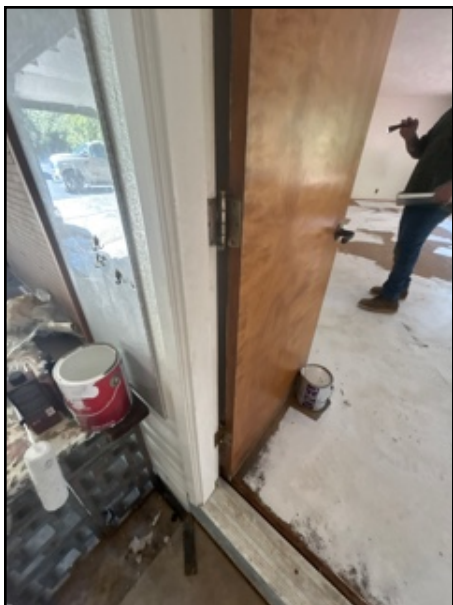
Figure 10-1

Noted that the garage spring assisted door hinges need to be adjusted, as this door should automatically close.

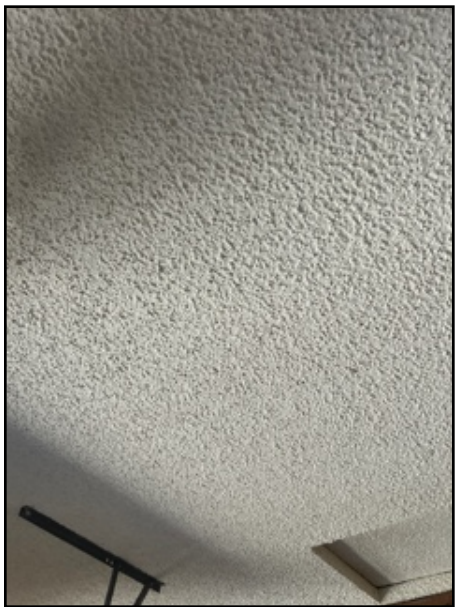
Figure 11-1

Noted that interior ceiling of the garage has a popcorn type ceiling. Due to the age of this house, it should be noted that asbestos may be present at the removal of this. Proper care should be given prior to removing this ceiling. This could include having a section of the finish tested by a qualified person.

Typically this would be visible by gold flakes left in the finish however this ceiling has been painted.

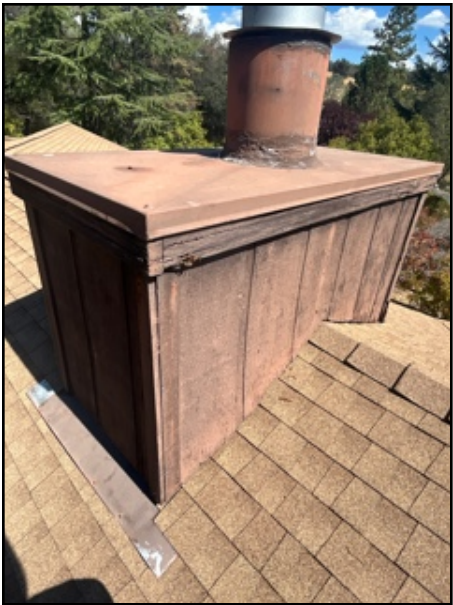
Figure 12-1

**Comment 12:**  
Wood deterioration was noted at the siding at the chimney chase. Recommend repairing or replacing all affected materials as needed.

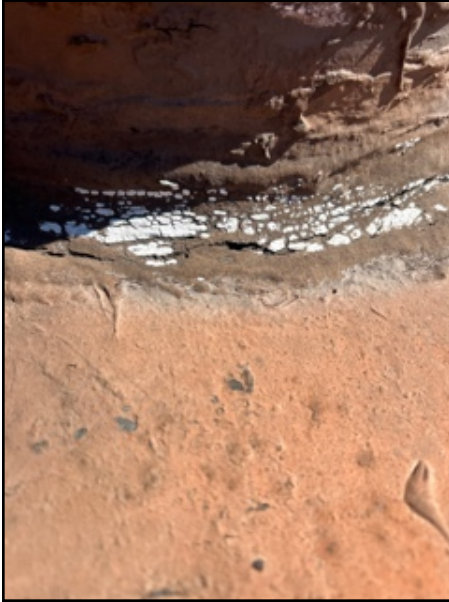
Figure 13-1

Damaged sealant was noted around the chimney flue. Recommend repairs to prevent moisture intrusion to the interior.

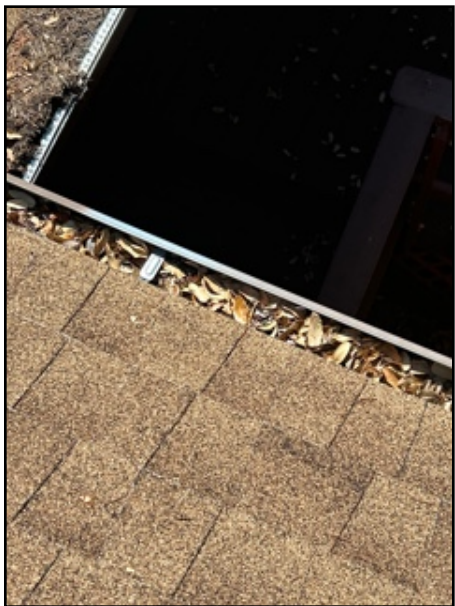
Figure 14-1

Suggest removing all debris and leaves from the gutters. Leaves are the leading cause of rot and rust on gutters. This is due to the acidic value when in contact with water and the galvanized gutters. Suggest cleaning gutters out at least twice a year.

12) Comment 14: Suggest removing all debris and leaves from the gutters. Leaves are the leading cause of rot and rust on gutters. This is due to the acidic value when in contact with water and the galvanized gutters. Suggest cleaning gutters out at least twice a year.

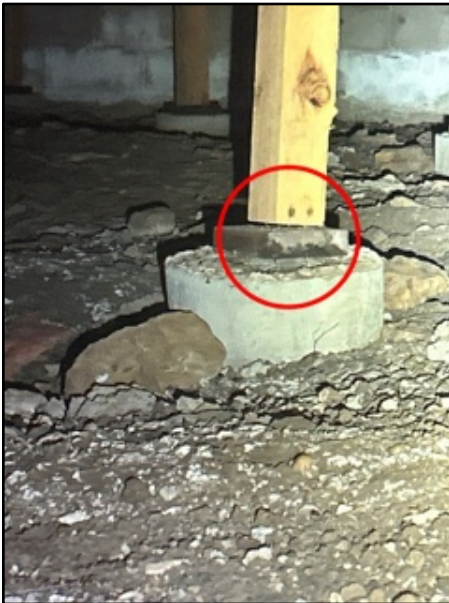
Figure 15-1

A loose foundation pier was noted beneath the living room. Recommend repairs by proper trades.

13) Comment 15: A loose foundation pier was noted beneath the living room. Recommend repairs by proper trades.

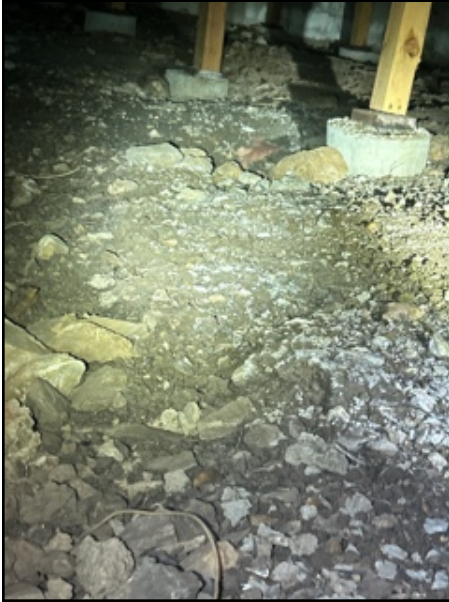
Figure 16-1

The sub area soil was slightly damp. This may be due to a high water table, poor site drainage, or a lack of ventilation. Recommend further review by proper trades.

14) Comment 16: The sub area soil was slightly damp. This may be due to a high water table, poor site drainage, or a lack of ventilation. Recommend further review by proper trades.

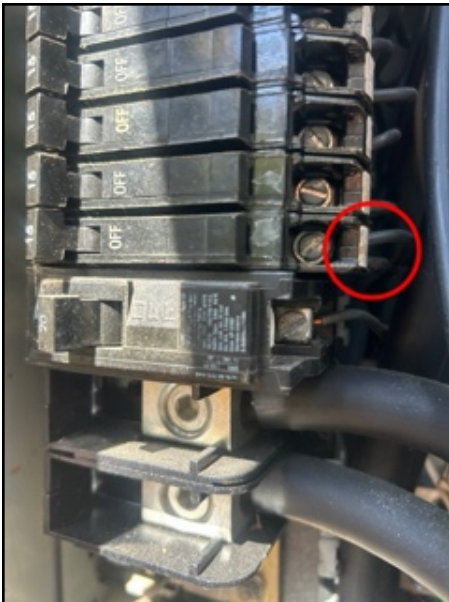
Figure 17-1

One double tapped breaker was noted in the electrical panel. This should be repaired by a qualified person as it could overheat the breakers, potentially causing an issue that could result in a damaged or a weakened breaker.

15) Comment 17: One double tapped breaker was noted in the electrical panel. This should be repaired by a qualified person as it could overheat the breakers, potentially causing an issue that could result in a damaged or a weakened breaker.

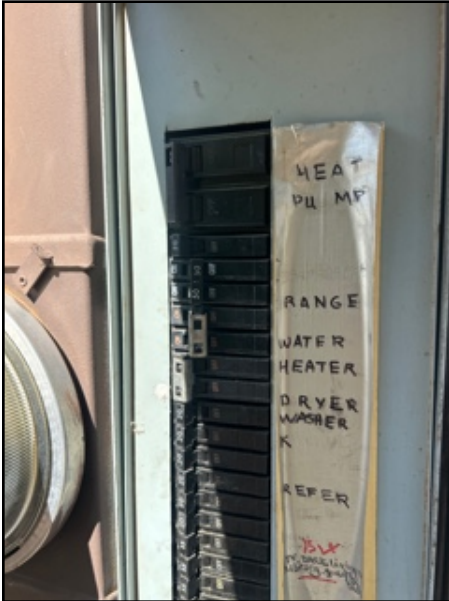
Figure 18-1

Multiple breakers were off in the service panel.

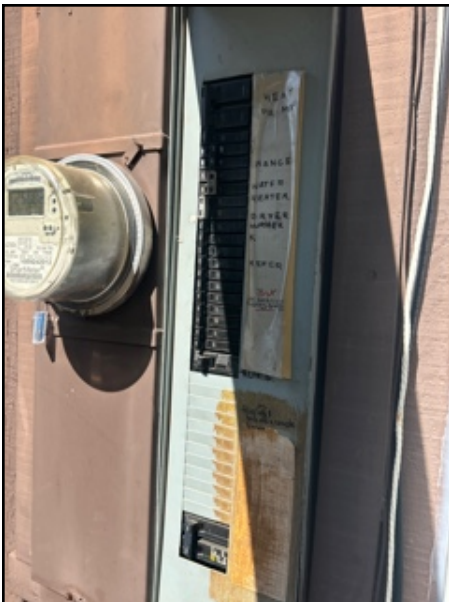
Figure 19-1

Poor labeling noted in the electrical panel. It is suggested to repair this in the event you need to shut off only one breaker instead of the entire system.

16) Comment 19: Poor labeling noted in the electrical panel. It is suggested to repair this in the event you need to shut off only one breaker instead of the entire system.

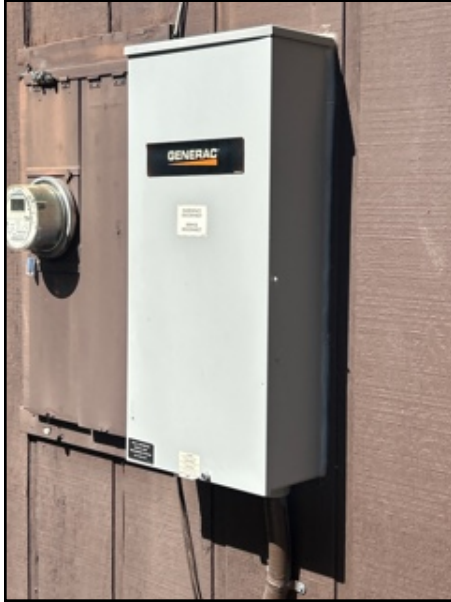
Figure 20-1

Noted that the house is equipped with a whole house generator. This is outside the scope of the general home inspection and was not ran or tested by the inspector.

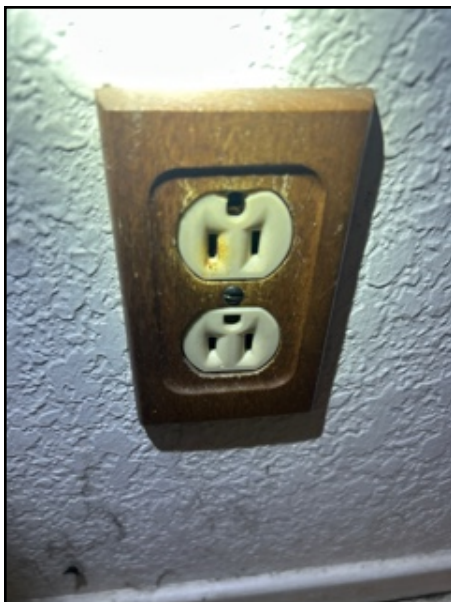
Figure 21-1

A scorched receptacle was noted at the back of the living room but was functional at the time of inspection. Recommend further review by a licensed electrician.

17) Comment 21: A scorched receptacle was noted at the back of the living room but was functional at the time of inspection. Recommend further review by a licensed electrician.

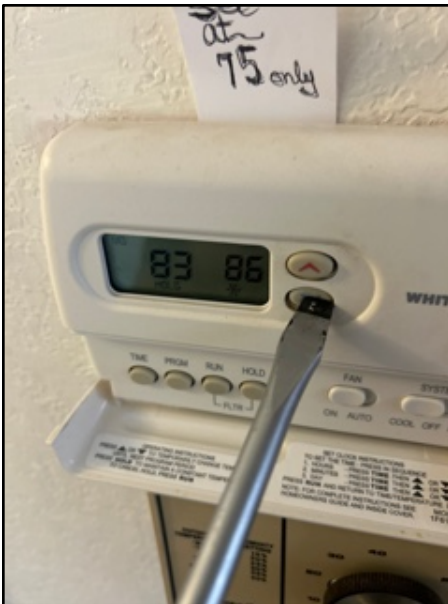
Figure 22-1

The temperature control buttons were not functioning correctly at the thermostat. Recommend for the review by a licensed technician.

18) Comment 22: The temperature control buttons were not functioning correctly at the thermostat. Recommend for the review by a licensed technician.

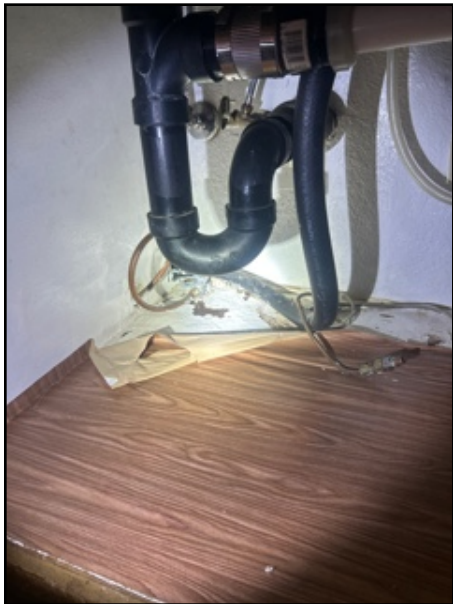
Figure 25-1

A leak was noted at the soft copper pipe to the dishwasher beneath the kitchen sink. Recommend repairing or replacing all affected materials as needed.

19) Comment 25: A leak was noted at the soft copper pipe to the dishwasher beneath the kitchen sink. Recommend repairing or replacing all affected materials as needed.

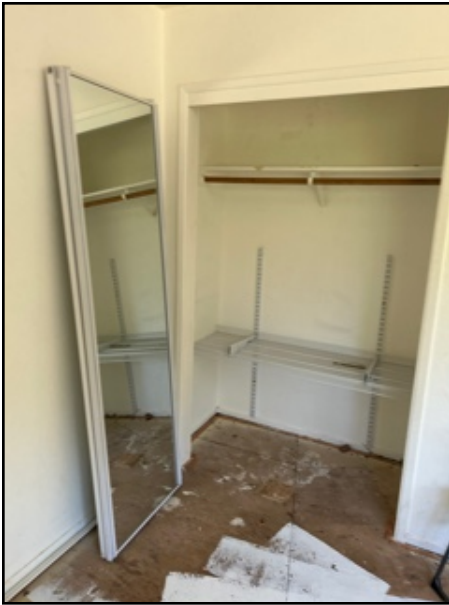
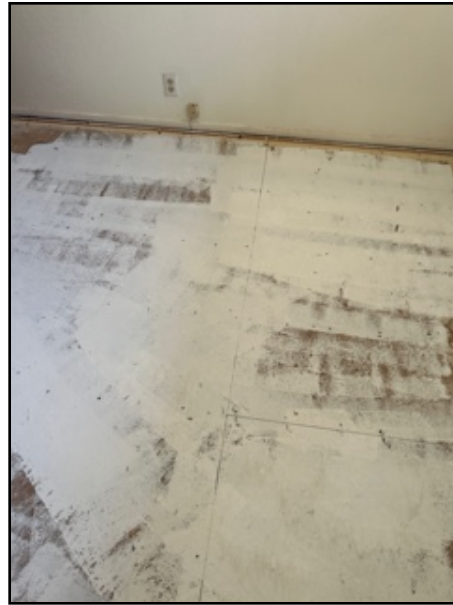
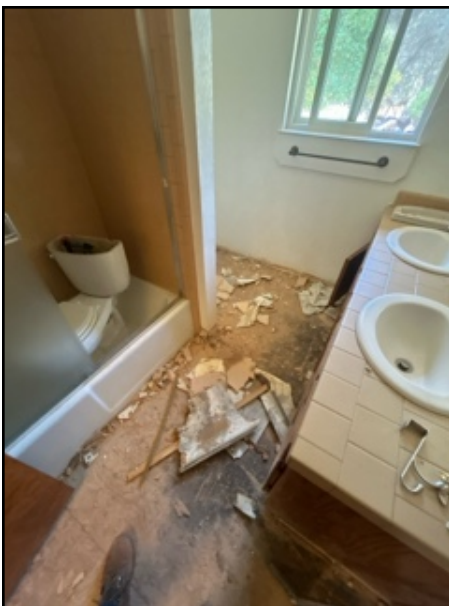
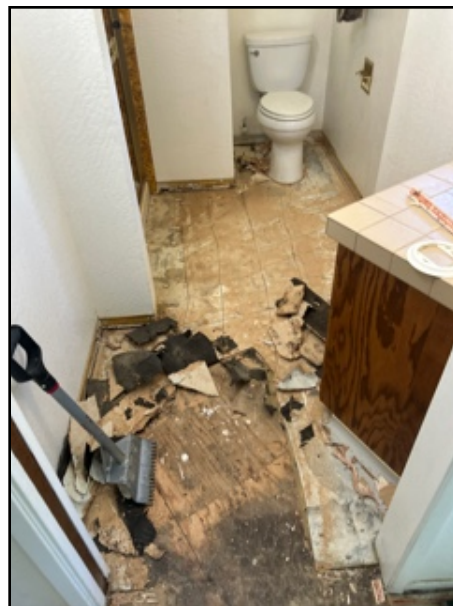
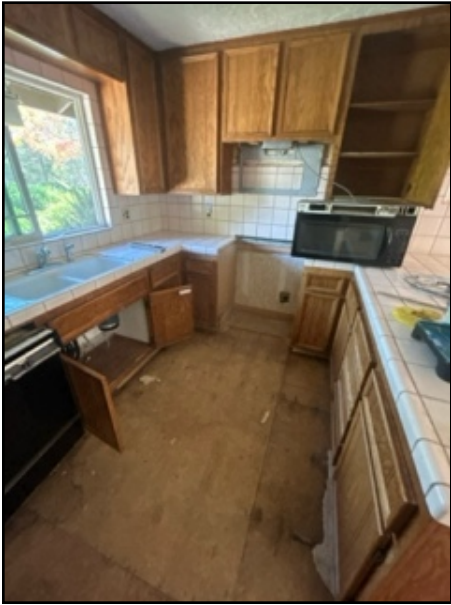
Portions of the interior, including the bathrooms and kitchen, were disassembled at the time of inspection.

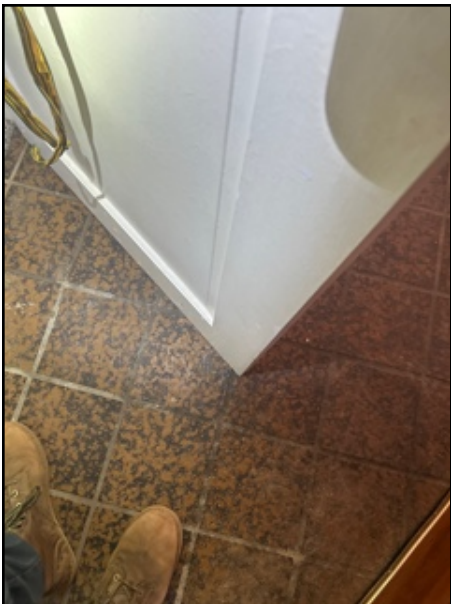
Figure 27-1

The entry closet door was noted to strike the ground.

20) Comment 27: The entry closet door was noted to strike the ground.

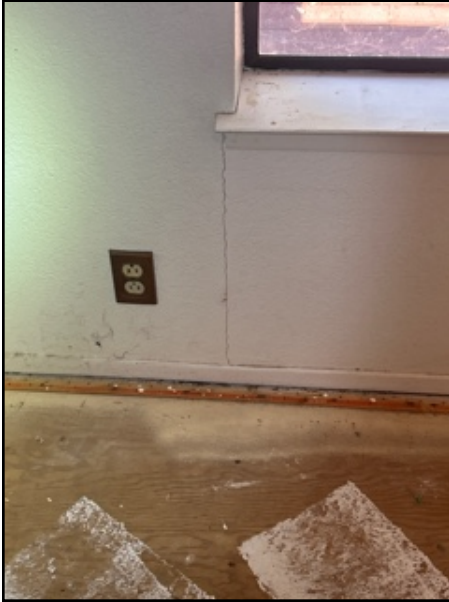
Figure 28-1

A drywall tape joint crack was noted at the wall at the back of the living room. This is not considered a structural or settling crack as it runs parallel to the structure.

21) Comment 28: A drywall tape joint crack was noted at the wall at the back of the living room. This is not considered a structural or settling crack as it runs parallel to the structure.

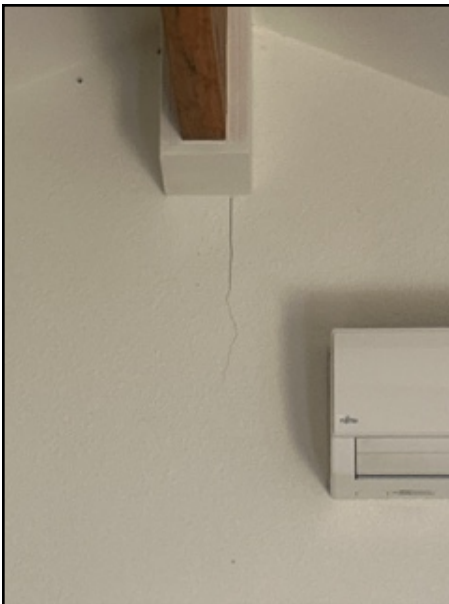
Figure 29-1

A small settlement crack was noted at the wall at the back of the ADU.

22) Comment 29: A small settlement crack was noted at the wall at the back of the ADU.
