WOOD DESTROYING PESTS AND ORGANISMS INSPECTION REPORT

BUILDING NO. 3136-3140	STREET GRAPE ST.	CITY SAN DIEGO	ZIP 92104	Date of Inspection 01/30/2026	NUMBER OF PAGES 1 of 5
---------------------------	---------------------	-------------------	--------------	----------------------------------	---------------------------

GENERAL DESCRIPTION: MULTI-FAMILY RESIDENCE.	Inspection Tag Posted: Hot water enclosure.
	Other Tags Posted:

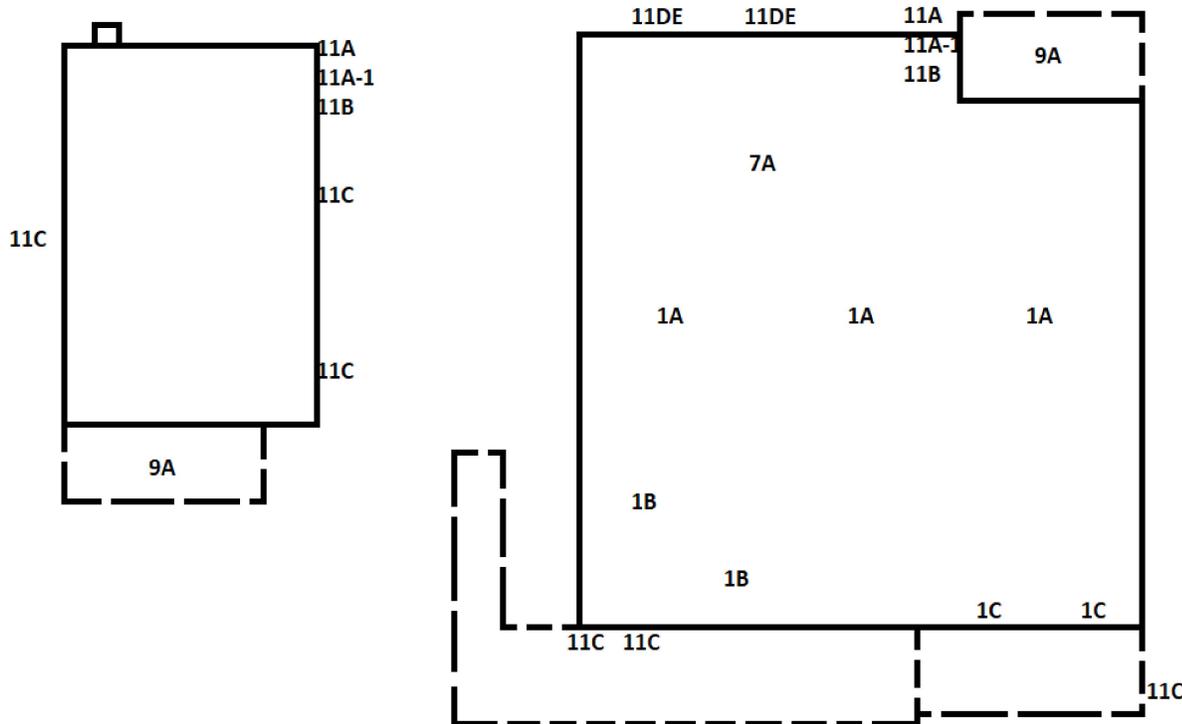
EXCESSIVE MOISTURE indicated by 1A on diagram. The EXCESSIVE MOISTURE was noted at or near: sub area soil.

CELLULOSE DEBRIS noted as 1B on the diagram.

FINDING: Subterranean termites noted at areas marked on diagram.

FINDING: Not enough clearance at attic in areas marked on diagram, making a complete inspection impractical.

FINDING: No access to the under side of decking in areas marked on diagram, making a complete inspection impractical.

Evidence of DRYWOOD TERMITES as indicated by 11A on the diagram. Evidence noted in or near: EAVES, RAFTER TAILS, FASCIA.

FINDING: Evidence of drywood termites noted in areas marked on diagram.

FINDING: Termite damaged wood noted at areas marked on diagram

FUNGUS DAMAGE indicated by 11C on diagram. The FUNGUS infection was noted in or near: RAFTER TAILS, FASCIA, FRONT PORCH RAIL CAP.

Moisture damage as indicated by 11D on diagram. The moisture damage was at or near: SIDING.

FUNGUS DAMAGE indicated by 11E on diagram. The FUNGUS infection was noted in or near: WINDOW SILL/TRIMS.

We recommend correcting this condition as appropriate.

We recommend removing CELLULOSE DEBRIS of rake size or larger.

RECOMMENDATION: Treat the areas marked on the diagram and the entire perimeter of the sub structure for the eradication of subterranean termites. Remove or destroy subterranean termite tunnels.

RECOMMENDATION: If inspection of area(s) is required it must be made accessible. We will then reinspect and issue a supplemental report of our new findings.

Fumigate the structure with a fumigant lethal to DRYWOOD TERMITES. See the occupants fumigation notice for further details. This company is not responsible for delays or schedule changes due to inclement weather or other agencies, nor is it responsible for damage to roof or plants as a result of the fumigation. Refer to the occupant's fumigation notice/preparation sheet (sent separately) for additional information.

RECOMMENDATION: Repair/Replace termite damaged wood members at fascia and rafter tails. Primer white only, or paint to match using customer supplied paint.

We recommend removing damaged wood and replacing with new wood in today's available widths and grades. Seal up area to prevent moisture and future fungus damage. Primer white only or paint to match using customer supplied paint.

We recommend removing damaged material and replace with today's available materials.
