## SUMMARY

15718 Creek Hills Rd, El Cajon, CA

Hardev Shergill  
07/31/2025

Christopher Tausaga  
Certified Commercial & Residential  
Inspector  
PROproperty Inspection and Services  
Inc.  
6194939557

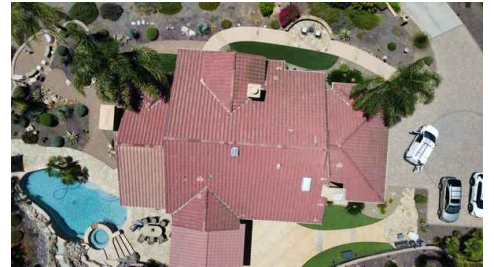
#### UNDERLAYMENT - TILE

Tile roofs have a lifespan of 60-70 years. What fails is the underlayment it has a lifespan of 24-26 years. I would recommend having a roof tune-up perform what this entails is to replace any broken or slid down tiles, replace or repair the concrete ridge and rake caps, sealing all vent and stove pipes, cleaning and cutting the valleys, and pulling a few tiles to check the condition of the underlayment to determine when it will need to be replaced.

Contact a qualified roofing professional.

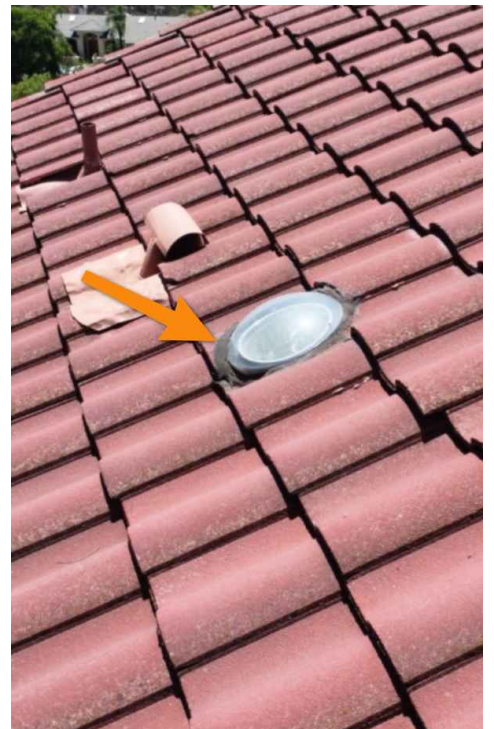
#### TAR USED AS FLASHING

Tar was used as flashing. This is considered to be substandard and not necessary when flashing is installed properly. Recommend further evaluation and needed repairs be made by a qualified licensed roofing contractor.❖❖

Contact a qualified roofing professional.

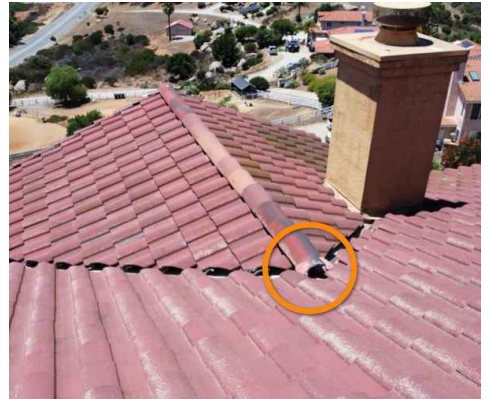
#### TILE ROOF- FAILED MORTAR BOND

Mortar bond/flashings was displaced or missing at roof to wall or hip/ridge locations. Failed mortar bond, can allow excessive rain below the tiles and may cause a leak. Recommend an evaluation and any necessary work be performed by a licensed roofing contractor.

Contact a qualified roofing professional.

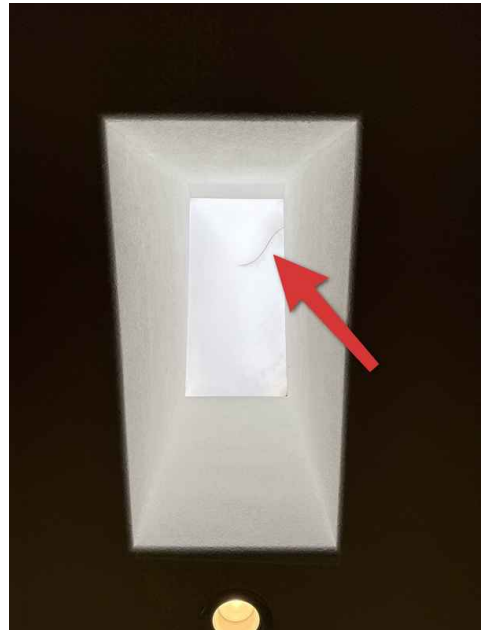
PRIMARY BATH

**SKYLIGHT - GLAZING CRACKED**

Glass in one or more skylights was cracked. Recommend that a qualified contractor replace glass as necessary.

Contact a qualified roofing professional.

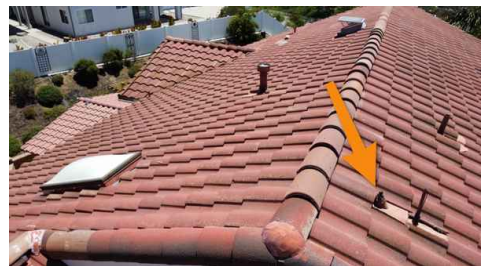
**PREVIOUS PROTRUSION NOT SEALED**

There was a previous protrusion through the roof surface that has since been removed. After removal, the area was not sealed, flashed, or appropriately patched, allowing for a hole to be present. Repairs to properly "finish" the past protrusion is recommended to be performed by a qualified roofing contractor.

Contact a qualified professional.

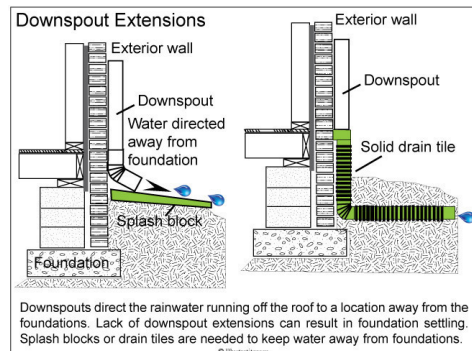
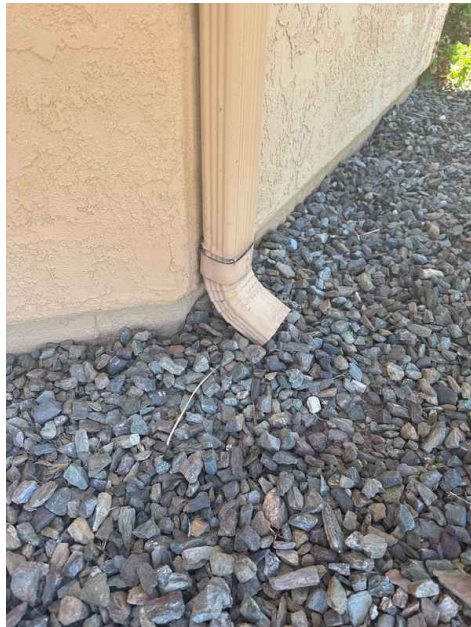
FRONT

**DOWNSPOUT POOR TERMINATION**

There were downspouts present that were discharging within five feet of the foundation of the home. Current standards require downspouts to be diverted at least five feet from the foundation of the home to prevent the grounds surrounding the foundation from becoming saturated. Saturated grounds can allow water / moisture to enter basement and crawl space areas, and in extreme cases can allow for settlement of the home. Properly extending all downspouts at least five feet away from the home is recommended to be conducted by a gutter contractor or other qualified person.

Contact a qualified professional.

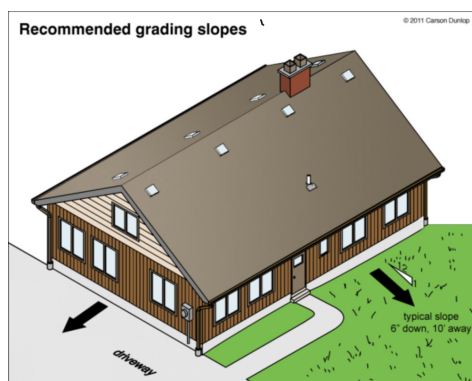
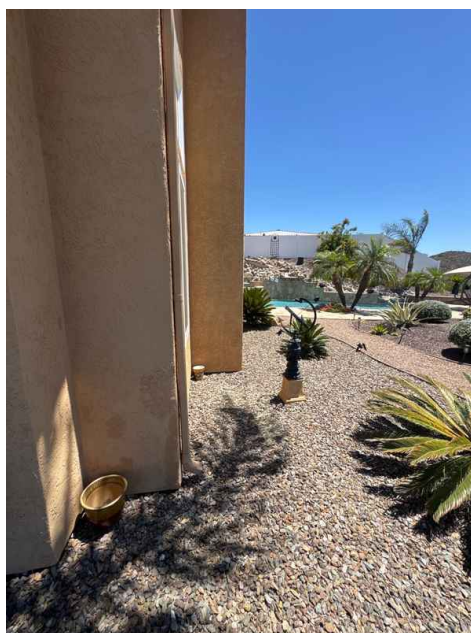
#### 5.1.1 Grading LOW AREAS

Grading and drainage is either negative or neutral adjacent to the residence, and moisture intrusion will remain a possibility. The soil or the hard surfaces should slope away from the residence to a distance of at least six feet, to keep moisture away from the footings. We can elaborate on this issue. Refer to a licensed geo technical and or licensed grading and drainage contractor.

Contact a qualified professional.

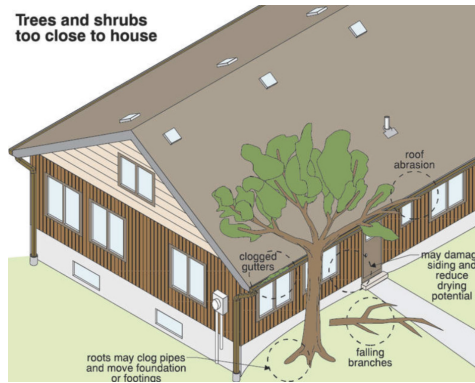
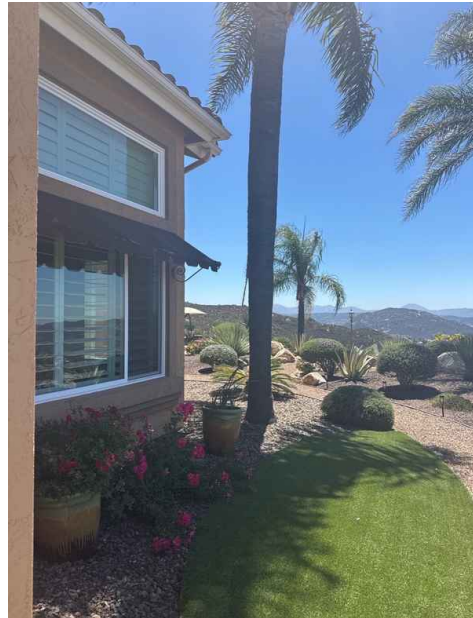
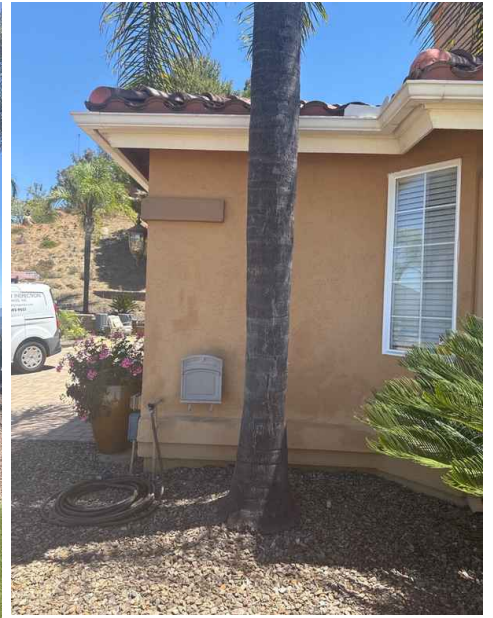
**TREE NEAR / CONTACTING BUILDING**

Trees were in contact with or were close to the building at one or more locations. Damage to the building can occur, especially during high winds, or may have already occurred (see other comments in this report if applicable). Recommend that a qualified tree service contractor or certified arborist remove trees as necessary to prevent damage to the building exterior.

Contact a qualified tree service company.

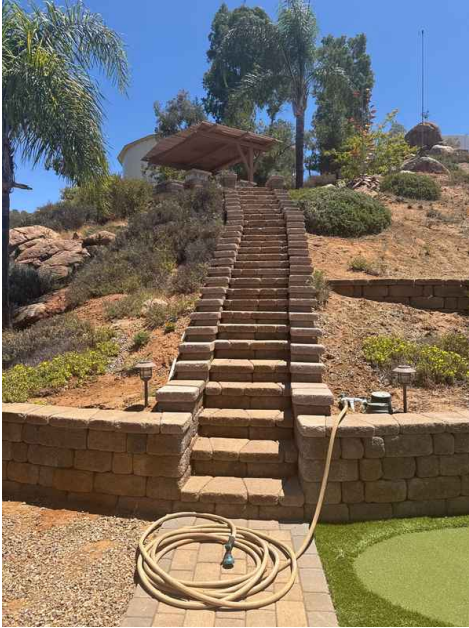
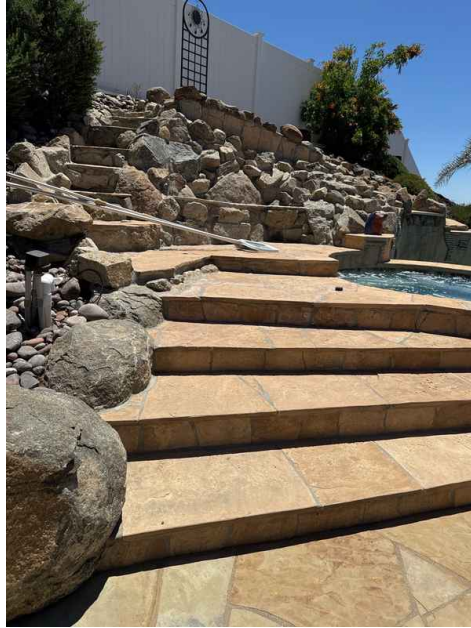
## REAR

**HANDRAILS MISSING MORE THAN 3 STEPS**

Handrails at one or more flights of stairs were missing. This is a potential fall hazard. Handrails should be installed at stairs with four or more risers or where stairs are greater than 30 inches high. Recommend that a qualified contractor install handrails where missing and per standard building practices.

Contact a qualified general contractor.

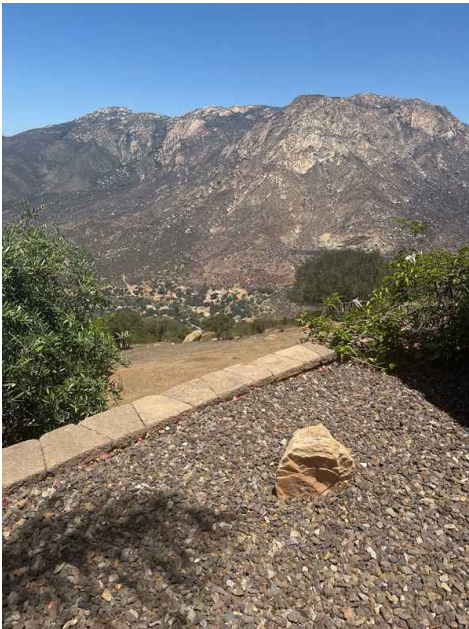
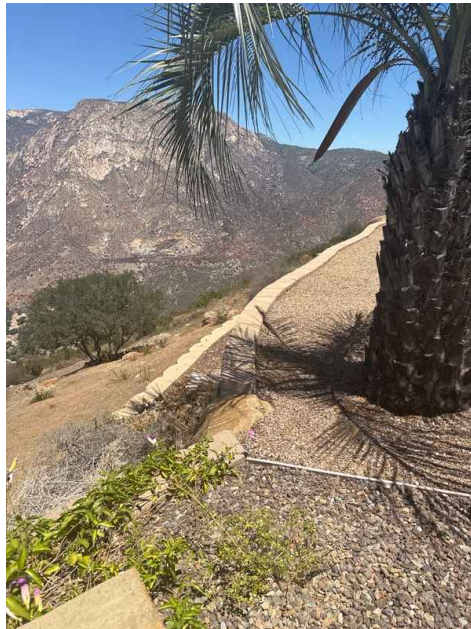
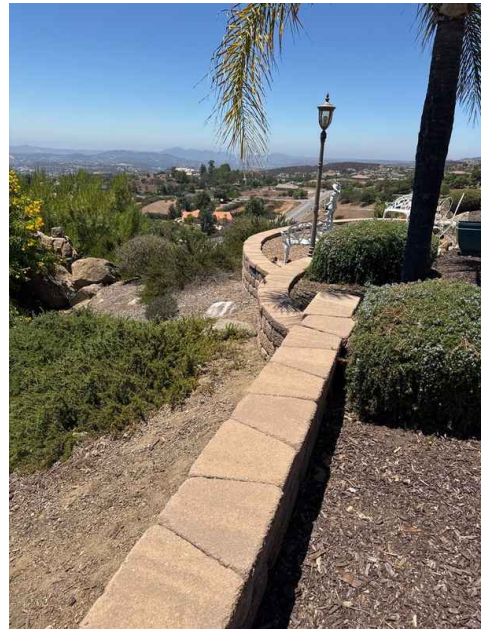
LEFT SIDE/RIGHT SIDE

### 5.6.2 Retaining Walls **WALKOFF HAZARD(S)**

A walk off or drop off hazard was noted in one or more areas. Recommend installing guard rails for added safety.

Recommendation  
Contact a qualified professional.

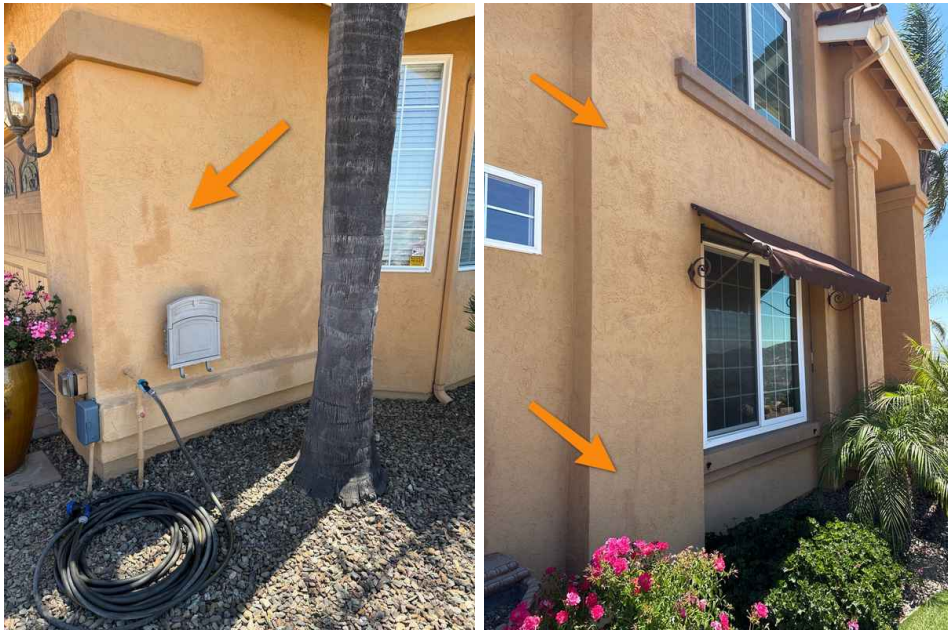
### 6.1.2 Exterior Walls / Trim **STUCCO - STAINING**

Stains noted on the stucco at one or more locations. This condition is typically a result of a lack of proper roof drainage or other moisture related issues. Recommend further evaluation by a licensed environmental contractor and/or stucco contractor to determine any corrections necessary at this time.

Contact a stucco repair contractor

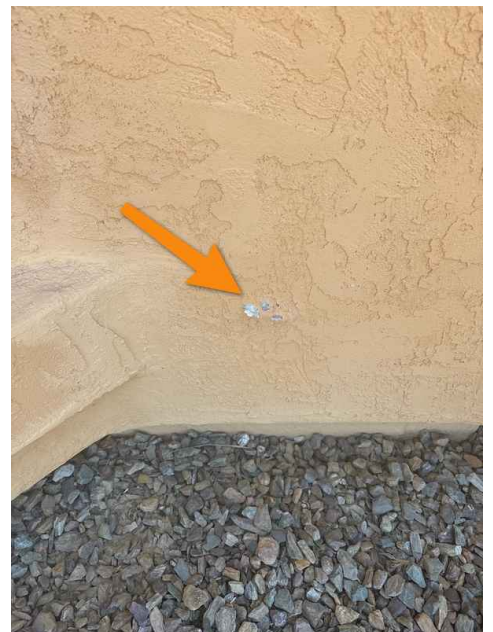
## FRONT

**STUCCO DAMAGE - MOISTURE**

Moisture damaged stucco noted in areas. In damp climates, moisture can enter cracks or damaged areas and further deteriorate the stucco. Also the wall behind the stucco can become damaged from moisture. Recommend further evaluation and repair by a licensed stucco contractor.

Contact a stucco repair contractor

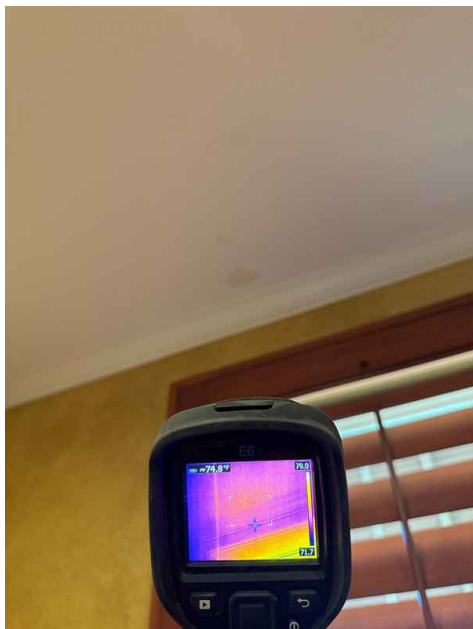
## FIRST FLOOR OFFICE

**WATER STAINS - DRY**

Water stains were noted on the ceiling which can be from a previous plumbing leak. These stains were tested for moisture and were found to be dry at the time of the inspection. Recommend asking the seller as to history, or if repairs have been performed. Otherwise, a licensed contractor should be consulted to determine whether additional repairs are needed at the time.

Contact a qualified professional.

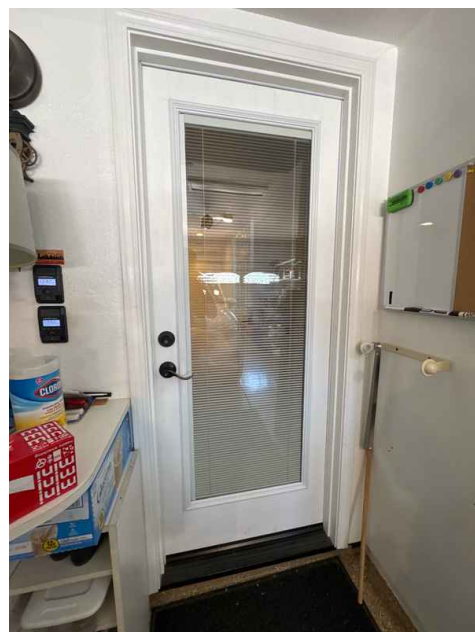
#### **DOOR NOT FIRE RESISTANT**

The door between the garage and the house did not appear to be fire resistant, or the inspector was unable to verify that it was via a label. This is a potential safety hazard. House to garage doors, to prevent fire and fumes from spreading from the garage into interior living space, should be constructed of fire-resistant materials. Doors, generally considered to be suitable for the purpose, are solid core wood (at least 1 3/8 inches thick), steel, honeycomb steel or a door that has been factory labeled as fire rated. Recommend that a qualified contractor replace or repair the door and, at that time, make any other corrections that might be required to provide suitable fire resistance between the garage and the dwelling per standard building practices.

Contact a qualified door repair/installation contractor.

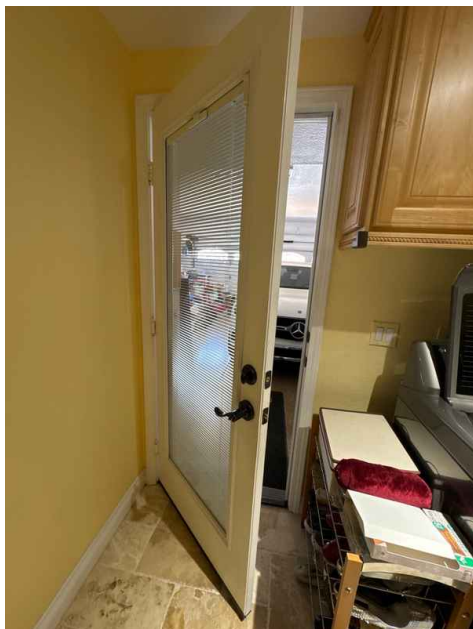
#### **SELF-CLOSING DEVICE MISSING**

The self-closing device on the door between the garage and the house is not installed / missing. These devices are installed to keep the door closed to prevent possible fire and fumes from the garage from spreading to the house. Recommend that a qualified person repair as necessary.

Contact a qualified professional.

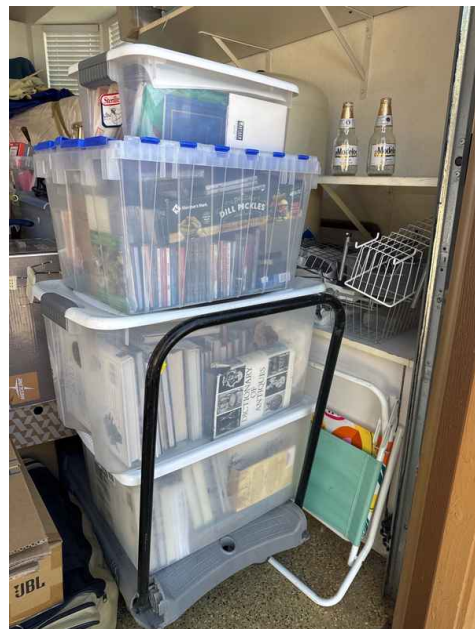
## GARAGE

**MAIN WATER SHUT-OFF DIFFICULT LOCATION**

The main water supply shut-off was located in a difficult location to access at time of inspection. Recommend that the client familiarize themselves with the location and make repairs to provide easier access.

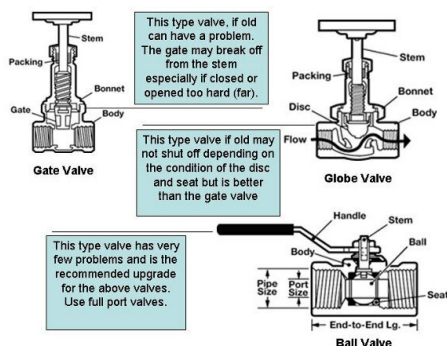
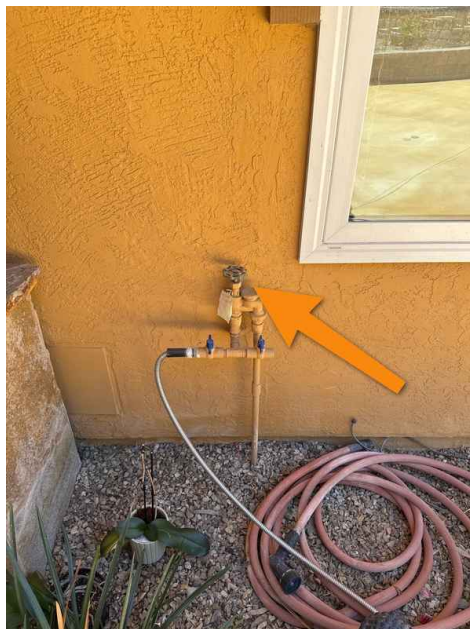
**GATE VALVE STYLE -SHUTOFF**

The home appears to be equipped with an older-style shut off valve at one or more areas. Gate valves are known to be less effective than a newer-style ball valve. Advise consulting a licensed plumbing contractor for replacement as necessary.

Contact a qualified plumbing contractor.

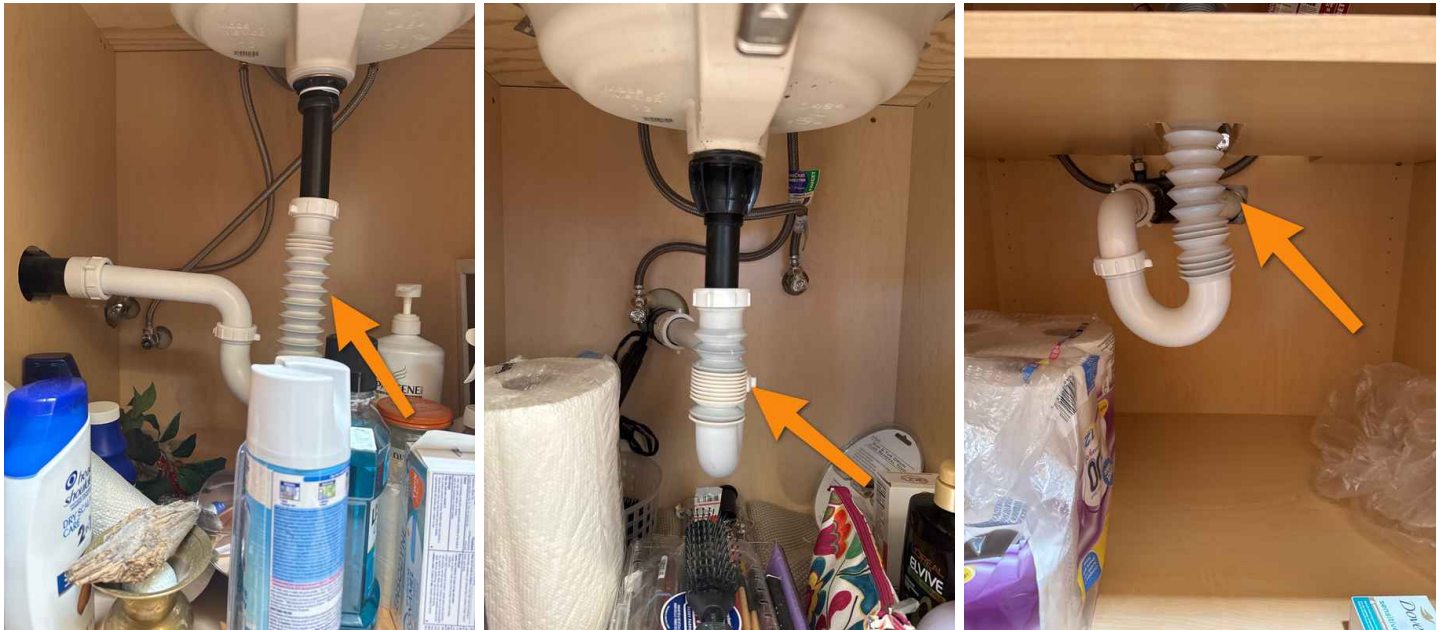
## PRIMARY BATH/HALLWAY BATH

**FLEXIBLE PIPE**

Ribbed, flexible drain pipe was used at the sink. This type of drain pipe accumulates debris more easily than smooth wall pipe and is likely to clog. Recommend that a qualified plumber replace flexible piping with standard plumbing components (smooth wall pipe) to prevent clogged drains.

Recommendation  
Contact a qualified plumbing contractor.

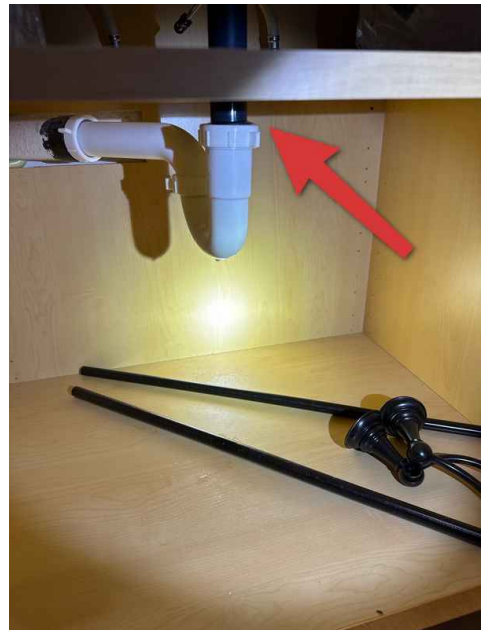
HALLWAY BATH

##### **DRAIN LEAK**

One or more leaks were found at the sink drain. A qualified plumber should repair as necessary.

Recommendation  
Contact a qualified plumbing contractor.

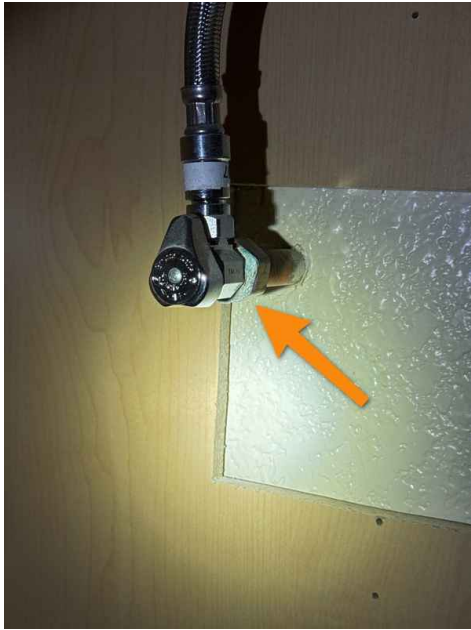
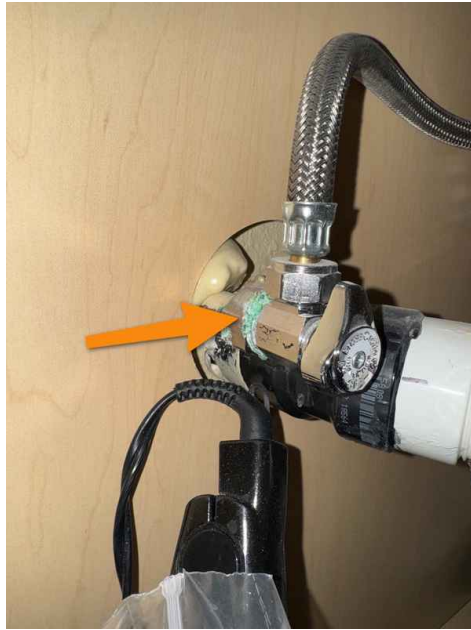
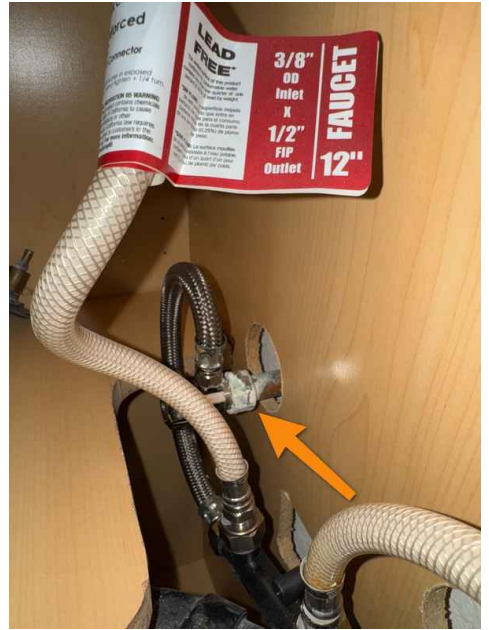
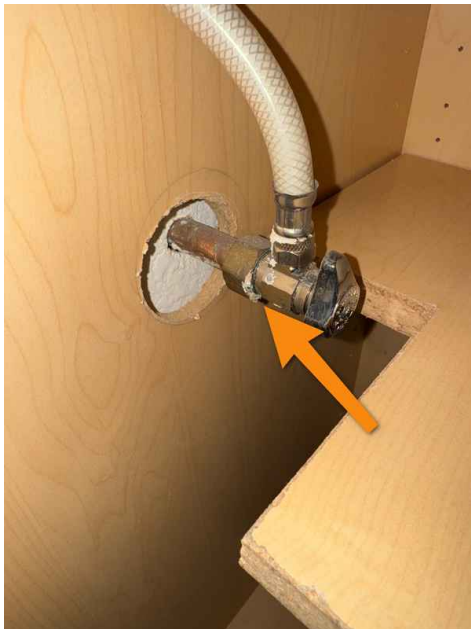
PRIMARY BATHBEDROOM 3 BATH/HALLWAY BATH

##### **SHUT-OFF VALVES CORRODED**

Shut-off valves were corroded. This indicates a past leak and could possibly leak again in the future. Recommend repairs be made by a qualified licensed plumbing contractor.

Recommendation  
Contact a qualified plumbing contractor.

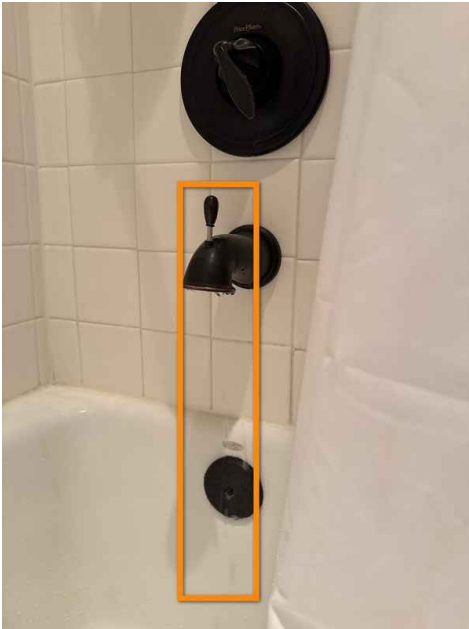
#### HALLWAY BATH

### DIVERTER - TUB SPOUT LEAKS WITH SHOWER ON

The tub diverter(s) did not function properly at the time of the inspection. Water sprays from shower head and tub spout at the same time. This is typically due to corrosion and or hard water build-up. Recommend further evaluation by a licensed plumber before the end of your contingency period to determine repairs necessary at this time.

Contact a qualified plumbing contractor.

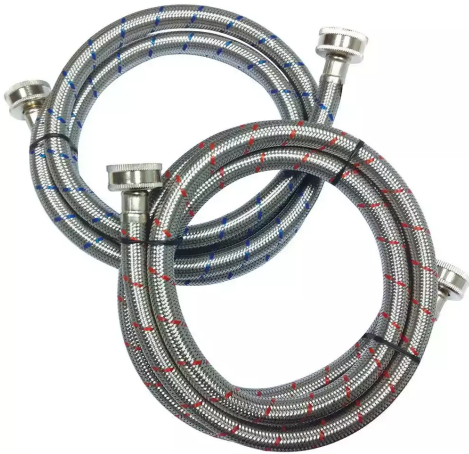
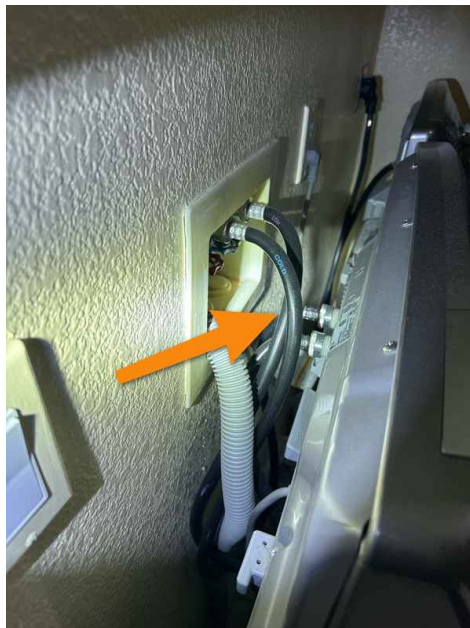
#### LAUNDRY HOSE UPGRADE

The laundry area is equipped with rubber supply lines. This type of line is prone to dry rot and failure. Advise upgrades to new steel braided hoses to prevent this condition.

Contact a handyman or DIY project

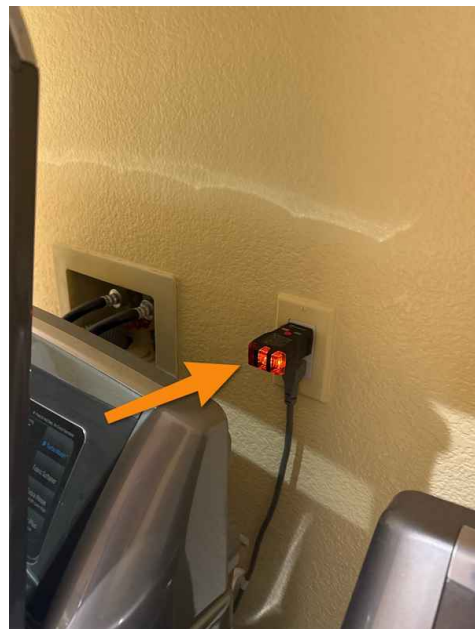
#### RECOMMEND GFCI UPGRADE - LAUNDRY

This house was built prior to the requirement for the installation of GFCI receptacles in certain locations in the house. The locations where GFCI receptacles are required has increased, but it is not required to retrofit older homes unless a remodel takes place. For safety, it is advisable to upgrade all receptacles within 6 feet of a plumbing fixture, in garage, all kitchen counter top outlets, and at exterior, to GFCI protected outlets. A complete list of GFCI installation requirements and the dates that they were first required can be viewed at [GFCI Requirements](#)

Contact a qualified electrical contractor.

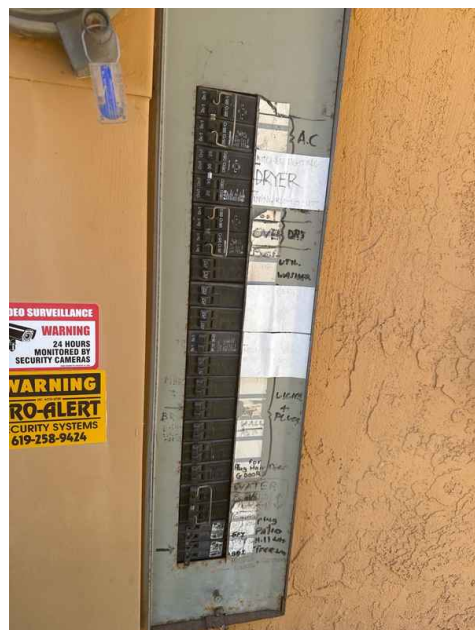
### LABELS - ILLEGIBLE

Some labels are present, but illegible or confusing. Recommend correction by a licensed electrical contractor or qualified professional for safety.

Contact a qualified professional.

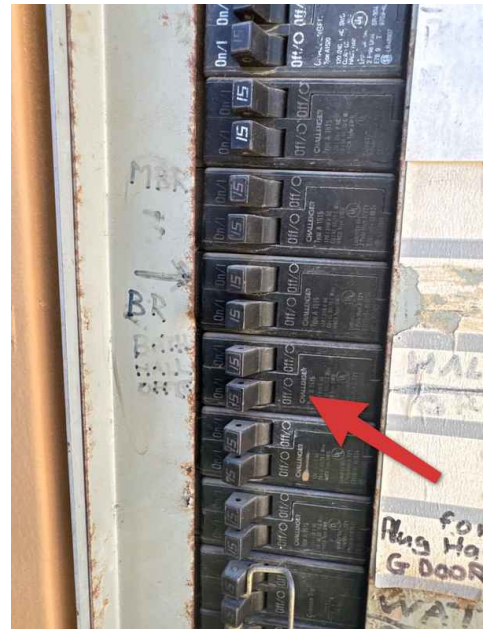
**CHALLENGER PANEL**

Challenger panels built and installed in the 1980s and 1990s were found to have an issue where they were overheating under normal conditions at the metal "bus bar." This led to expansion and contraction of the bus bar, and electrical arcing between the bus bar. Over time, these components could melt down, causing a shock or fire hazard. Challenger breaker panels started facing recalls in 1988. Recommend consulting with a licensed electrician for options on replacement.

Contact a qualified electrical contractor.

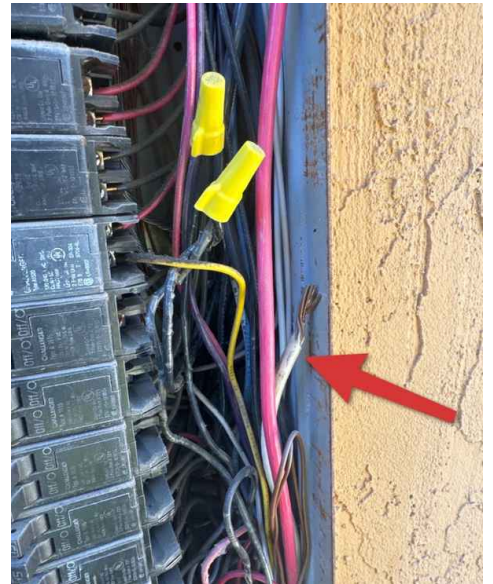
**LOOSE WIRES NOT TERMINATED**

One or more wires inside the panel were loose, and were not terminated. This poses a safety hazard for shock and/or fire. Recommend that a qualified electrician remove any abandoned wiring or repair as necessary. For example, by trimming wires to length and installing wire nuts.

Contact a qualified electrical contractor.

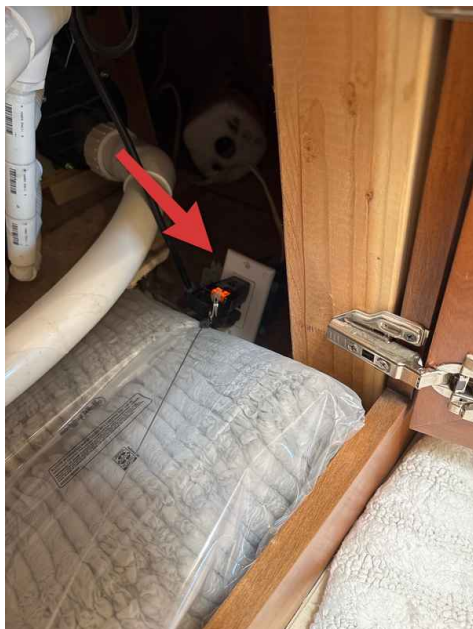
**GFCI ISSUES**

One or more ground fault circuit interrupter (GFCI) receptacles (outlets) were not functioning properly (would not trip / would not reset / still energized when tripped). Recommend repairs be made by a qualified licensed electrical contractor. For example, replacing with new GFCI receptacle outlet.

Contact a qualified electrical contractor.

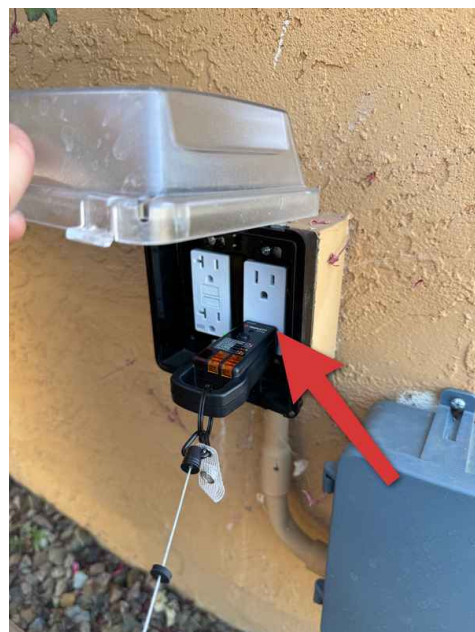
#### FRONT

### MISSING GFCI PROTECTION - EXTERIOR

One or more locations at this property were noted as not having GFCI protection or the i was unable to verify if GFCI protection existed at these locations. Adoption of GFCI outlets was generally phased in over numerous years/decades. Recommend client evaluate upgrading these areas to GFCI protection at their discretion.

Contact a qualified electrical contractor.

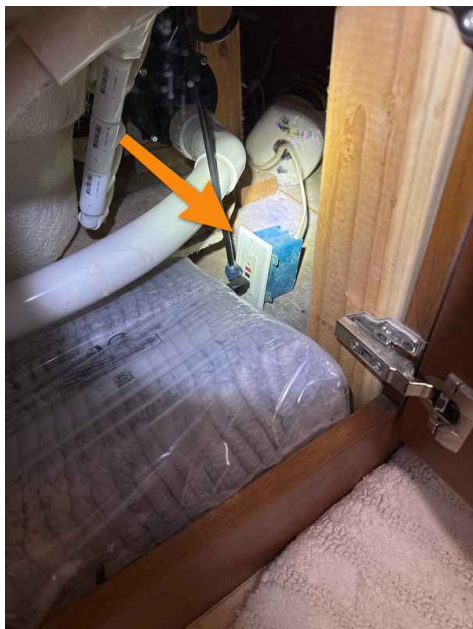
#### PRIMARY BATH

### RECEPTACLE LOOSE

One or more receptacles were not properly secured and loose. Recommend a licensed electrician repair as necessary.

Contact a qualified electrical contractor.

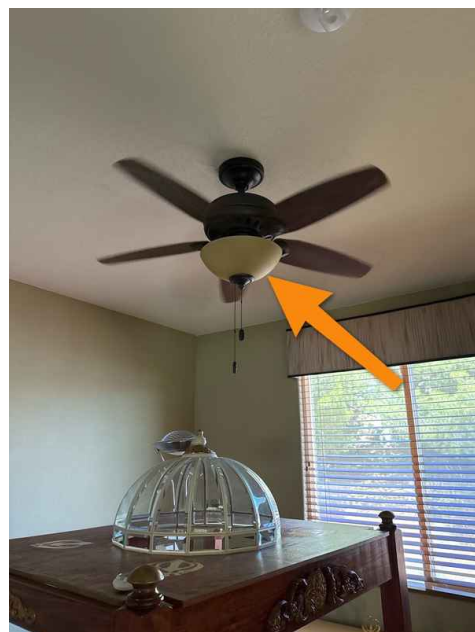
#### BEDROOM ONE

### 10.7.1 Lighting & Fans **LAMPS INOPERABLE**

One or more light fixtures were inoperable (didn't turn on when nearby switches were operated) and/or were very dim. Recommend further evaluation by replacing bulbs and/or consulting with the property owner (perhaps on a switch that was not identified). If replacing bulbs doesn't work and/or no other switch(es) can be found, then recommend that a qualified electrician evaluate and repair or replace light fixtures as necessary.

Contact a qualified electrical contractor.

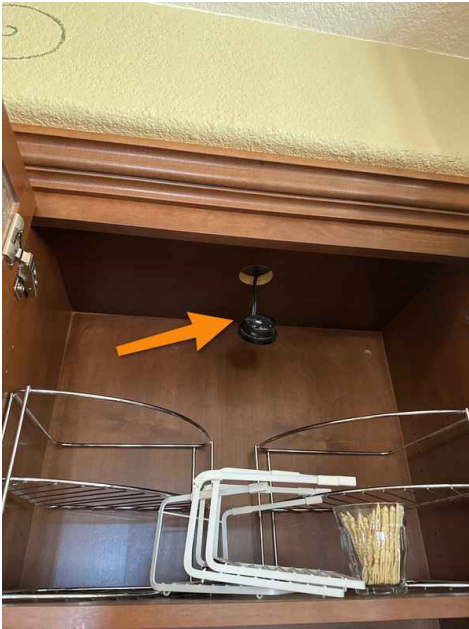
#### KITCHEN

### 10.7.2 Lighting & Fans **LIGHTING LOOSE - INTERIOR**

One or more light fixtures were loose and/or damaged. Recommend that a qualified electrician repair or replace light fixtures as necessary.

Contact a qualified electrical contractor.

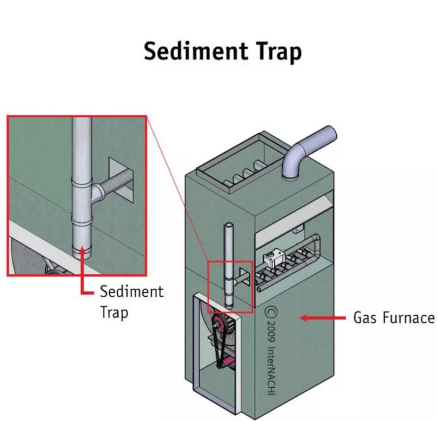
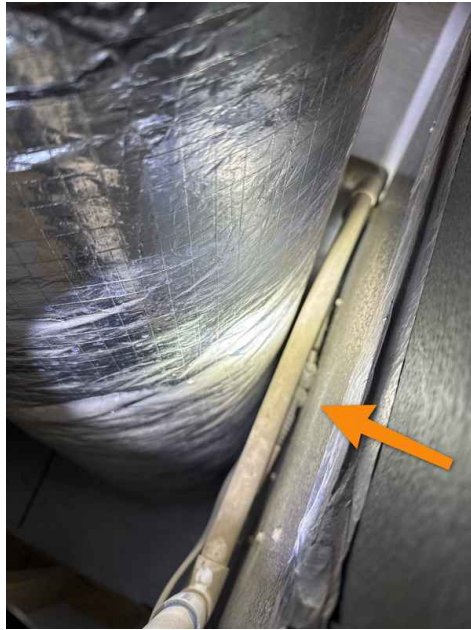
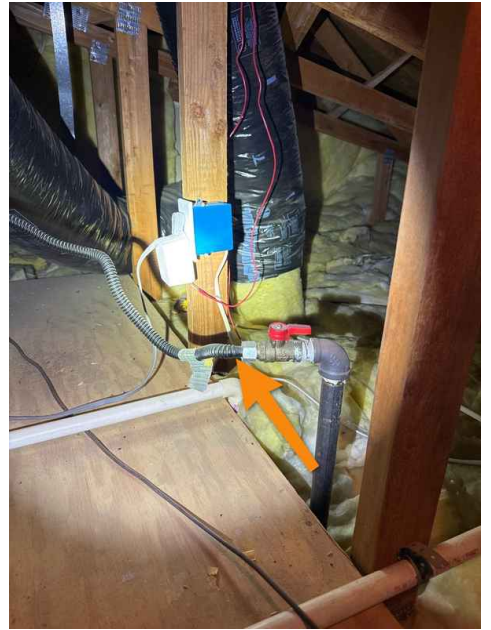
### SEDIMENT TRAP (DRIP LEG)

The furnace gas piping is not equipped with a sediment trap. Advise installation by a licensed HVAC or qualified professional to comply with today's HVAC safety standards.

Contact a qualified HVAC professional.

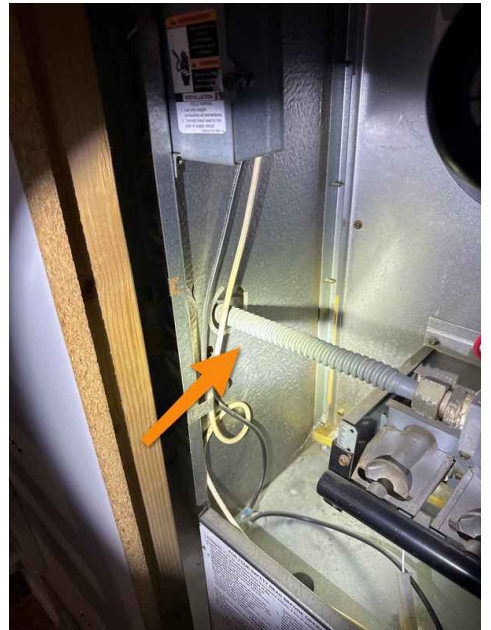
#### **FLEXIBLE GAS LINE PASSES THROUGH FURNACE WALL**

The flexible gas line passes through the sidewall of the furnace. This soft flex gas line is easily damaged if it contacts the sharp edge of the furnace wall. We recommend that a licensed HVAC contractor and repair as necessary to comply with today's safety standards.

Contact a qualified professional.

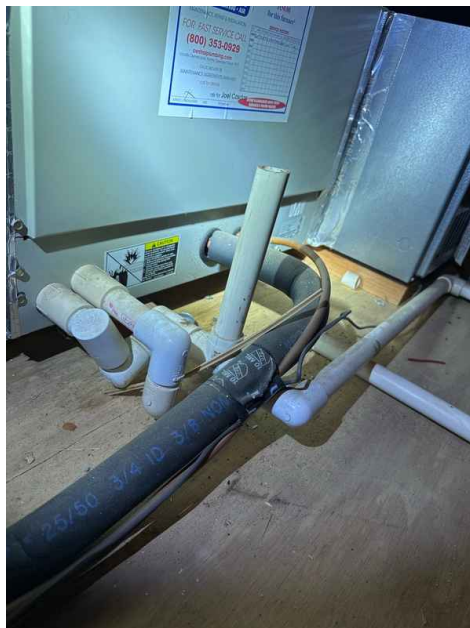
#### **NO CONDENSATION CATCH PAN INSTALLED**

No condensation catch pan installed under the evaporative case. In the event the condensate drain line becomes clogged water from the condensate line will overflow onto whatever is below/around the unit, potentially causing water damage. Recommend a qualified licensed HVAC contractor evaluate the unit and add if allowed.

Contact a qualified HVAC professional.

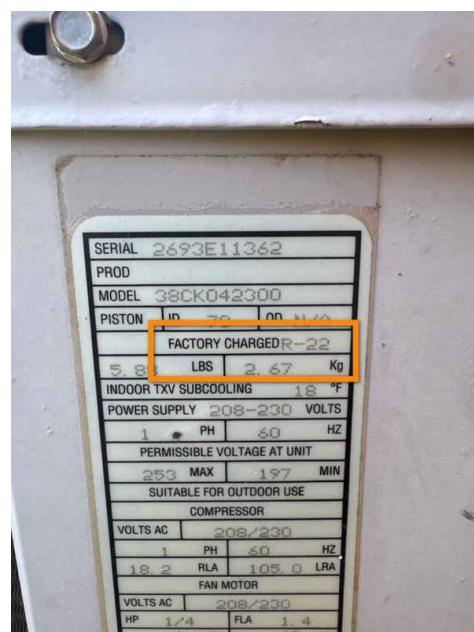
By industry lifespan standards, one or more hvac components appeared to be at or near its useful lifespan (~15 years) and may need replacing or significant repairs at any time. Recommend budgeting for a replacement in the near future or discussing replacement options with a qualified HVAC technician to determine applicable costs.

Contact a qualified HVAC professional.

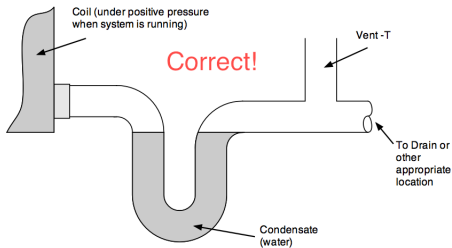
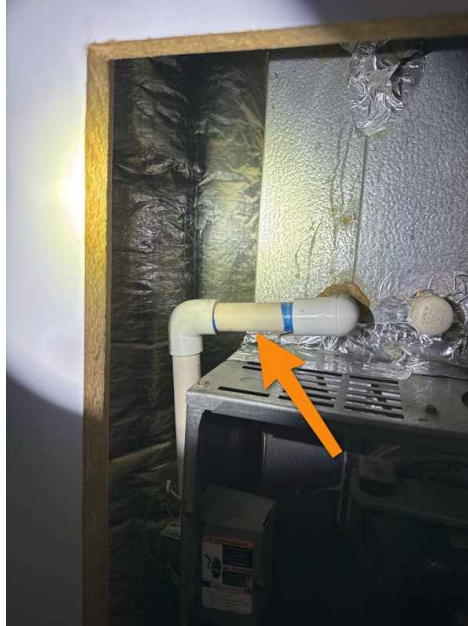
**CONDENSATE DRAIN LINE TRAP MISSING**

The P trap for the primary condensation drain was missing. The intended purpose of the p-trap is to allow condensate to flow from the equipment while simultaneously preventing air leakage into or out of the unit. Recommend further evaluation and repair by a qualified professional.

Contact a qualified HVAC professional.

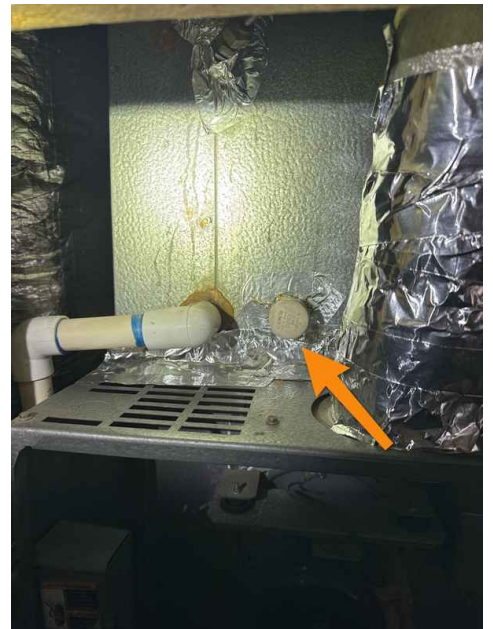
**SECONDARY DRAIN NOT INSTALLED**

The secondary condensation drain (or equivalent) at the evaporative coil was not installed at the time of the inspection. This may not have been required at the time of installation. However, this is a recommended retrofit. The secondary condensation drain acts as a redundancy to prevent leaks in the event the primary drain becomes clogged. Advise consulting a licensed HVAC contractor for necessary correction.

Contact a qualified HVAC professional.

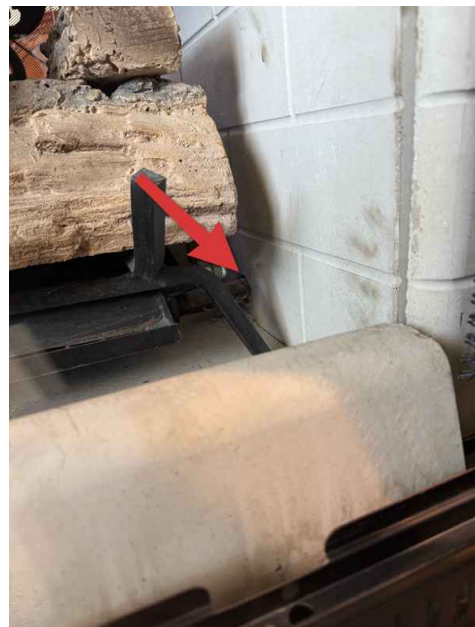
PRIMARY BEDROOM

**GAPS FACE / FIREBOX**

The opening where the fireplace gas line penetrates the refractory panel is not sealed. Super-heated gasses can enter the wall cavity. Fire hazard. Recommend that a qualified contractor repair as necessary.

Contact a qualified fireplace contractor.

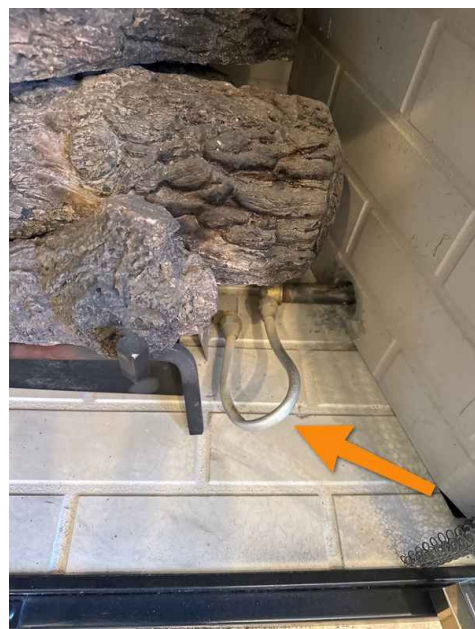
#### ALUMINUM FLEX

An aluminum-type gas line was noted installed at one or more location. This style of gas line was common at the time of construction, but are considered unsafe by today's building standards. Advise consulting a licensed contractor for necessary replacement.

Contact a qualified professional.

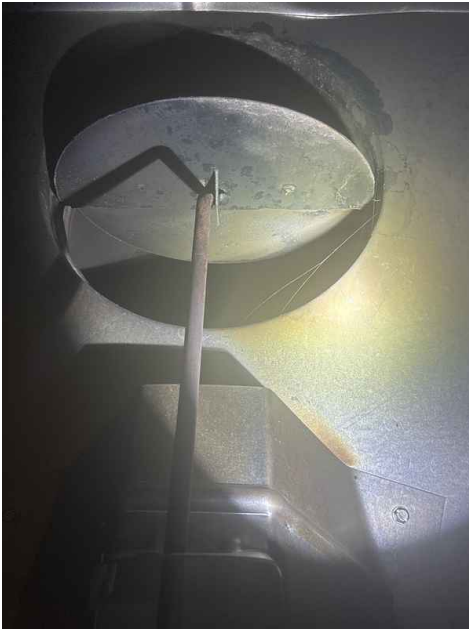
#### CHIMNEY LINER DIRTY

Chimney liner had layer of creosote/soot/dust, so inspection of the underlying structure was limited. Recommend qualified chimney sweep company inspect and/or clean.

Contact a qualified chimney sweep.

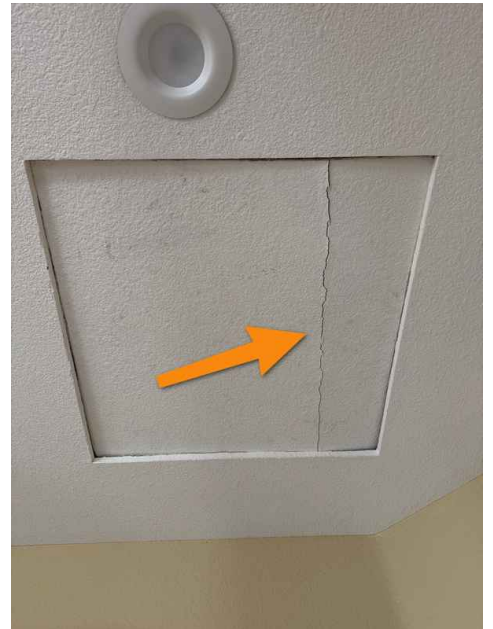
### ACCESS PANEL DAMAGED

The drywall access panel was damaged. Replacement of the panel is recommended to be performed by a qualified professional.

Contact a handyman or DIY project

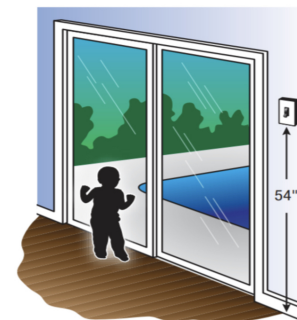
### FEWER THAN TWO DROWNING PREVENTION SAFETY FEATURES

Effective January 1, 2018 the California Business and Professions Code Section 7195 require home inspectors to state the following in their reports when there are fewer than Two drowning prevention safety features:

Recommend installing two or more of the choices above. A qualified person should evaluate and repair or replace as necessary, and as per standard building practices.
