WOOD DESTROYING PESTS AND ORGANISMS INSPECTION REPORT

Building No. 1837	Street Avenida Sevilla	City Oceanside	ZIP 92056	Date of Inspection 04/22/2025	Number of Pages 6
 		Pest Patrol, Inc. 9920 Scripps Lake Drive Suite 107 San Diego CA 92131 (760) 789-5889 office@pestpatrol.com		Report # : 20173 Registration # : PR1612 Escrow # : <input type="checkbox"/> CORRECTED REPORT	
Ordered by: Chris Jensen	Property Owner and Party of Interest: 1837 Avenida Sevilla Oceanside CA 92056 United States			Report sent to: Chris Jensen	
COMPLETE REPORT <input type="checkbox"/> LIMITED REPORT <input type="checkbox"/> SUPPLEMENTAL REPORT <input checked="" type="checkbox"/> REINSPECTION REPORT <input type="checkbox"/>					
GENERAL DESCRIPTION: 2 story, slab foundation, single family residence, stucco siding, concrete tile roof, and attached garage.				Inspection Tag Posted: Garage	
This supplemental report was created to add tile insurance.				Other Tags Posted:	
An inspection has been made of the structure(s) shown on the diagram in accordance with the Structural Pest Control Act. Detached porches, detached steps, detached decks and any other structures not on the diagram were not inspected.

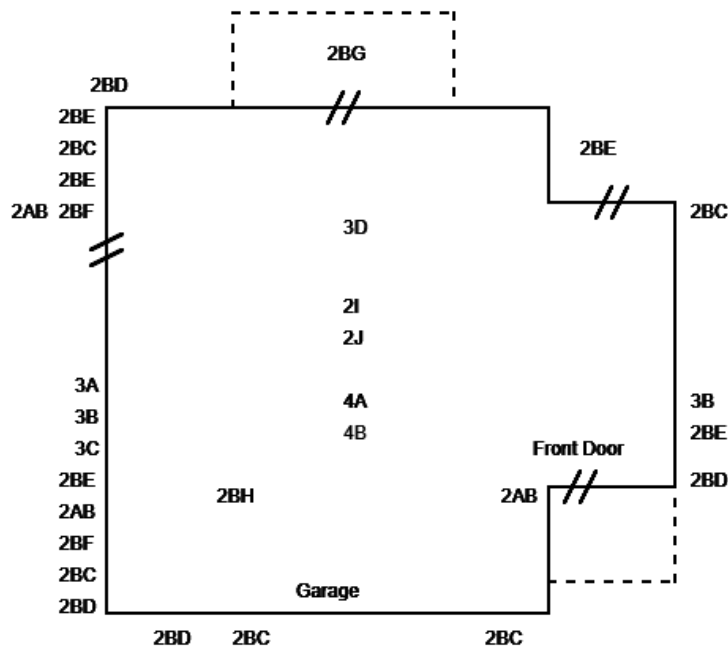
Diagram Not To Scale

FINDING - Evidence of drywood termite infestations at second story fascia as indicated on the diagram.

FINDING - Evidence of termite damaged wood members noted at time of inspection at first and second story fascia, rafter tail, out looker, shiplap, second story rafter tail, pergola trim, slats, joist, balcony trim, and handrail as indicated on the diagram.

FINDING - Evidence of drywood termite infestations at rafter tail and out looker as indicated on the diagram.

FINDING - Evidence of drywood termite infestations at first story fascia as indicated on the diagram.

FINDING - Evidence of drywood termite infestations at shiplap as indicated on the diagram.

FINDING - Evidence of drywood termite infestations at second story rafter tail as indicated on the diagram.

FINDING - Evidence of drywood termite infestations at pergola trim, slats, and joist as indicated on the diagram.

FINDING - Evidence of drywood termite infestations at balcony trim and handrail as indicated on the diagram.

FINDING - Evidence of drywood termite infestations at attic as indicated on the diagram.

FINDING- Evidence of swarmers noted at time of inspection at attic as indicated on the diagram.

FINDING - Dry-rot wood members found at time of inspection at fascia as indicated on the diagram.

FINDING - Dry-rot wood members found at time of inspection at shiplap as indicated on the diagram.

FINDING - Surface fungus condition visible at time of inspection at fascia and shiplap as indicated on the diagram.

FINDING - Dry-rot wood members found at time of inspection at roof ply as indicated on the diagram.

RECOMMENDATION - Fumigate the structure for the control of drywood termites. Remove or cover drywood termite fecal pellets in accessible areas. Owner/agent to prepare for fumigation as per list of instructions to be furnished by this company. The structure must be vacated until released for re-entry by the licensed fumigator. See fumigation notice for terms and liabilities.

RECOMMENDATION - Remove and replace and/or repair the damaged wood member(s) as necessary in currently available widths and grades. Minor damage may be filled, or where impractical, reinforcement will be done. If, upon performance of the work, the damage extends into inaccessible areas, a new supplemental report with cost estimate may be issued.

RECOMMENDATION - Replace the damaged wood member(s) as necessary. Minor damage may be filled, or where impractical, reinforcement will be done. If, upon performance of the work, the damage extends into inaccessible areas, a new supplemental report with cost estimate may be issued.
