# **SewerLine Check Professionals, LLC**

## **Sewer Line Inspection Report**

709 Wilson Court Burbank, CA 91501

Inspector: Ken Bell

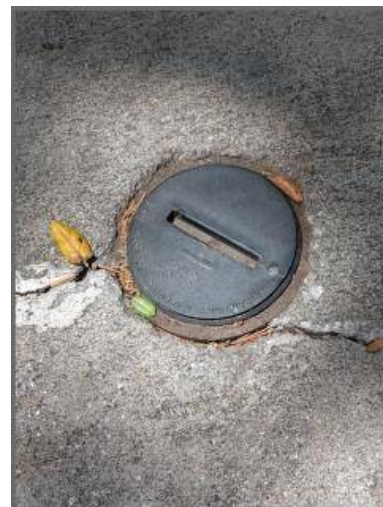
The main sewer line was accessed through the 4 inch main sewer line cleanout located in the driveway.

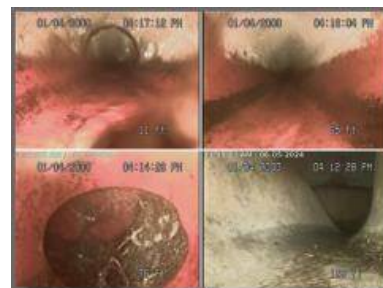
**Needs Attention:** This line appears to be functioning as intended water also appears to be flowing fine and moving debris, however, there are significant root intrusions, at 76 feet into the system, that prevent the view of the inner walls of the piping, so no conclusive findings can be made on this area. The system needs to have a thorough cleaning to rid the system of roots and a follow up inspection should then be performed for more data on this area should the roots be hiding any damage (SEE VIDEO).

COMMENTS: Roots intruding into a clay main sewer line sewer line are common and can normally be maintained with regular sewer line cleanings. It is when roots are left un-maintained for an extended period of time that they can cause blockages and or damage to a clay main sewer line. Roots most commonly intrude at the joint lines where the pipes are typically held together with mortar which breaks down over time. The roots that are present within the main sewer line indicates that the integrity of the mortar filled joints have been compromised to a degree and may worsen over time. Regular sewer line cleanings will help to prolong the life of the main sewer line but as the root intrusions intensifies over time the system may need to be replaced in the future.

The line would need to be cleaned and for this system I would recommend a hydro-jetting, which is a very effective cleaning method for the pipe. It utilizes a high pressure water system to cut the roots and remove the soil from the inner walls of the pipe, while also washing them down the line. This type of cleaning will allow for maximum visibility of the inner walls of the pipe so that the proper repair recommendations can be made, if necessary.

Once the system has been cleared a follow up video examination will need to be performed to assess the main sewer line's condition along the root intruded area.

Regular sewer line cleanings should be performed every 8 to 10 months, utilizing a full size sewer cleaning blade, in order to maintain the roots in the system to help keep them from creating future blockages and/or damage within the system.
