Davidson Inspection

Inspection Date: 06/11/2024

File #-24-1355 Hewlett

Subject Property:
5410 Hewlett Dr.

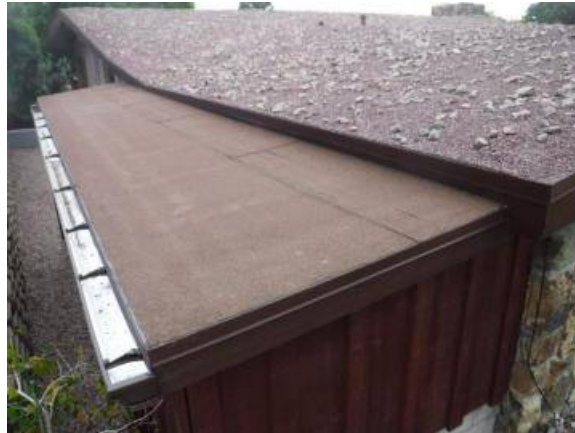
Structural alteration(s)/ addition where the garage was extended.

Addition(s) were present. Recommend verifying if the construction was permitted. The owner should be aware of the ramifications of ownership concerning an unpermitted addition.

The structure was not setback a minimum of 5 feet from the perimeter fence. There is a concern that the structure is encroaching within the lot setback requirement. Recommend verifying if the construction was permitted and if it meets the lot setback requirement.

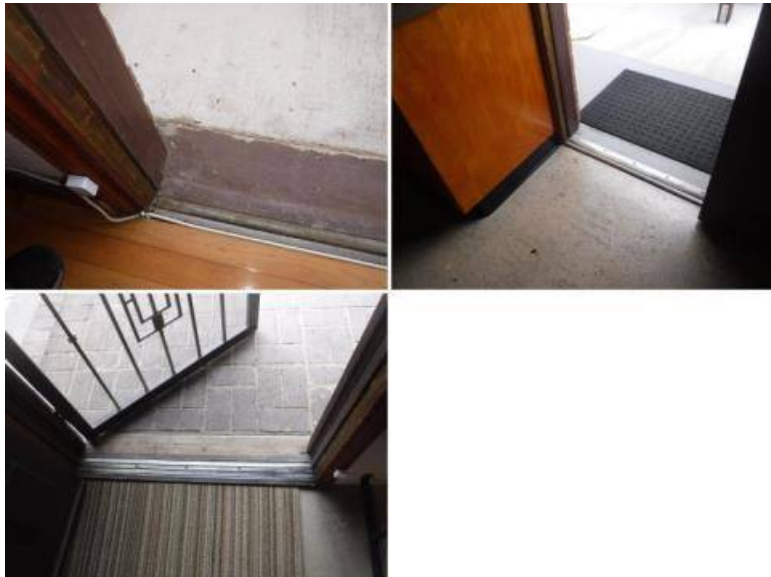
3.4 Exterior Grade at Foundation:

Marginal - The exterior grade level was too high next to exterior door threshold(s) at flatwork and porches. Ideally, the exterior grade at door landings should be a minimum of 1-1/2" below the door threshold or interior floor. The present condition can allow for water infiltration during wet periods.

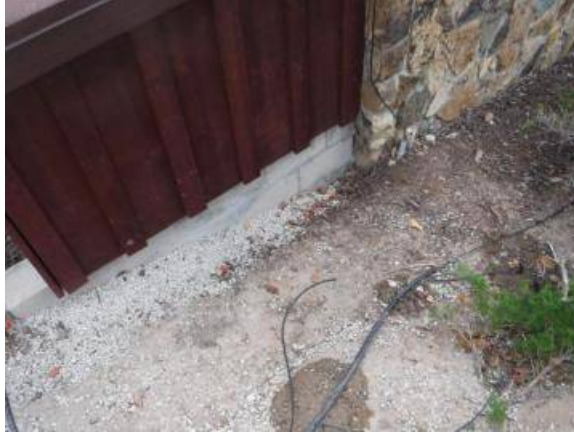
Repair - The soil gradient sloped toward the foundation at the garage. The slope should fall away from the foundation to keep surface runoff from collecting at the foundation. Correcting the soil pitch is needed to improve drainage. If drainage systems are installed underground and not visible in any areas around the house we recommend gathering any documentation of this installation and any permits before listing.

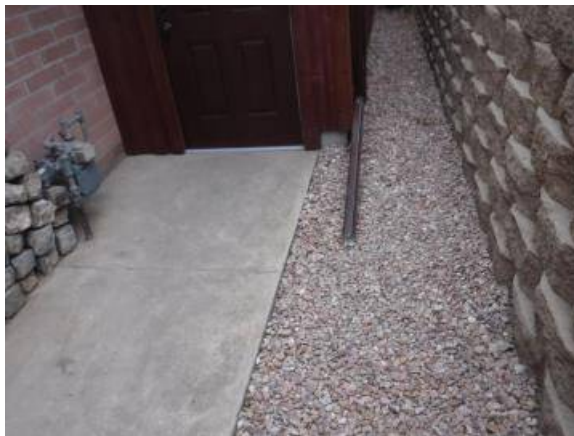
Marginal - Surface drainage was blocked / trapped near the garage. Drainage improvements are recommended. Corrective action should be undertaken by a licensed landscaping contractor to divert water away from the foundations.

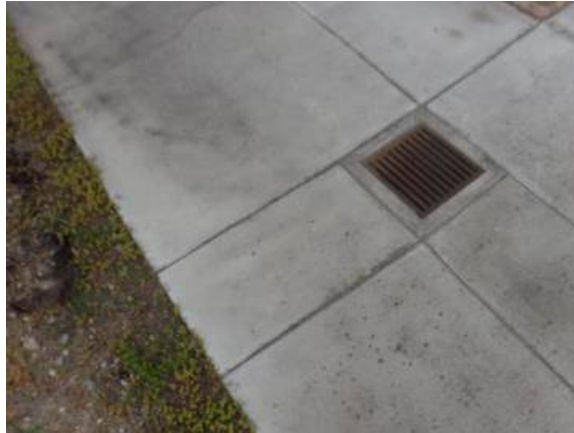
Advisory - Recommend verifying that the underground drainage system is functional, and recommend flushing drains annually.

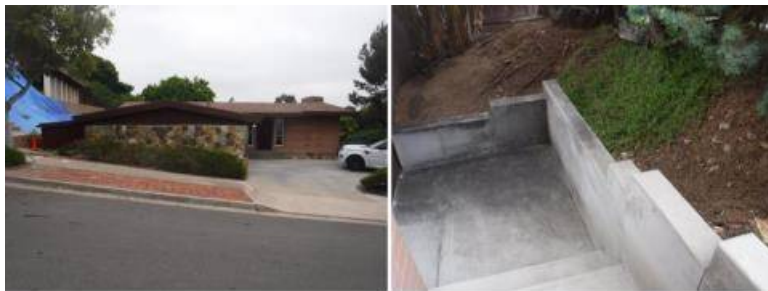
Marginal - The building pad sits below the street grade. Strict drainage controls and restricting irrigation are advisable to better ensure that stable site conditions prevail and to keep moisture out of the structure or foundation.

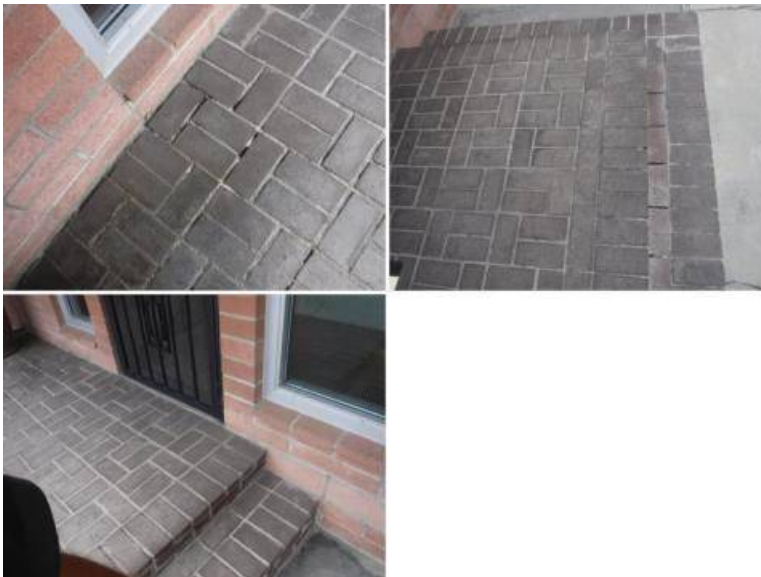
Maintenance - Cracks and gaps in paving should be sealed/repared to stop water infiltration, which can help prevent further damage.
Maintenance - Front porch grout need to be re-tuckpointed/ sealed for longevity.

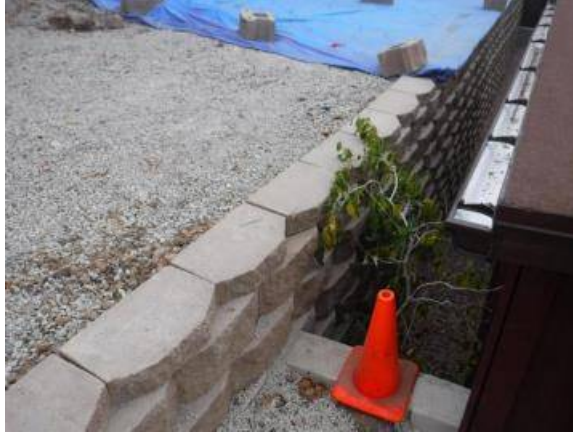
Safety - No guardrail present at walk-off. Guardrails are required for user safety where there is an elevation change (drop off) of 30 inches or more.

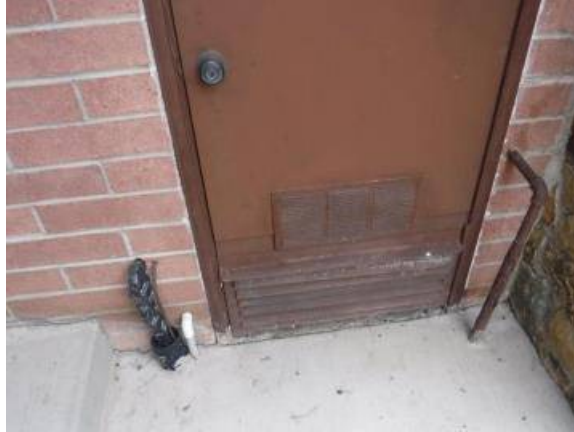
Maintenance - Poor finish was noted on exterior side of one or more door. Painting/Refinishing is needed to protect the wood construction.

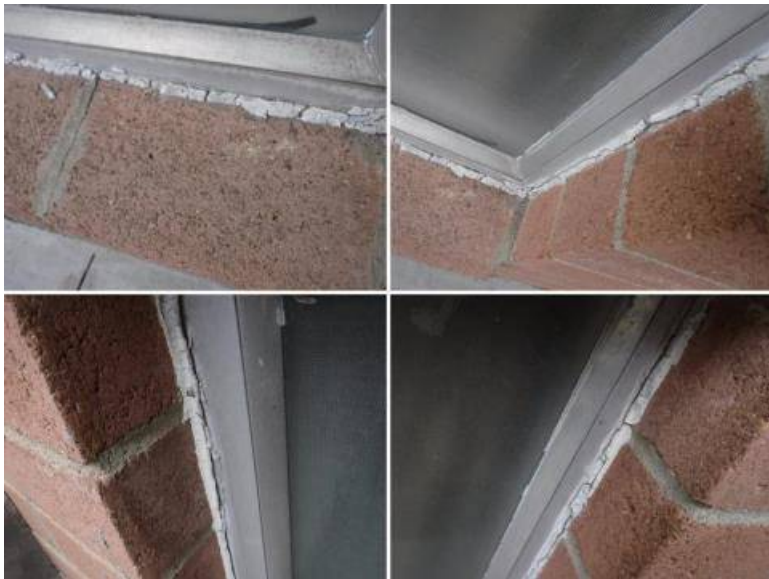
Marginal - Sealant is deteriorated at one or more windows sampled. Deteriorated glazing putty should be removed and re-applied to guard against moisture damage and air infiltration.

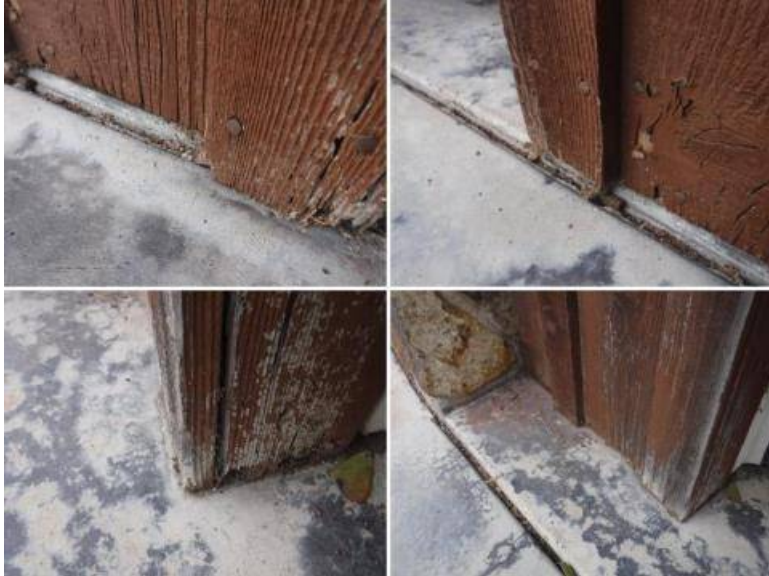
Further Evaluation - There was evidence of a past insect infestation. See Pest Inspection Report or have one performed.

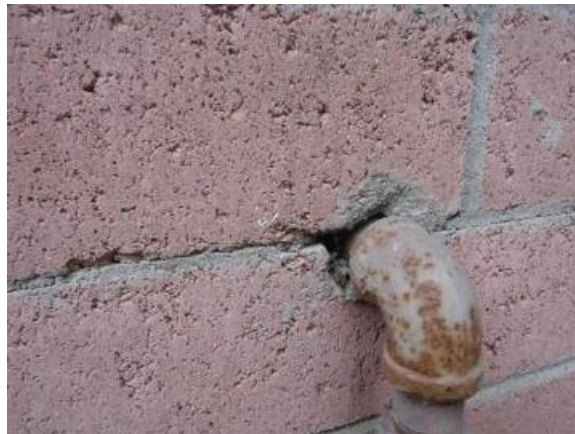
Maintenance - Gaps were noted in stone veneer and at brick around penetrations. . Gaps can be re-tuckpointed or sealed to help prevent water infiltration and moisture damage.

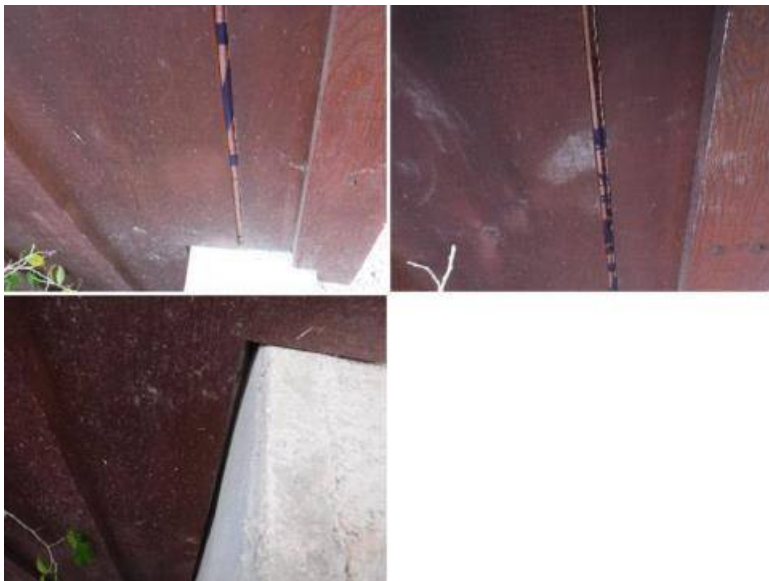
Maintenance - Gaps were noted where flashing behind the wood was visible at the garage addition. Gaps in exterior siding or trim should be sealed/protected to help prevent water infiltration and moisture damage.

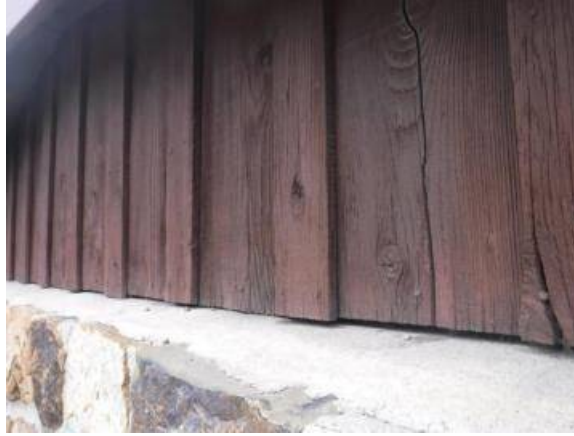
Maintenance - Faded and/or peeling paint was noted. Cracking/Weathering noted with exterior wood trim. This component was showing signs of advanced aging. Painting is needed at this time to preserve the condition of the exterior wood. Paint helps to protect exterior wood from weathering and dry rot.

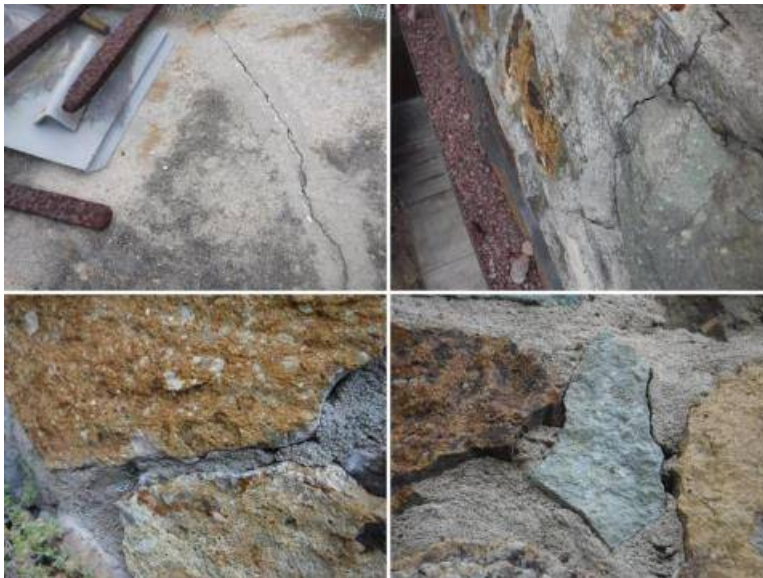
Maintenance - Small cracks were observed in grout. This is often an early sign of aging and deterioration. It would be beneficial to investigate what measures can best be take to slow or halt future deterioration and/or to find out if routine service/repair is needed at this time. We recommend contacting a qualified fireplace professional for this.

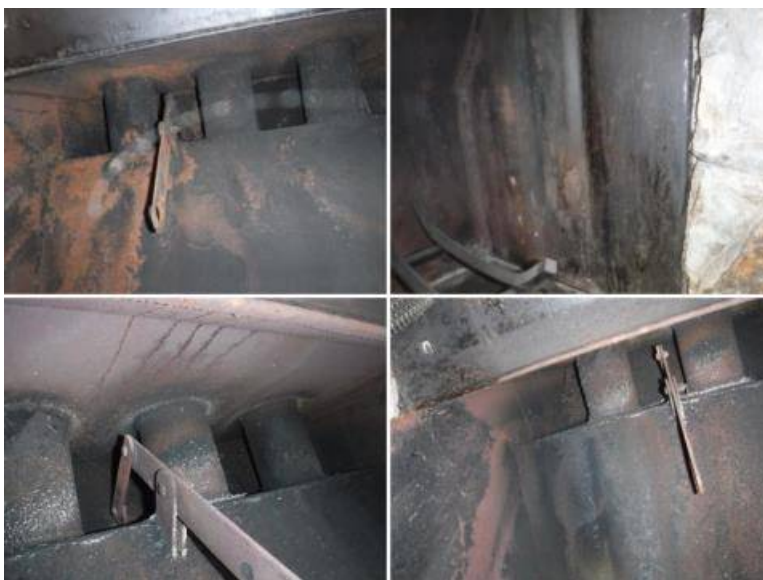
Further Evaluation - There was evidence of water infiltration at the top of the firebox and rust/ corrosion was noted. The source should be found and the problem corrected. Corrosion to firebox should be evaluated at this time.

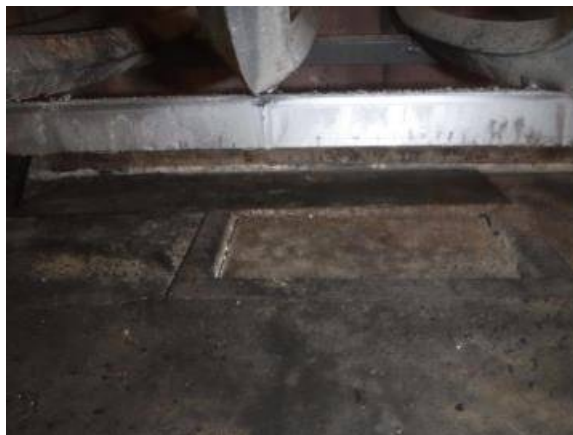
Marginal - Ash pits are now considered unsafe (fire hazard) and most fireplace companies recommend sealing them off and discontinuing use of the ash pit. We recommend doing so.

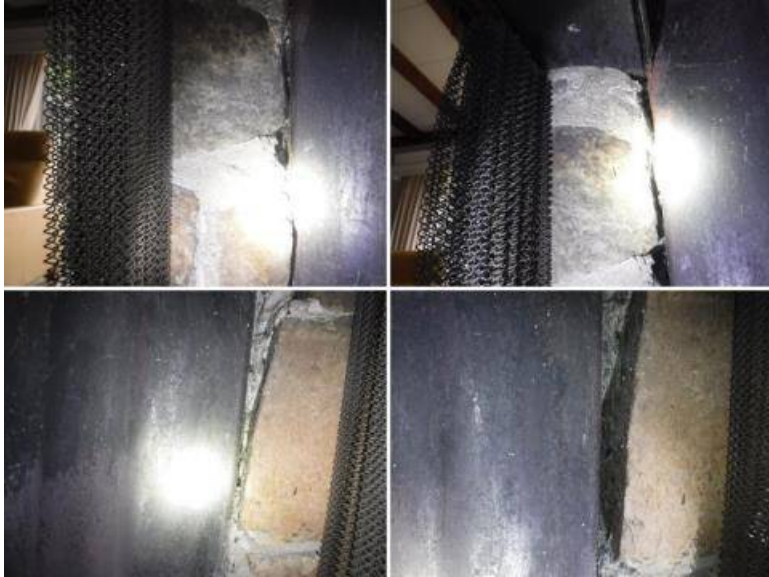
Maintenance - Mortar is missing or deteriorated in masonry joints. It is important for that the fireplace and chimneystack are smoke tight for safe. Correction is recommended by a qualified fireplace professional prior to use.

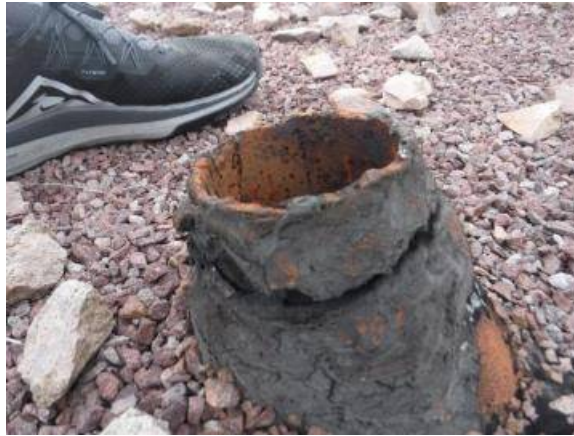
Maintenance - Sealant around vent penetrations is cracked/deteriorated. Fresh sealant is needed at this time to prevent leakage.

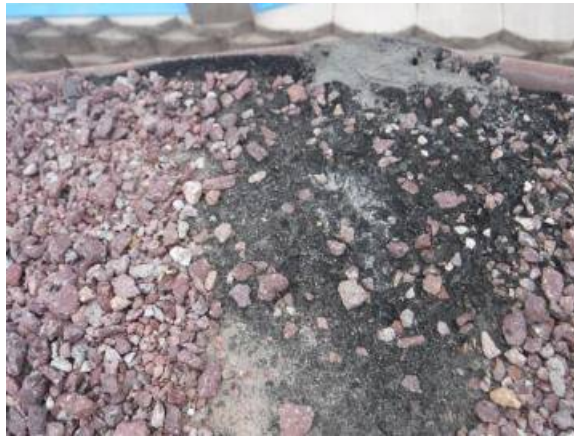
Advisory - Repairs and/or patching were observed that may indicate the roof has leaked in the past. Recommend asking the seller as to the history of any leaks and subsequent repairs.

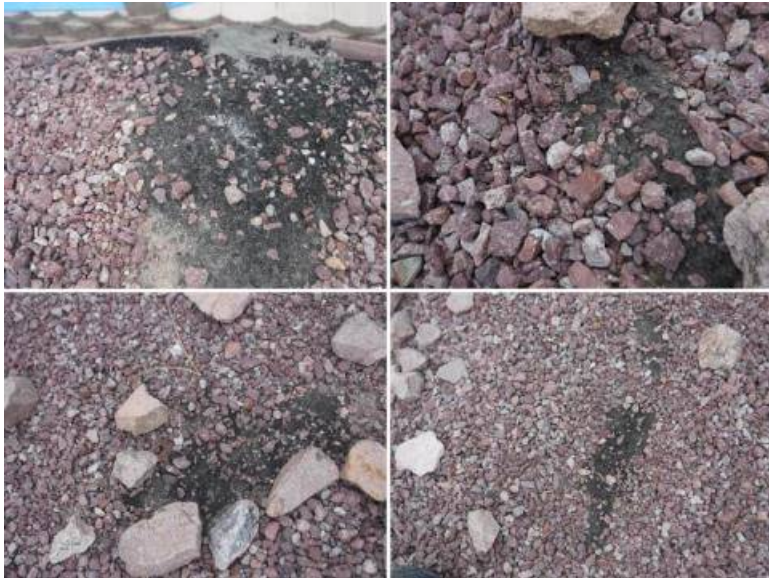
Repair - Bare spots or thin areas in the protective gravel cap were observed. Cracking and blistering of underlying felts has occurred due to exposure to UV light. Repair is recommended in these areas at this time.

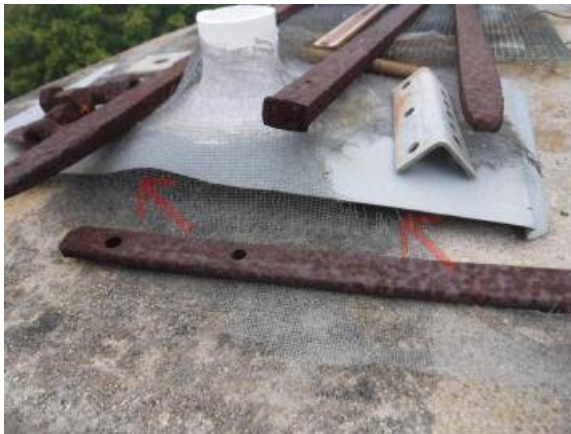
Repair - Metal flashing was improperly installed / was not sealed at the furnace vent.

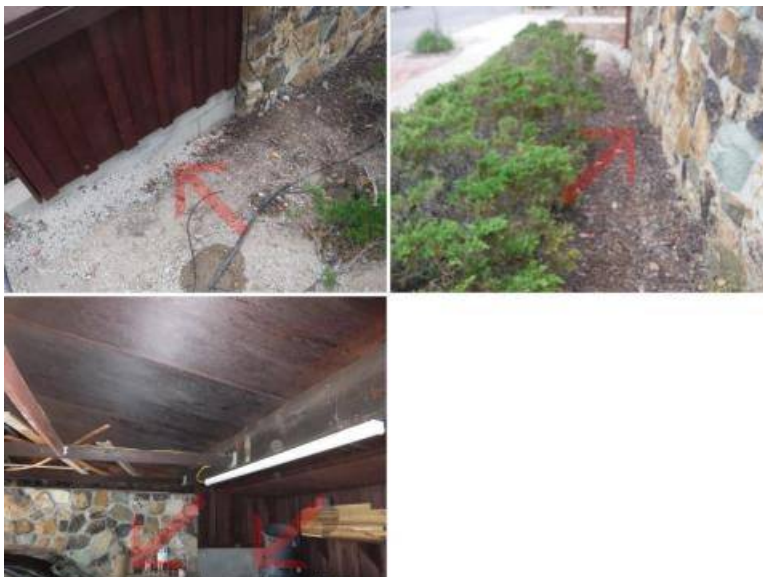
Advisory - Subterranean space was present, meaning the interior floor elevation of the garage was significantly lower than the exterior soil grade. While moisture stains or other evidence of moisture were not observed at the interior associated with subterranean living space, below grade construction is prone to having moisture problems. Even in the absence of visual evidence, we recommend a mold/moisture specialist for further evaluation.

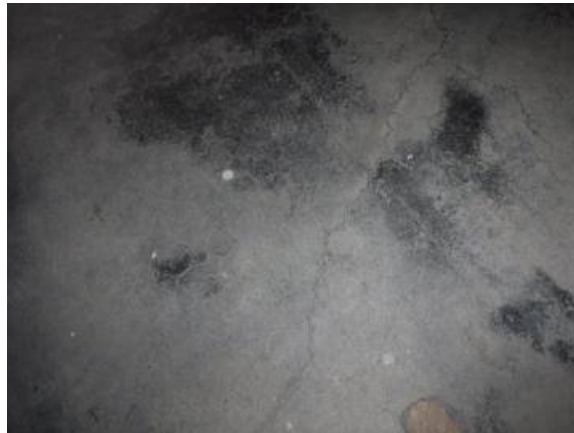
Functional - Hairline crack(s) noted in the floor slab.

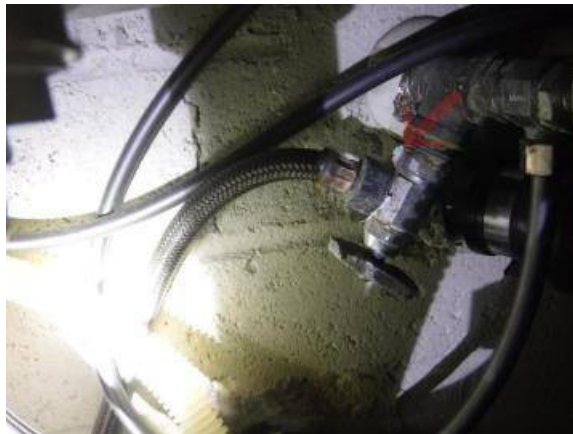
Upgrade - Some newer or replacement local shutoff valves and/or plumbing connections were installed serving the sinks and/or toilets. Remaining components were old/original, beyond their expected service life. These components have a 15-20 year life expectancy and are prone to failure as they age. Recommend replacing old components as an upgrade to the system.

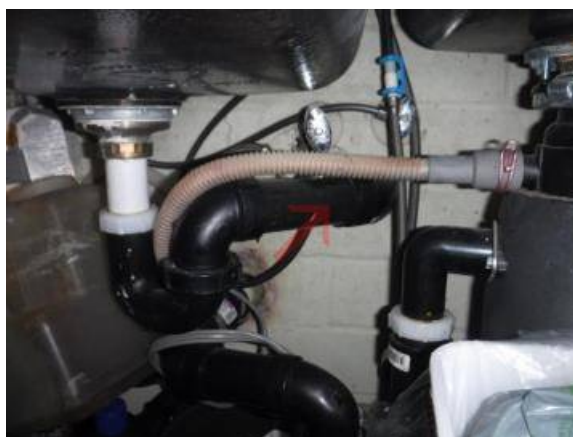
Maintenance - A slightly negative pitch was observed in the drain arm at the kitchen. This condition promotes clogging. Adjustment or repair is recommended to create a positive pitch for proper flow.

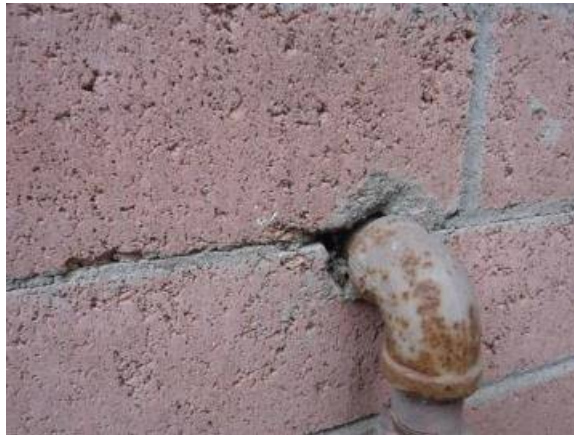
Maintenance - Corrosion was noted on iron gas pipe(s). Routine maintenance is needed. A rust inhibitor should be applied to prevent further deterioration.

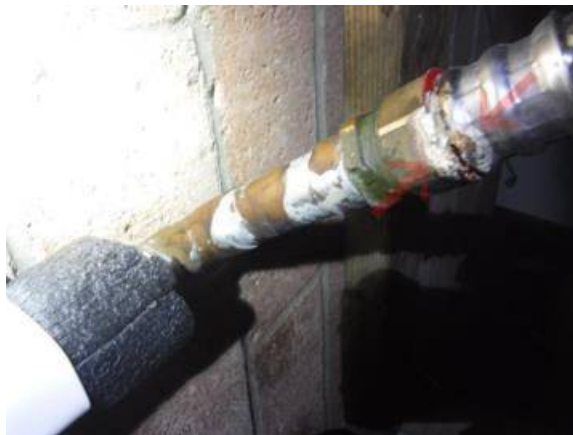
Repair - Rust/corrosion was noted on plumbing connections. Repair/ corrections are needed to protect against unexpected leaking.

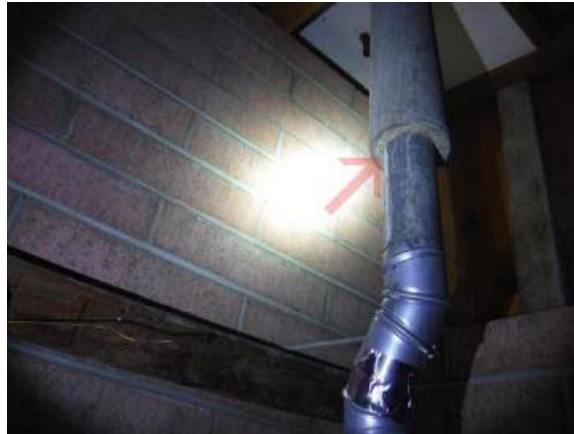
Marginal - Vent pipe materials were incompatible. Metal vent pipe was connected to old style transite pipe. Excessive condensation is a common occurrence with a transite pipe and may lead to premature corrosion/deterioration of the metal vent pipe and/or of the appliance below. Recommend replacing the old vent pipe when the appliance is eventually replaced or when roof repairs are undertaken.

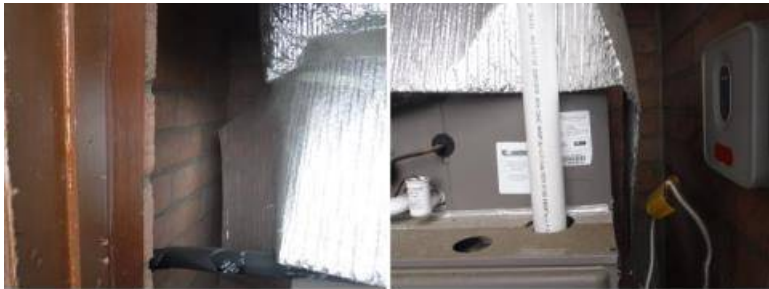
Maintenance - Insulation is falling off the plenums in the closet and needs to be taped.

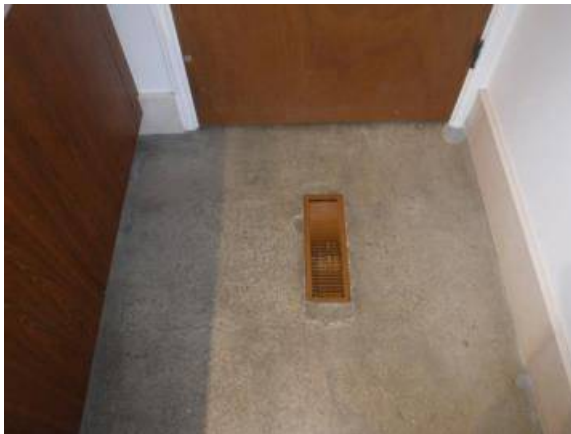
Advisory - HVAC register in the middle of the entry to the hall bathroom upstairs. Typically they are installed along the wall/ away from the middle of pathways. This register cover can get damaged when walked on.

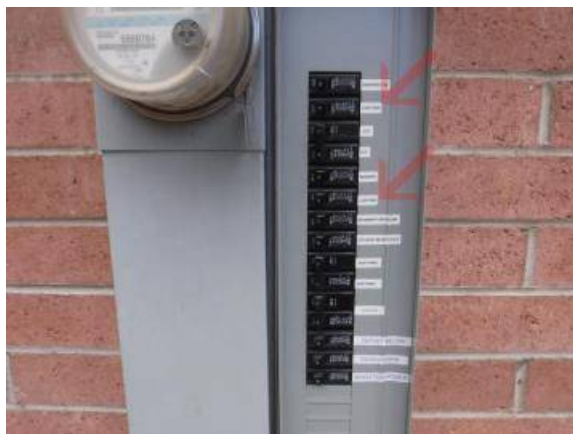
Maintenance - Not all branch circuits were labeled specifically. Generic labels such as lights, outlets, appliances were used. All circuits should be labeled sufficiently so that any one circuit can be quickly turned off in an emergency.

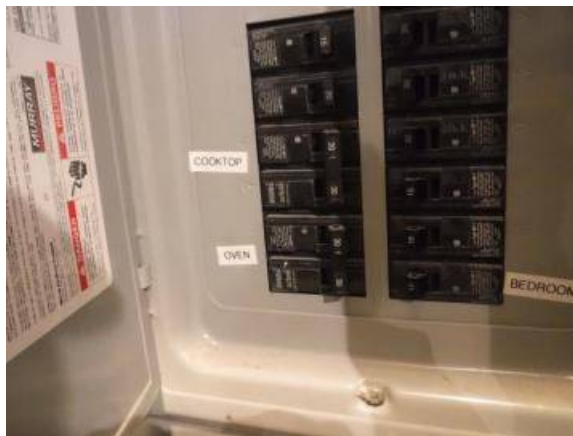
Maintenance - Branch circuits were not labeled. All circuits should be labeled so that any one circuit can be quickly turned off in an emergency. We could not tell if all appliances had dedicated circuits with current labeling. Ideally each appliance should be on a dedicated circuit properly sized for the appliance load in order to prevent overload and overheating of wiring.

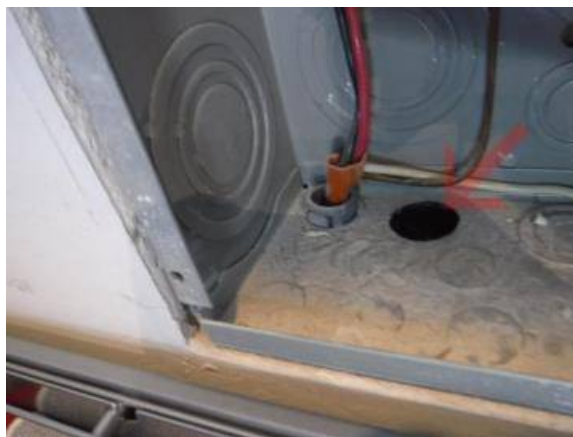
Maintenance - Unused wire run(s) or knockout opening(s) were noted inside the panel. Unused knockouts inside the panel may allow small rodents or other pests to enter that can potentially damage components. Additionally, unused knockouts negate the fire protection of a sealed panel box. A blank cover should be installed over each unused opening.

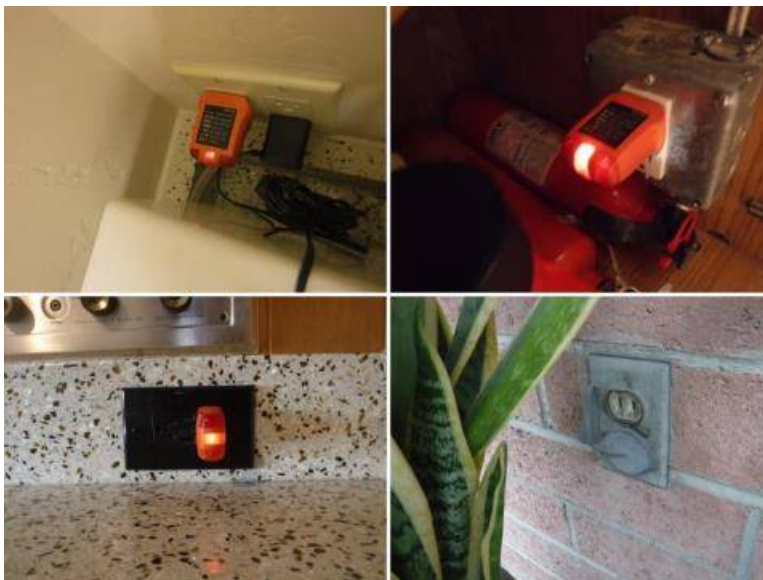
Repair - 3 hole grounded outlets were installed at many locations, even though outlets were testing ungrounded. The use of 3 hole grounded type outlets gives the false impression of a grounded circuit. Older style 2 slot outlets are still available and should be installed. Alternatively, GFCI protection may be installed for ungrounded outlets. Ungrounded small appliance use outlets were found at: the mini bar closet, lower bathroom and the kitchen

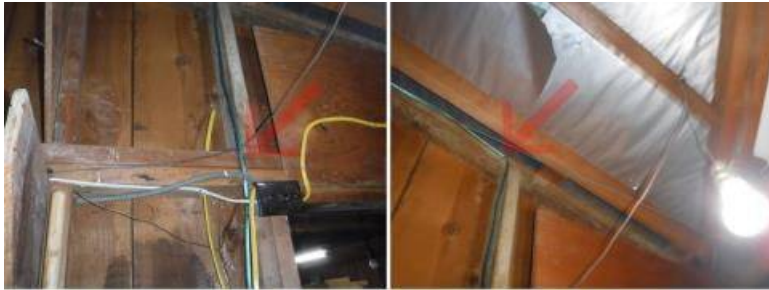
Marginal - Old or worn wiring was found at various locations. Wiring should be replaced at the first signs of wear and tear. Recommend a licensed electrician for further evaluation and corrections as needed.

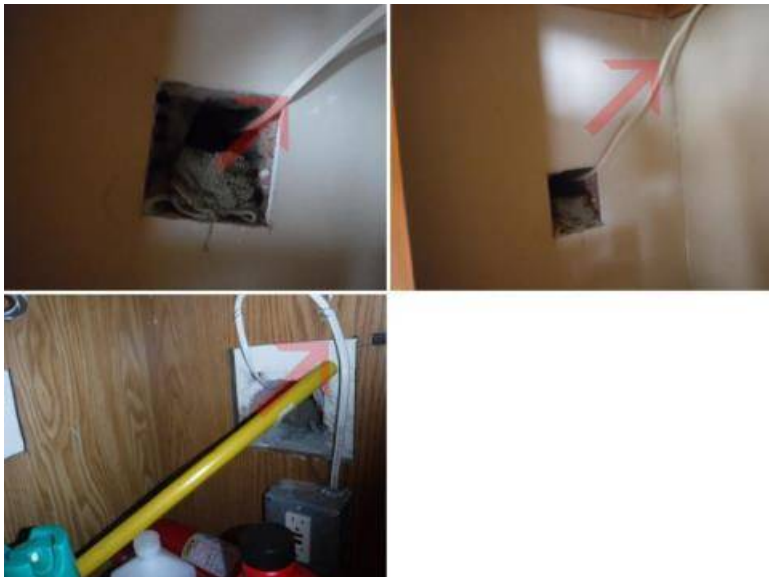
Marginal - Plastic sheathed cables were exposed in cabinets to potential mechanical damage in the lower bathroom and the downstairs mini bar closet. In this situation, the wiring should be housed in a protective conduit.

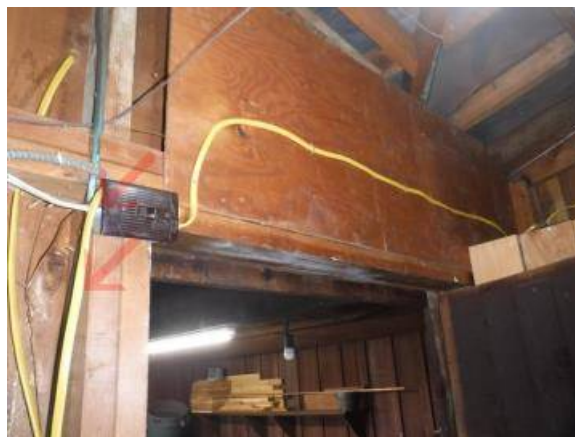
Marginal - Plastic sheathed cables were installed on the face of the wall studs below 7 feet in the garage. This is improper because cables are exposed to potential mechanical damage.

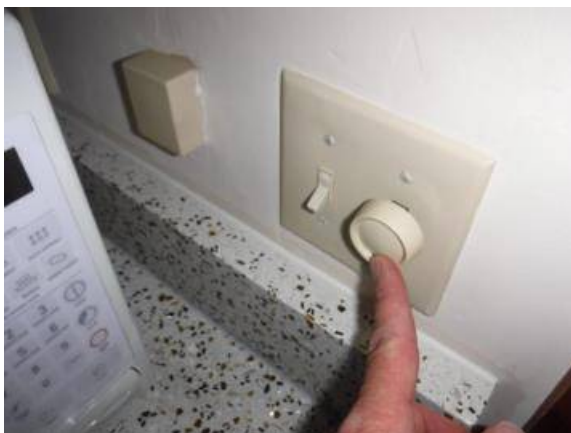
Advisory - Light switch(s) was tested but did not seem to operate any fixture or appliance at the mini bar closet. Recommend asking the seller about the operation of this switch or contacting an electrician for further evaluation.

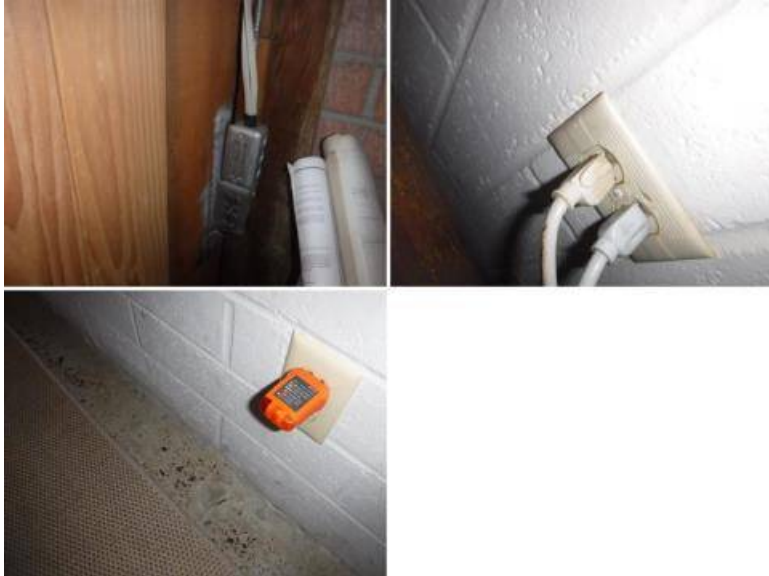
Marginal - Outlets are older in various locations. These devices have a limited reliable service life. Recommend replacing old outlets.

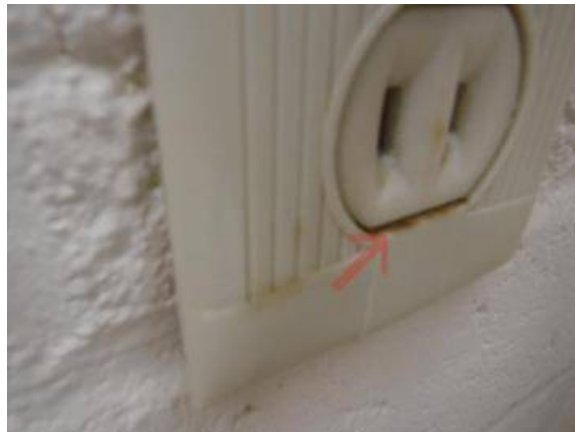
Marginal - Moisture was found on subterranean walls. Outlets were installed on lower sections of the walls and some rust was seen on the outer covers. We recommend having an electrician evaluate the outlets and wiring on these walls to ensure no corrosion or damage is present on the inside of the outlet boxes.

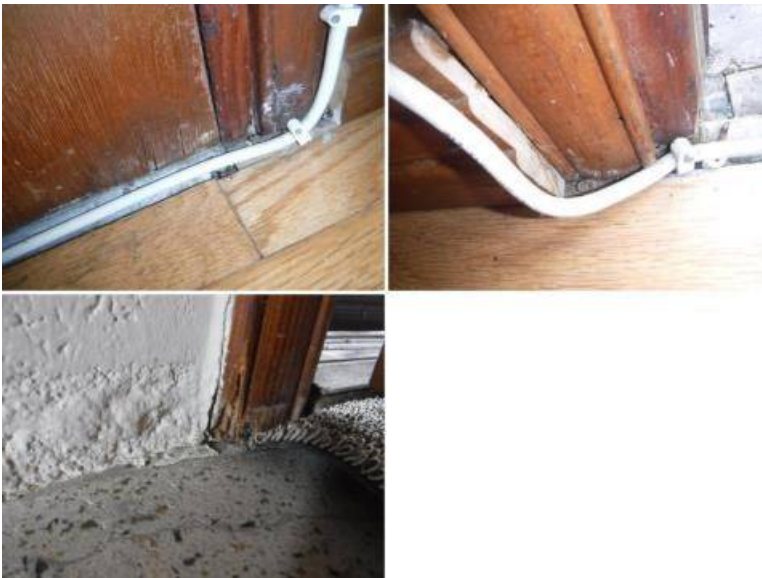
Further Evaluation - Water stains and/or water damage was noted at the interior around door opening(s). There is a concern about past moisture intrusion. The door may not have proper weather protection or flashing (or this may be an exterior grade issue). We recommend correcting the source as well as any damaged materials.

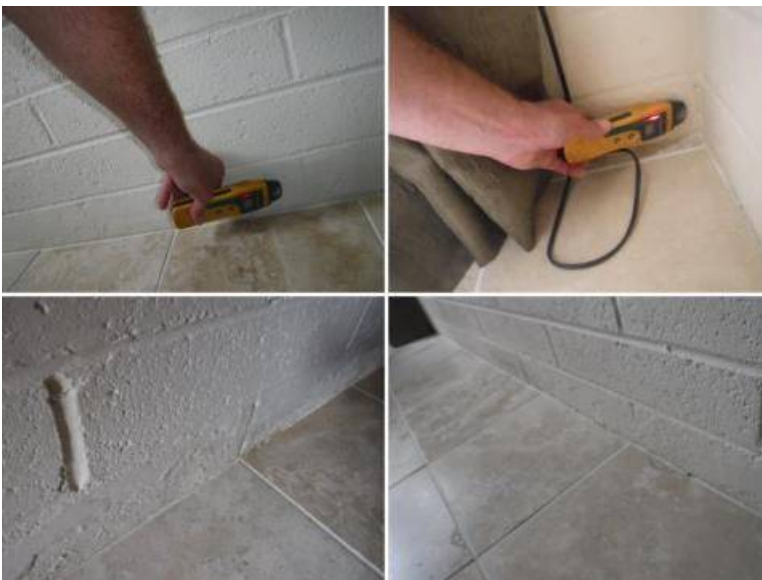
Further Evaluation - Water stains and/or water damage was not visible at the interior (or has been painted over in the past). However, areas were tested and found to have elevated levels of moisture. Moisture problems are often associated with subterranean construction even in the absence of visual evidence. We recommend a mold/moisture specialist for further evaluation.

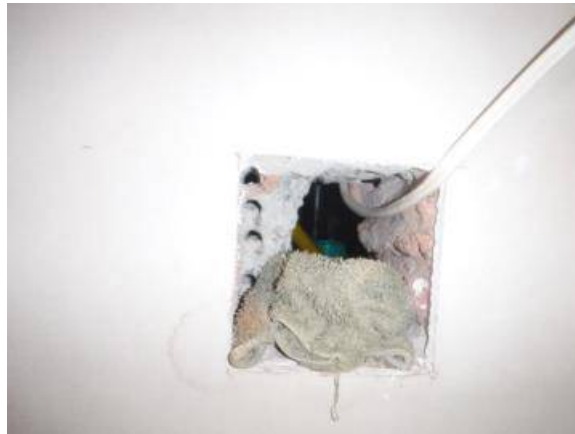
Maintenance - Wall finishes are missing under the cabinet (mini bar). This is a health issue because all surfaces in this area should be cleanable / washable.

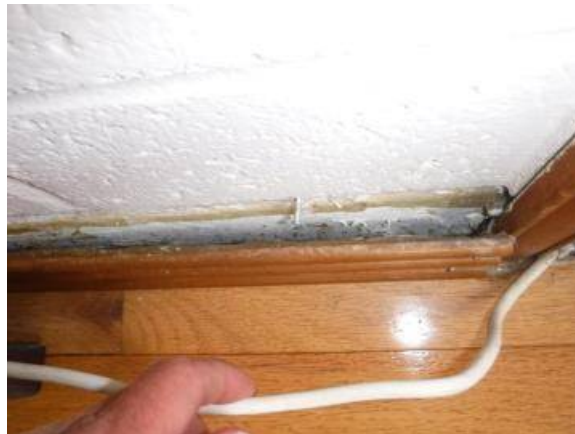
Maintenance - Wall trim, such as baseboard and/or door casing, was loose or gapped downstairs.

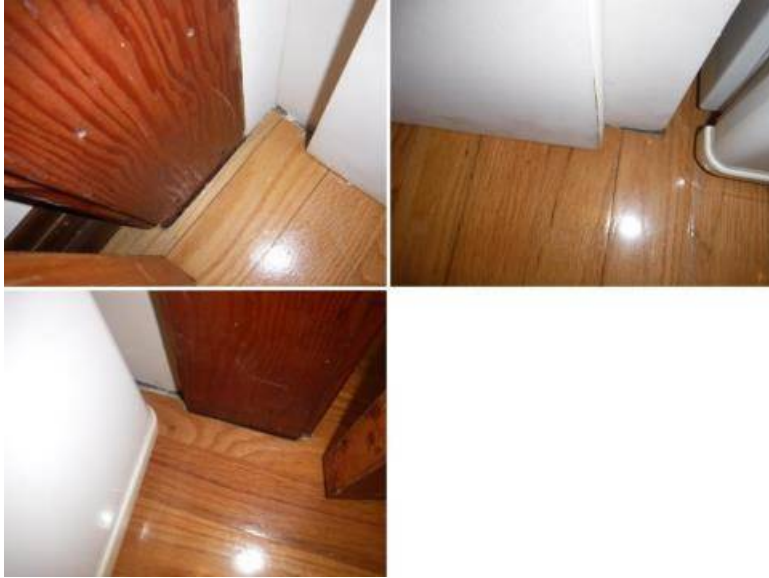
Maintenance - Floor gaps were noted. We recommend filling or covering floor gaps to prevent debris from collecting in the gaps.

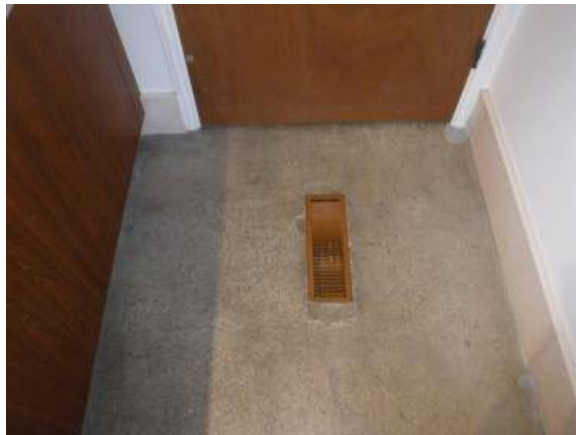
Advisory - HVAC register in the middle of the entry to the hall bathroom upstairs can be a trip hazard. Typically they are installed along the wall/ away from the middle of pathways.

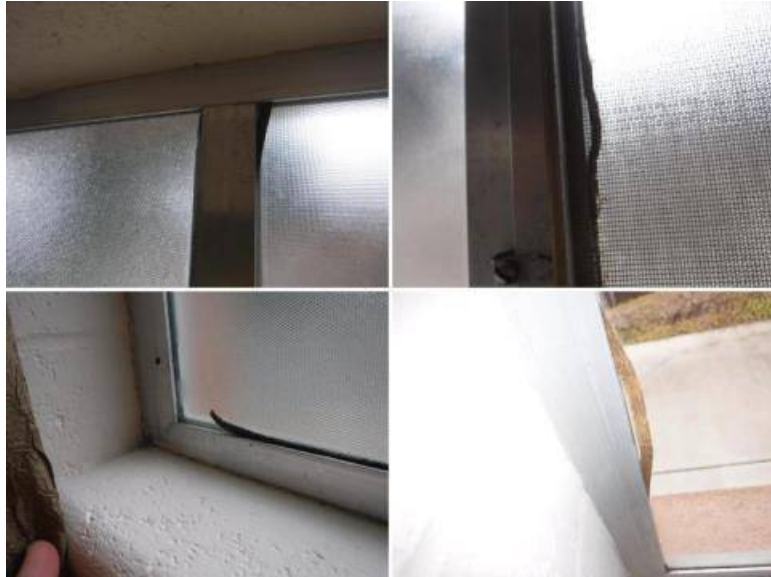
Marginal - The windows were older than their expected service life. Future performance may not be reliable. Better weather protection, improved operation, and energy savings can be gained with modern dual glazed windows.

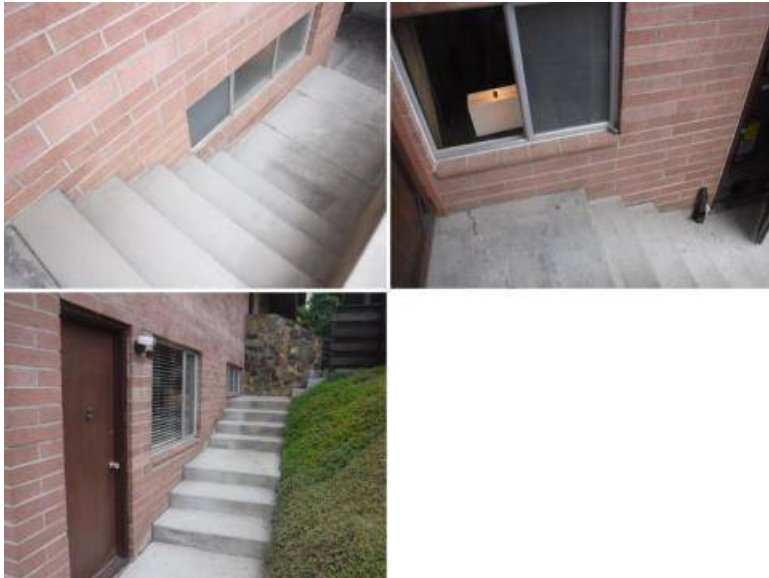
Safety - It did appear that safety tempered glass was not installed at several high risk locations at stairways and or walkways adjacent to windows. Glazing that is safety tempered should bear a mark or etching at one corner. But this marking was not visible. We recommend installing safety glass or safety film at all locations subject to human impact. A glazing contractor should be contacted to determine where safety glazing is needed and when windows are upgraded we recommend using safety glazing.

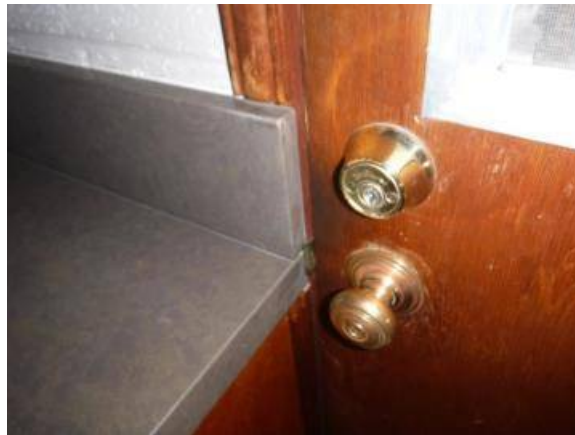
Safety - One or more exterior doors had a deadbolt that was key operated on the inside. This can impede exiting in an emergency. For enhanced safety, we recommend replacing double-keyed cylinders with single-keyed cylinder deadbolts that are hand operated from the inside.

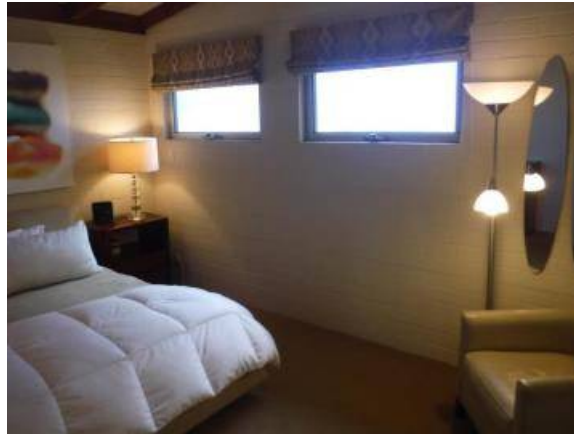
Safety - Window(s) did not meet emergency egress requirements at one or more bedrooms. Window sill(s) were noticeably too high above the floor. The window sill should not be higher than 44" by current safety standard (46" by old standard). Window(s) at the downstairs bedroom were 46" tall and windows at the upstairs bedroom were 5' tall.

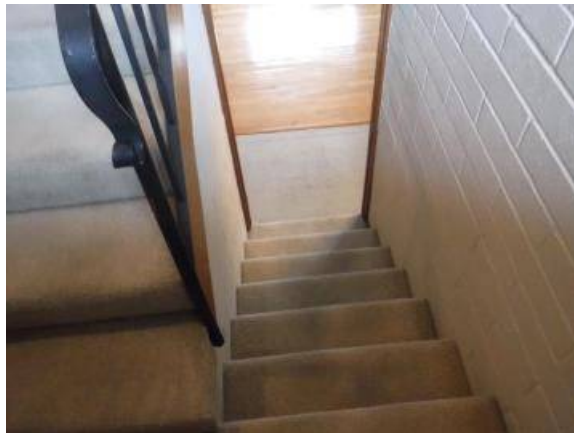
Safety - Handrails were missing at the lower stairs. Handrails are required where 4 or more risers are present. A trip or injury hazard was present.

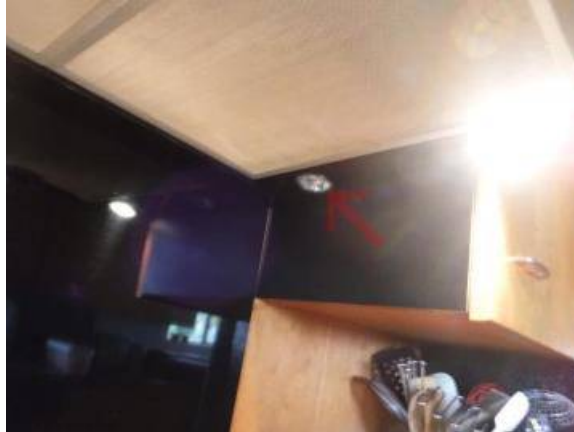
Maintenance - Light(s) were not working or missing bulb(s). Recommend installing new light bulb(s) to test if the light fixture(s) are working.

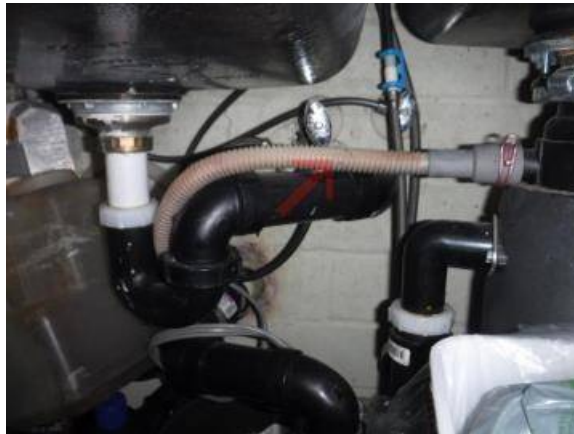
Marginal - An air gap device was not installed on the dishwasher drain hose above the sink. An air gap is required to prevent cross contamination from back siphoning in the event the sink becomes clogged. It may also help the dishwasher drain (and not leak) if the sink or disposal are clogged.

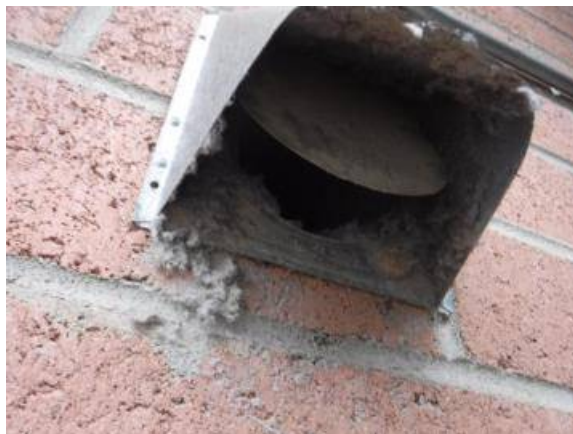
Maintenance - The dryer vent had lint build-up as seen from one of its ends. This can be a fire hazard. We recommend cleaning the dryer vent at this time and on a regular basis.
