# PROPERTY INSPECTION REPORT

489 E San Jose Rd.  
Palm Springs, Ca

Prepared for: Doug Bayer (6-4-25)

Prepared by: CTS Inspections

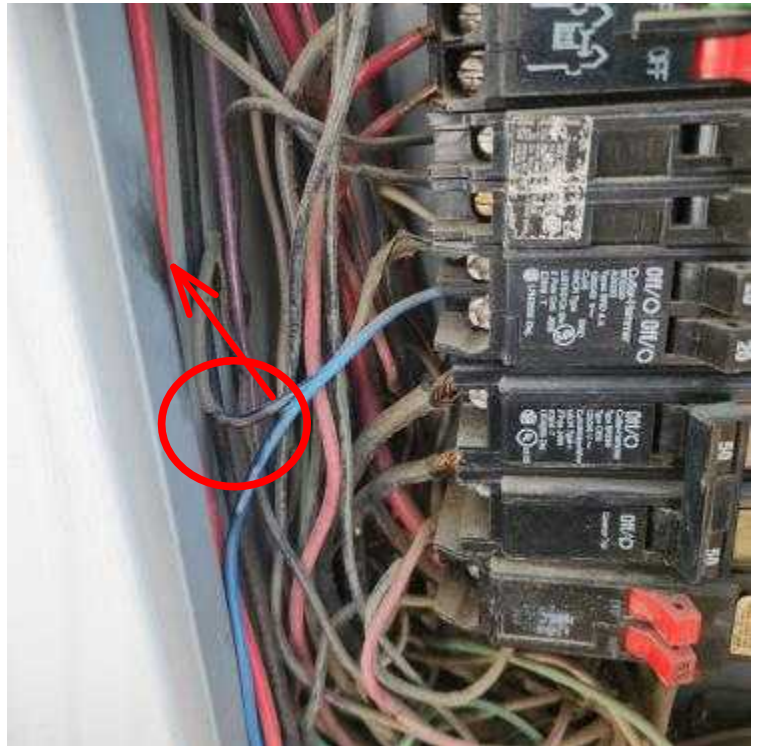
Double tap load wires present inside electrical panel-NTBS

- Double tap load wires present inside electrical panel, Damage insulation to (1) wire with evidence of arcing inside electrical panel.
- Missing anti-chafe bushing around wires inside electrical panel, Interior cover to electrical panel missing knockout insert.

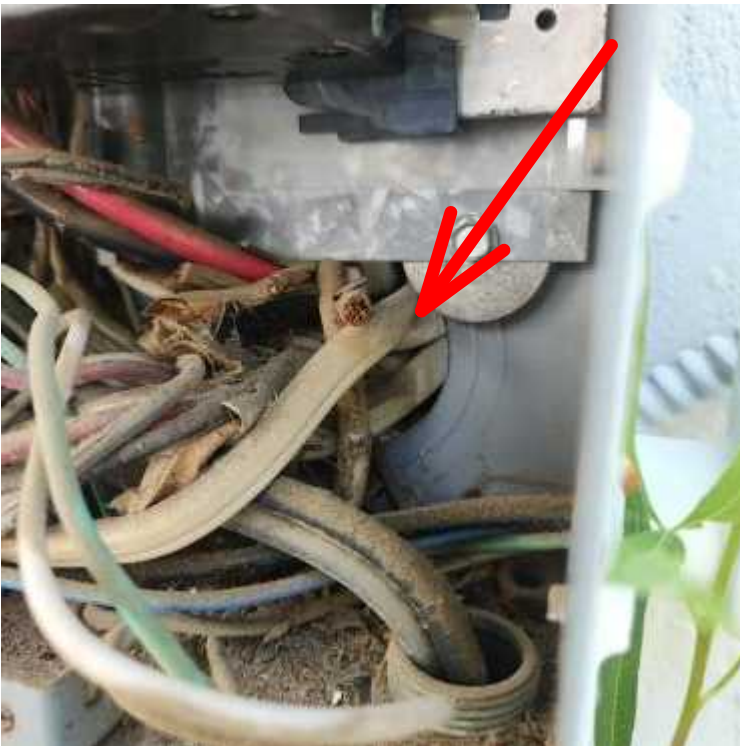
Damaged insulation to (1) wire with evidence of arcing inside electrical panel

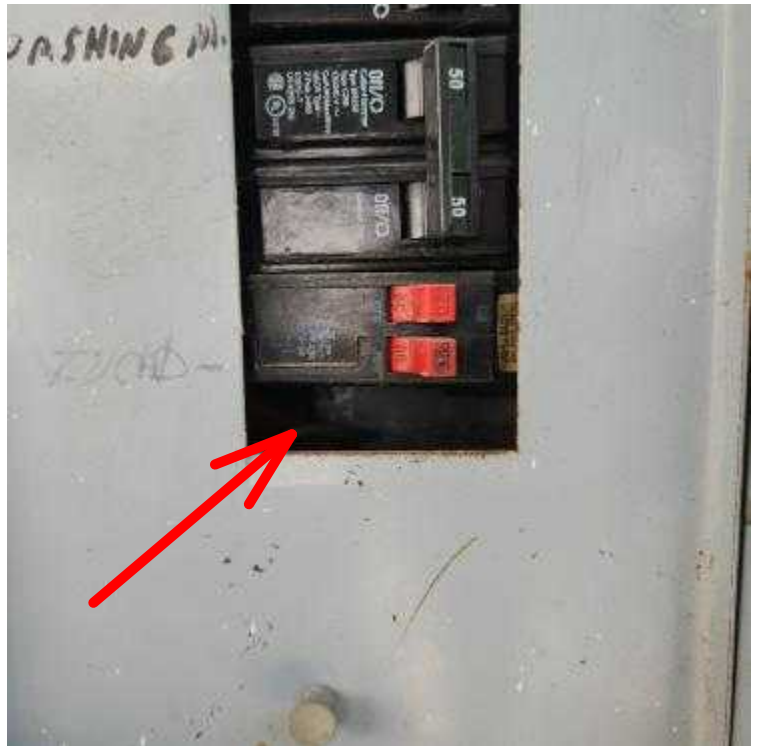
Missing anti-chafe bushing around wires inside electrical panel-NTBS

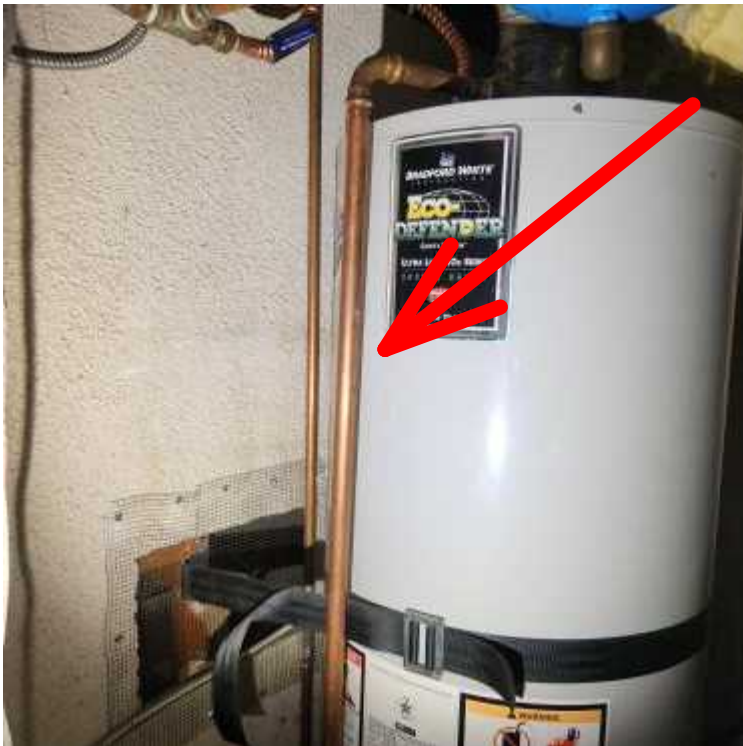
Missing insulation on supply/flow pipes to water heater-NTBS

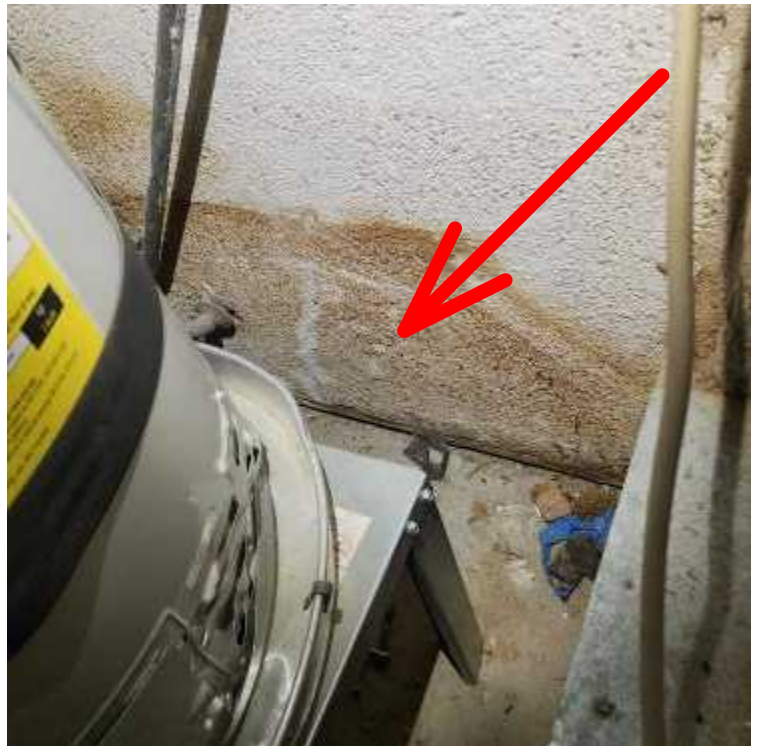
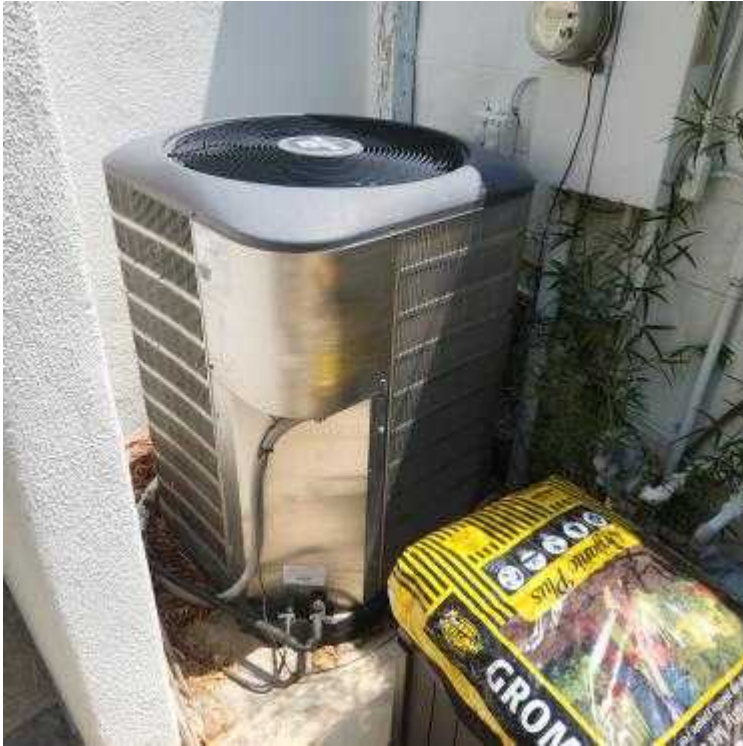
Dry moisture stains present on interior walls in utility closet

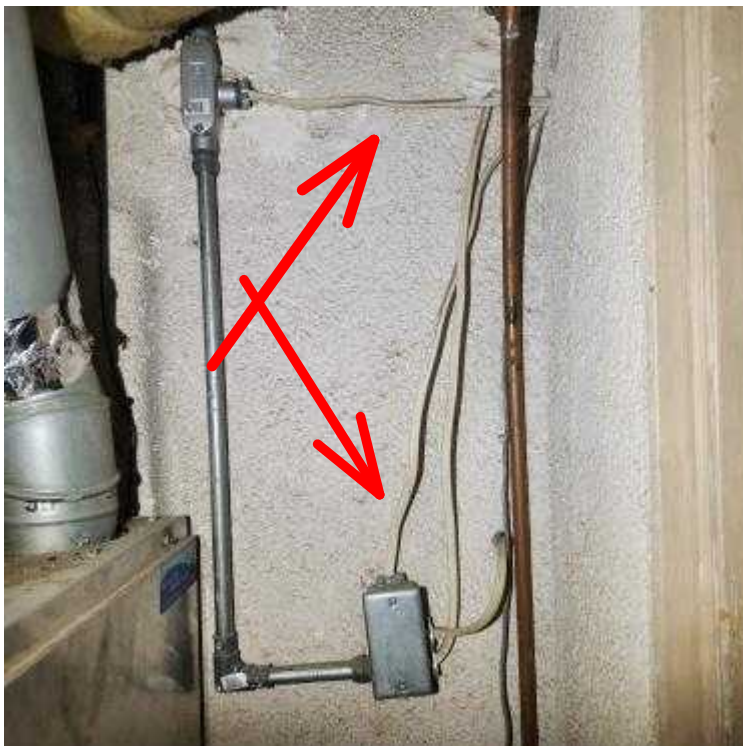
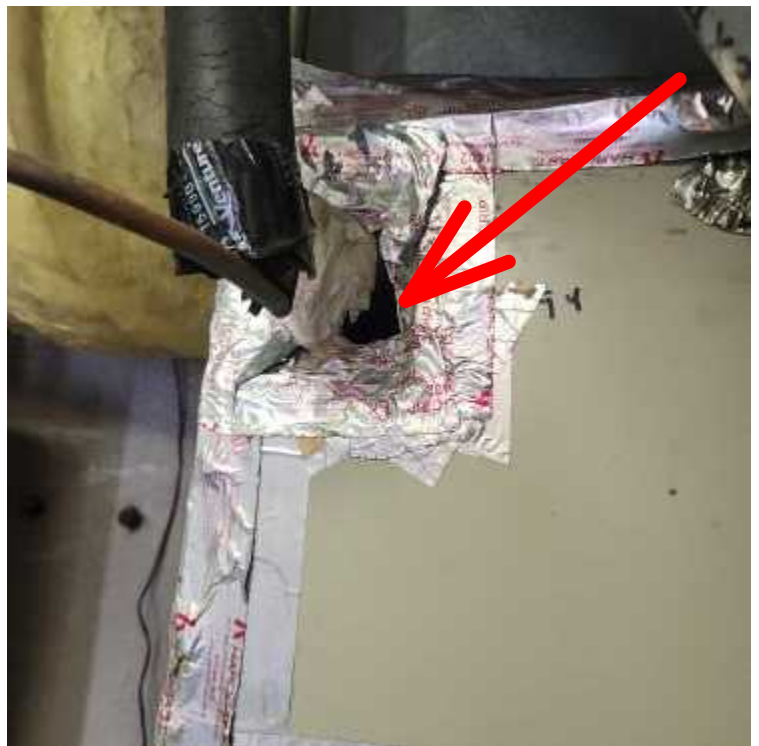
Outlet on south wall inside utility closet separated from box/missing cover plate

- Utility closet in converted garage: Outlet on south wall inside utility closet separated from box/missing cover plate, Exposed wiring on west wall inside closet

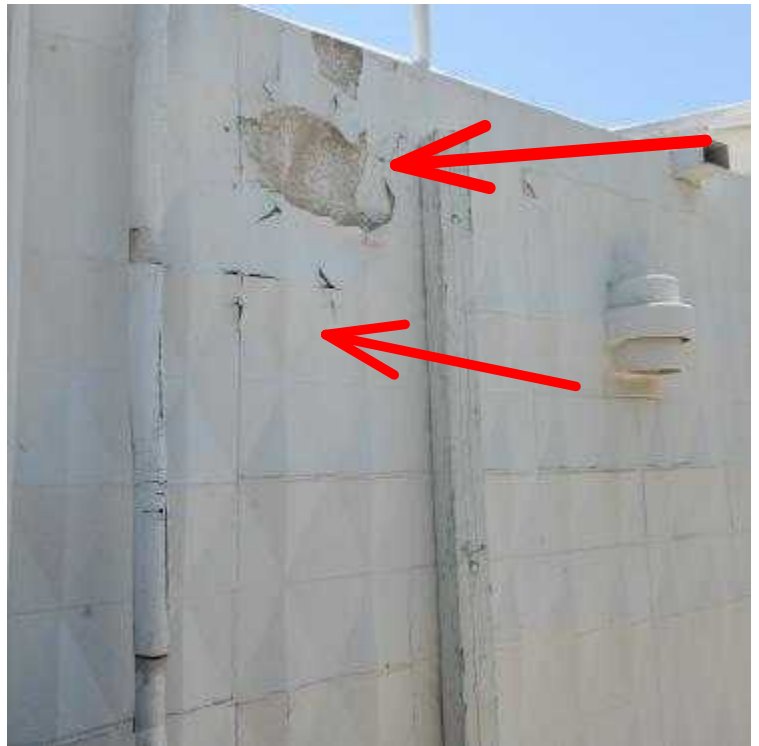
Chipped/Peeling stucco top coat in areas on north side of house

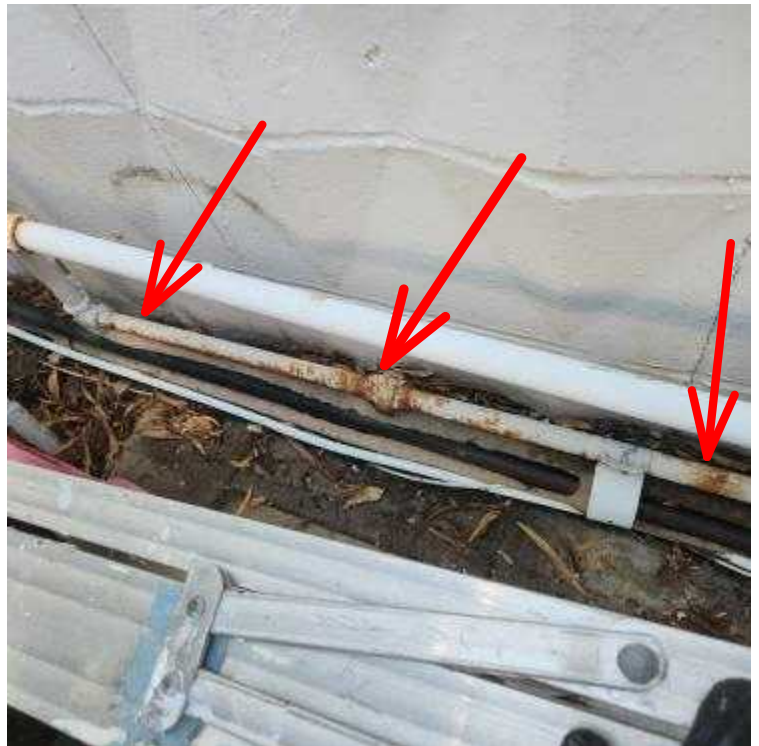
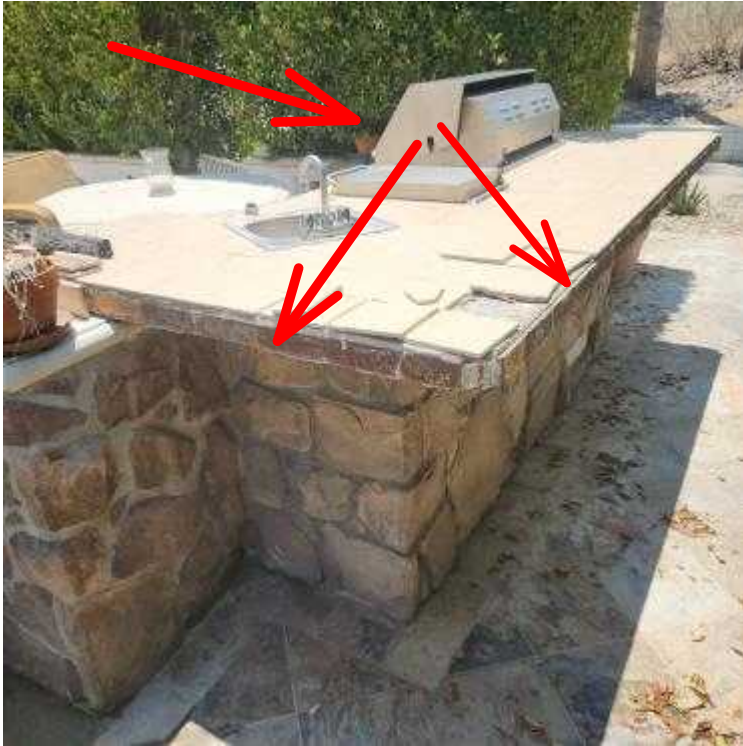
Rusted pipes on/from gas meter

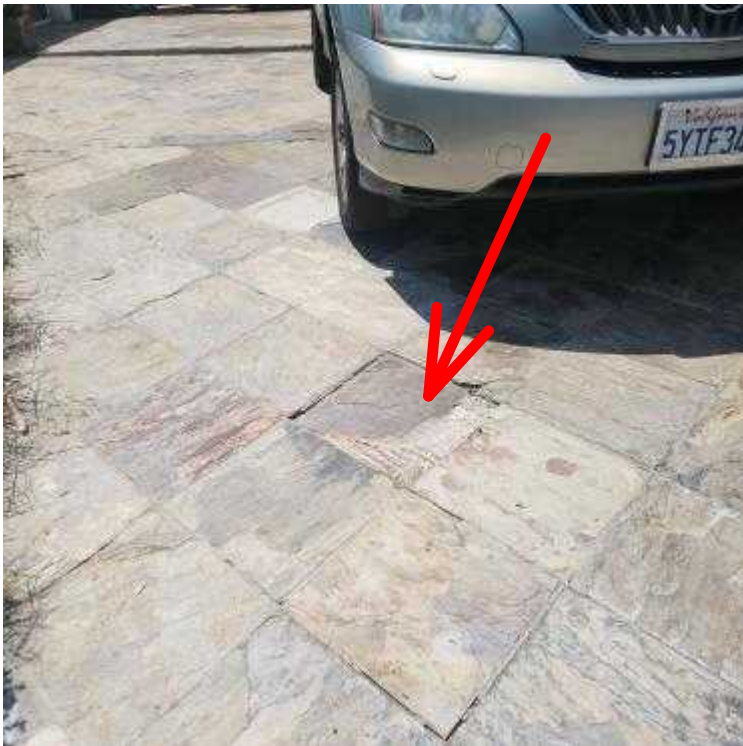
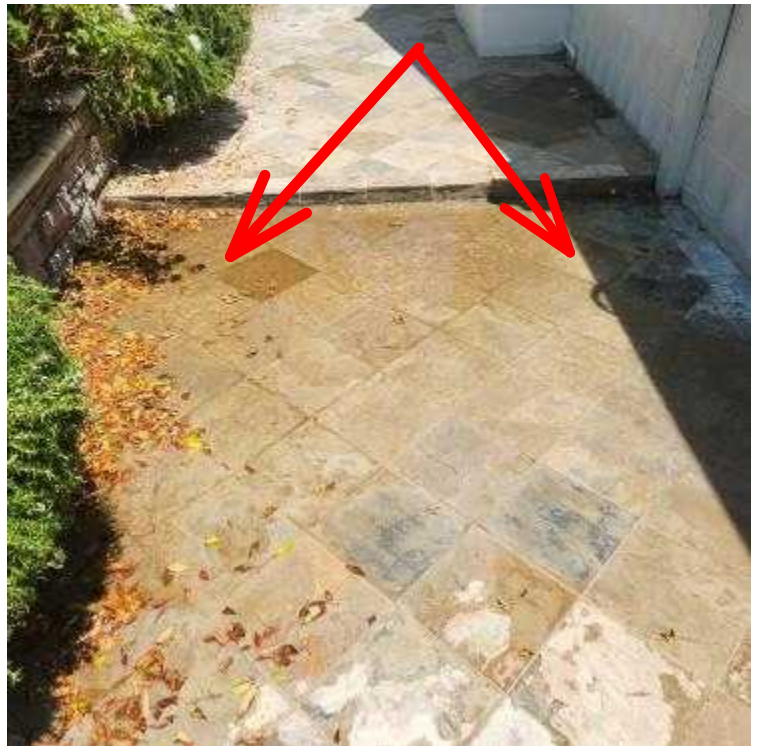
Broken/Missing tiles in driveway

- Primary: (1) Damaged dimmer switch on east wall
- Primary bathroom: Inoperative exhaust fan (was working properly, switch in water closet)
- Repair slate driveway and walkway in various places

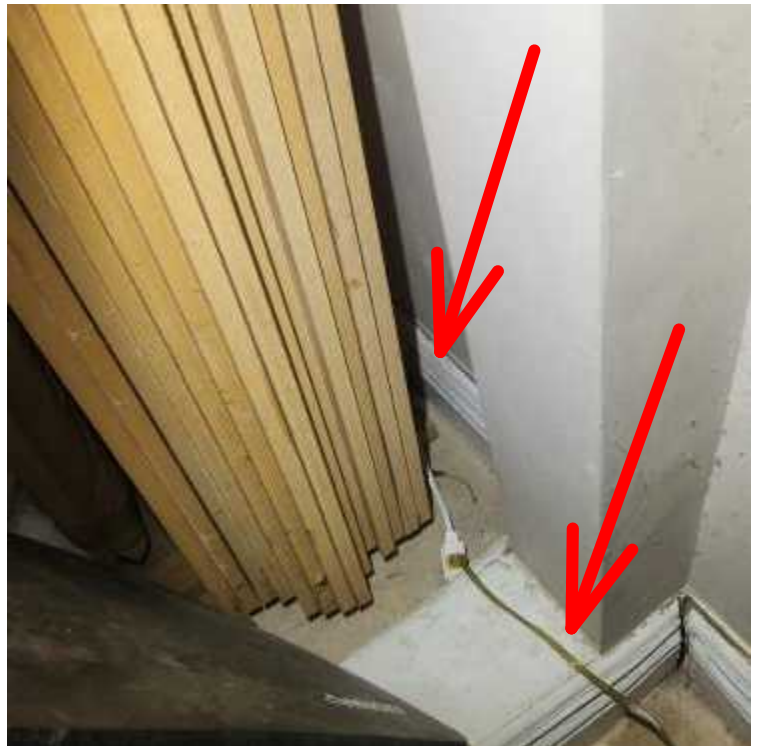
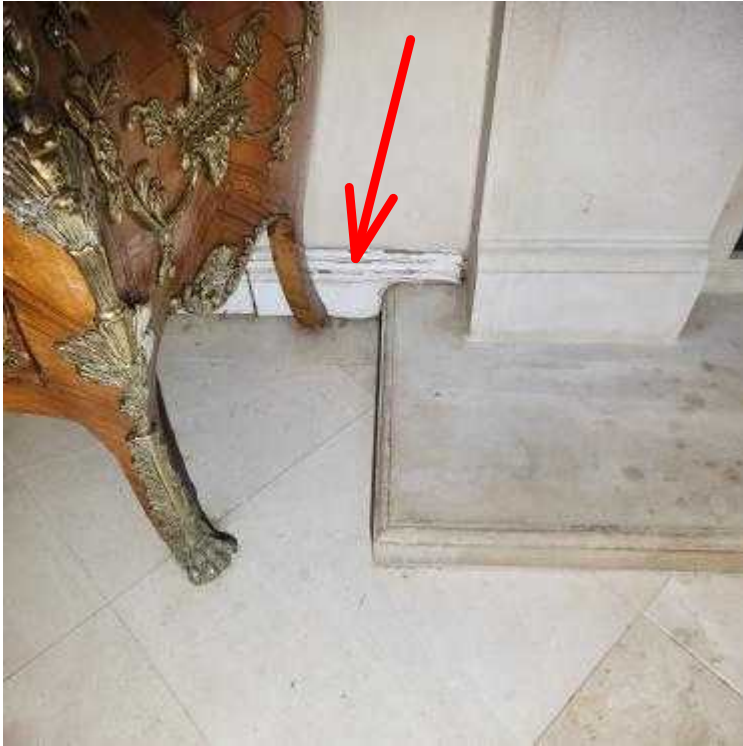
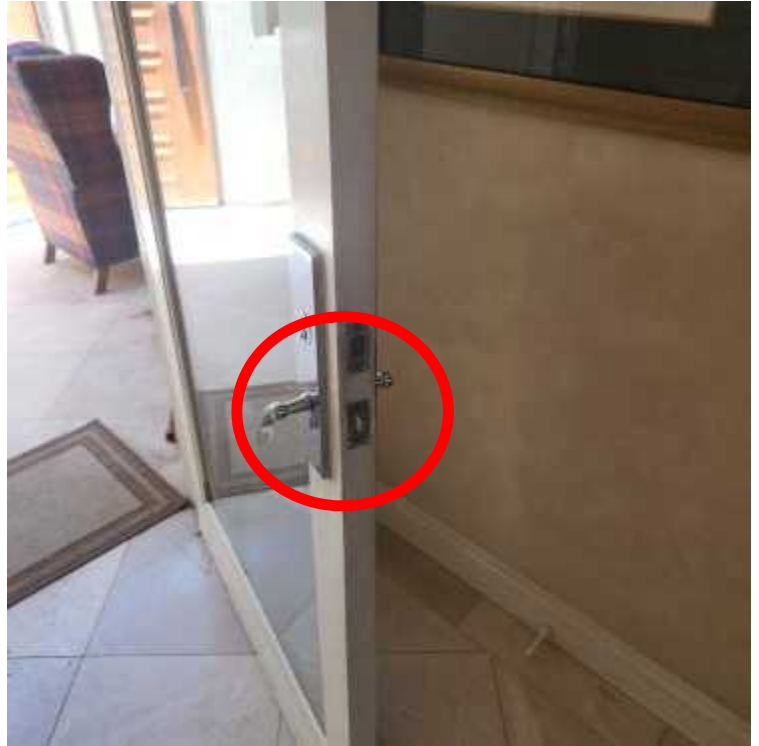
Moisture damage present to baseboard in areas on west wall in living room

- Drywall repair primary bathroom and guest bathroom
- Re-install duct vent in primary bathroom
- Replace damaged baseboard in main living area, primary bedroom, and bathroom

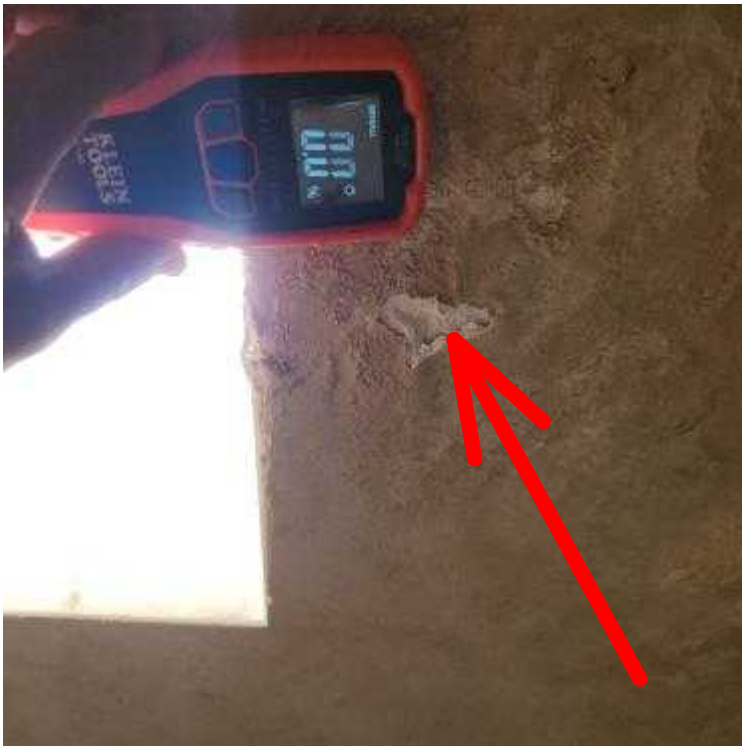
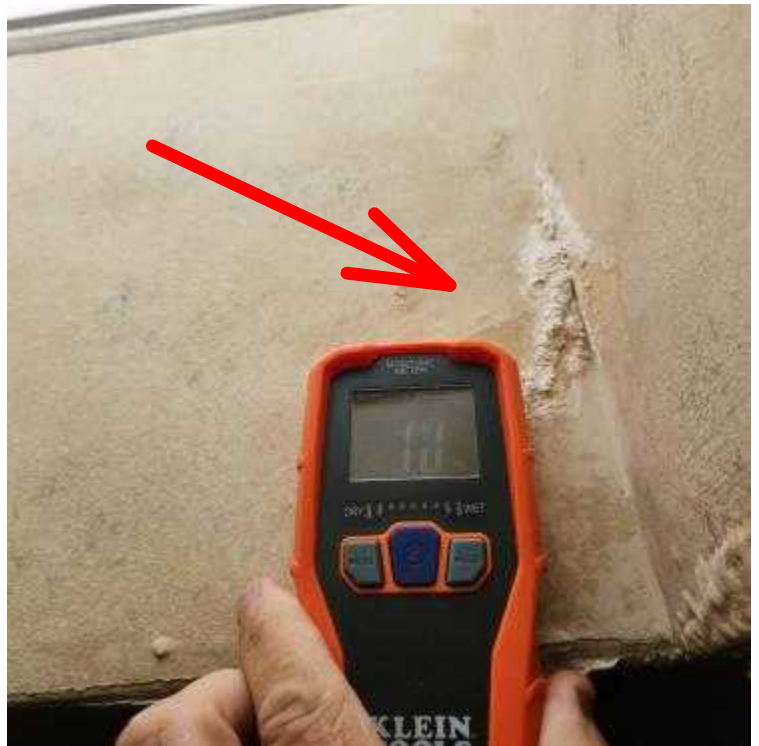
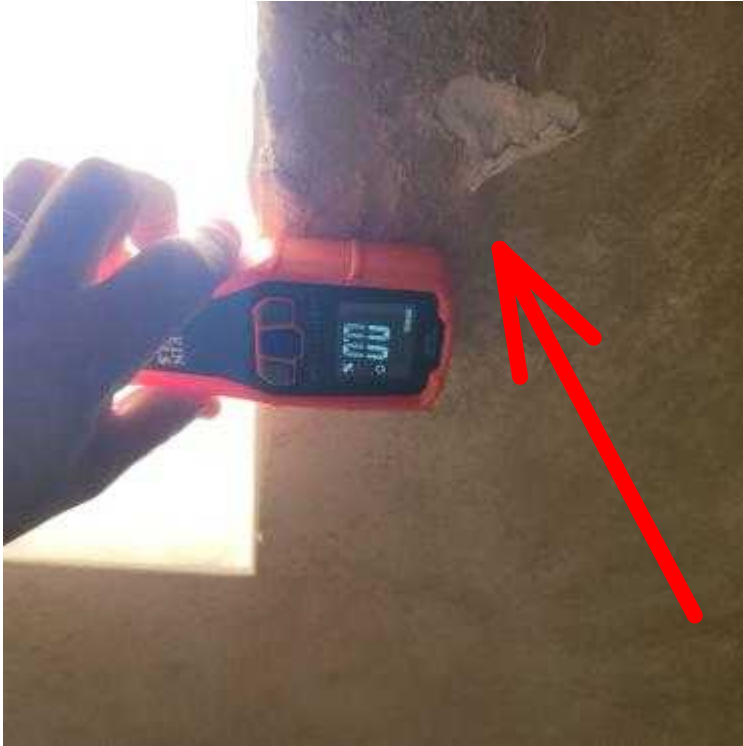
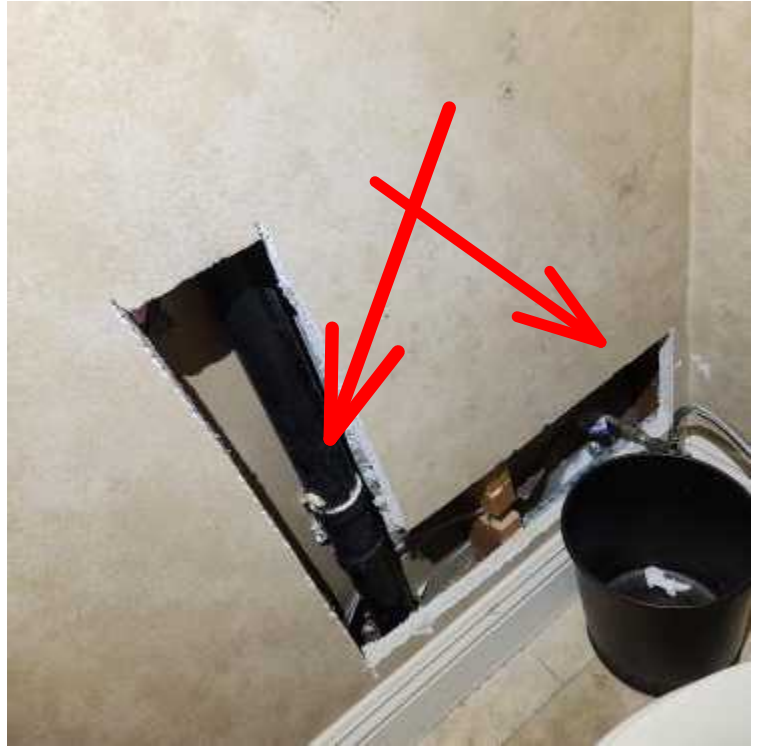
Dry moisture damage on primary bathroom ceiling adjacent to skylight-Evidence of past roof leak

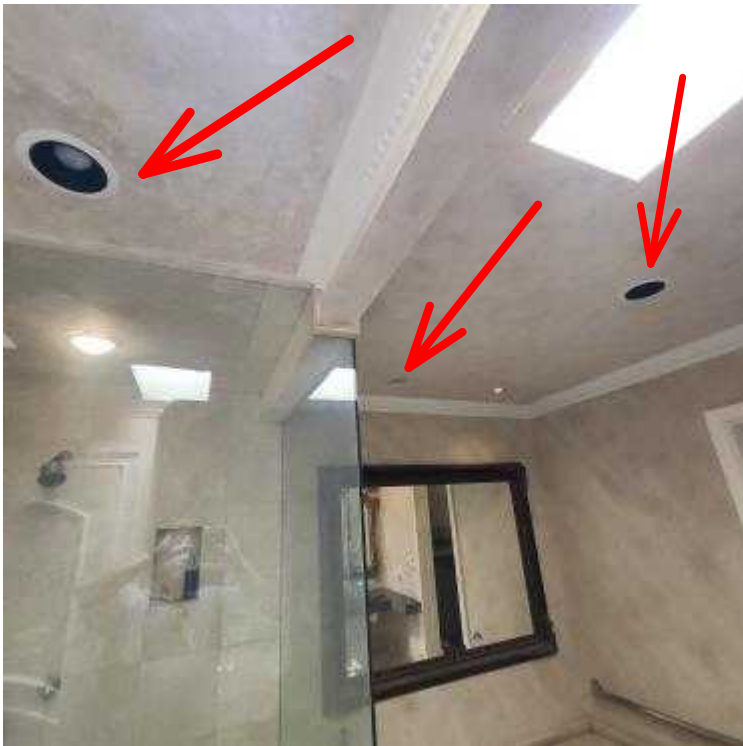
Hole present/Missing drywall in primary bathroom on wall in toilet room

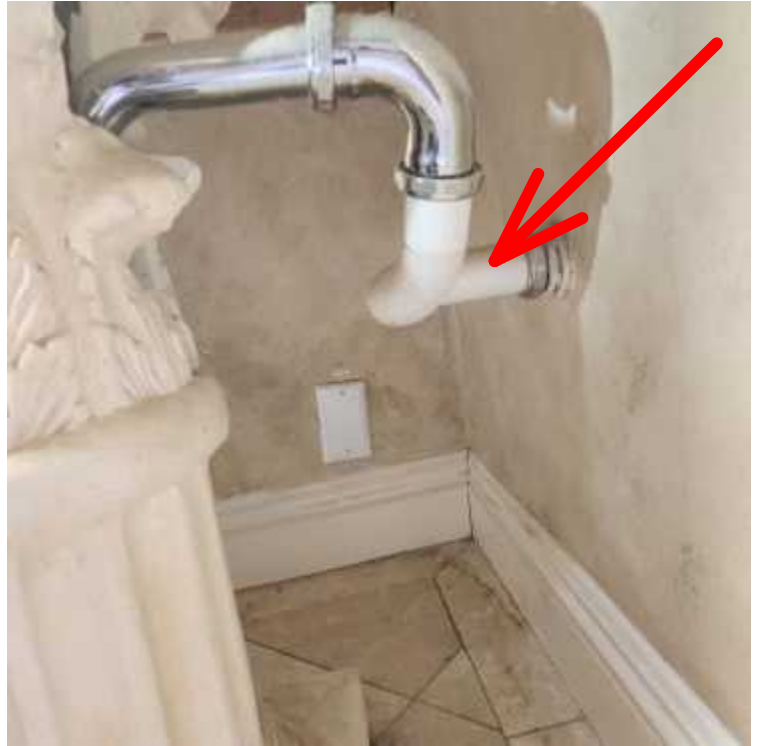
Improper material used for section of drain pipe below north sink in primary bathroom-NTBS/Accordion flexible type present

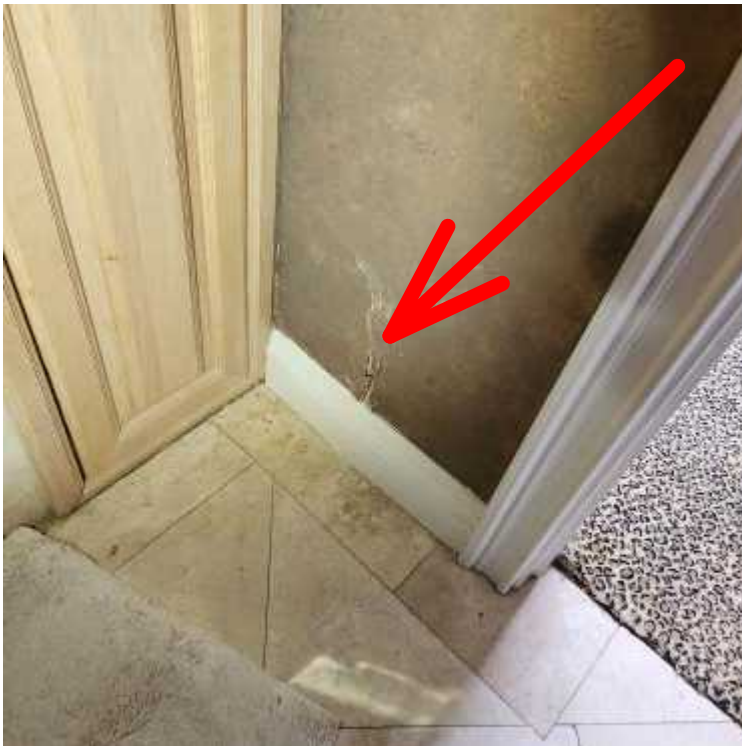
Hole/Moisture damaged baseboard present on west wall in north bathroom

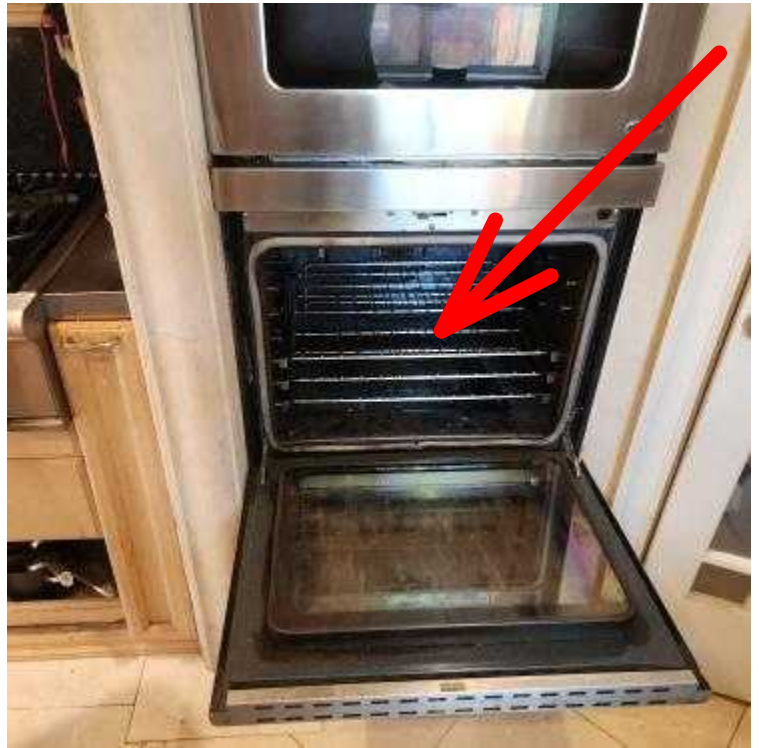
Low visible display on oven control panel
