Davidson Inspection
619.435.0845 Office
Lonny@DavidsonInspection.com
www.DavidsonInspection.com

Re: 5002 Dubois Dr., San Diego, CA 92117
Inspection Date: 09/08/2025
File #-25-1569 Dubois

SUMMARY REPORT

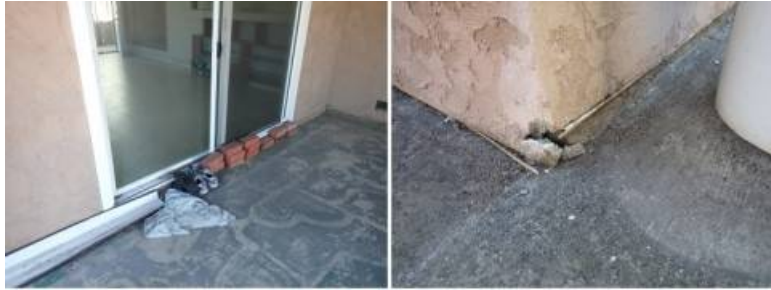
Marginal - The finished grade level of exterior flatwork was too high against the building at the patio slab addition. Ideally, the exterior flatwork should be held at least 2" below the bottom edge of the siding to help protect the siding and structure against moisture damage and termite infestation.

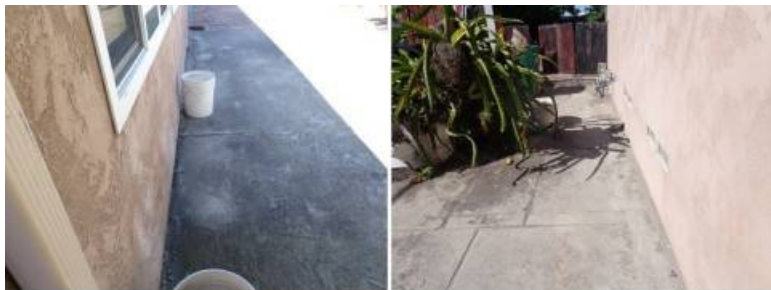
Marginal - Paved surfaces directed surface runoff toward the foundation or were flat against the foundation. Paving abutting the structure should not be pitched so that surface runoff collects against the foundation. Corrective measures recommended.

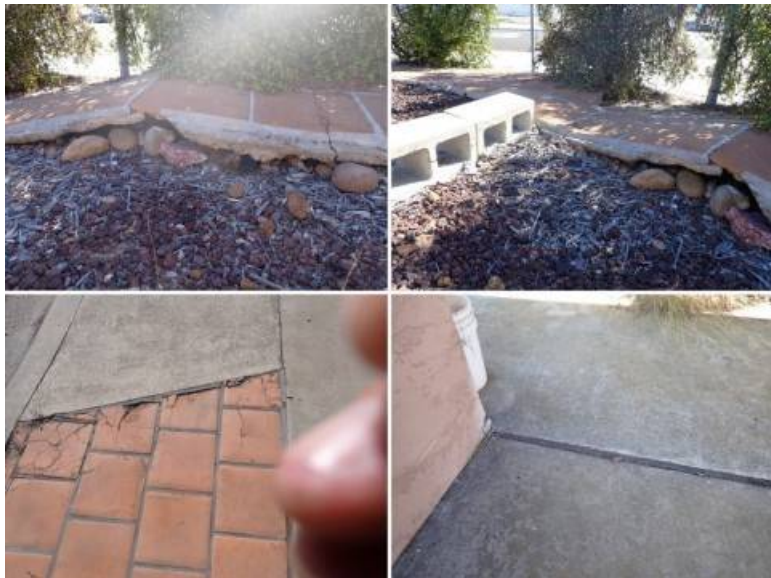
3.9 Damage:

Marginal - Raised/Settled surface was noted. Repairs are recommended.

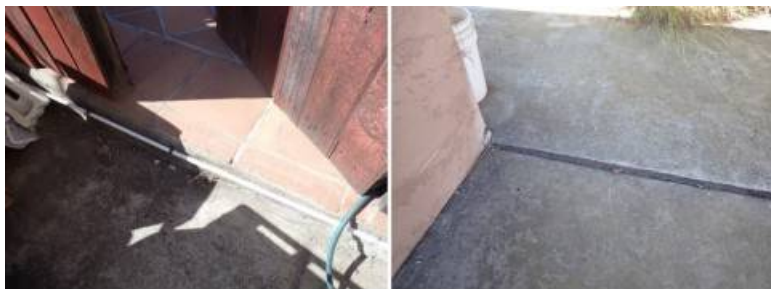
Advisory - Raised/Settled surfaces were present at one or more location that represent a trip hazard.

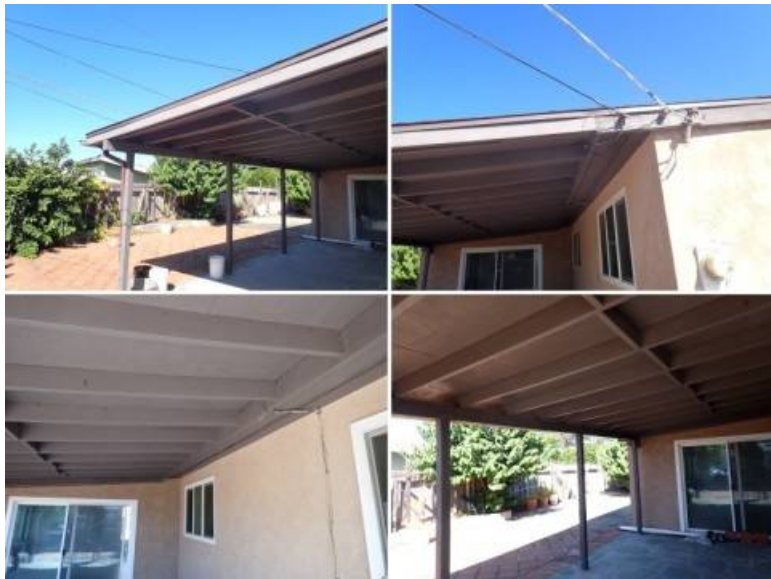
Repair - The rear cover is nailed to the building, not bolted as required by today's standards. This type of installation does not last as well as a bolted system and may fail in the event of seismic movement or strong winds.

Further Evaluation - Framing member(s) appear to be undersized for the length of span at the rear cover.

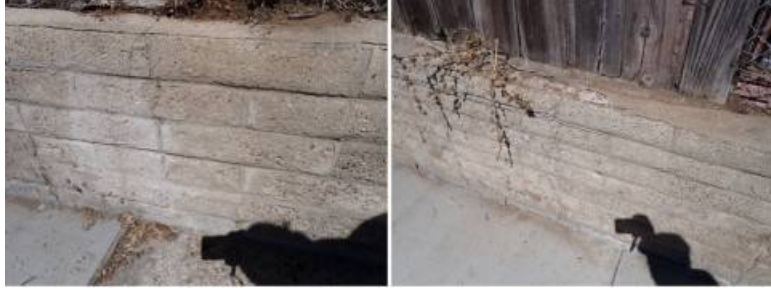
Maintenance - Moderate cracks / movement are present in the wall. Cracking of this nature is not uncommon and is an indication of modest movement/settlement in underlying soils. Generally, repair or sealing of these cracks is recommended to prevent moisture infiltration, which can cause further damage.

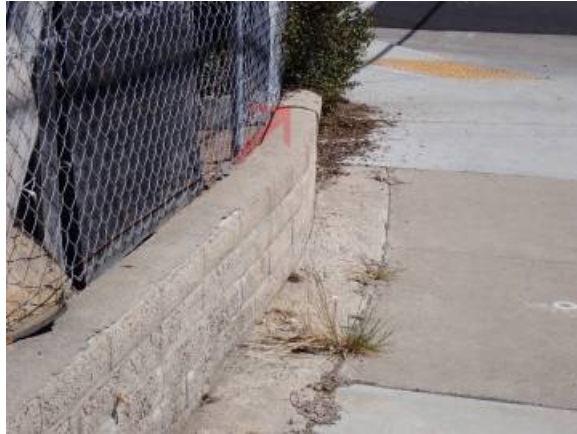
Marginal - The mortar cap or cap blocking was loose. The wall cap is in need or repair ed to prevent moisture from entering the top of the wall.

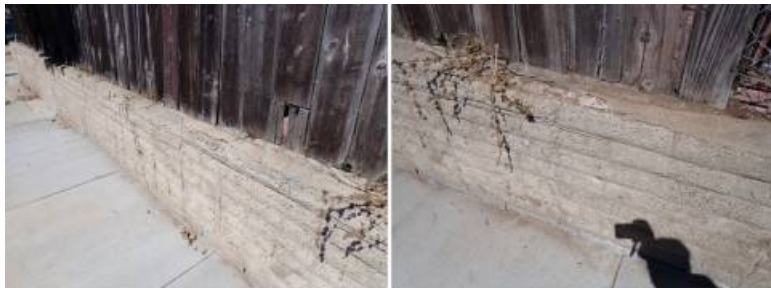
Marginal - Surface deterioration and water stains noted to the wall. This is usually an indication that the waterproofing and/or drainage system behind the wall is damaged or insufficient.

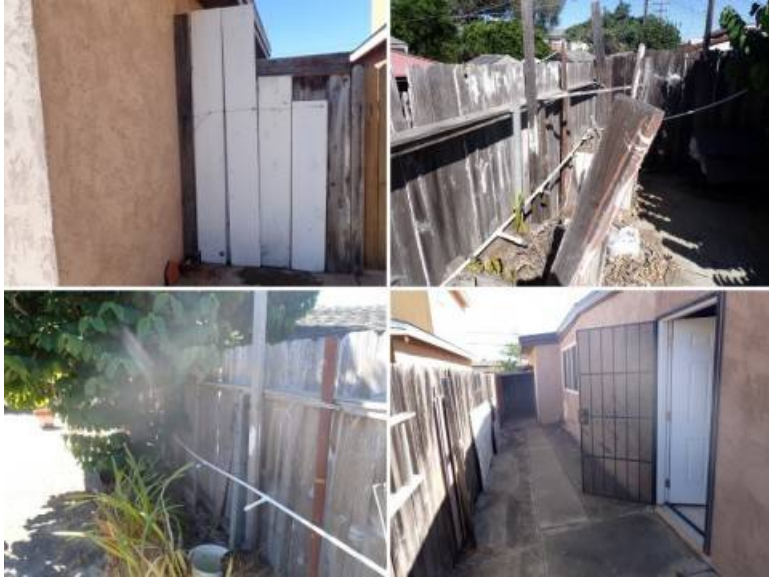
Repair - Sections of the fencing were tipping.

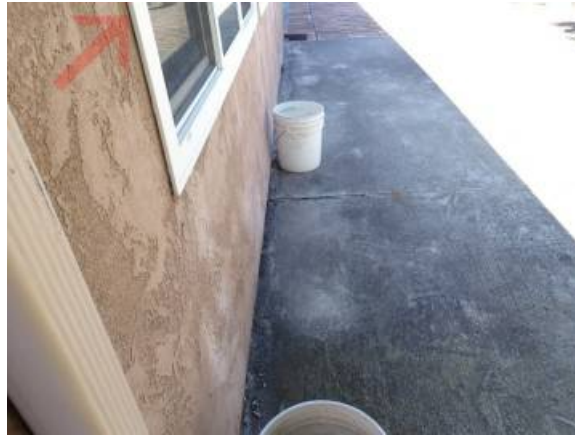
Repair - Replacement windows were not caulked around the top and sides of the window frame at the enclosed patio addition. Caulking is needed to prevent moisture intrusion.

Repair- Replacement windows were not caulked around the top and sides of the window frame at the enclosed patio addition. Caulking is needed to prevent moisture intrusion.

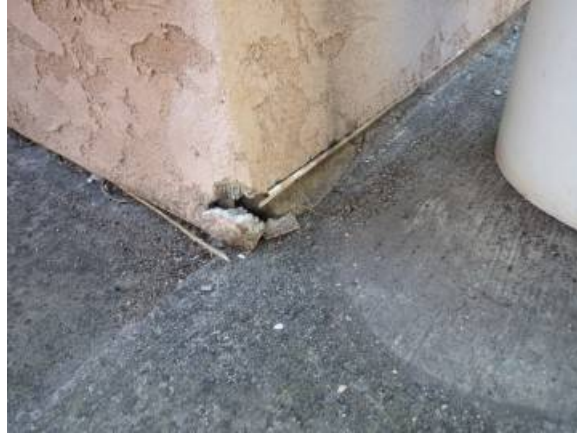
Maintenance - Small areas, typically at corners or bottom edge of the stucco siding, were chipped, loose or missing. Routine repairs recommended.

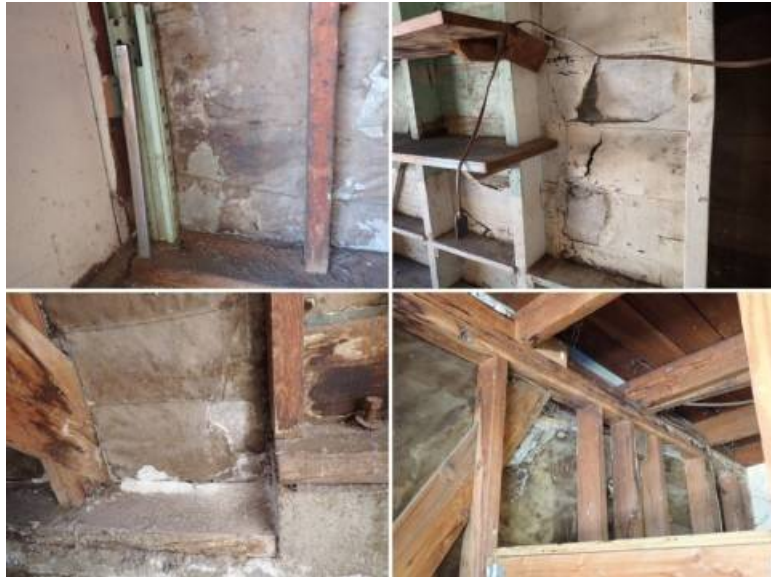
Marginal - The paper flashing was visible in the garage and damaged in places. Damaged flashing will not be effective in protecting the wood structure from moisture. The paper flashing was not visible from the interior of the house because wall finishes were installed. This component is the water protective element behind the siding material. Its expected useful life is approximately 30 years. In drier climates, such as Southern California, the life expectancy of the flashing paper can be increased to 50 years. Older flashing paper will have less ability to repel moisture and a greater tendency to crack or deteriorate. Painting the stucco can help to repel moisture. Recommend consultation with a qualified siding contractor.

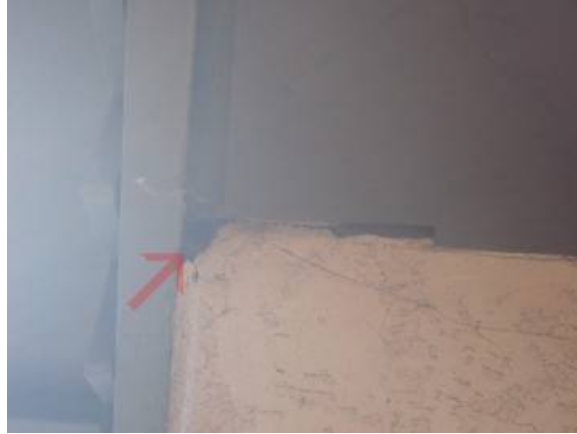
Marginal - Opening(s) present where moisture and/or small rodents can intrude. Corrective action is recommended.

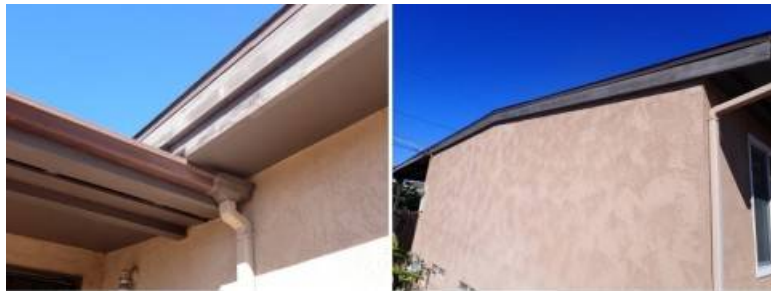
Maintenance - Gaps were noted. Gaps in exterior siding or trim should be sealed/protected to help prevent water infiltration and moisture damage.

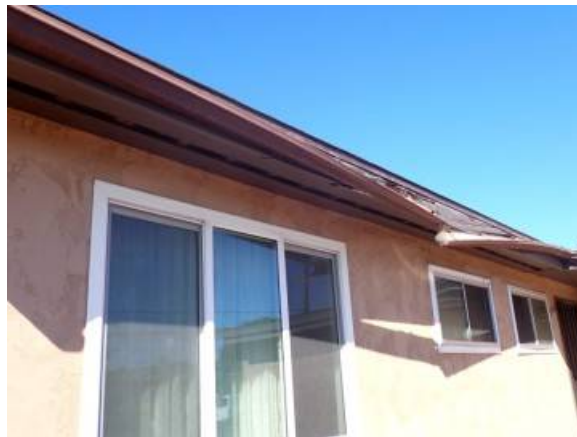
Repair - Moisture damage was observed. See Pest Inspection Report for damage to exterior wood members or have one performed.

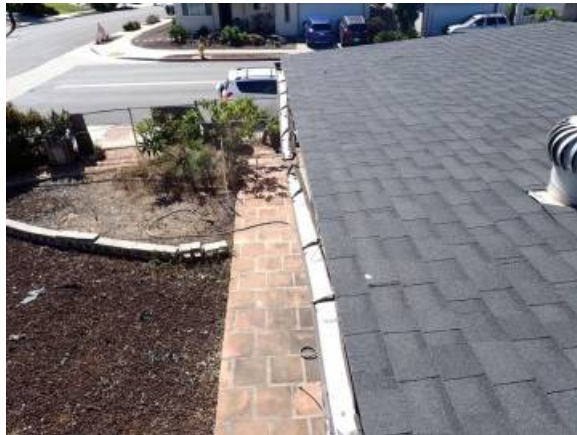
Repair - Gutters were damaged at one or more locations.

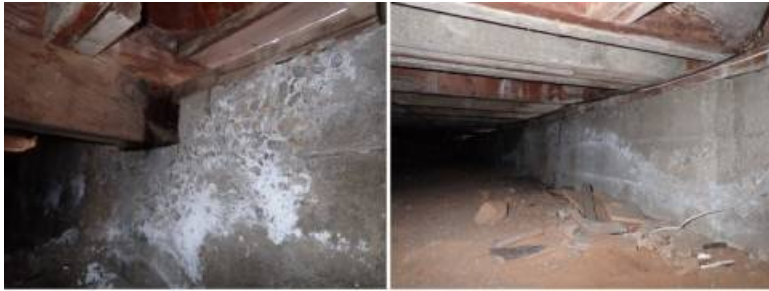
Maintenance - Spalling, weathering or surface deterioration was noted to the concrete foundation stem wall(s). This is often a symptom of excessive moisture in the soils as a result of poor drainage. The rough concrete surface tends to trap moisture that could possibly infiltrate and damage to the concrete or embedded steel reinforcement. The rough surface should be coated to fill the voids or otherwise sealed with a waterproofing agent. Also, recommend correcting drainage at any areas where water may be ponding or otherwise reducing irrigation.

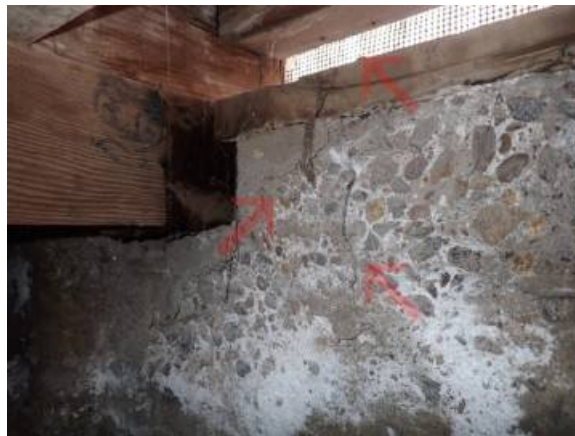
Marginal - Damage is present to outer foundation stem walls in areas where it appears as though anchor bolts have swollen. It is a common occurrence for anchor bolts to swell when they are installed close to the surface of the foundation walls and/or grading and drainage is poor/ when sprinklers are wetting the foundation. We recommend having a foundation contractor evaluate these anchor bolt "pops" or damage to determine if this is truly what this damage is and what repairs are needed. Correcting grading and drainage is the best way to prevent anchor bolts from

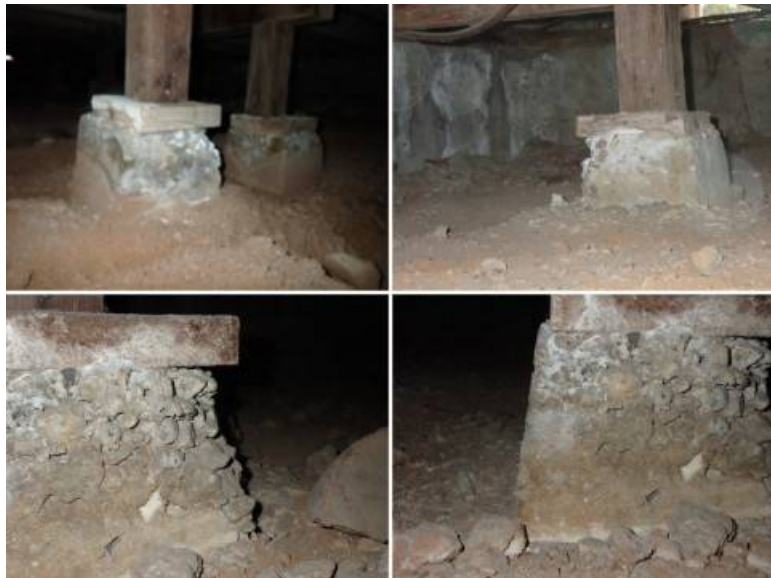
Further Evaluation - Deterioration was noted to some of the concrete piers. This condition is typically caused by excessive moisture is reaching the sub-area. It is important to take action in order to stop further damage to the foundation. Corrective action may include improving site drainage, as well as replacing damaged piers. Further evaluation and corrections as needed are recommended by a qualified foundation contractor.

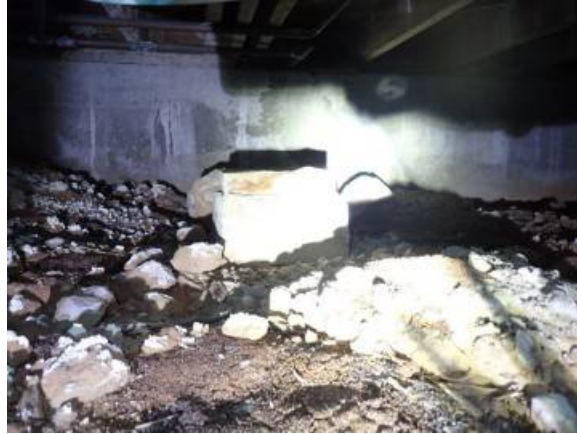
Further Evaluation - One pier appears to have been removed. We do not know the reason for this condition and if this pier was needed. Further evaluation and corrections as needed are recommended by a qualified foundation contractor.

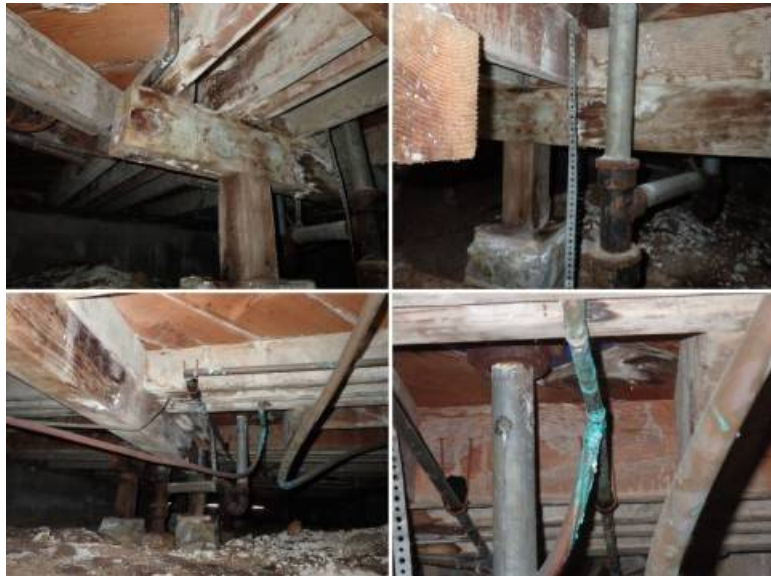
Further Evaluation - Water stains noted on framing or sheathing. A licensed pest inspector should evaluate this condition for possible moisture damage. Stains are an indication of a past or present leak, which should also be evaluated further.

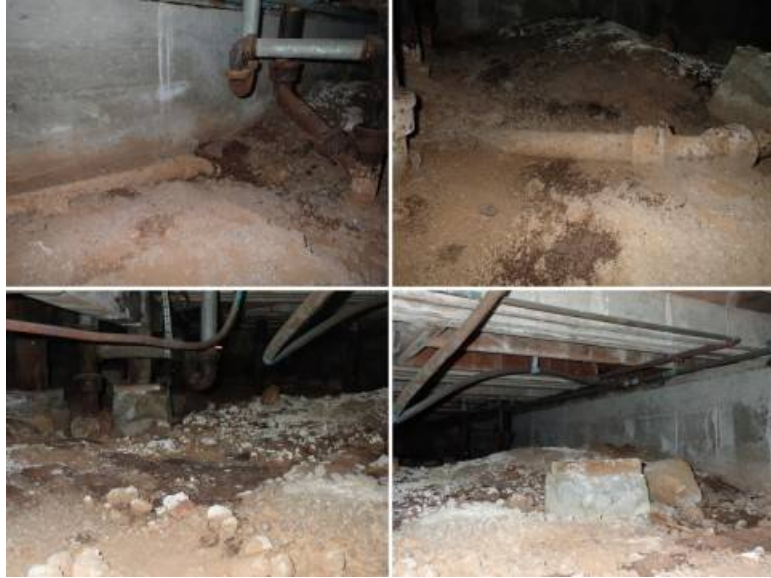
Further Evaluation - Moist soil conditions were present. The source of the moisture was not determined. This is usually an indication that drainage around the foundation needs to be corrected/improved but this also may be from lwaking cast iron pipes. It is important to take action in order to prevent damage to the foundation.

Further Evaluation - Moist soil conditions were present. The source of the moisture was not determined. This is usually an indication that drainage around the foundation needs to be corrected/improved but this also may be from leaking cast iron pipes. It is important to take action in order to prevent damage to the foundation.

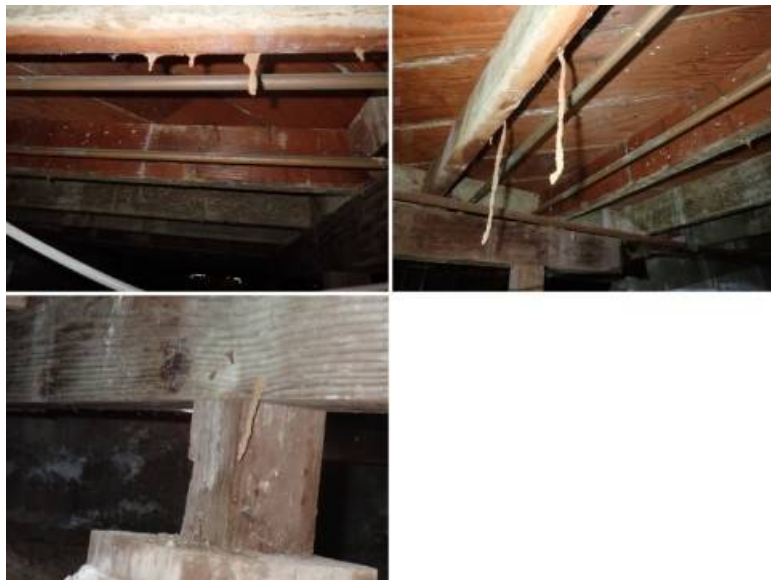
Further Evaluation - There was evidence of a insect infestation. See Pest Inspection Report.

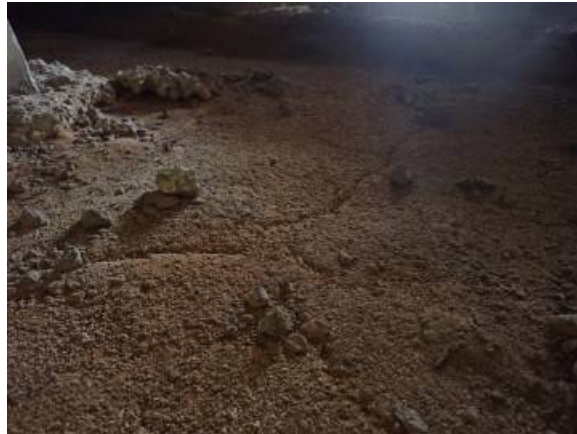
Advisory - Soils appeared to be clayey. Movement of underlying soils may occur with excessive moisture that could damage exterior flatwork and adversely affect the foundation. Drainage controls and restricting irrigation are advisable.

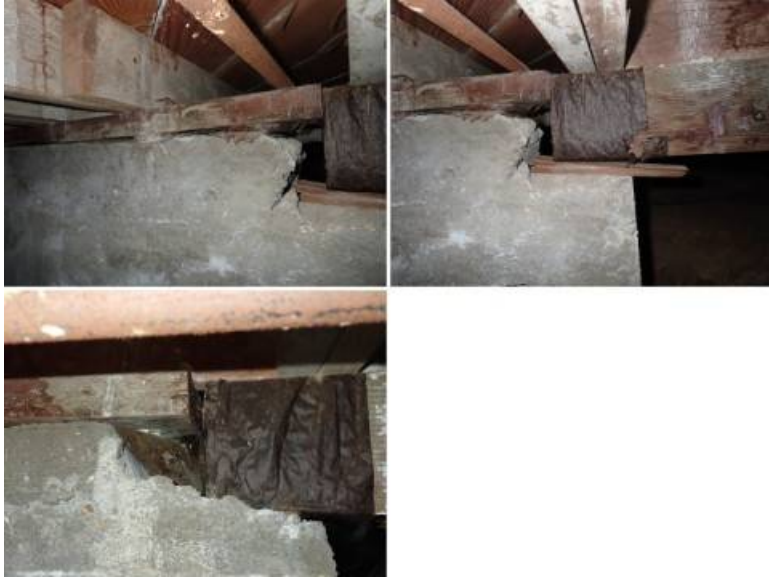
Further Evaluation - Lifting or gaps under the wood plate line were noted. Additionally a beam end is being supported by a sloped/ uneven section of wall rather than a horizontal surface of the appropriate depth. Further evaluation is recommended by a framing specialist/ engineer.

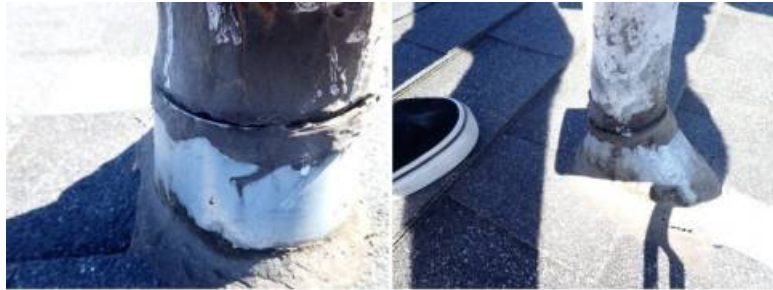
Maintenance - Sealant around vent penetrations is cracked/deteriorated. Fresh sealant is needed at this time to prevent leakage.

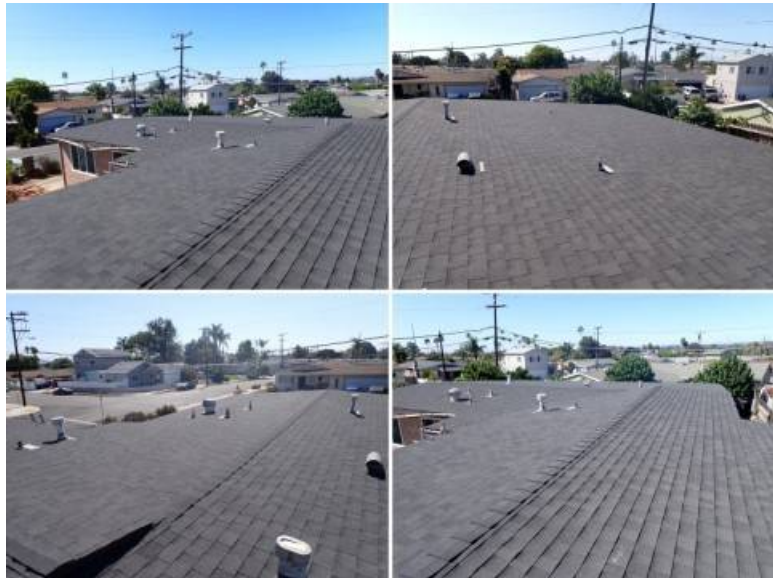
Repair - The roof pitch was not sufficient for the type of roof covering installed. Problems associated with this include excessive moisture retention, moisture infiltration or leaking, and limited service life. A licensed roofing contractor should be called to make further evaluation and corrections as needed.

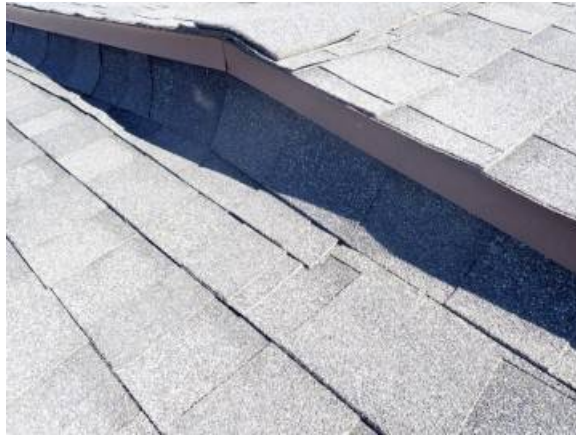
Repair - Metal flashing was not visible and appears to be missing at roof to wall transitions. Metal flashing is a component of the roofing system that would ordinarily be installed at this location to prevent water infiltration. This installation requires more maintenance than flashing to prevent leaking. We recommend installing metal flashing.

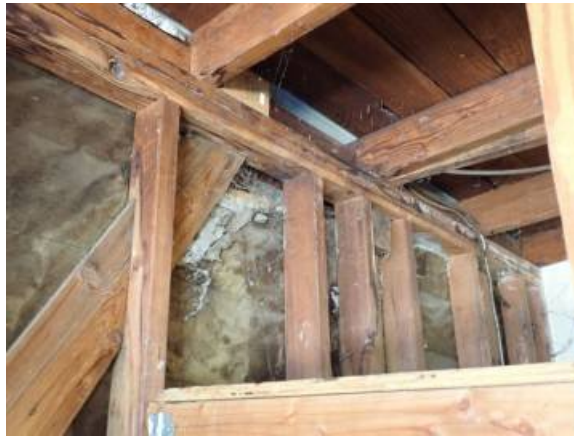
Advisory - Water stains were noted on the underside of the roof sheathing or framing. We suspect that the stains occurred prior to the installation of the current roof covering, however, you may wish to have a roofing contractor investigate the condition.

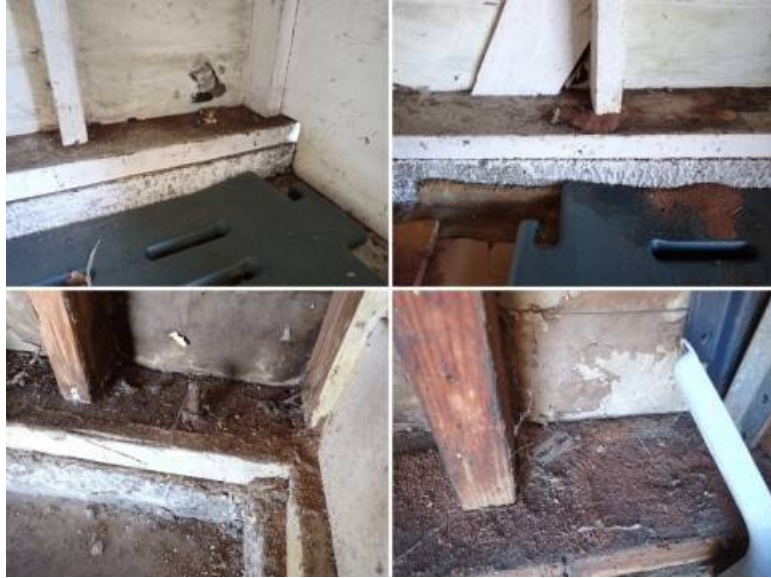
Further Evaluation - There was evidence of a insect infestation. See Pest Inspection Report.

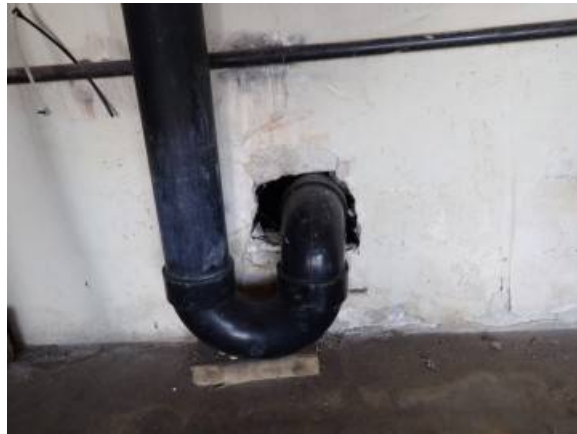
Safety - Hole(s) were noted in the drywall between the garage and the crawlspace/ floor framing. This interrupts the integrity of the fire separation wall. All holes should be filled with an approved material.

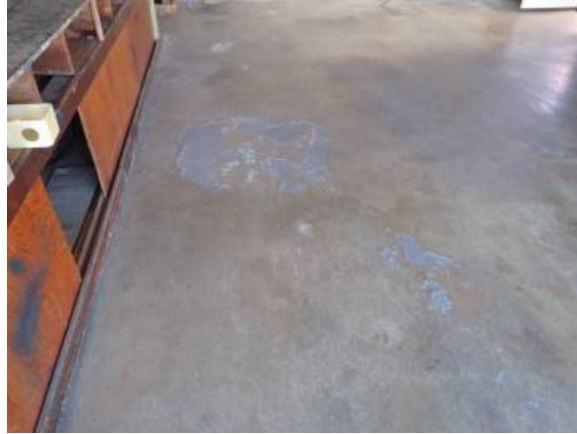
Marginal - Some wear was noted to the slab that can be repaired.

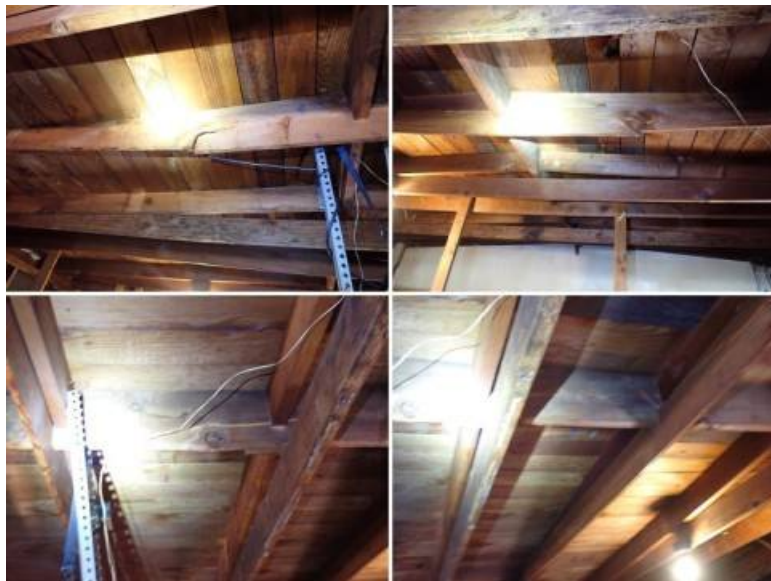
Further Evaluation - Split/damaged roof framing was observed. Recommend further evaluation and repair by a qualified framing contractor/ engineer at this time.

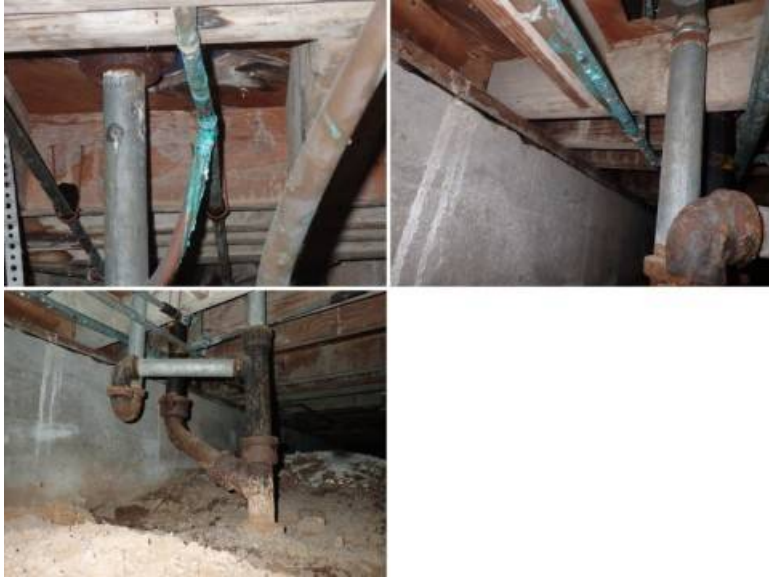
Marginal - Corrosion was noted on several sections of piping under the house. The component was showing signs of advanced aging and likely would have limited remaining life. Be aware that old corroded pipes and fittings are at a higher risk of leaking. Recommend a licensed plumbing contractor for further evaluation.

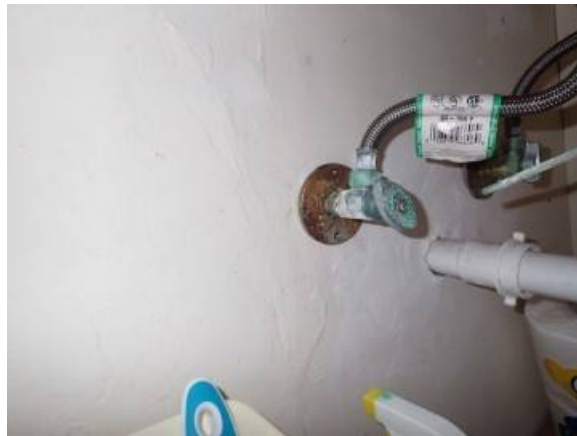
Upgrade - Some newer or replacement local shutoff valves and/or plumbing connections were installed serving the sinks and/or toilets. Remaining components were old/original, beyond their expected service life. These components have a 15-20 year life expectancy and are prone to failure as they age. Recommend replacing old components as an upgrade to the system.

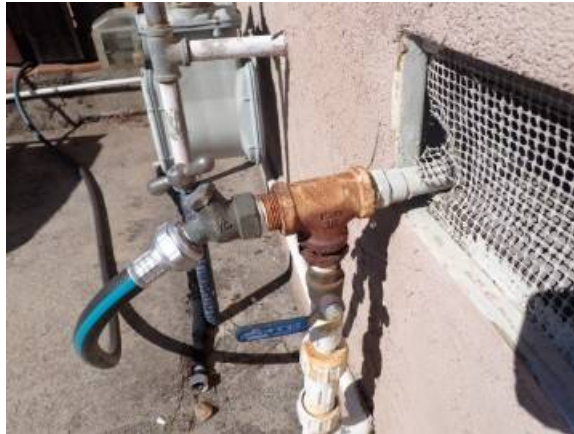
Upgrade - Anti-siphon device is missing at one or more locations. Installing anti-siphon devices at all hose connections will protect the potable water supply from possible cross contamination.

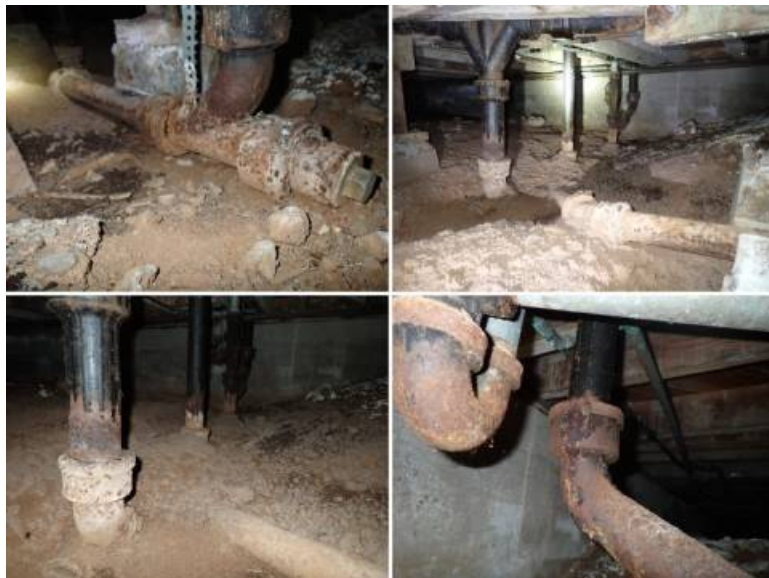
Repair - The cast iron drain pipes were old. Excessive rust/corrosion was present. Ongoing repairs should be anticipated as this older system continues to age. Replacing the entire system will eventually need to be undertaken. We recommend further evaluation of the cast Iron system and needed repairs made at this time by a

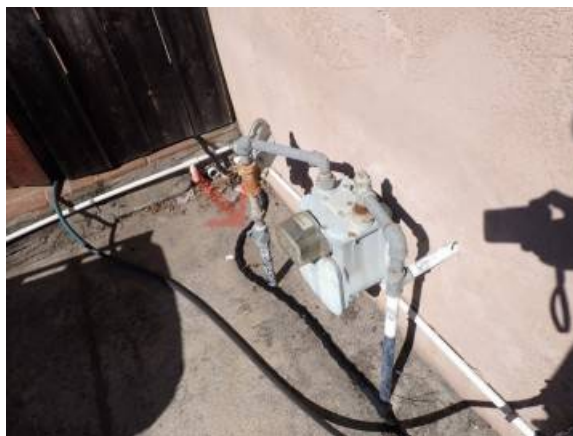
Further Evaluation - Gas service was not on at the time of the inspection. We did not test any gas appliances.

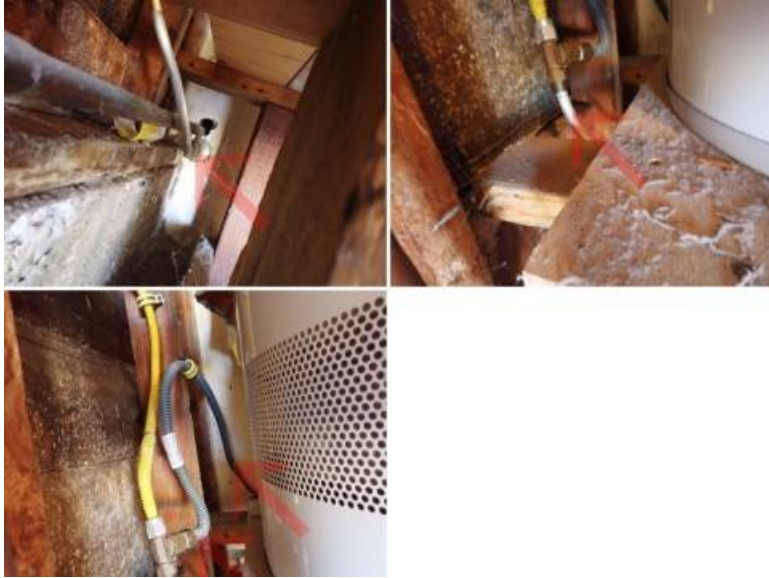
Repair - An old type solid brass or aluminum gas connector was noted in the garage. This ductile metal tubing can become brittle with age and susceptible to crimping and cracking. Additionally appliance connectors were being used as gas distribution (not at appliances). Repairs are recommended at this time for safety.

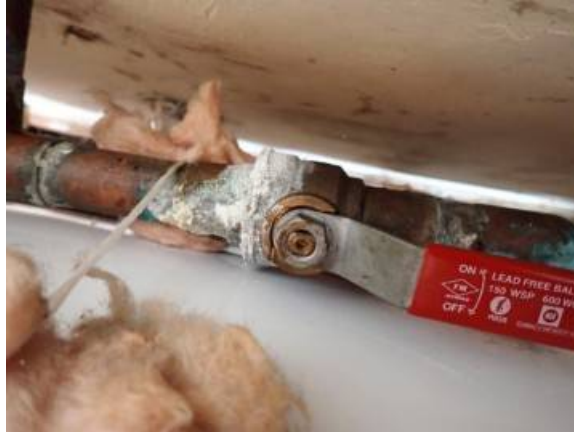
Repair - Corrosion was noted at the shutoff valve. Recommend further evaluation or replacement.

Repair- Corrosion was noted at the shutoff valve. Recommend further evaluation or replacement.

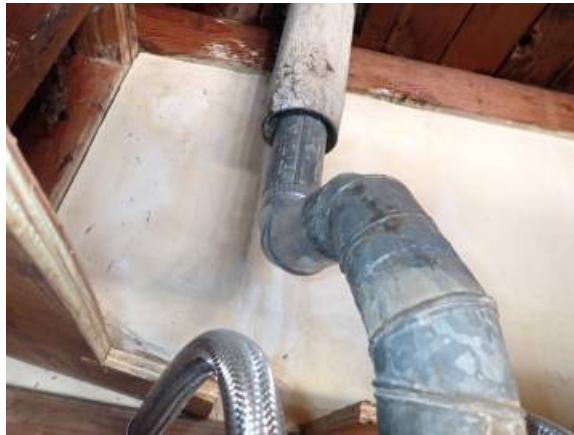
Marginal - Vent pipe materials were incompatible. Metal vent pipe was connected to old style transite pipe. Excessive condensation is a common occurrence with a transite pipe and may lead to premature corrosion/deterioration of the metal vent pipe and/or of the appliance below. Recommend replacing the old vent pipe when the appliance is eventually replaced or when roof repairs are undertaken.

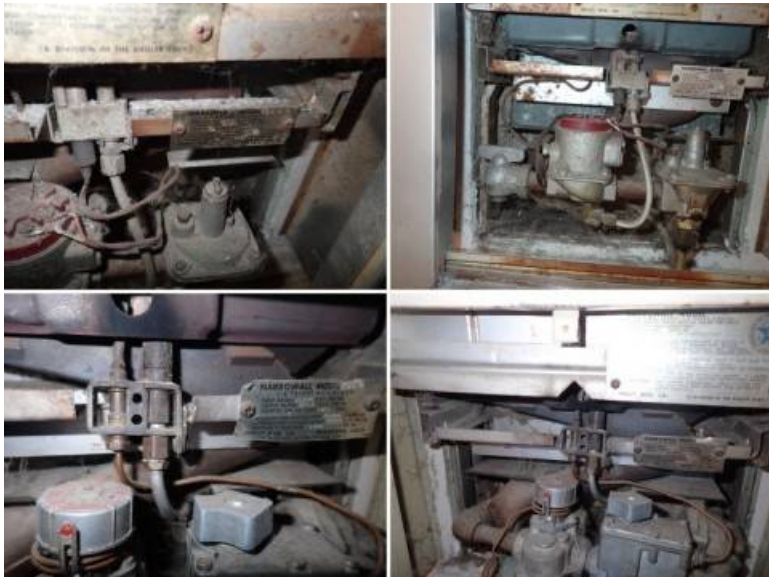
Safety - The wall furnace(s) did not have the safety spill sensors that are present on newer heaters. These sensors will turn off the heater if the vent does not work properly, possibly saving someone's life. Recommend upgrading to a newer and safer heating system.

Safety - The wall furnace(s) did not have the safety spill sensors that are present on newer heaters. These sensors will turn off the heater if the vent does not work properly, possibly saving someone's life. Recommend up grading to a newer and safer heating system.

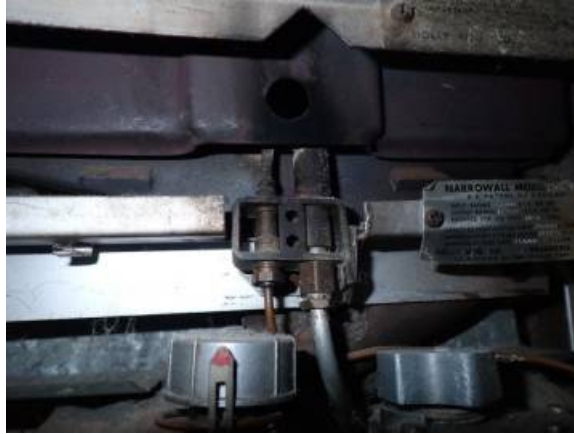
Safety - There are burn marks and/or rust outside of the burn chamber. This may be from combustion gases spilling out. **This should be considered a serious safety hazard and needs further evaluation / correction.**

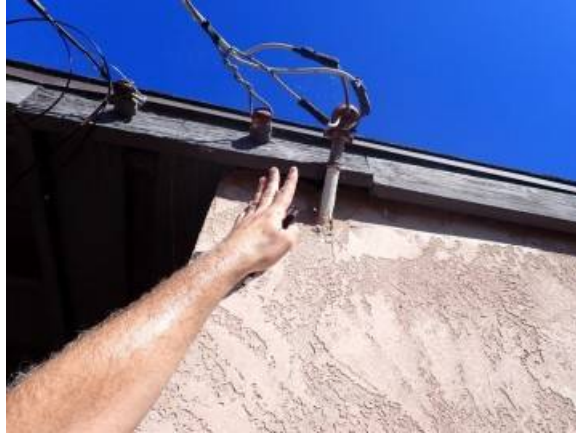
Safety - The overhead main service wires lacked adequate clearance. Service lines were less than 10' over walkway (accessible to pedestrians). We recommend installing a service pole and raising the service wires to the correct height for safety.

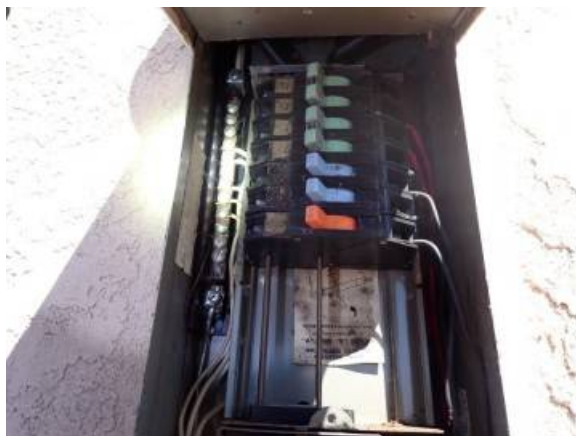
Marginal - Old panel with original circuit breakers and buss bar noted. The expected service life of a circuit breaker/ bus bar is 40-50 years. These breakers/ bus bar appear to have reached or exceeded this time frame. No damage, melting or scorching was noted at this time. However, old, outdated breakers may not perform in a reliable manner. Recommend further evaluation by a licensed electrician.

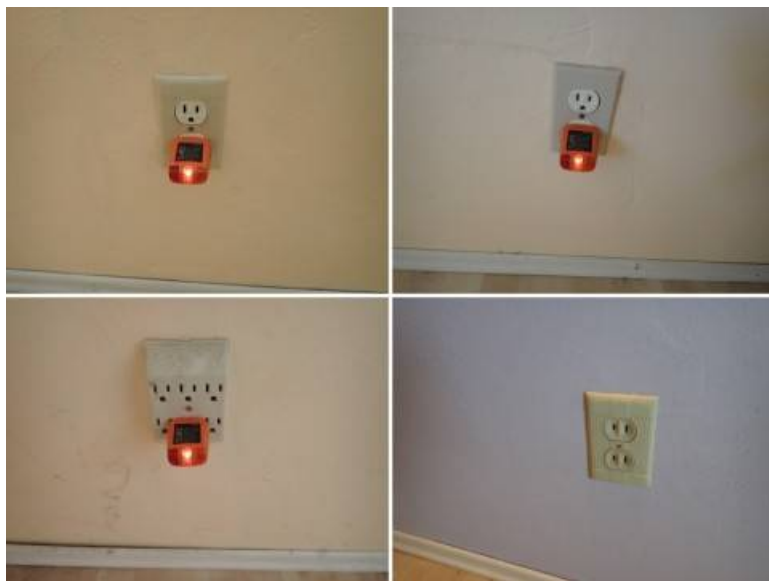
Repair - 3 hole grounded outlets were installed at many locations, even though no grounding wire was present throughout most of the electrical system. The use of 3 hole grounded type outlets gives the false impression of a grounded circuit. Older style 2 slot outlets are still available and should be installed. Alternatively, GFCI protection may be installed for ungrounded outlets.

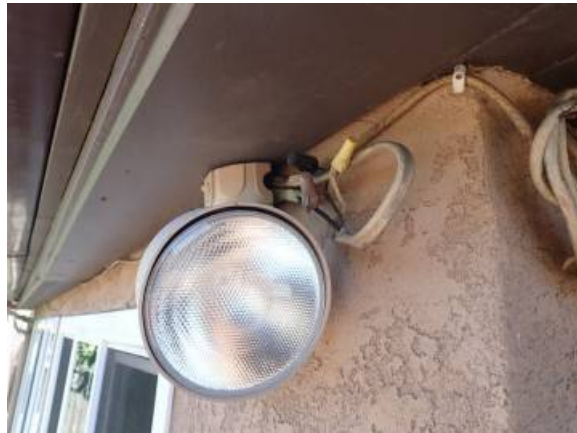
Safety - Open splices were noted. Wire connections are exposed, and consequently, are a shock and fire hazard. Correction is needed to contain spliced wires/connections inside a sealed junction box.

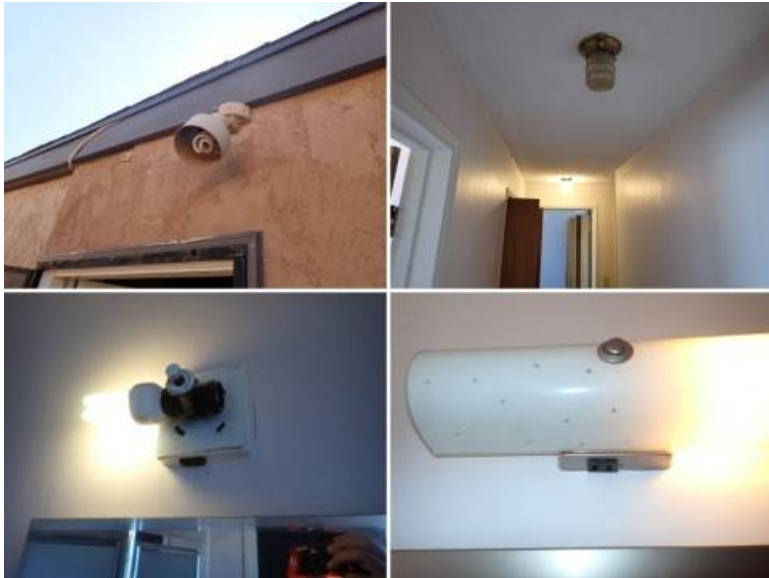
Maintenance - Light(s) were not working or missing bulb(s) in many locations. Recommend installing new light bulb(s) to test if the light fixture(s) are working.

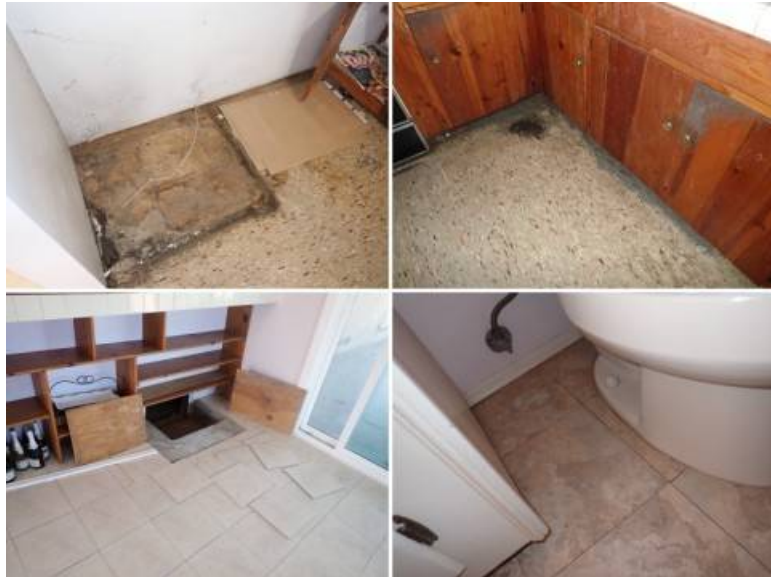
Repair - Damage was noted to finish flooring.

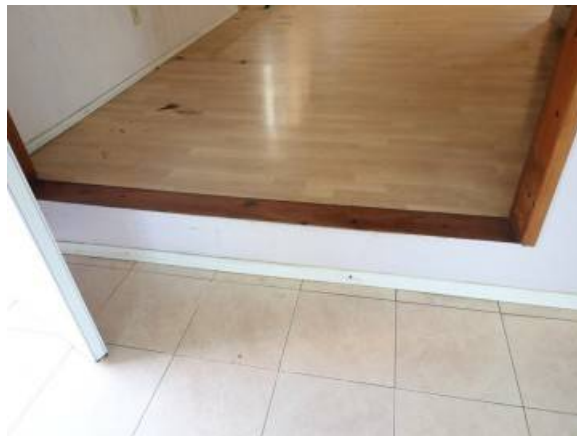
Marginal - There are steps taller than 8". This should be considered a trip or injury hazard.

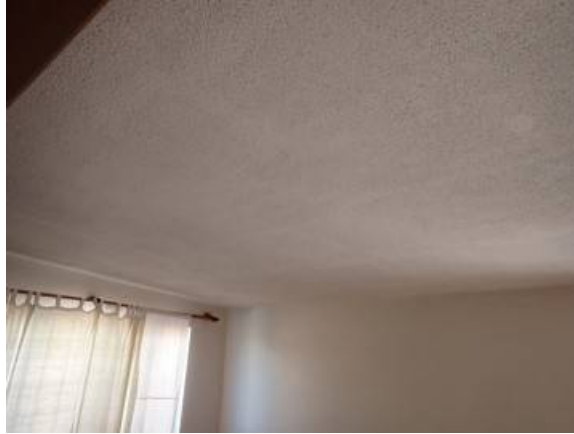
Advisory - "Popcorn" or acoustic texture was present. Texture installed prior to 1979 may contain asbestos, however, testing is necessary to know this. Also, be aware that a permit is required before interior walls/ceiling are altered, sanded or scraped for homes predating 1979.

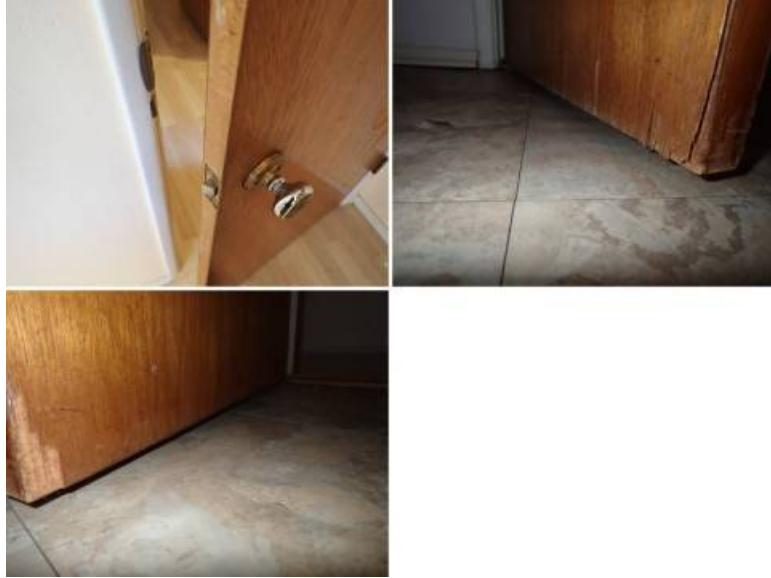
Maintenance - Door hardware did not operate properly where strike is installed backwards.

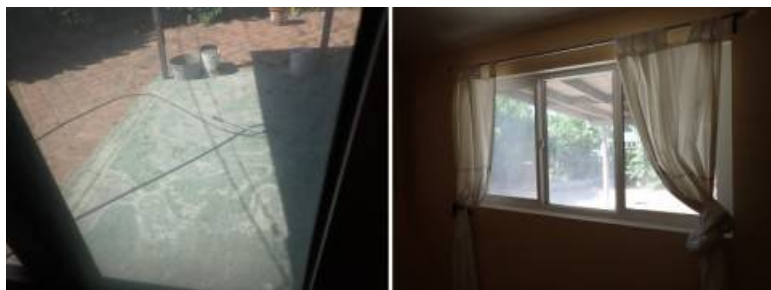
Maintenance - Glazing was dirty. Not all defective glazing may be readily apparent due to dust/dirt on the glazing. We recommend cleaning the windows and sliding doors and checking for any glazing issues. Seals on double pane glazing are normally covered under the manufacturer's warranty for a minimum period of 5 year and often longer. Recommend checking the warranty period and to see if the warranty is transferable.

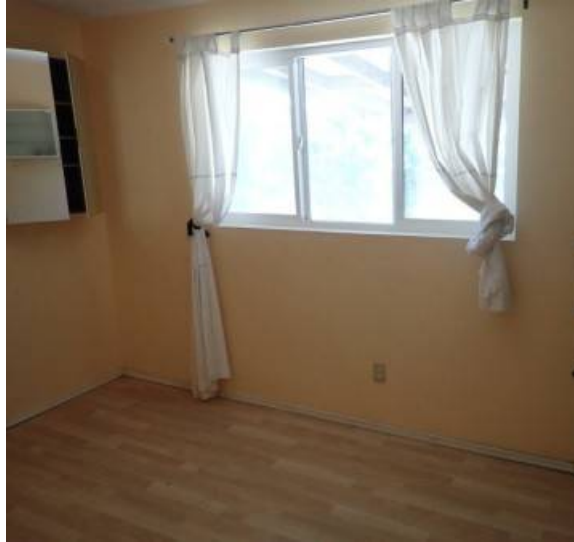
Safety - Window(s) did not meet emergency egress requirements at one or more bedrooms. Window sills were slightly higher than the current code requirement, which is a maximum 44" above the floor. Because of the old construction standard (46") and replacement windows, the sill height is now higher than 46" above the floor.

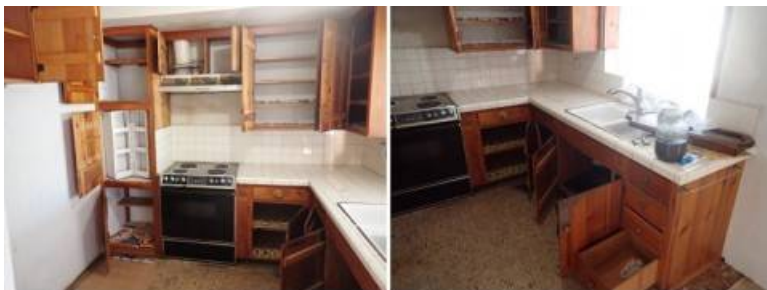
Countertop and cabinet finish surfaces had heavy wear and damage.

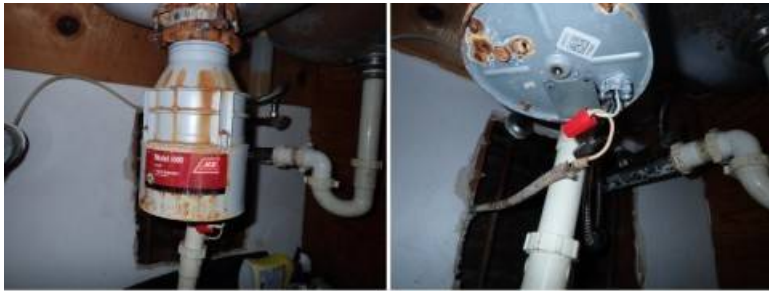
Safety - There are open splices in the electrical wiring to the disposal. This is a potential shock hazard. Repair is needed.

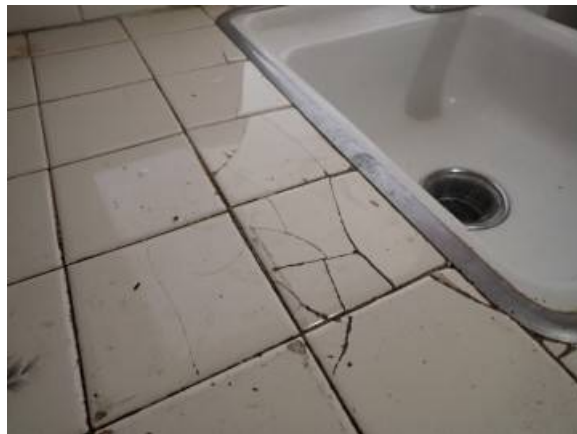
Repair - Damage noted.

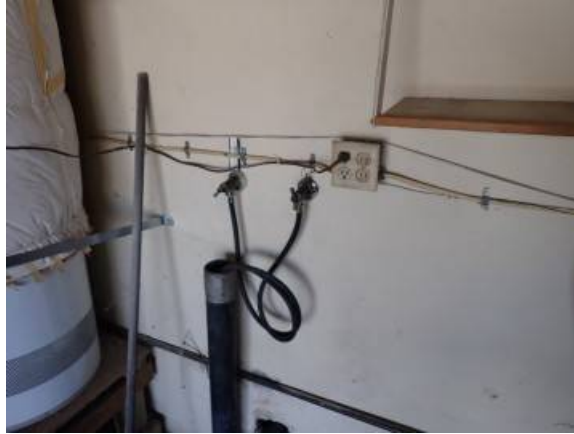
Upgrade - Standard rubber hoses are present, which should be replaced every 5 years to help prevent against failure. We recommend replacing with woven metal hoses for better performance/ less maintenance.

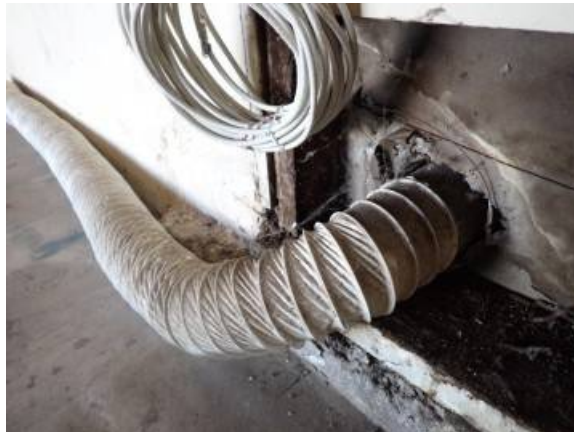
Safety - The flex vent is not an approved material. This is a safety concern. Corrections are needed for safety.

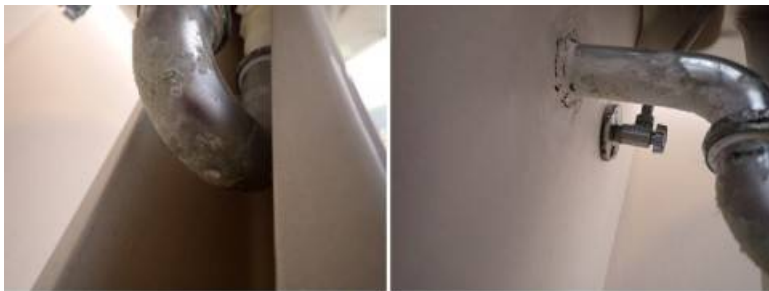
Repair - Deterioration/Corrosion noted to the drain line and/or wet trap under the sink. Replacement recommended.
