Davidson Inspection
619.435.0845 Office
Lonny@DavidsonInspection.com
www.DavidsonInspection.com

Re: 5002 Dubois Dr., San Diego, CA 92117
Inspection Date: 09/08/2025
File #-25-1569 Dubois

SUMMARY REPORT

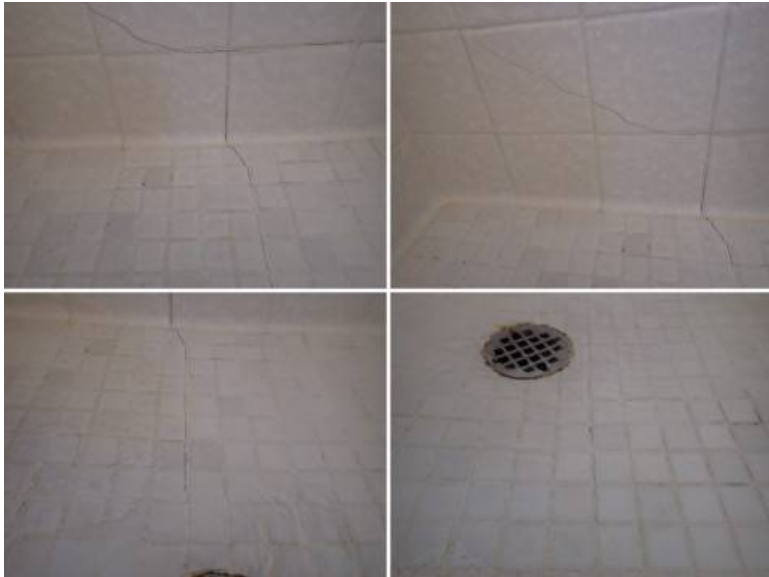
Repair - Tile(s) are cracked / damaged. Cracks may allow moisture into the wall causing hidden damage and the edges can be sharp. Repair / replacement is recommended by a tile contractor.

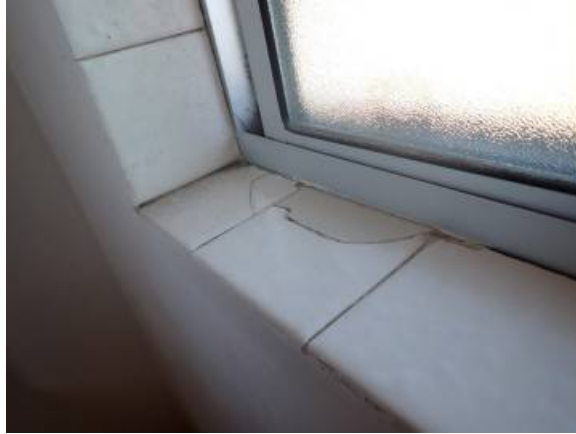
Repair- Cracked tiles were present on the window sill.
