# WOOD DESTROYING PESTS AND ORGANISMS INSPECTION REPORT

Building No. 3400	Street Pine Ave.	City Manhattan Beach	Zip 90266	Date of Inspection 10/02/24	Number of Pages 9

4424 W. PICO BLVD. LOS ANGELES, CA 90019 TEL: (800) 953-8677 FAX: (323) 954-4909		Report #: TT 24368-SC Registration #.PR 3315	
Ordered By:  <p style="text-align: center;">Dan May</p>		Property Owner and/or Party of Interest:		Report Sent To:	
COMPLETE REPORT <input checked="" type="checkbox"/> LIMITED REPORT <input type="checkbox"/> SUPPLEMENTAL REPORT <input type="checkbox"/> REINSPECTION REPORT <input type="checkbox"/>					
General Description: One Family, Two Stories, Frame/Stucco & Partial Wood Siding(s) & Partial Masonry Brick(s), Residence (Partially Furnished & Partially Occupied), Attached Garage, Composition Shingle Roof				Inspection Tag Posted: <p style="text-align: center;">Garage</p>	
				Other Tag Posted: <p style="text-align: center;">None</p>	
An Inspection has been made of the structure(s) shown in accordance with the Structural Pest Control Act. Detached porches, detached steps, detached decks, and any other structures not on the diagram were not inspected

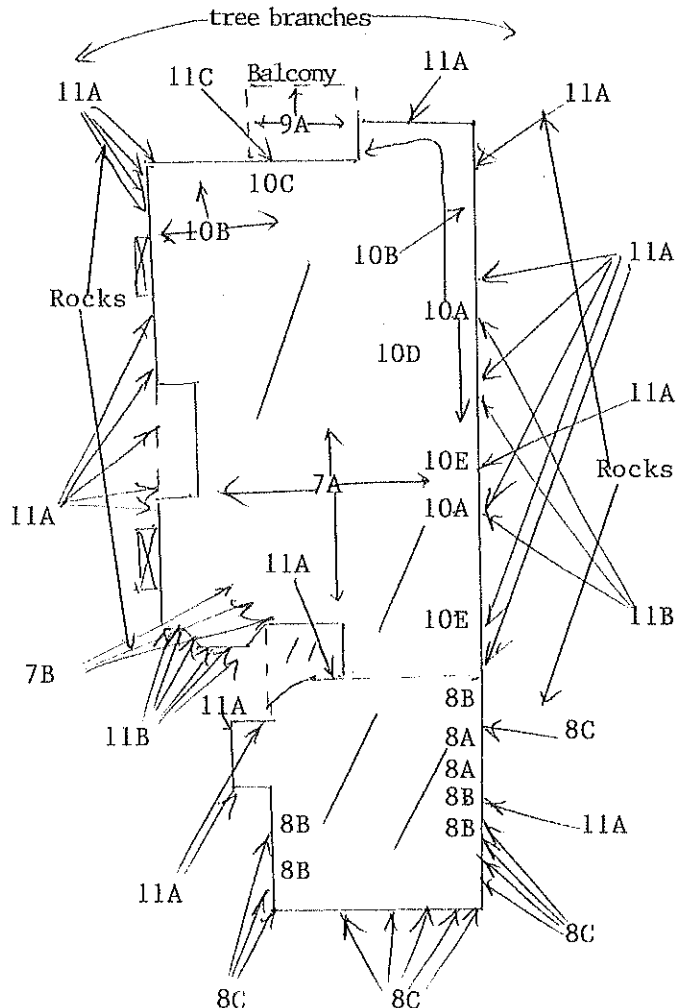
See Second Page for Diagram

FINDING 7A : Drywood termites noted in attic, 7A on diagram. (Section I)

FINDING 7B : Drywood termite damages noted on rafter, blocking, and cripple, 7B on diagram. (Section I)

FINDING 8A : Subterranean termites noted in garage, 8A on diagram. (Section I)

**FINDING 8B :** Drywood termites noted in garage, 8B on diagram. (Section I)

**FINDING 8C :** Drywood termite damages noted on door jambs, door quarter moldings, rafter tails, fascia boards, fascia moldings, and sheatings, 8C on diagram. (Section I)

**FINDING 9A :** Even though balcony was not inspected due to safety issues, drywood termite damages and/or fungus damages was noted from below, 9A on diagram. (Section I)

**FINDING 10A :** Drywood termites noted on walls and window, 10A on diagram. (Section I)

**FINDING 10B :** Drywood termite damages noted on sub floors and cripple, 10B on diagram. (Section I)

**FINDING 10C :** Fungus damages noted on French doors and door molding, 10C on diagram. (Section I)

**FINDING 10D :** Water stain(s) noted on 2<sup>nd</sup> floor closet ceiling, 10D on diagram. (Section II)

**FINDING 10E :** Water stain(s) and plaster damage(s) noted on 2<sup>nd</sup> floor ceiling and water heater closet walls, 10E on diagram. (Section II)

**FINDING 11A :** Drywood termite damages noted on window casing, trims, fascia boards, gables, rafter tails, fascia moldings, door molding, and water heater closet door & door jambs & door quarter moldings, 11A on diagram. (Section I)

**FINDING 11B :** Drywood termite damages and/or fungus damages noted on trims, window sills, and window casings, 11B on diagram. (Section I)

**FINDING 11C :** Fungus damages noted on French doors, door casing, and door jamb, 11C on diagram. (Section I)

RECOMMENDATION 7A : Seal the entire structure, and fumigate with a state-approved fumigant (Vikane; sulfuryl fluoride with chloropicrin as warning agent) for the eradication of drywood termites (kaloternes). This process is guaranteed to eliminate all present drywood termites (kaloternes). Remove or cover the evidence of termites, where visible and/or accessible. Top Termite Co., Inc. guarantees fumigation for drywood termites (kaloternes) for two years.

RECOMMENDATION 7B : Employ an appropriate tradesman to make necessary repairs.

RECOMMENDATION 8A : Drill vertically through floor slab(s) and treat beneath slab(s) for the control of subterranean termite infestation. Fill drilled holes with mortar mix. Remove all accessible evidences (tubes) of subterranean termites. (Chemical: Termidor)

**RECOMMENDATION 8B :** Seal the entire structure, and fumigate with a state-approved fumigant (Vikane; sulfuryl fluoride with chloropicrin as warning agent) for the eradication of drywood termites (kaloterms). This process is guaranteed to eliminate all present drywood termites (kaloterms). Remove or cover the evidence of termites, where visible and/or accessible. Top Termite Co., Inc. guarantees fumigation for drywood termites (kaloterms) for two years.

**RECOMMENDATION 8C :** Employ an appropriate tradesman to make necessary repairs.

**RECOMMENDATION 9A :** Employ an appropriate tradesman to make necessary repairs.

**RECOMMENDATION 10A :** Seal the entire structure, and fumigate with a state-approved fumigant (Vikane; sulfuryl fluoride with chloropicrin as warning agent) for the eradication of drywood termites (kaloterms). This process is guaranteed to eliminate all present drywood termites (kaloterms). Remove or cover the evidence of termites, where visible and/or accessible. Top Termite Co., Inc. guarantees fumigation for drywood termites (kaloterms) for two years.

**RECOMMENDATION 10B :** Employ an appropriate tradesman to make necessary repairs.

**RECOMMENDATION 10C :** Employ an appropriate tradesman to make necessary repairs.

**RECOMMENDATION 10D :** Employ an appropriate tradesman to correct cause of water stain(s), and make necessary repairs.

**RECOMMENDATION 10E :** Employ an appropriate tradesman to correct cause of water stain(s) and plaster damage(s), and make necessary repairs.

**RECOMMENDATION 11A :** Employ an appropriate tradesman to make necessary repairs.

**RECOMMENDATION 11B :** Employ an appropriate tradesman to make necessary repairs.

**RECOMMENDATION 11C :** Employ an appropriate tradesman to make necessary repairs.
