## HPI DRAINAGE SERVICES

### EXTERIOR DRAINAGE SYSTEM SUMMARY

1234 Oribia Rd  
Del Mar, CA 92014

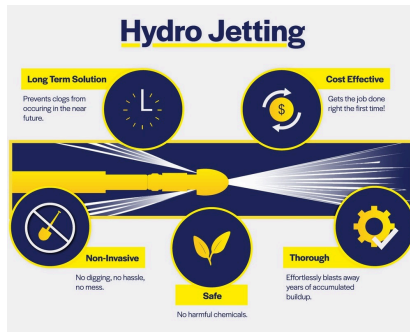
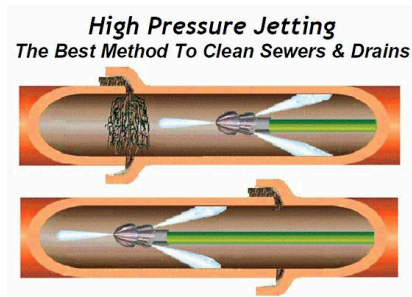
- **Recommend a qualified professional to provide annual hydro-jetting cleaning/servicing/maintenance of the entire exterior drainage system. Debris/roots can build-up and develop inside the drainage system over time which can cause blockages/clogs to occur.**

Contact a qualified professional.

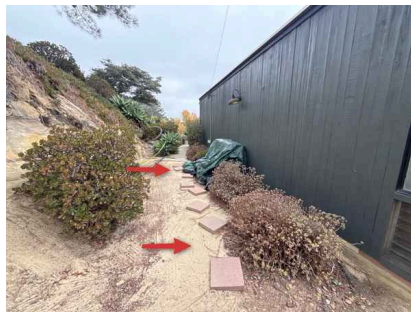
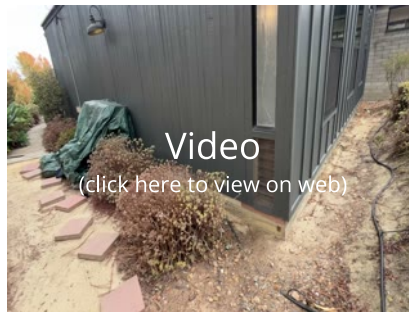
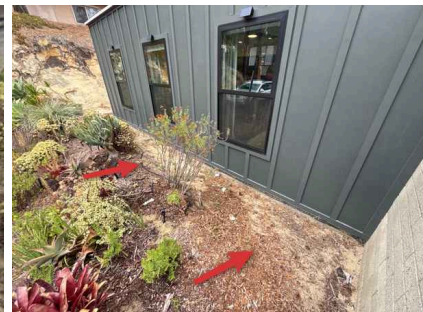
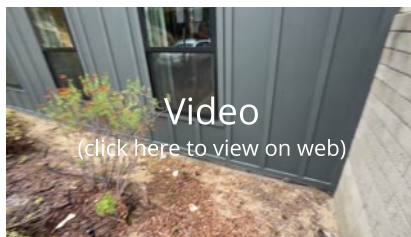
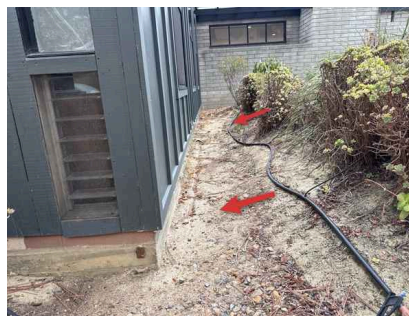
Throughout the property, several areas exhibit visible negative grading, particularly along portions of the west side and front of the residence. Rather than encouraging surface water to drain away from the structure, these areas allow stormwater and irrigation runoff to migrate toward the home's foundation and surrounding hardscape. Although no active drainage failures were observed during this inspection, improving these grades would provide better long-term water management. Re-establishing positive drainage through minor regrading, natural drainage swales, and strategically placed surface drains would help redirect runoff away from the foundation while reducing unnecessary moisture accumulation adjacent to the residence.

**GROUND: NEGATIVE GRADING TOWARDS THE HOME**

Grading slopes towards the home in one or more areas. This negative grading could lead to water intrusion and foundation issues.

- **Recommend a qualified professional to further evaluate and repair.**

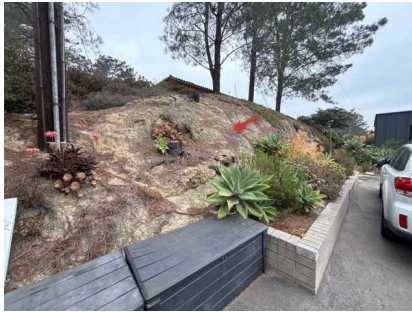
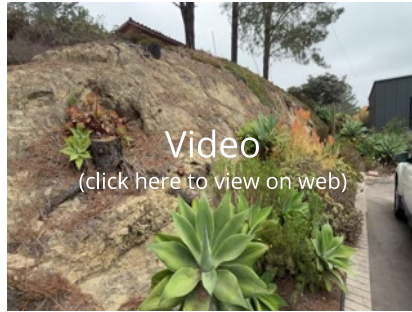
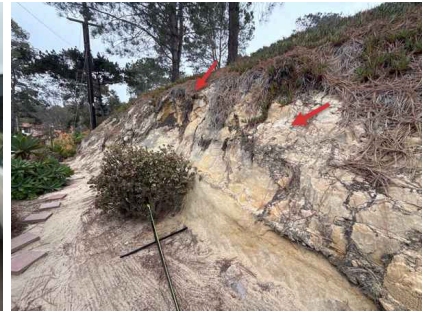
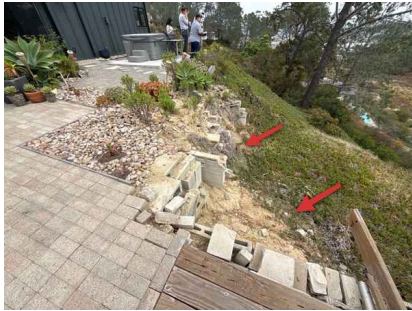
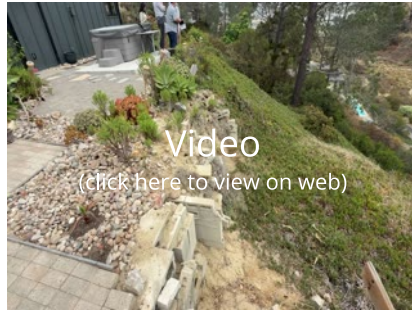
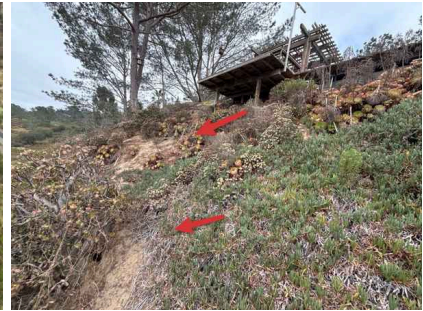
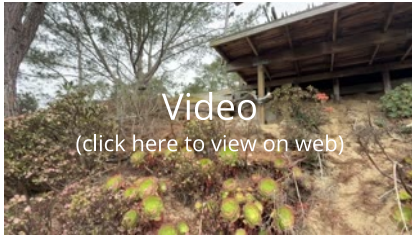
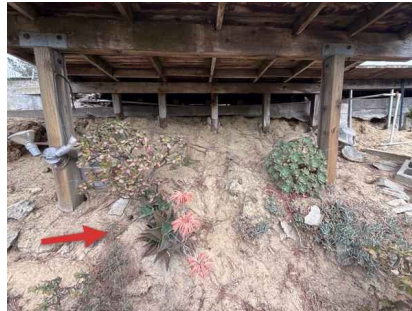
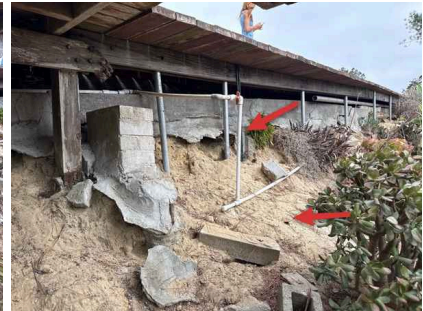
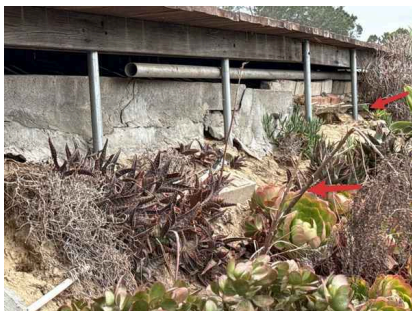
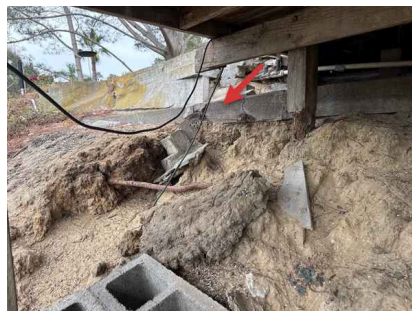
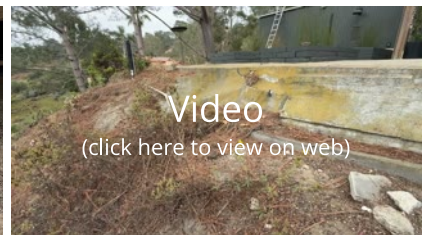
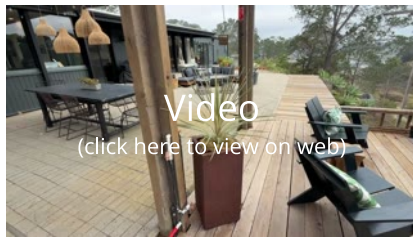
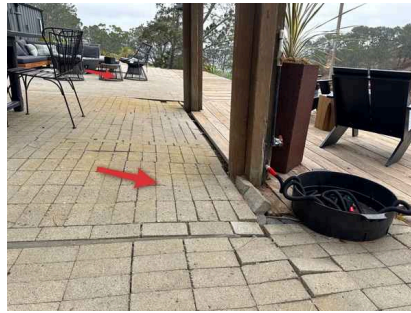
**GROUND: SOIL EROSION**

Soil erosion appears to be occurring in one or more areas of the hillside/embankment.

- **Recommend a qualified professional to further evaluate and repair.**

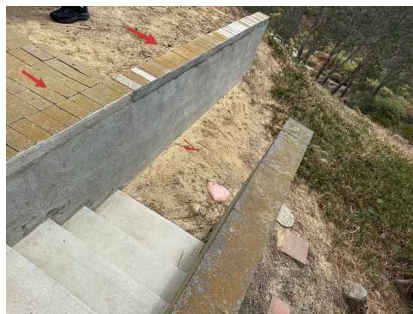
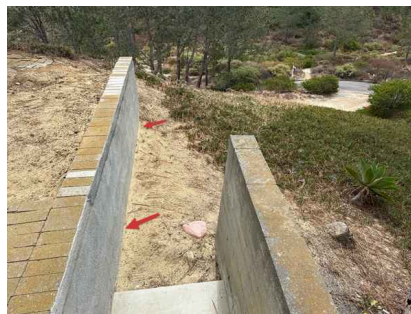
**RETAINING WALL(S): NOT VISIBLE DRAINAGE SYSTEMS**

During the visual inspection, no visible drainage improvements were observed behind or along the base of the southeast backyard retaining walls. Specifically, no French drainage system, surface drains, or weep holes were identified to provide relief for groundwater or subsurface moisture that may accumulate behind the retaining walls during irrigation or rainfall events.

While the retaining walls are currently functioning in their intended capacity, the absence of dedicated drainage components can allow hydrostatic pressure to gradually build behind the wall over time. Excessive moisture retention may contribute to unnecessary stress on the retaining wall system, potentially leading to movement, cracking, settlement, or reduced long-term performance.

- **Recommendation: It is recommended that a qualified retaining wall and drainage contractor further evaluate the retaining wall system and determine the most appropriate drainage improvements. These may include the installation of a properly designed French drainage system behind the retaining walls, strategically placed surface drains to capture runoff, and weep holes at the base of the wall to provide pressure relief. Incorporating these drainage improvements can help reduce hydrostatic pressure, improve water management, and enhance the long-term stability and service life of the retaining wall system.**

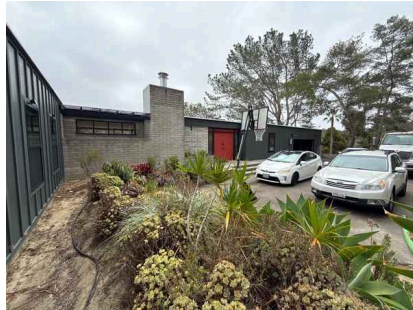
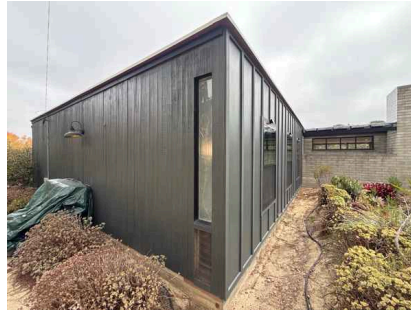
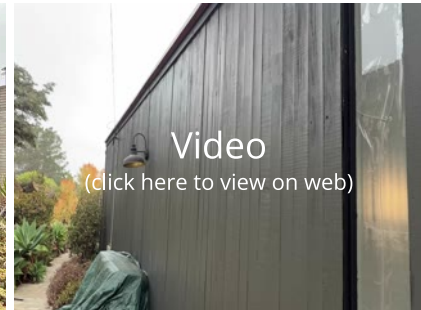
**GUTTER(S): MISSING**

Root gutters are missing in some areas around the home. Roof gutters collect water from the roof and flow the water to proper exit locations around the house property. Missing gutters can cause water to pond are the home and its foundation and also cause deterioration to the siding, trim, and fascia boards/eaves.

- **Recommend having a qualified roof professional to further evaluate and install proper gutter/downspout system.**

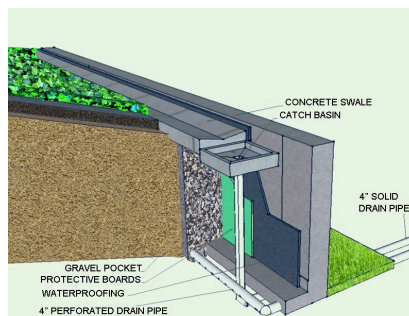
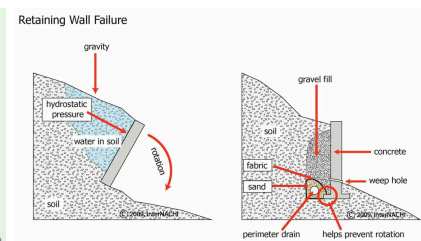
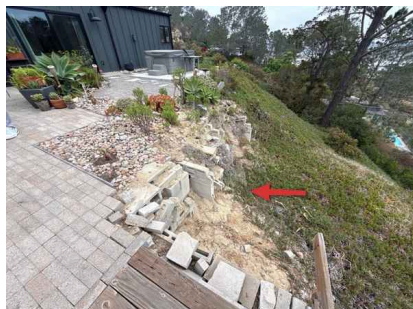
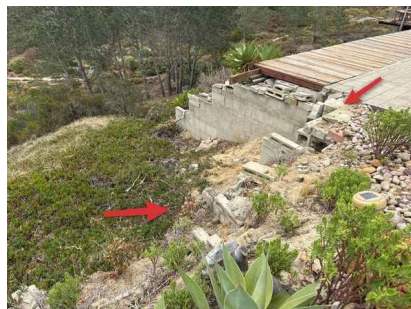
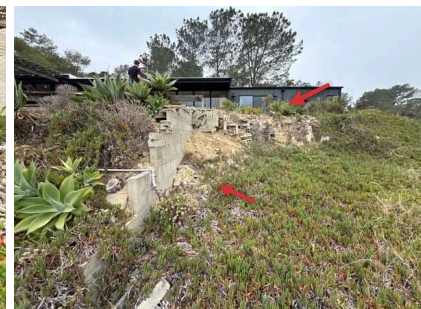
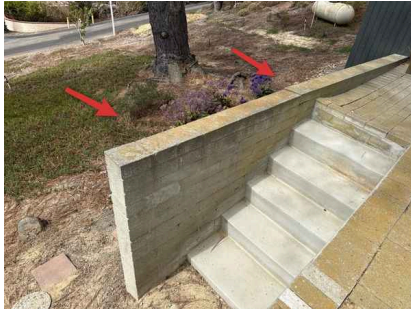
The retaining walls located along the southeast corner of the property and adjacent to the east-side patio exhibit visible signs of age-related deterioration, moderate leaning, and long-term movement. While retaining wall movement can occur naturally over many years, particularly within coastal hillside environments, the combination of visible movement, sandstone topography, localized erosion, and limited drainage improvements indicates that additional evaluation would be beneficial. During the inspection, no visible French drainage systems, surface drainage collection systems, or weep holes were observed serving these retaining walls. Without adequate drainage, moisture can gradually accumulate behind retaining walls, increasing hydrostatic pressure and placing additional stress on the wall over time.

### RETAINING WALL: DETERIORATION/ DAMAGE

The retaining wall is showing signs of deterioration/damage and has visible cracks. Lack of maintenance and improper/missing drainage can cause deterioration/damage.

It is recommended that these retaining walls be evaluated by a qualified retaining wall contractor or structural professional to determine whether repairs or reinforcement are appropriate. Incorporating properly designed drainage improvements, including French drains, surface drains, and weep holes where applicable, would improve groundwater management, reduce hydrostatic pressure, minimize soil erosion, and help extend the service life and stability of both the retaining walls and the surrounding hillside.

- **Recommend having a qualified professional to further evaluate and repair.**

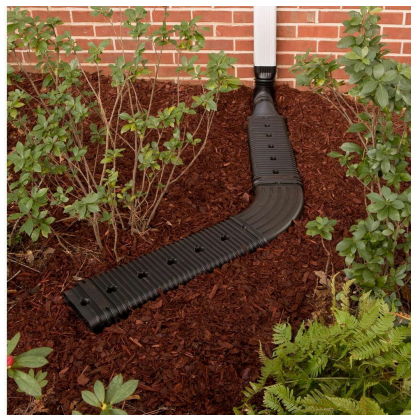
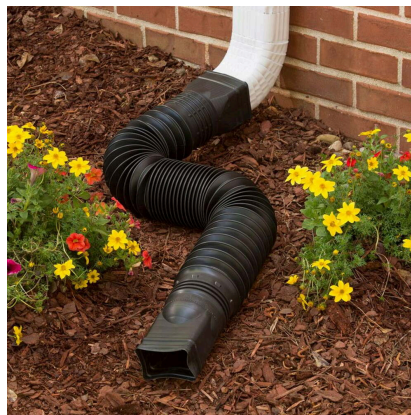
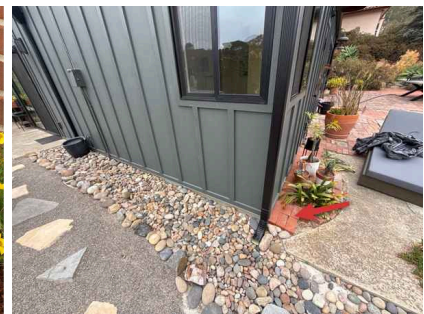
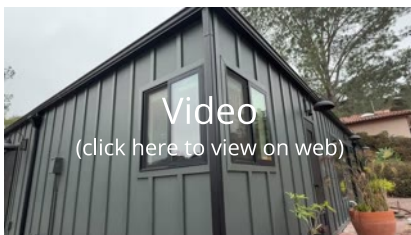
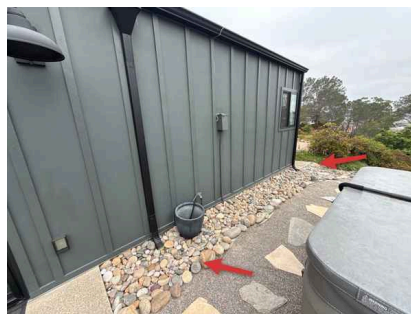
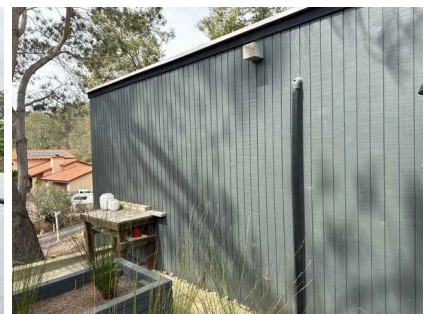
The two roof gutter downspouts located at the northeast corner of the backyard are currently not directly connected to the property's primary drainage system. Instead, roof runoff is discharged directly onto the adjacent hillside. Over an extended period, concentrated roof runoff may contribute to localized soil erosion, particularly within sandstone soils and sloping terrain. It is recommended that these downspouts be directly interconnected into the existing north-side drainage system. This improvement appears to be relatively straightforward, as the existing drainage line was successfully located at an approximate depth of 1 foot 5 inches below finished grade, allowing for a practical connection while minimizing excavation.

**GUTTER DOWNSPOUTS: EXTENSIONS MISSING**

Extensions are missing on gutter downspouts in some areas around the home. Extensions flow water away from the house, preventing water from ponding near the home's foundation and siding.

Recommend having a qualified professional to evaluate and repair.
