WOOD DESTROYING PESTS AND ORGANISMS INSPECTION REPORT

Building No. 29672	Street Butte Ct.	City Cold Springs	Zip 95335	Date of Inspection 05/23/25	Number of Pages 1 of 16
------------------------------	----------------------------	-----------------------------	---------------------	---------------------------------------	-----------------------------------

Report # 7143

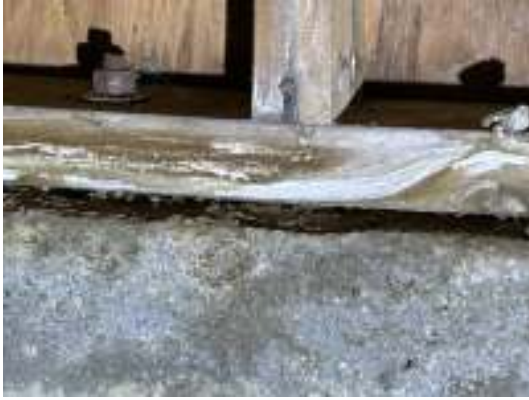
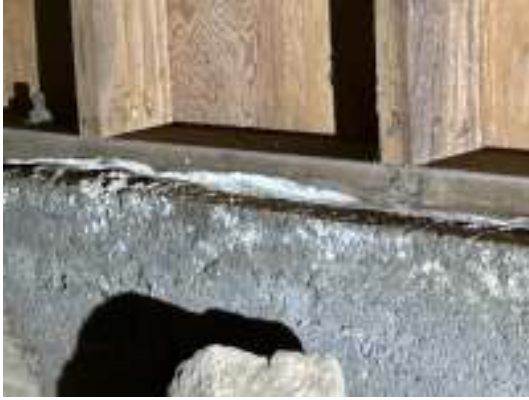
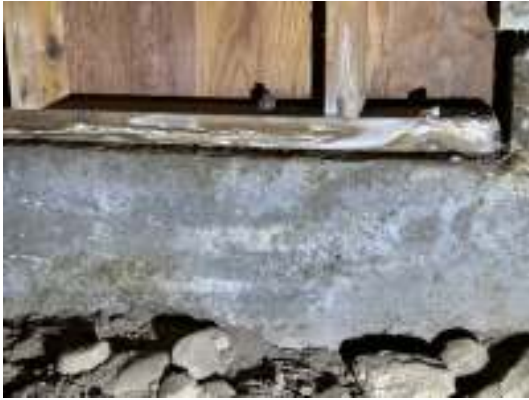
1A:

1A.
Wood decay fungus is infecting the surface of the framing in the subarea below the shed.

RECOMMENDATION: Scrape and treat infected wood with (Tim-bor) disodium octaborate tetrahydrate. All chemicals are to be applied by a state licensed applicator in accordance with manufacturer labels.

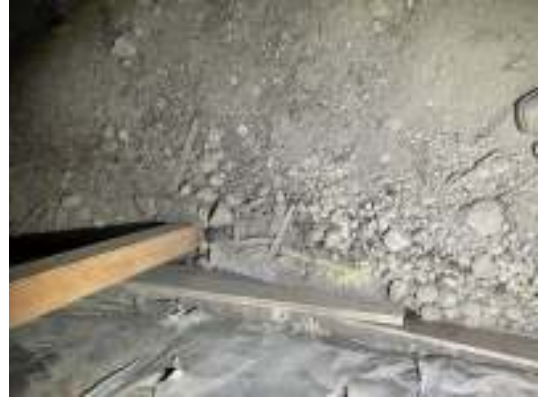
1B:

1B.
Cellulose debris was noted in subarea; this can attract subterranean termites to the structure.

RECOMMENDATION: Remove and dispose of cellulose debris as practical. (Note: Should any evidence of subterranean termites be uncovered upon removal of cellulose debris, recommendations and prices for treatment will be given in a supplemental report.)

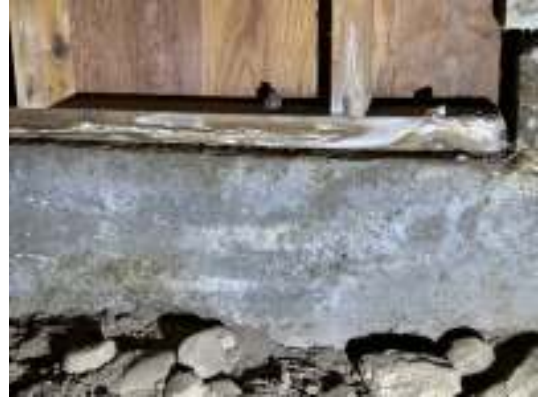
1C:

NOTE: Efflorescence is present at the foundation wall indicating excessive moisture at the exterior of foundation in this area.

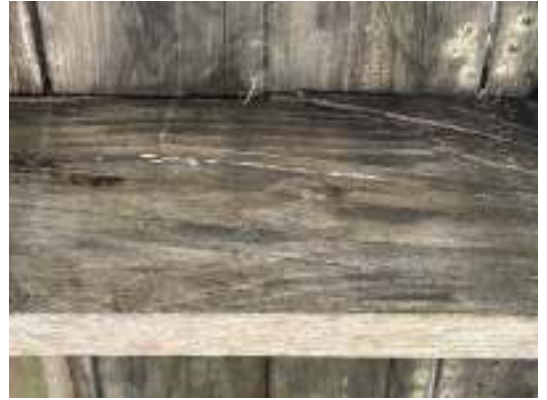
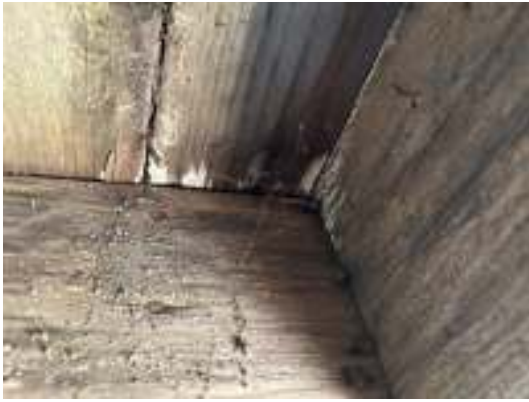
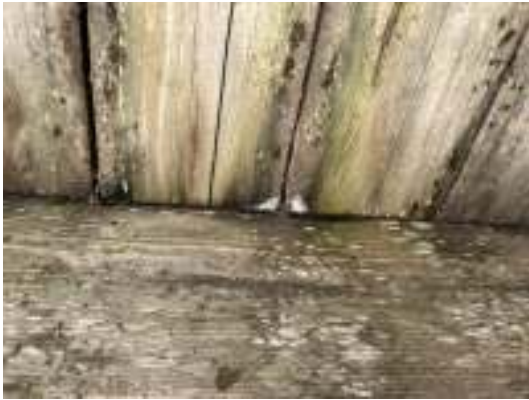
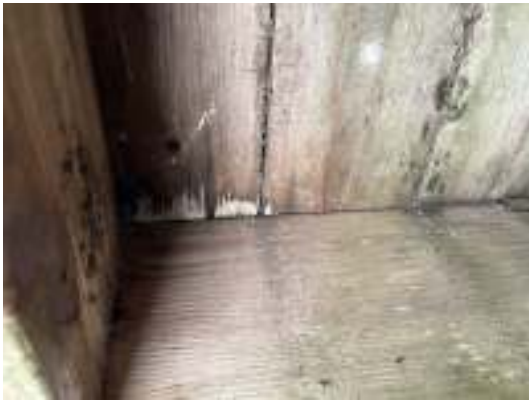
9A:

Wood decay fungus is infecting the surface of the underside of the upper deck.

RECOMMENDATION: Scrape and treat infected wood with (Tim-bor) disodium octaborate tetrahydrate. All chemicals are to be applied by a state licensed applicator in accordance with manufacturer labels.

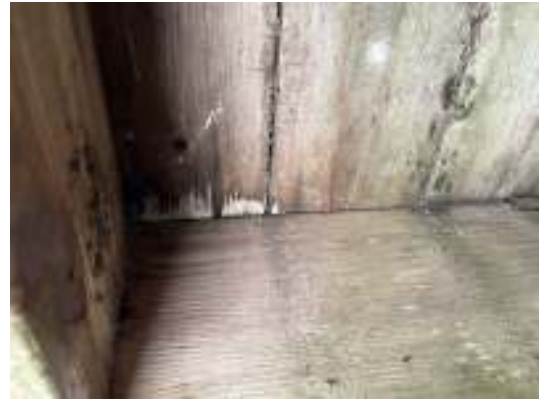
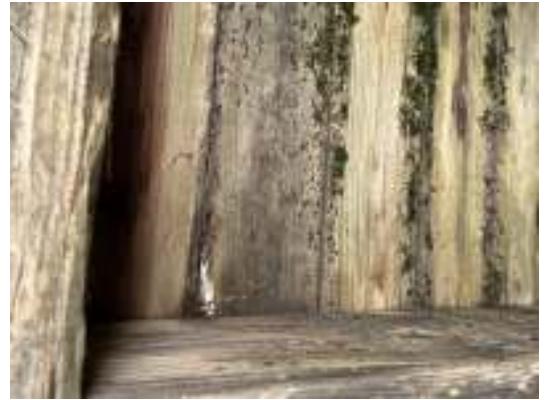
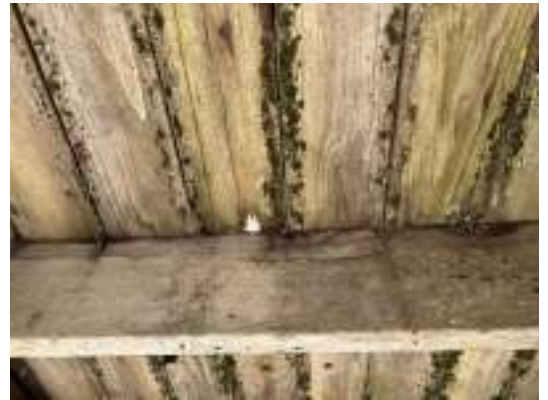
9B:

Wood decay fungus is infecting the surface of the underside of the lower deck.

RECOMMENDATION: Scrape and treat infected wood with (Tim-bor) disodium octaborate tetrahydrate. All chemicals are to be applied by a state licensed applicator in accordance with manufacturer labels.

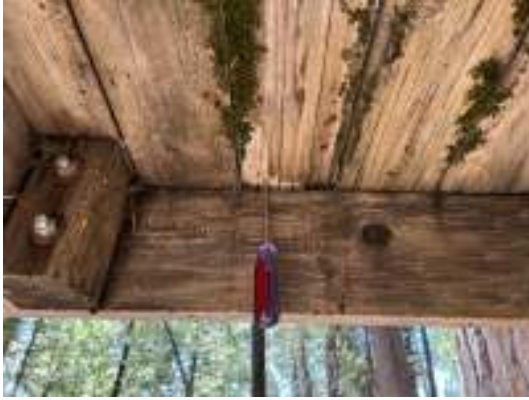
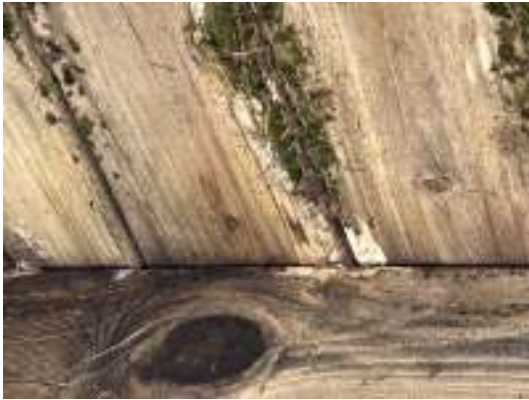
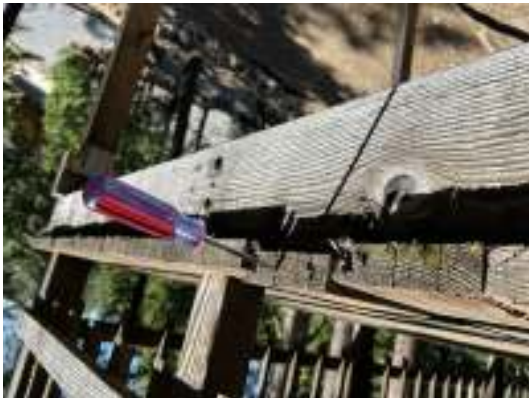
9C:

Wood decay fungus is infecting and damaging the lower level deck wood members.

NOTE: While not anticipated, it is unknown if further damage exists in the inaccessible areas behind the visibly affected wood members stated above. Should additional damage be exposed during the course of repairs, new findings, recommendations, and prices for additional scope of work will be given in a supplemental report.

RECOMMENDATION: Remove and replace up to 20 linear feet of damaged 2x6 decking boards, and up to 2 linear feet of damaged 2x8 blocking; price for repairs does not include paint / stain. Treat all exposed wood members with (Tim-bor) disodium octaborate tetrahydrate to arrest the growth of wood decay fungi. All chemicals are to be applied by a state licensed applicator in accordance with manufacturer labels. *Upon request, prices can be given for others to perform repairs and Streamline Inspections to chemically treat only.

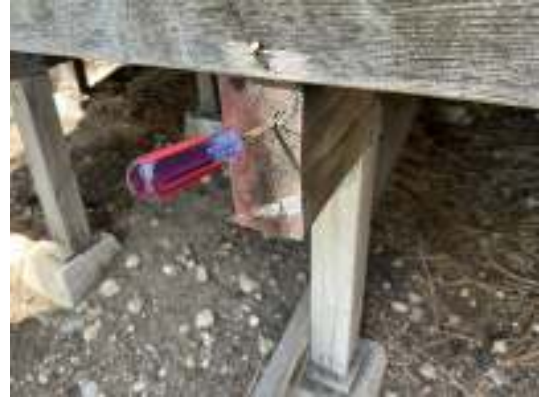
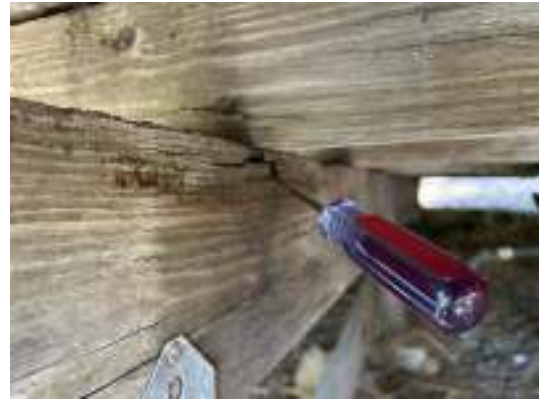
9D:

Wood decay fungus is infecting and damaging the back deck girder.

NOTE: While not anticipated, it is unknown if further damage exists in the inaccessible areas behind the visibly affected wood members stated above. Should additional damage be exposed during the course of repairs, new findings, recommendations, and prices for additional scope of work will be given in a supplemental report.

RECOMMENDATION: Remove and replace up to 20 linear feet of damaged 4x8 girder; price for repairs does not include paint / stain. Treat all exposed wood members with (Tim-bor) disodium octaborate tetrahydrate to arrest the growth of wood decay fungi. All chemicals are to be applied by a state licensed applicator in accordance with manufacturer labels. *Upon request, prices can be given for others to perform repairs and Streamline Inspections to chemically treat only.

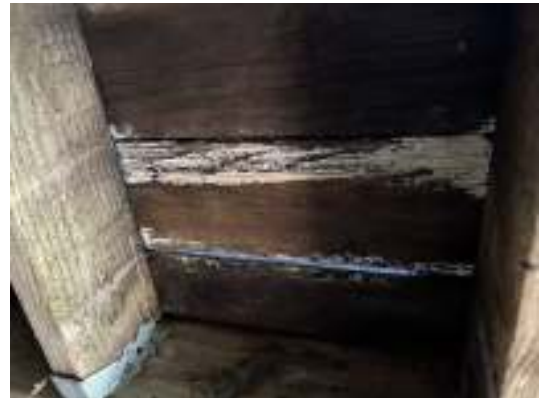
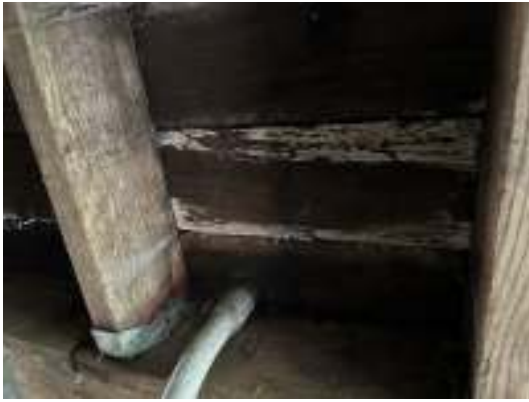
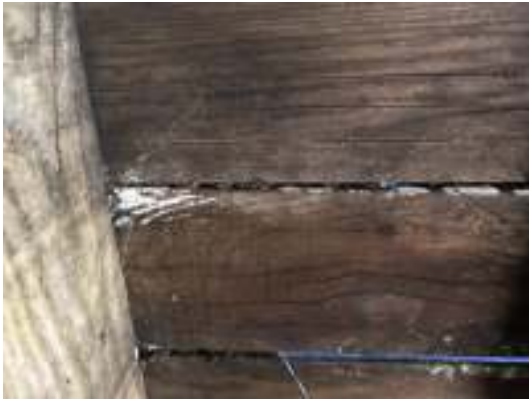
9E:

Wood decay fungus is infecting the surface of the underside of the back deck.

RECOMMENDATION: Scrape and treat infected wood with (Tim-bor) disodium octaborate tetrahydrate. All chemicals are to be applied by a state licensed applicator in accordance with manufacturer labels.
