# Confidential Inspection Report

LOCATED AT:  
1805 Nichols Canyon Rd  
Los Angeles, CA 90046

INSPECTED ON:  
Tuesday, December 15, 2015

Inspector, Rick Sailors  
AAA Property Inspection Services

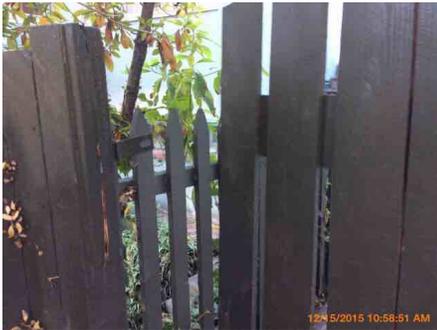
**CR** 28: - The gate(s) need adjustment or repairs to restore proper operation. **RECOMMENDATION:** We recommend proper repair as necessary by a qualified technician.

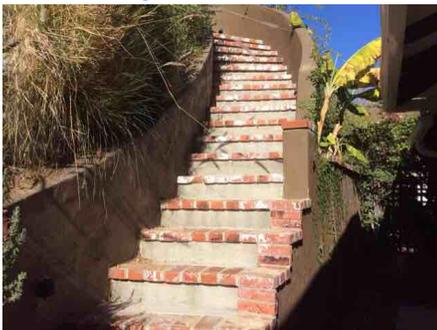
**SC** 29: - The safety handrail serving the rear yard steps is missing. This condition is a safety hazard. **RECOMMENDATION:** We recommend installation of a handrail as a safety upgrade by a qualified technician. Handrails shall be provided on at least one side of each continuous run of treads or flight with four or more risers.

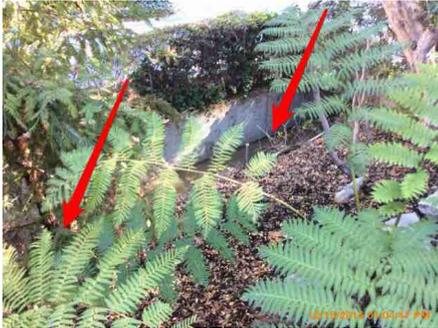
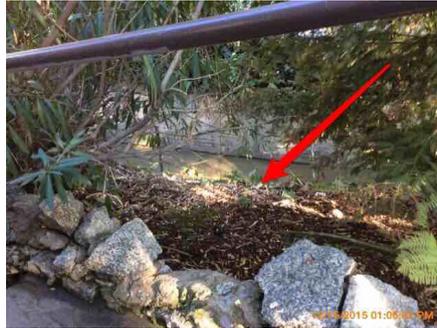
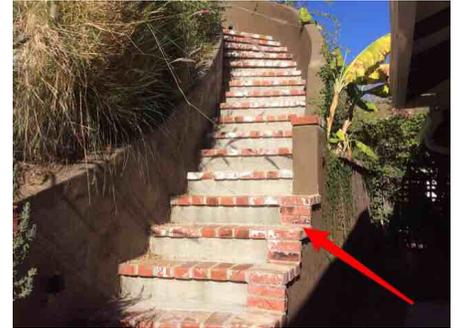
**SC 30:** - There were no guardrails where needed at the drainage ditch and rear steps.  
**RECOMMENDATION:** We recommend installation of handrails as a safety upgrade. Required guards on open sides of stairways, raised floor areas, balconies and porches shall have intermediate rails or ornamental closures which do not allow passage of a sphere 4 inches or more in diameter. Porches, balconies or raised floor surfaces located more than 30 inches above the floor or grade below shall have guardrails not less than 42 inches in height. Open sides of stairs with a total rise of more than 30 inches above the floor or grade below should have guardrails not less than 34 inches in height measured vertically from the nosing of the treads. The balusters should be run vertically to prevent the railing used as a ladder assembly.

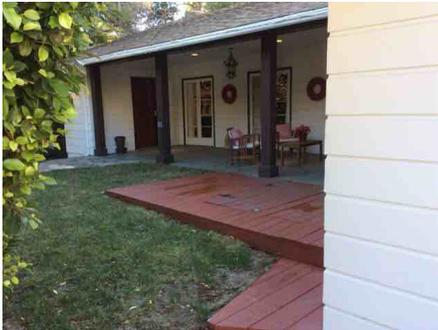
**31:** - The deck cover is in satisfactory condition.

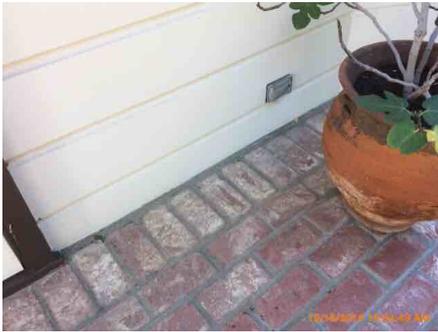
**CR** 48: - The siding was embedded into the masonry surface. This condition is conducive to moisture relate deterioration. Present standards require a minimum of 6 inches clearance between the finish grade and any wood/metal construction **RECOMMENDATION:** We recommend correction to prevent moisture infiltration and deterioration to the siding.

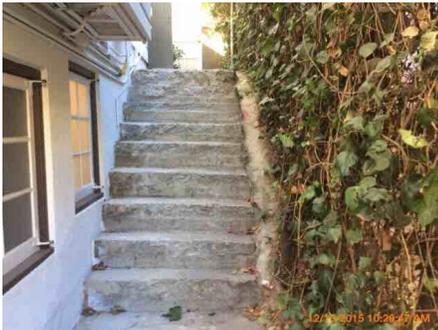
**SC** 51: - The riser heights/ tread depths on the steps/stairs was inconsistent and greater then 3/8's of an inch in variance. This condition is non complying and presents a safety hazard. **RECOMMENDATION:** We recommend modification of the stairs in accordance with current industry standards. Current building standards recommend no more than 3/8" difference in variation on the stair risers and tread run.

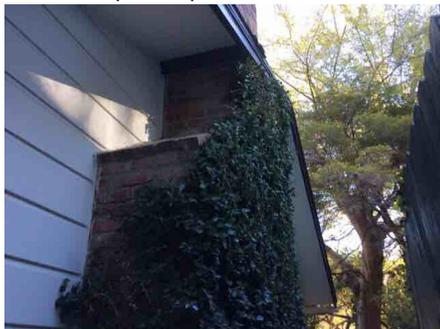
**CR** 54: - Vegetation was growing on and attaching itself to the stucco chimney. This condition limits the inspection of the chimney and is conducive to moisture intrusion/deterioration of the brick/mortar and hazardous using the fireplace with dead vegetation in and around the weather cap and spark arrestor. RECOMMENDATION: We recommend the vegetation be trimmed away from the chimney

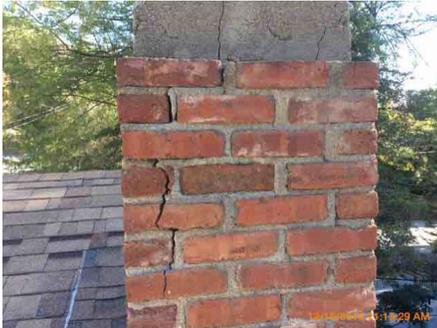
**FE** 61: - The chimney wall is cracked on exterior facing and should be further evaluated by a certified chimney specialist.

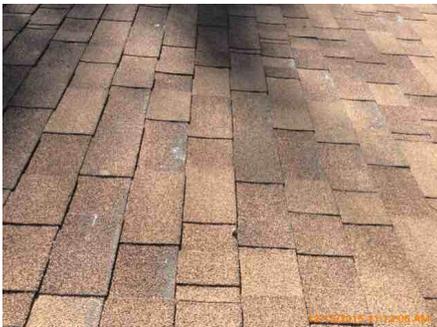
**FE** 63: - The visible areas of the roof show signs of weathering and aging due to loss of granules on the shingles. Periodic maintenance and inspection is recommended and recommend a licensed roofing contractor provide a roof certification.

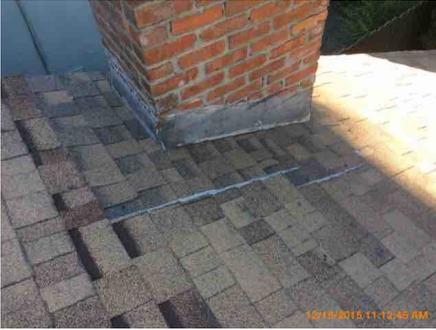
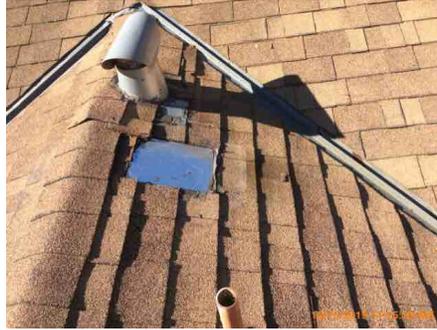
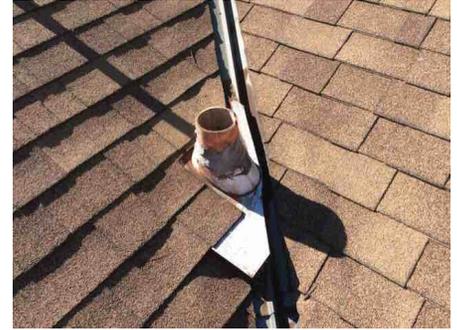
**FE 64:** - Obvious repairs by others have been made to the roof covering. All warranties and/or assurances should come directly from the company performing these repairs.

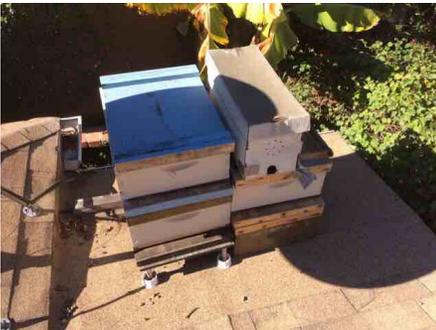
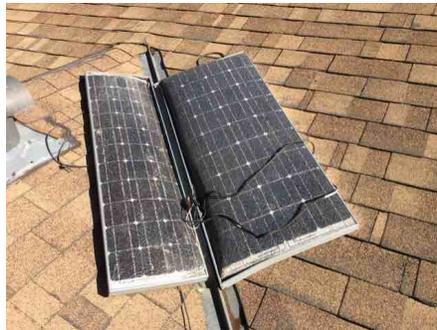
**CR 65:** - There was debris on the roof. **RECOMMENDATION:** We recommend the debris be removed and the roof be inspected regularly.

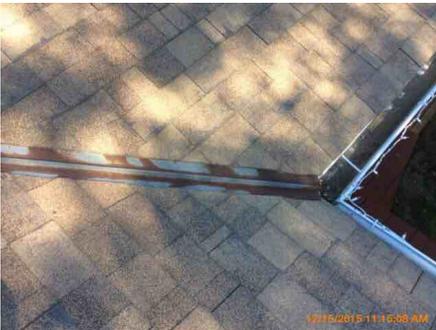
**CR 67:** - The flashings were not all painted. This is conducive to premature deterioration and recommend painting by a qualified specialist.

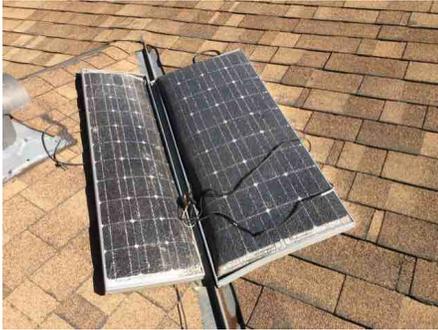
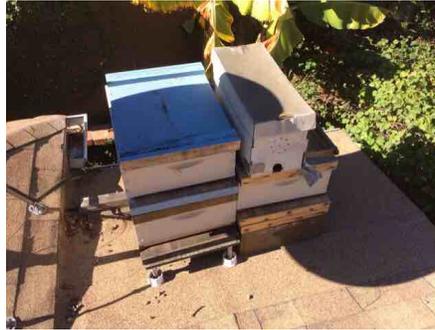
**CR** 70: - The roof needs to be cleaned and any foliage removed to facilitate drainage.

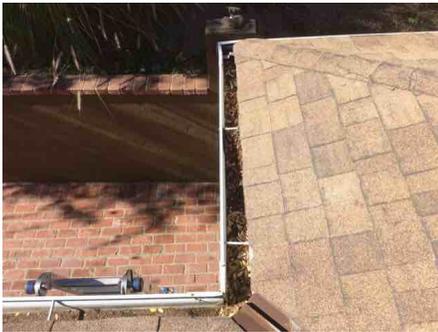
**CR** 71: - The gutters were partially filled with debris. **RECOMMENDATION:** We recommend all debris be removed to ensure proper drainage. Keeping the gutters free of debris as part of a routine maintenance schedule is recommended.

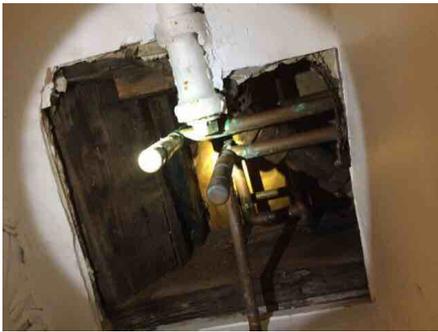
**NOTE** 76: - Newer plumbing work has been completed to the drain, waste or vent piping. Recommend verifying permits and ask Seller to provide details concerning the repair / replacement work, i.e. receipts, company name, warranties, etc.

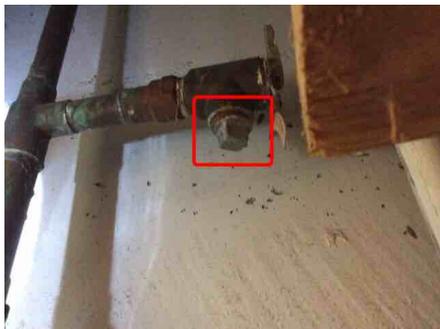
**CR** 80: - The pressure relief valve is capped indicating possible prior leakage and prohibits Proper functioning of the valve. We recommend the services of a California licensed Plumbing Contractor

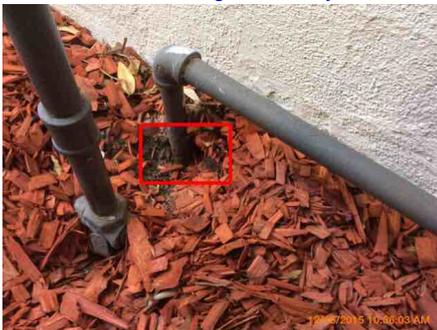
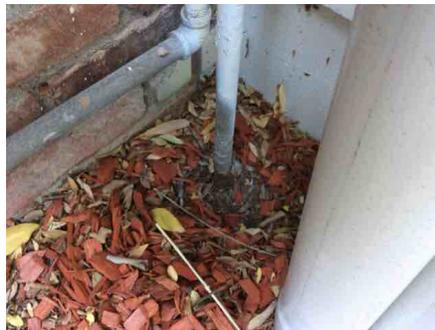
**SC** 91: - Gas piping did not have the proper corrosion protection tape entering the ground. This condition can lead to damage to the piping and is non conforming to industry standards. **RECOMMENDATION:** We recommend correction by a qualified plumbing contractor.

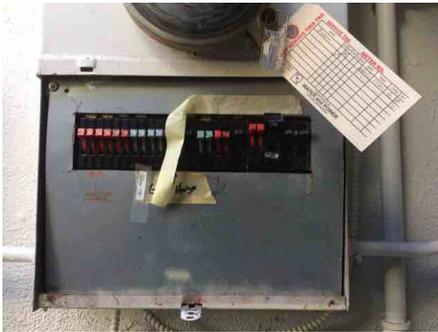
**CR** 115: - A number of breakers were not labeled or faded and were illegible. **RECOMMENDATION:** We recommend they be accurately labeled to allow individual circuits to be shut off for maintenance or emergency needs.

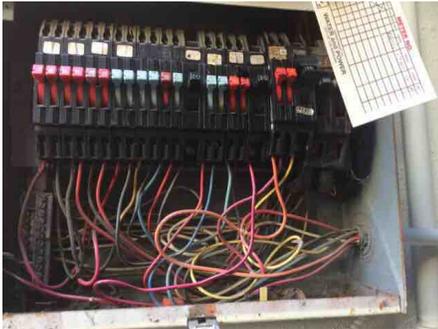
**SC** 116: - The main panel is manufactured by Zinsco. Panels of this type have been known to present latent hazards by malfunctioning under certain conditions resulting in jammed circuit breakers. The breakers may not trip (disconnect) under imposed load conditions. **RECOMMENDATION:** Further evaluation and/or upgrading this panel box to a more reliable one by a qualified electrician is recommended.

117: - The visually accessible wiring and system components within the panel are in satisfactory condition.

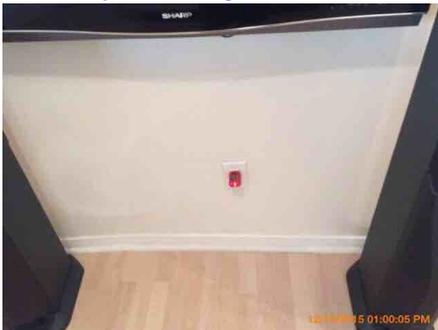
**SC** 119: - One or more receptacles were found to have reversed polarity connection. This is an unsafe connection and needs repaired for user safety. Location: guest room

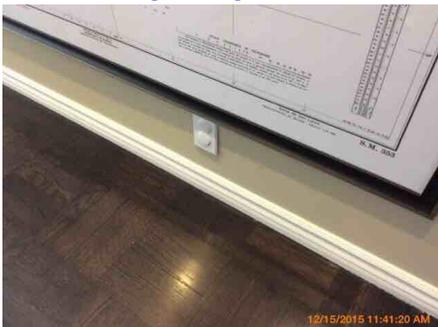
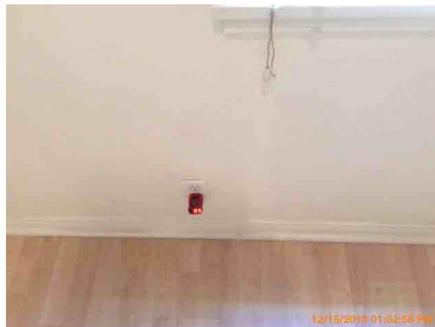
**SC** 120: - Receptacles were found to have a loose/unsecured connection to the box or loose blades inside the receptacle. This is conducive to wires arcing and overheating, creating a potential fire hazard. Repair is recommended. We recommend evaluation of all receptacles and repair as necessary by a qualified electrician.

Location: dining room, guest room

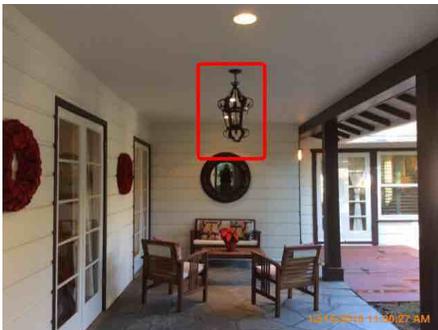
**CR** 123: - One or more light(s) did not respond. This may be due to burnt/missing bulbs. **RECOMMENDATION:** We recommend replacement of the bulb(s). If this does not correct the condition, further evaluation and correction by a qualified electrical contractor is advised..

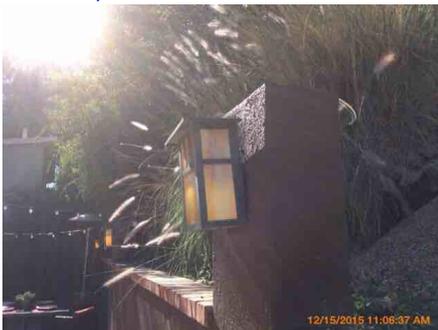
**CR** 124: - One or more of the exterior light fixtures is loose from the wall and does not consist of a weather tight seal/gasket to prevent moisture penetration and deterioration. Recommend securing and sealing as necessary to prevent damage.

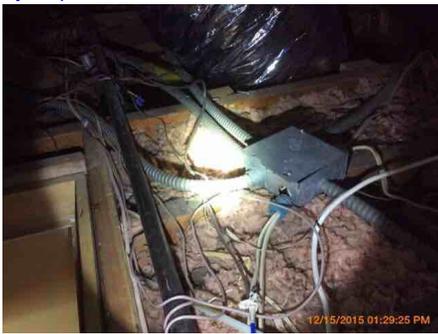
**SC 126:** - Electrical cables/ wires are missing/damaged strain relief clamps where the wires enter the junction boxes. This condition allows the potential for mechanical damage to the cable and indicates non professional installation. RECOMMENDATION: We recommend correction by a qualified electrical contractor

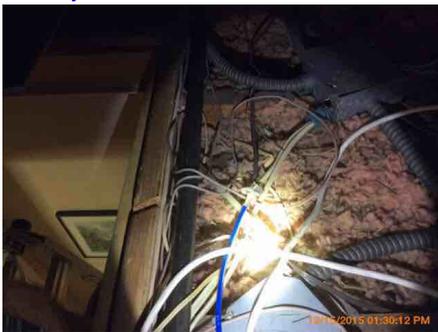
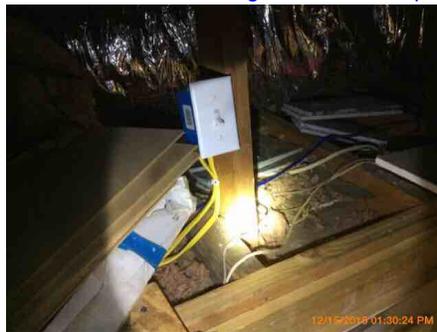
**SC 127:** - The exposed wiring within six feet of the attic access opening was not protected from damage. This condition is non conforming to industry standards. RECOMMENDATION: We recommend that the wiring in this area be protected from damage for safety reasons.

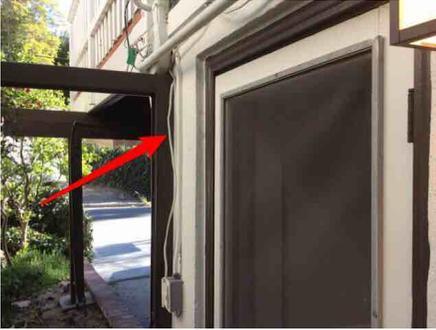
**SC** 128: - Exposed non metallic sheathed cables non rated for exterior use and subject to damage. This is a potential safety hazard and needs corrected.

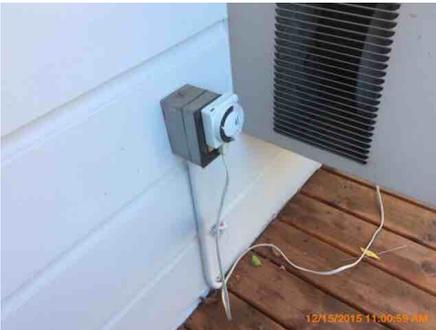
**CR** 130: - Exterior cover damaged/missing and needs repaired/replaced.

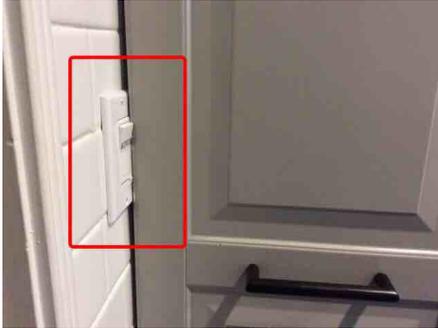
**CR** 152: - Doors/drawers are blocked and need repair/re-designed to be functional. We recommend the advice and services of a California licensed electrical contractor.

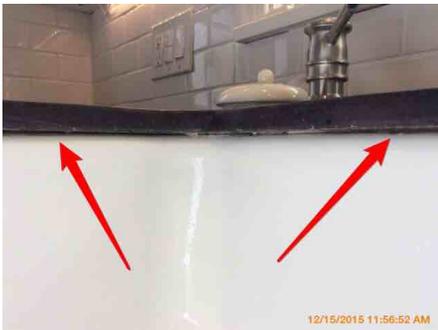
**CR** 153: - The sink needs sealed to the counter top to prevent moisture intrusion inside cabinet.

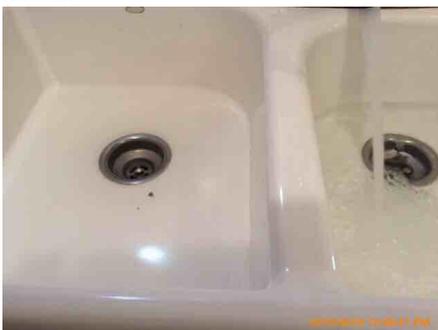
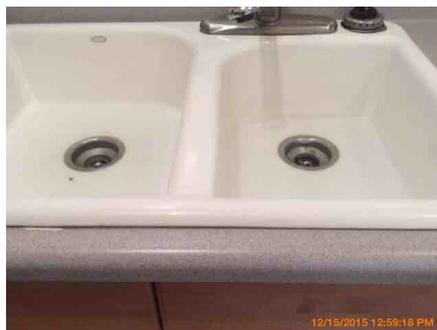
**CR** 155: - The sink drain was slow or blocked. RECOMMENDATION: We recommend correction by a qualified plumbing contractor. Guest kitchen

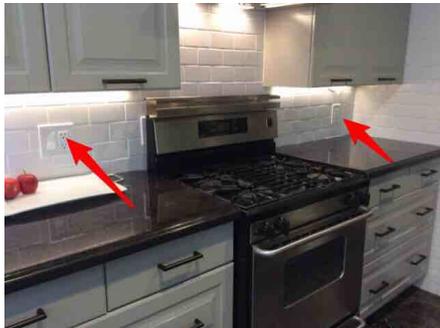
**SC** 156: - Some GFCI protected countertop receptacles were installed but not all are protected. The kitchen appears to have been recently remodeled. This condition is non conforming to industry standards. **RECOMMENDATION:** We recommend providing GFCI protection for all countertop receptacles for safety reasons by a qualified electrician.

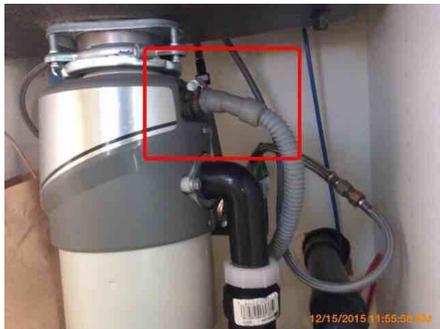
**CR** 159: - The dishwasher was connected directly to the garbage disposal. This is conducive to cross contamination and needs service. **RECOMMENDATION:** Installation of an air gap device to prevent back siphoning is recommended.

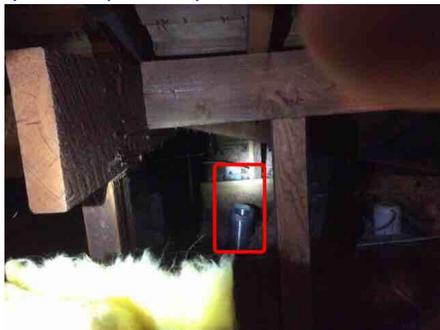
**CR** 164: - The exhaust vent terminates inside the attic and should vent to the exterior to prevent moisture related damage. Recommend a qualified specialist provide service as necessary.

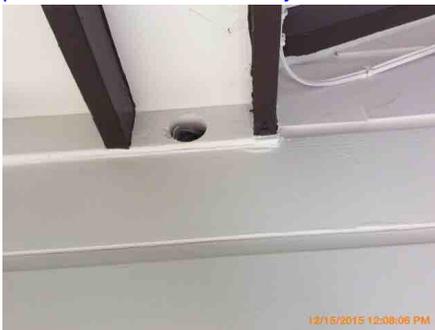
**CR** 172: - Exterior vent screen is missing. This is conducive to birds, rodents and small animals entering. Recommend a qualified specialist provide service as necessary.

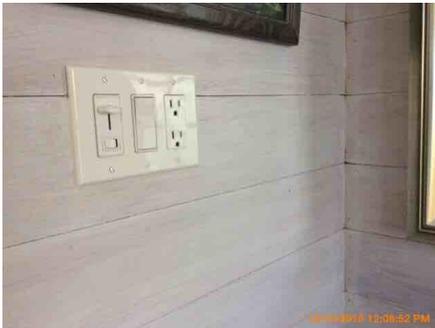
**SC** 173: - The accessible receptacles were not GFCI protected. RECOMMENDATION: We recommend upgrading to provide GFCI protection for the receptacles for safety reasons.

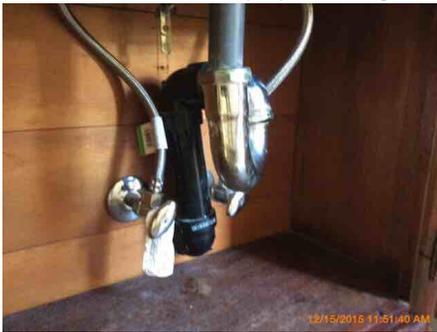
**CR** 175: - The sink drain has an "S" type drain trap configuration. This is an older type of drain configuration that can lead to a loss a trap seal and does not allow proper venting of the sink drain. RECOMMENDATION: We recommend correction by a qualified plumbing contractor.

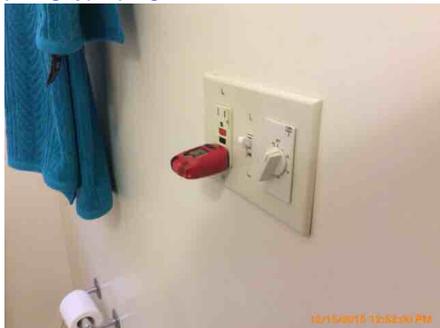
**182:** - The three prong duplex receptacle is not grounded; therefore, does not provide adequate user protection for appliances using a three prong type plug. We recommend this to be either grounded or replaced with a GFCI receptacle.

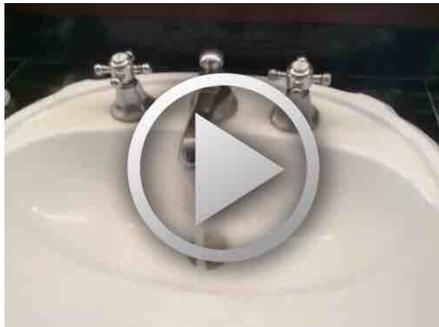
**CR** 197: - The hot water valve was defective and needs repaired/replaced. Water flow starts strong and then shuts down. We recommend the services of a California licensed Plumbing Contractor

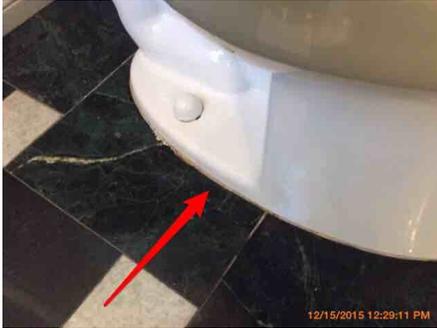
**CR** 201: - The toilet is not loose on the floor however there was leakage observed. RECOMMENDATION: We recommend correction by a qualified plumbing contractor.

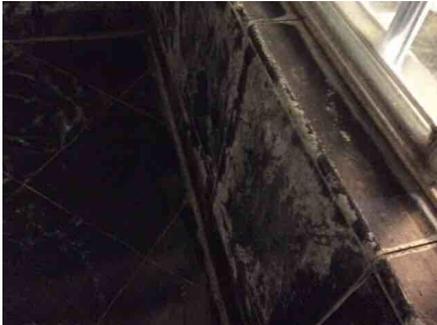
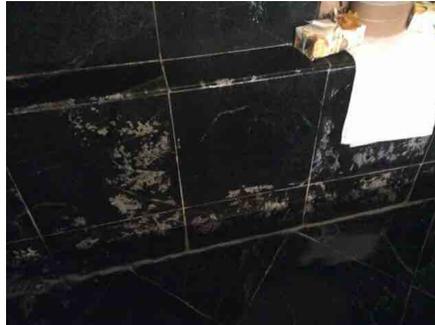
**CR** 204: - The tiled tub/surround was noted to be deteriorating on the surface. This condition allows bacteria growth. Replacement of the tiled surround is recommended. Suggestion: We recommend repair by a specialist in the appropriate trade.

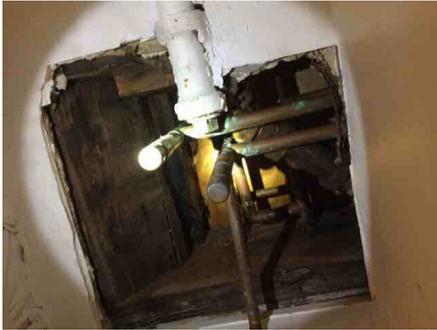
**CR** 224: - Unfinished repair work noted and needs finished. Guest room

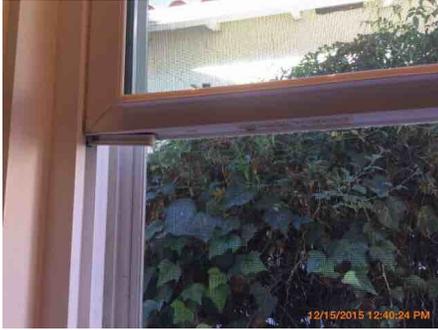
**CR** 237: - The counter balance mechanism on the window(s) in the [ ] were damaged and non functional. **RECOMMENDATION:** Replacement of the damaged mechanism is suggested. We recommend proper repair as necessary by a qualified tradesperson.

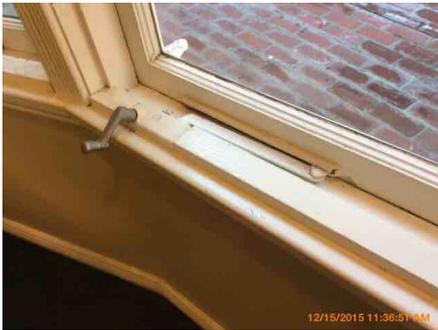
**CR** 238: - Several window crank handles were stripped or missing. This condition does not allow operation of the windows. Suggestion: We recommend correcting the condition noted.

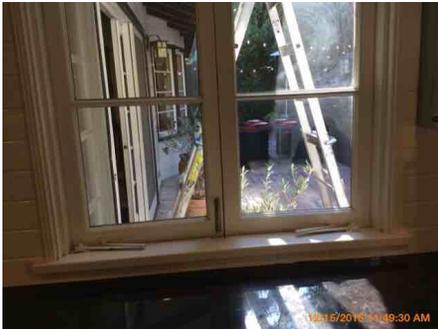
**CR** 239: - One or more of the window lock were not latching/defective/missing. Suggestion: We recommend correcting the condition noted for security reasons. Location: kitchen, living room,
