**RE: 945 McHugh Ct. Ventura CA 93003**

# WOOD DESTROYING PESTS AND ORGANISMS INSPECTION REPORT

| Building No.<br><b>945</b> | Street<br><b>McHugh Ct. Ventura CA 93003</b> | City<br><b>93003</b> | Zip<br><b>93003</b> | Date of Inspection<br><b>04/08/25</b> | Number of Pages<br><b>3</b> |

REPORT# az5472

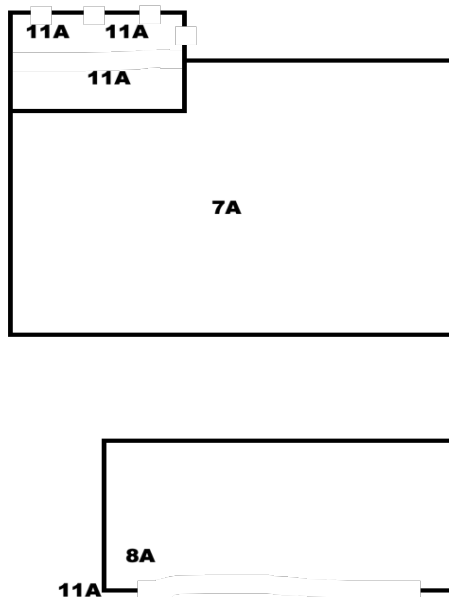
FOUNDATION DIAGRAM (Diagram not to scale)

Finding: 7A EVIDENCE OF DRYWOOD TERMITES NOTED AT ATTIC - AS INDICATED ON DIAGRAM.

Finding: 8A EVIDENCE OF DRYWOOD TERMITES NOTED AT GARAGE - AS INDICATED ON DIAGRAM.

Finding: 11A EVIDENCE OF DRYWOOD TERMITES NOTED AT HANDRAIL, FASCIA, AND JOIST. - AS INDICATED ON DIAGRAM.

Recommendation: 7A **IN LIEU OF FUMIGATION; IMPRACTICAL TO FUMIGATE DUE TO ADJOINING STRUCTURES LOCAL TREAT INFESTED AREAS WITH Termidor SC (ACTIVE INGREDIEBTS:FIPRONIL (5-AMINO-(2,6-DICHLORO-4-TRIFLUOROMETHYL)PHENYL)-4-((1,R,S)-(TRIFLUOROMETHYL SULFINYL---1-H-PYRAZOLE-3 CARBONTRILE) DURSBN CHLOROPHRIFORS FOR THE CONTROL OF DRYWOOD TERMITES.**

Recommendation: 8A **SEE 7A**

Recommendation: 11A **REPAIR DAMAGE WOOD AS NEEDED. PAINTING NOT INCLUDED IN ESTIMATE. NOTE: IF INFESTATION(S) OR INFECTION(S) PERTAINING TO DAMAGE CAUSED BY EITHER EXTENDING INTO INACCESSIBLE AREAS A COST ESTIMATE WILL BE PROVIDED WITH A SUPPLEMENTAL REPORT.**
