# REAL ESTATE INSPECTION REPORT

709 Wilson Ct Burbank, CA 91501

DATE OF INSPECTION: 6/5/2024  
INSPECTION TIME: 3:00 PM

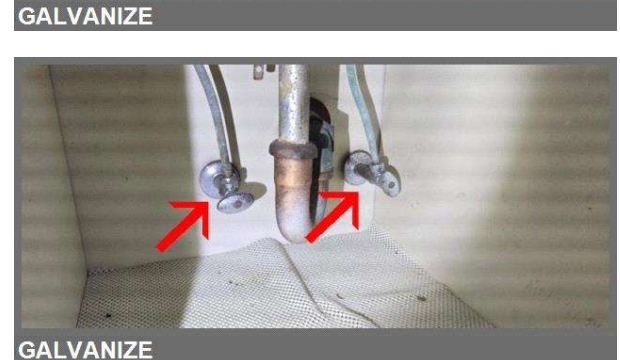
**NEEDS ATTENTION.** The water lines are galvanized steel pipes. These original galvanized steel pipes are rusting, corroded and are showing deterioration. They are at the end of their life and will need to be replaced. It is not possible to determine how much longer they will last.

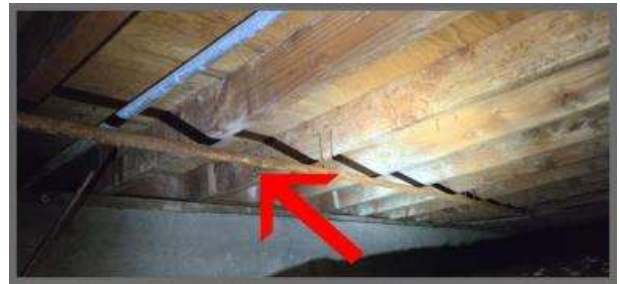
**SAFETY ALERT.** There are areas of rusty and deteriorated gas piping on the property. Such as under the building.

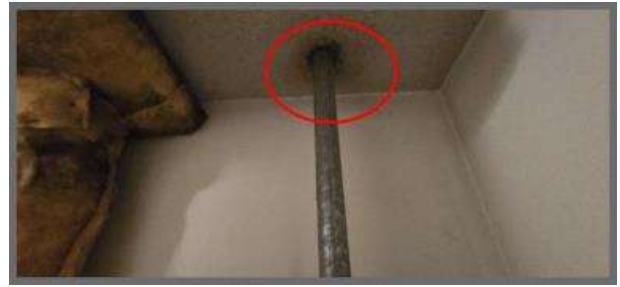
**SAFETY ALERT.** The water heater vent is too close to combustible/building material. It needs to have adequate clearance to minimize any possible fire hazard. Single wall vent pipe is required to be at least 6 inches from wood framing or roof sheeting.

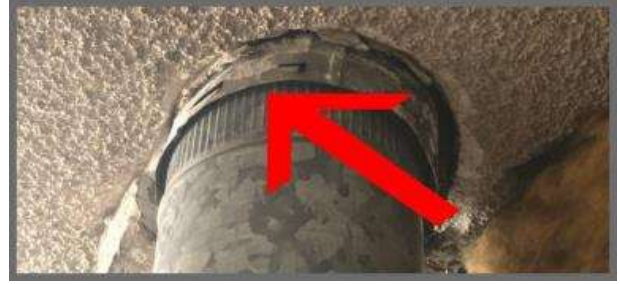
**NOT ACCEPTABLE.** The vent line is disconnected and exhaust gases from the furnace are escaping. This is a safety hazard and needs to be repaired by a heating contractor.

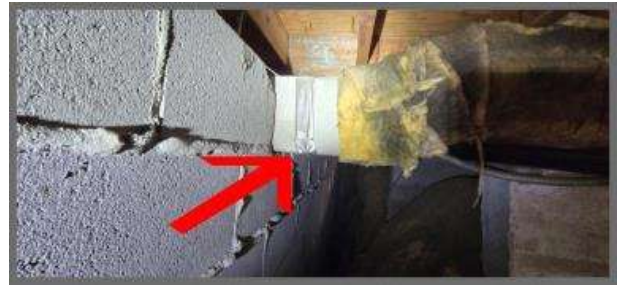
**NEEDS ATTENTION.** The insulation on the outside of the ducts is a material that is usually found to contain asbestos. It would have to be tested in a laboratory to confirm if it is asbestos or not. Ideally this ducting would be replaced. Further evaluation of this ducting is recommended to determine its true condition. There is also newer ducting. It is beyond this inspection to determine the percentage of newer ducting in relation to old.

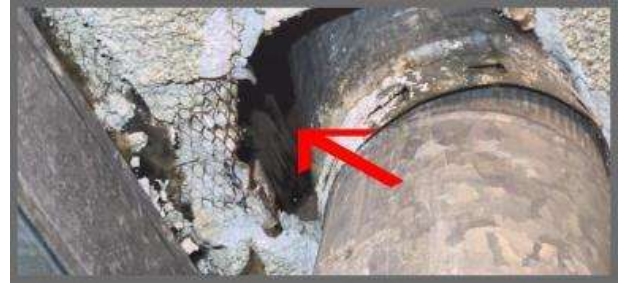
**NEEDS ATTENTION.** There are areas of staining noted to the framing lumber that may be due to roof leaks. It is not determined if the staining is from a past or current condition.

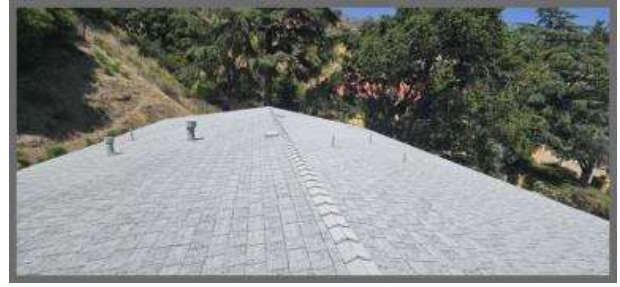
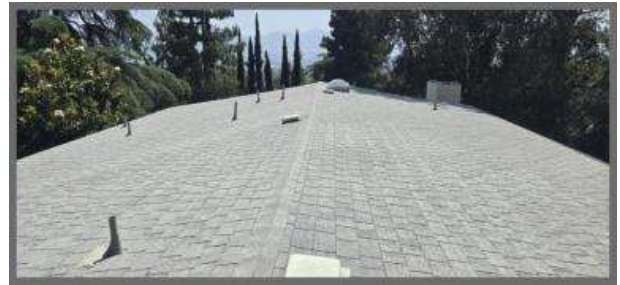
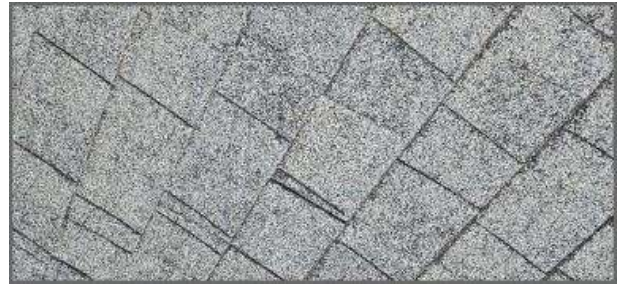
**NEEDS ATTENTION.** On the composition roof: Standard composition shingles are usually not recommended for low pitched roofs in some areas or all areas. This roof may be lower than a 4/12 pitch and hence a double layer of waterproof roofing paper would have been required. I am unable to verify this. Consult with a qualified roofing contractor to determine whether or not this roof has been installed correctly.

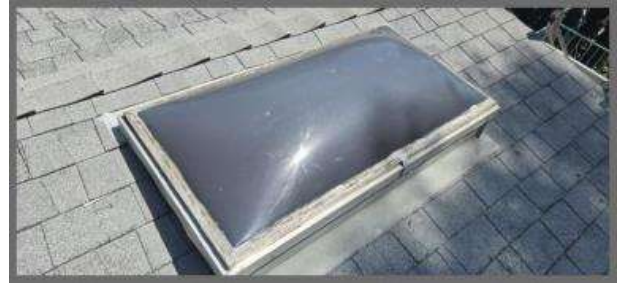
**NEEDS ATTENTION.** It appears the skylight was repaired with silicone. This repair may be temporary.

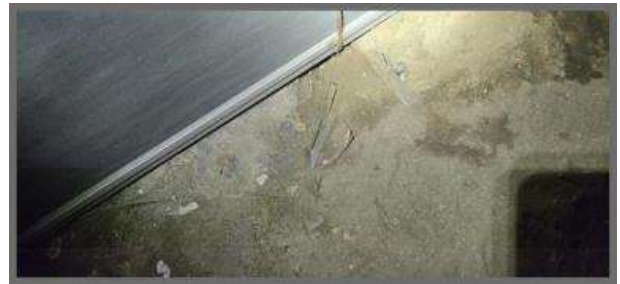
**NEEDS ATTENTION.** There are areas of damp soil under the house.

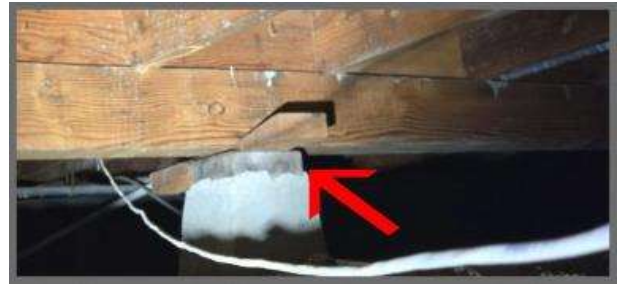
**NEEDS ATTENTION.** A number of pieces of wood such as shims are being used in place of a single support post in areas. These tend to fall out during seismic activity and are not attached to each other or the framing of the structure.

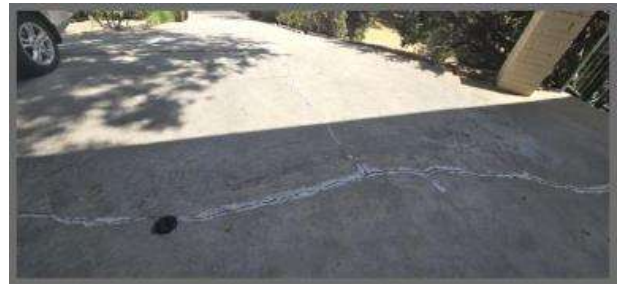
**NEEDS ATTENTION.** There are significant cracks and shifted areas of the driveway.

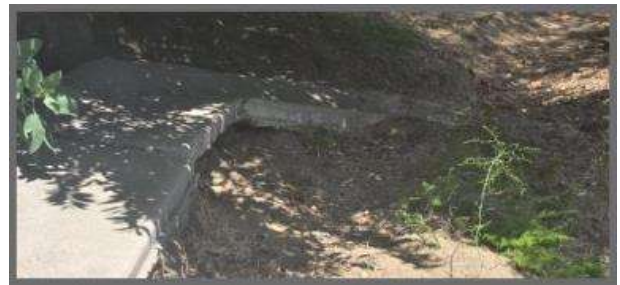
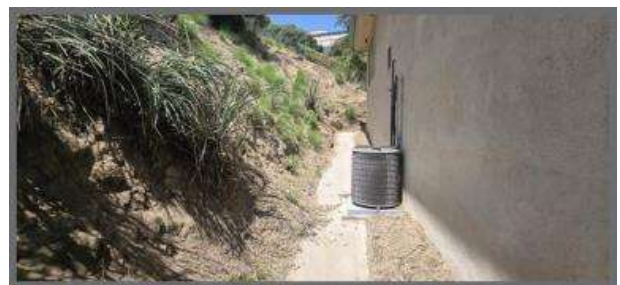
There is evidence of improper drainage on the site causing erosion of the soil.

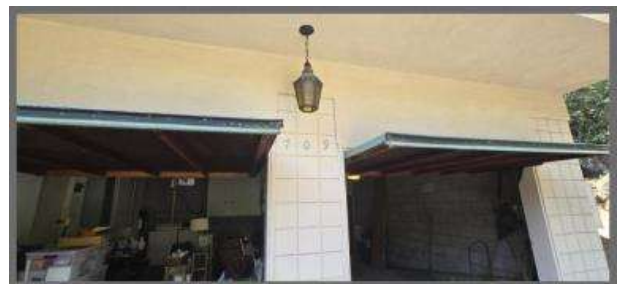
**NEEDS ATTENTION.** This older style openers do not have the added safety feature of a photo light beam at the base of the door to cause the closing door to reverse and open, as is recommended for child safety.

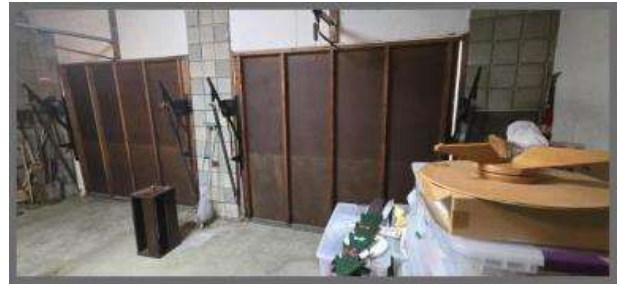
**SAFETY ALERT.** The automatic reverse feature of the garage door opener to the right did not stop the door from closing when light pressure was applied, this is a safety hazard. The sensor should be adjusted or the opener replaced.

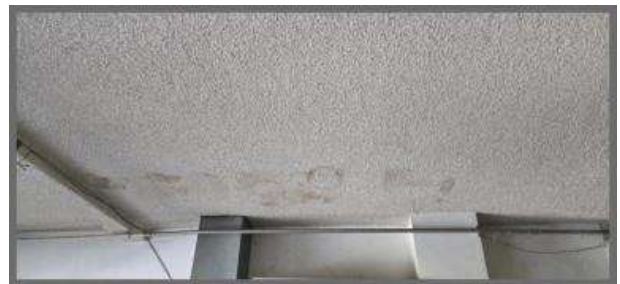
**NEEDS ATTENTION.** The garage interior has areas of moisture stains.

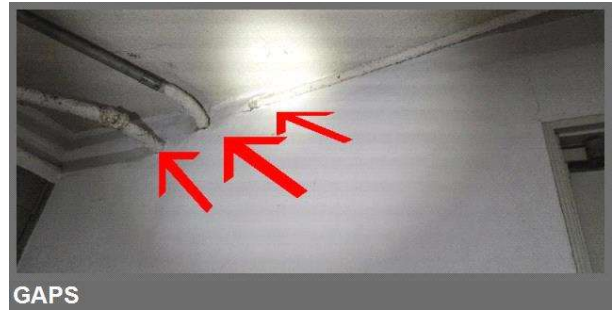
**NEEDS ATTENTION.** The garage interior has areas of damage.

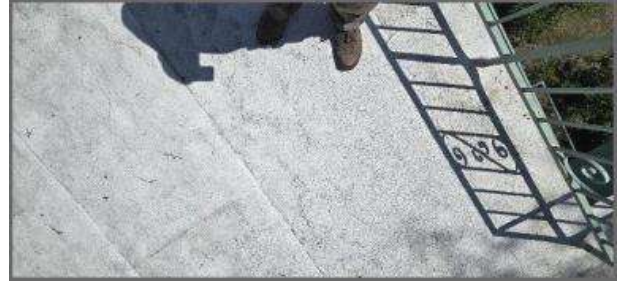
**NEEDS ATTENTION.** Some areas of the floor are "soft" as from damage to the subfloor by moisture.

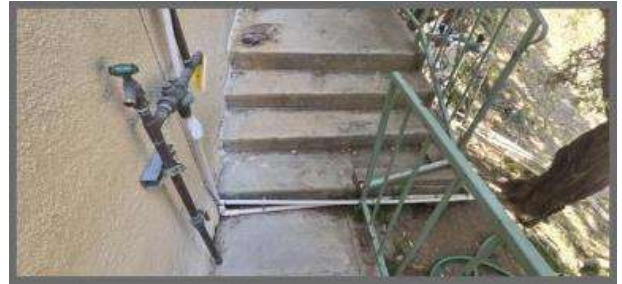
**SAFETY ALERT.** The risers of the stairs have uneven heights and may be a trip hazard.

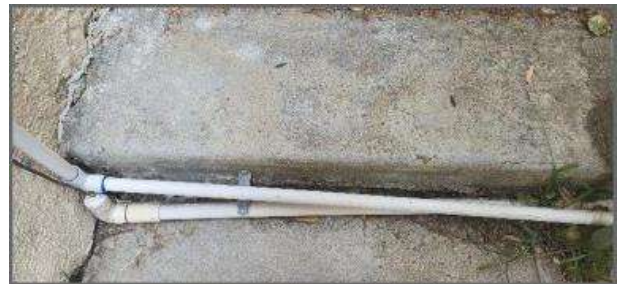
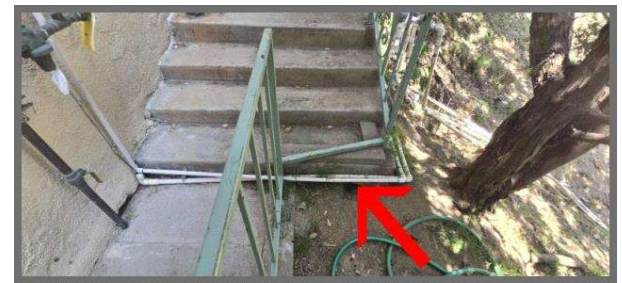
**SECURITY ALERT.** There are pipes in front of the steps, this can be a trip hazard.

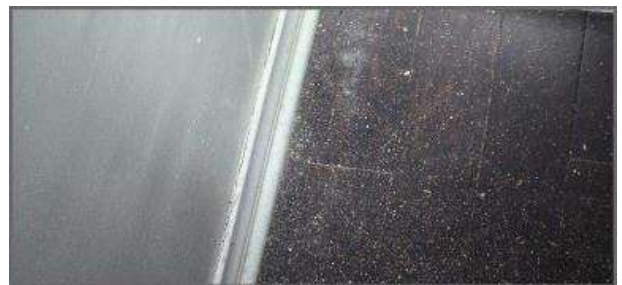
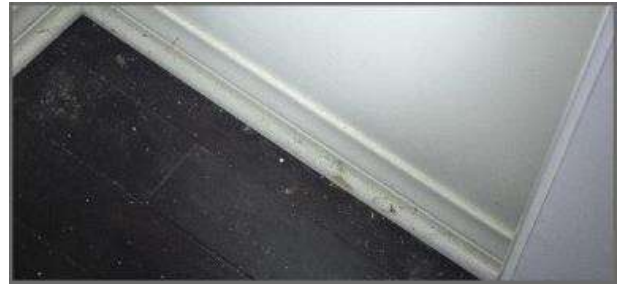
**NEEDS ATTENTION.** there are areas of moisture deterioration inside the closet.

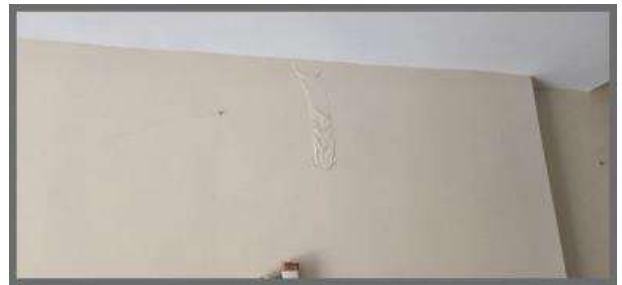
**NEEDS ATTENTION.** There are areas of moisture stains, on the wall.

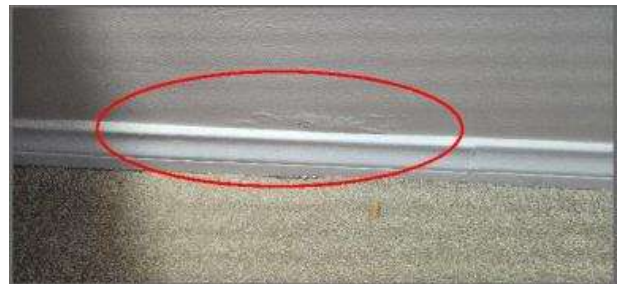
**NEEDS ATTENTION.** There are areas of moisture stains on the wall.

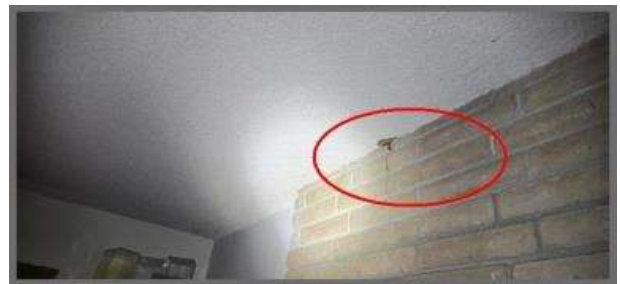
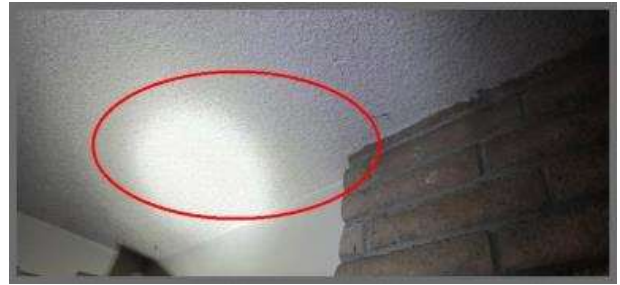
**NEEDS ATTENTION.** There are areas of moisture stains on the ceiling, on the wall.

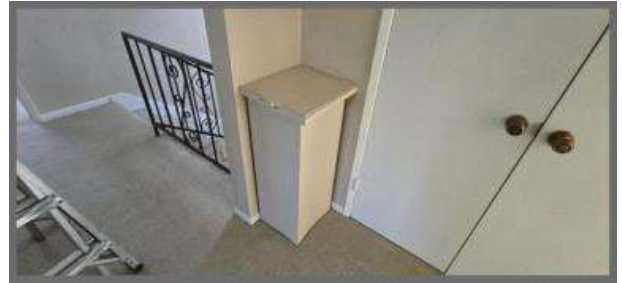
**SAFETY ALERT.** There is a laundry chute in the hallway, which is not locked. It appears that it would be easy to climb by a child. This could be a fall hazard.

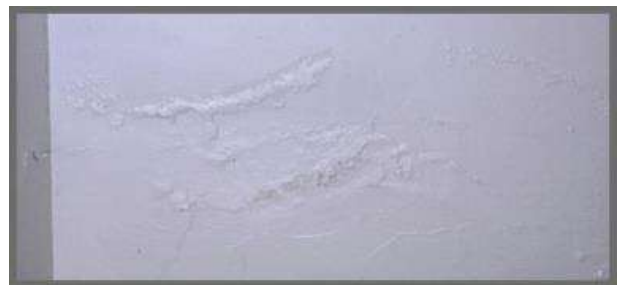
**NEEDS ATTENTION.** There are areas of moisture stains and deterioration, such as in the closet.

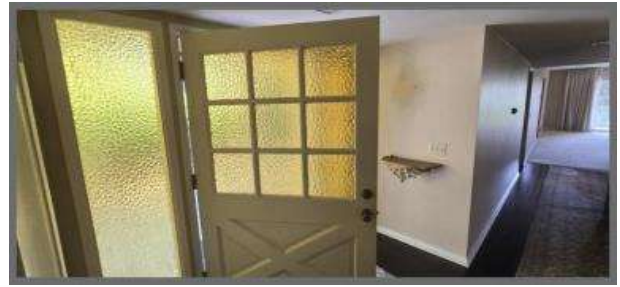
**SAFETY ALERT.** The glass in the door window(s) does not appear to be tempered or safety glass, as is recommended for safety.

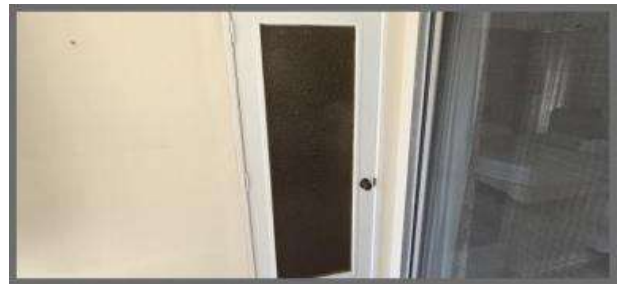
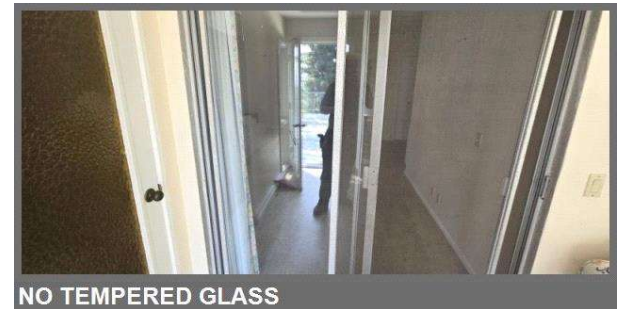
**SAFETY ALERT.** The glass doors do not seem to have tempered glass.

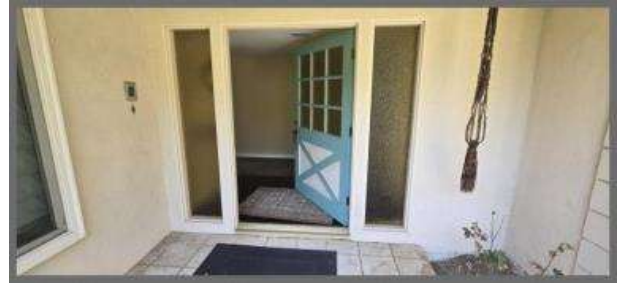
**SAFETY ALERT.** There are panes of glass that are within 18 inches of the floor. In newer construction it is required that the glass be a tempered type of safety glass. Making this older glass into safety glass by tempering or putting a safety film on it may not be a requirement for this sale but it is recommended.

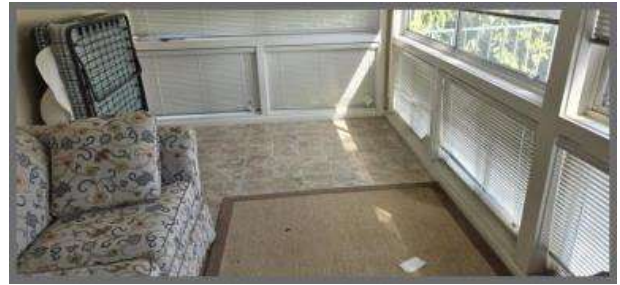
**NEEDS ATTENTION.** There is moisture staining on the window sill in some of the windows.

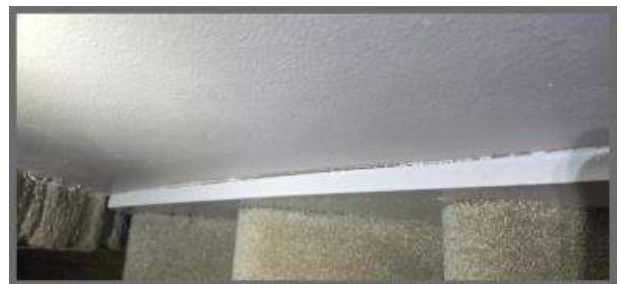
**NEEDS ATTENTION.** There are gaps between the stairs and the walls, on the stairs going to the downstairs area. Separation of material sometimes is related to moisture exposure.

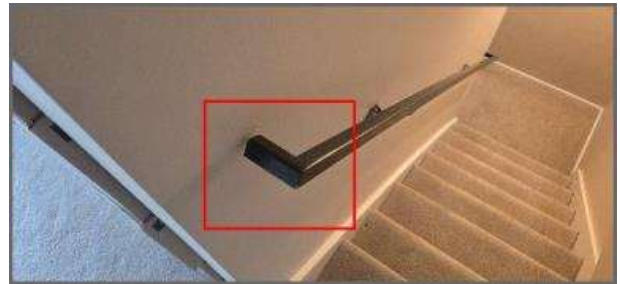
**SAFETY ALERT.** The handrail does not 'return' to the wall. The end can act as a hook to catch clothing and can be a trip and fall hazard.

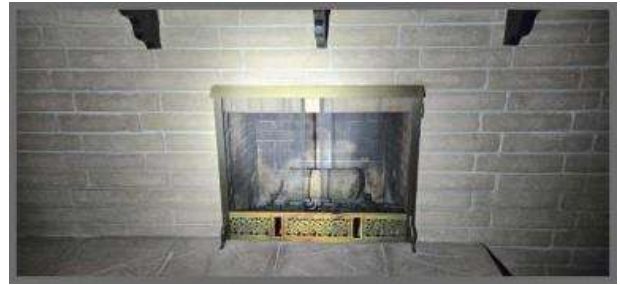
**SAFETY ALERT.** Where the gas line enters the firebox there is a gap that is not sealed, this can allow heat and fire into the wood framing behind the firebox. This gap needs to be sealed. It is typically an inexpensive repair to fill and seal this opening with approved heat rated caulk.

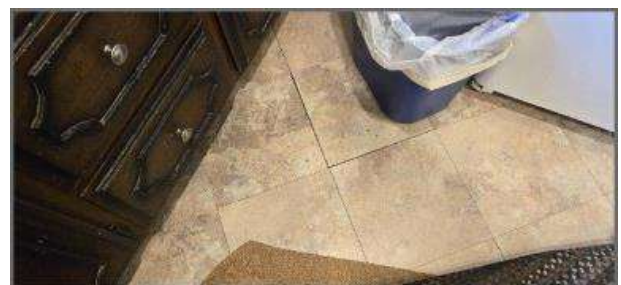
**NEEDS ATTENTION.** The kitchen linoleum flooring is worn and lifting in areas.

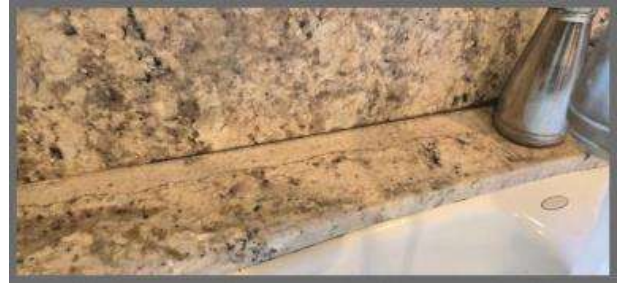
**NEEDS ATTENTION.** There are gaps in the seam where the counter meets the backsplash that should be properly repaired/maintained.

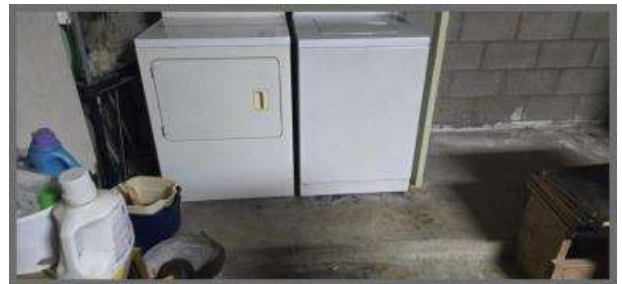
**SAFETY ALERT.** In a garage protection, such as steel posts, are recommended (and sometimes required) to separate a car from the laundry equipment. They are currently not present.

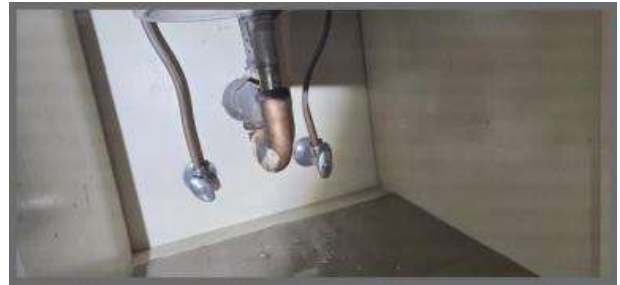
**NEEDS ATTENTION.** There is corrosion to the drain pipes.

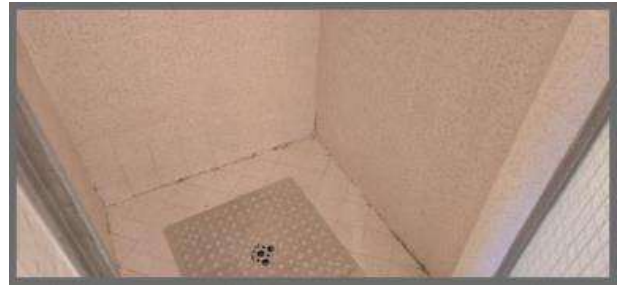
**NEEDS ATTENTION.** The shower has areas of deteriorated grout.

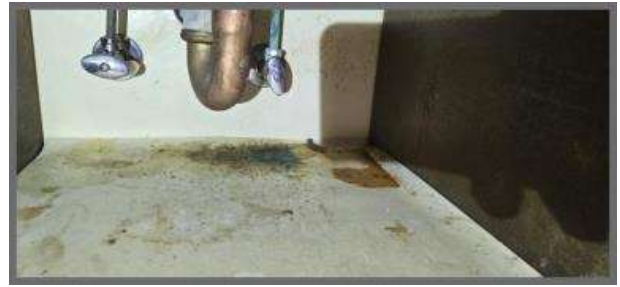
**NOT ACCEPTABLE.** There is a leak in the sink drain line.
