## Inspection Report

**Dong & Justina Nguyen**

840 Paula St  
Escondido CA 92027

**All Pro Property Inspection**

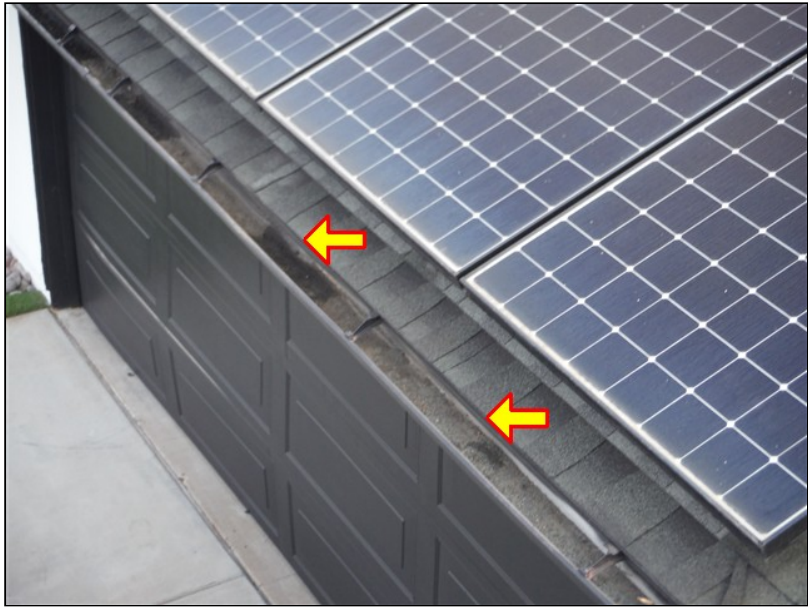
1.2 Item 4(Picture)

(3) Gutters require cleaning. We recommend having the gutters cleaned by a qualified licensed contractor.

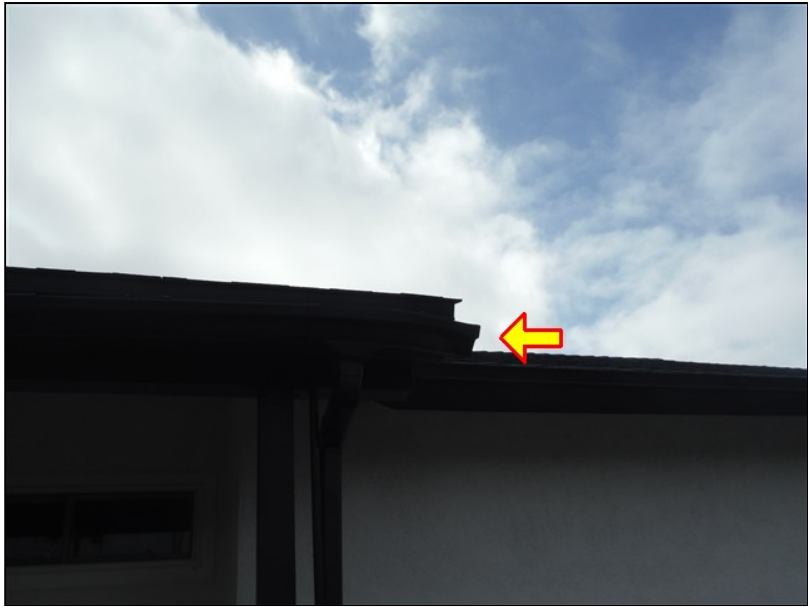
1.2 Item 5(Picture)

(4) The gutter is damaged/sagging at one or more areas. We recommend replacing this gutter by a qualified licensed contractor.

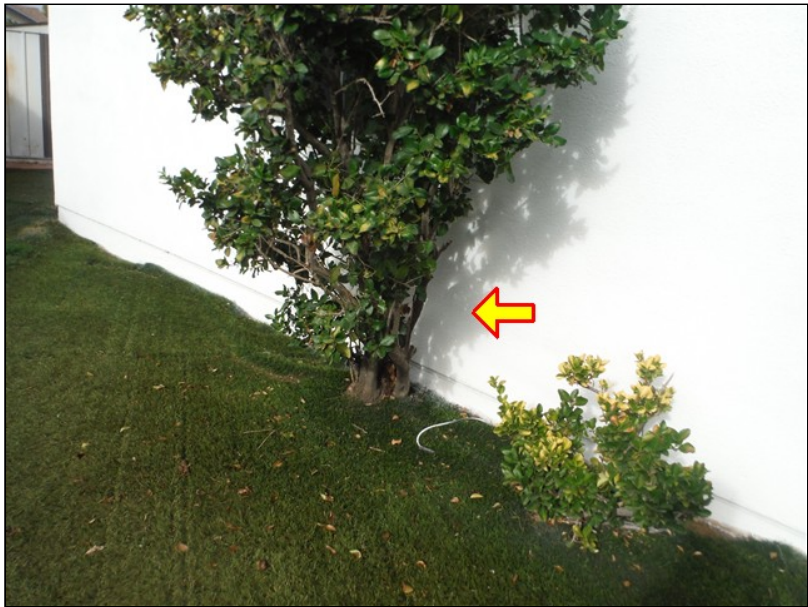
2.1 Item 1(Picture)

Tree(s) and/or large plants are located too close to the house. Tree limbs/vegetation that are too close to the house can cause damage in several ways. Limbs or vines in contact with roof or hanging near roof should be trimmed to prevent damage to roof and/or to prevent rodent infestation. Also, as the plants grow, damage can occur to the siding, concrete flat work and to the foundation. We recommend having the foliage removed or trimmed by a qualified professional to prevent damage to the house as soon as possible.

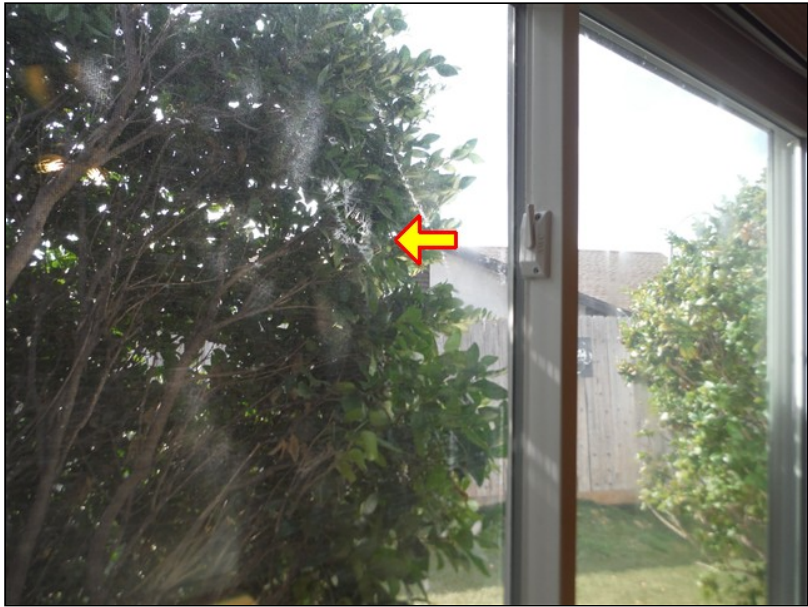
2.6 Item 3(Picture)

(2) There are several damaged window screens throughout the house. We recommend repair or replace as needed by a qualified person.

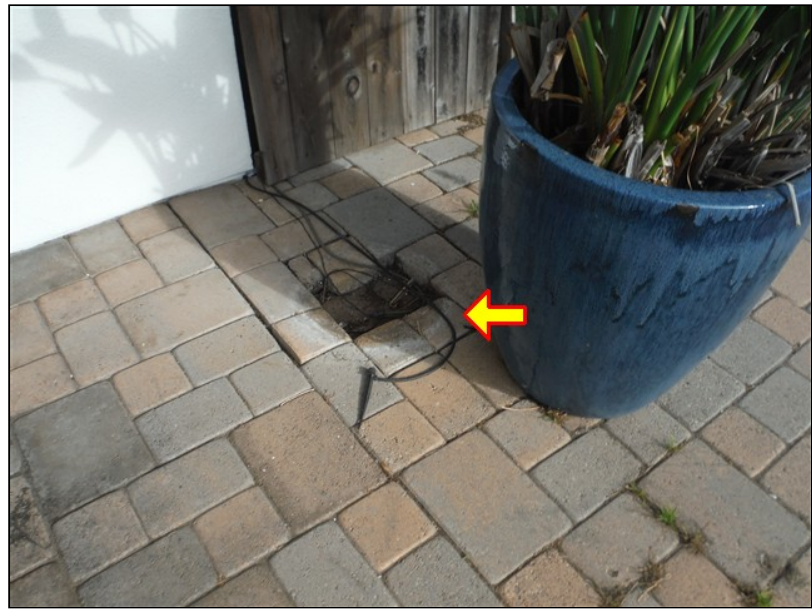
2.8 Item 3(Picture)

(2) A tripping hazard exists at the patio where pavers are missing. We recommend necessary repairs by a qualified licensed contractor to avoid injuries.

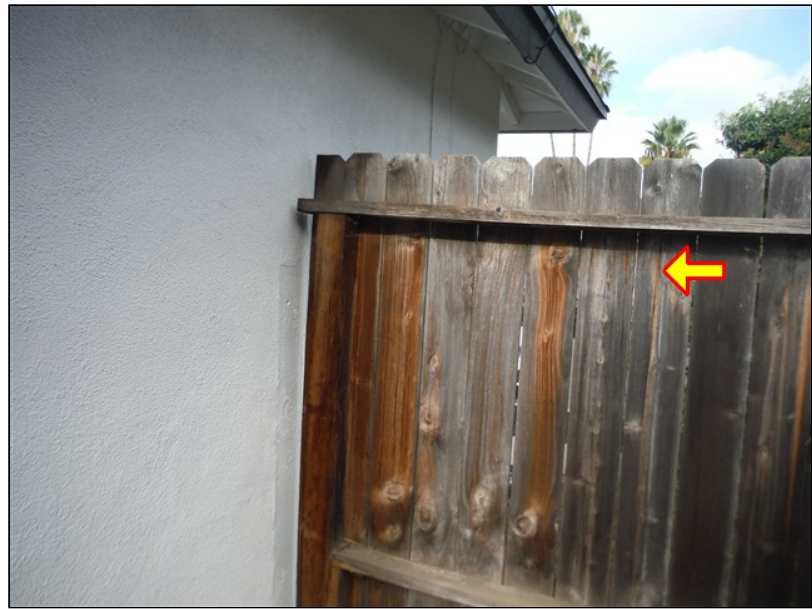
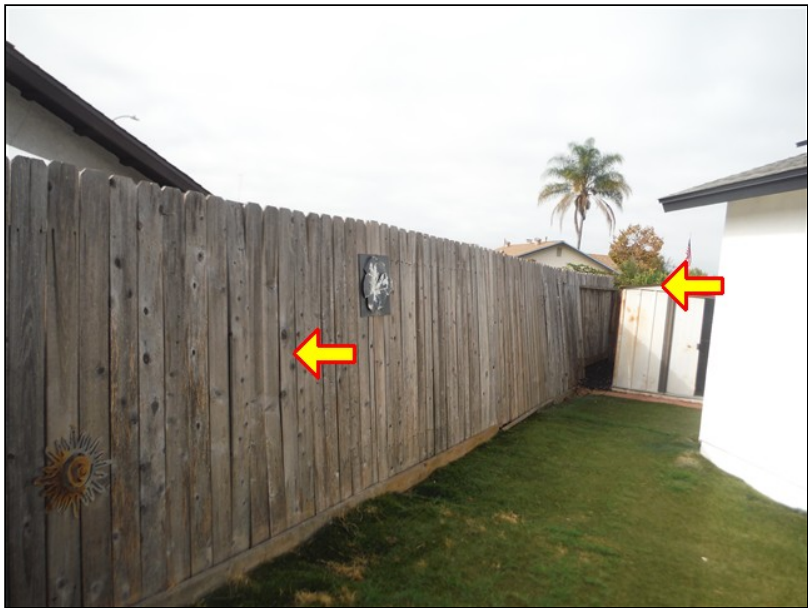
2.9 Item 1(Picture)

The fence is loose, leaning and deteriorated in several areas. We recommend necessary repairs or replacing as needed by a qualified licensed fence contractor.

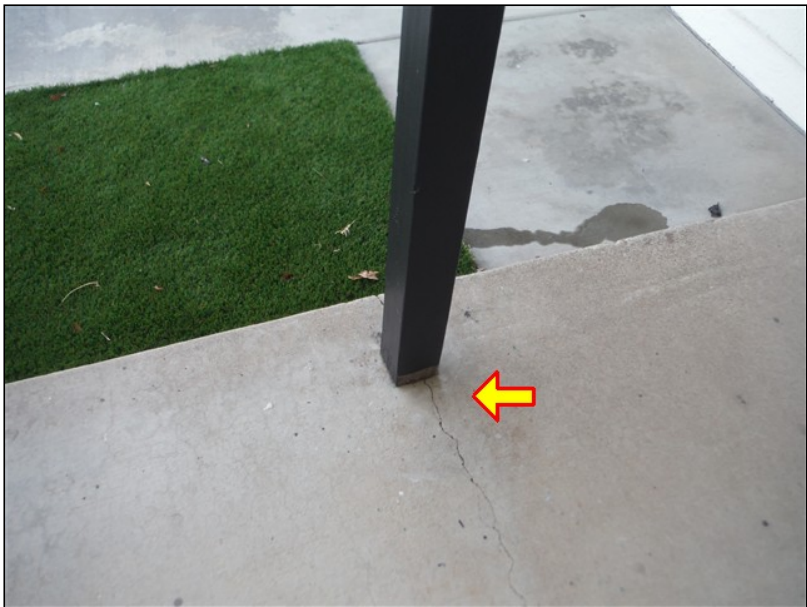
2.11 Item 1(Picture)

(1) Posts in contact with the concrete patio at the front of the house. Posts should be elevated off the ground on a footing/strap system to prevent moisture damage. We recommend corrections by a deck contractor as needed.

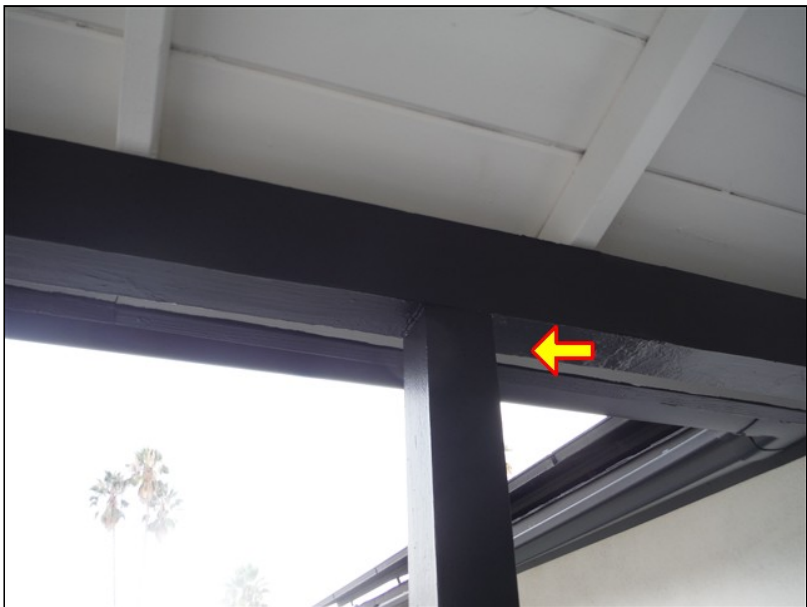
2.11 Item 2(Picture)

(2) The wood posts are not strapped to the beams. We recommend having the posts strapped for stability and seismic resilience. We recommend necessary repairs by a qualified licensed deck contractor.

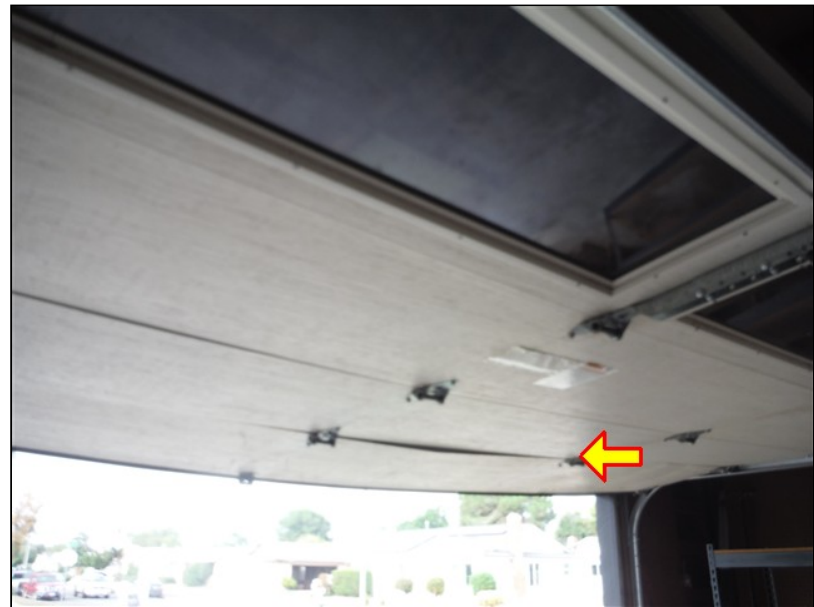
3.0 Item 1(Picture)

**Findings**  
The garage vehicle door is dented/damaged. Over time, dents/damage may become larger or develop cracks due to the bending of the metal panels. We recommend necessary repairs by a qualified licensed garage door contractor

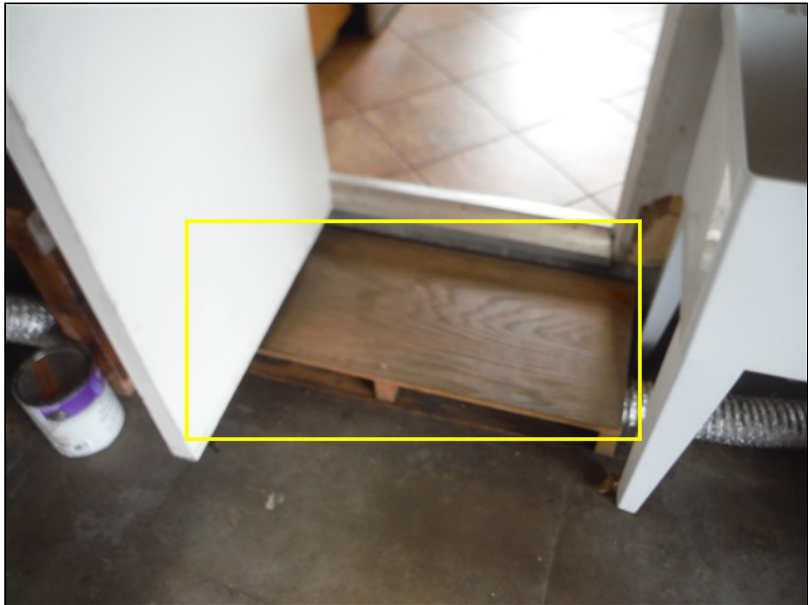
3.6 Item 1(Picture)

(1) The garage fire door to the house swings toward the garage, which has a lower floor level. Current building standards would require that a 36 inch landing no more than 1 inch lower than the threshold be installed so that the door does not swing over a lower floor level. This may have been acceptable at the time of construction and therefore the requirement is unknown. Recommend installing a proper landing by a qualified licensed contractor as an upgrade for safety.

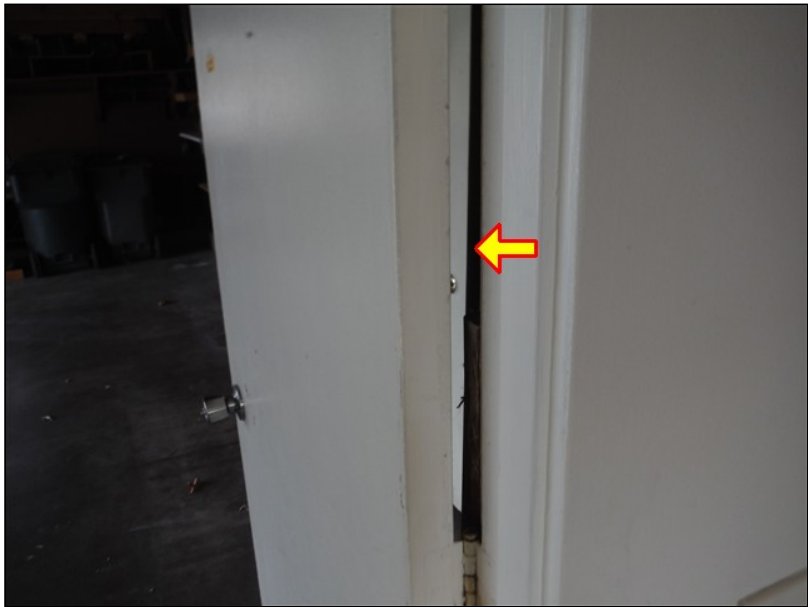
3.6 Item 2(Picture)

(2) The door between the house and garage did not have a Fire Rating Certificate or Plate. Without a plate, I could not confirm whether the door meets fire code safety requirements. We recommend further evaluation by a licensed door contractor. The "fire door" is required to meet one of the following characteristics:1-3/8 inch thick solid wood, 1-3/8 inch thick steel shell door with Honeycomb core, Fire-rated (with certificate plate). If the door is not rated as a fire door we recommend replacing by a qualified licensed door contractor for safety.

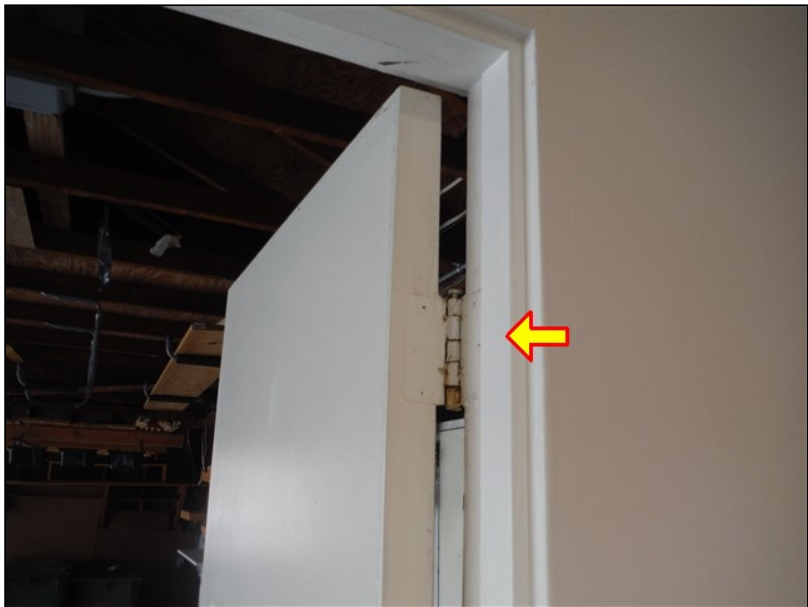
3.7 Item 1(Picture)

The required auto-closing hinge was not installed and requires installation at the door to the garage. We recommend installing an auto-closing hinge by a qualified licensed door contractor.

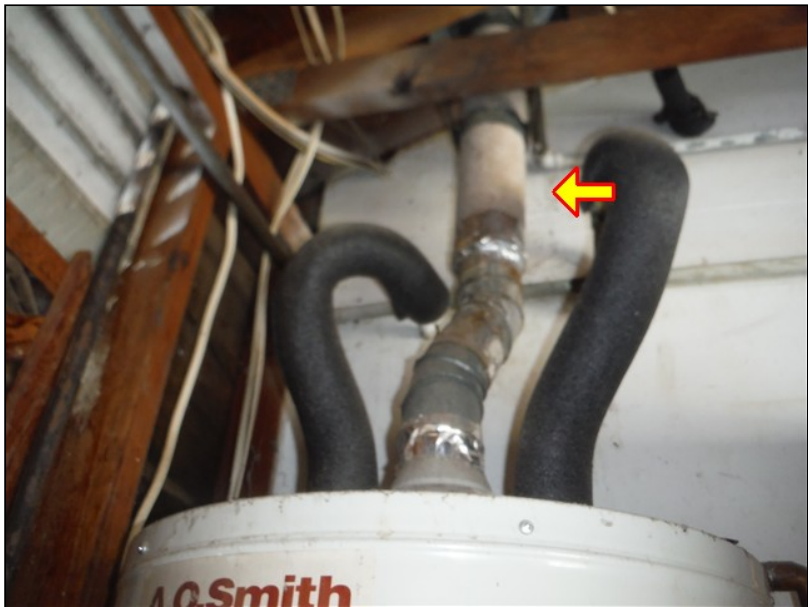
4.1 Item 1(Picture)

asbestos is through lab testing. It is beyond the scope of a home inspection to test for the presence or absence of asbestos. We recommend replacing this section of the water heater flue by a qualified licensed plumber.

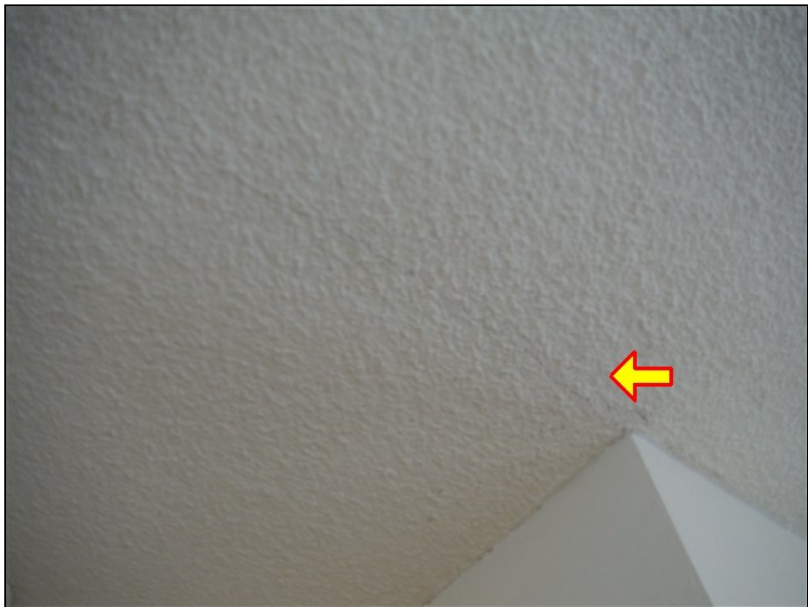
5.1 Item 1(Picture)

(1) Hairline cracking was observed at the ceiling at several locations in the house. These hairline cracks are likely due to material shrinkage or settlement of the structure. We recommend prep and paint by a qualified licensed contractor.

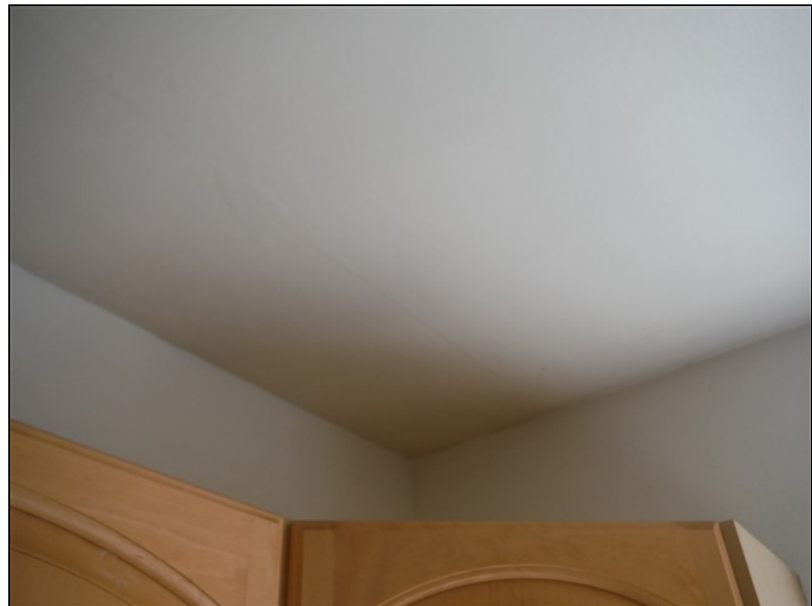
5.1 Item 3(Picture)

(2) The ceiling has typical cosmetic wear in areas. We recommend prep and paint by a qualified person.

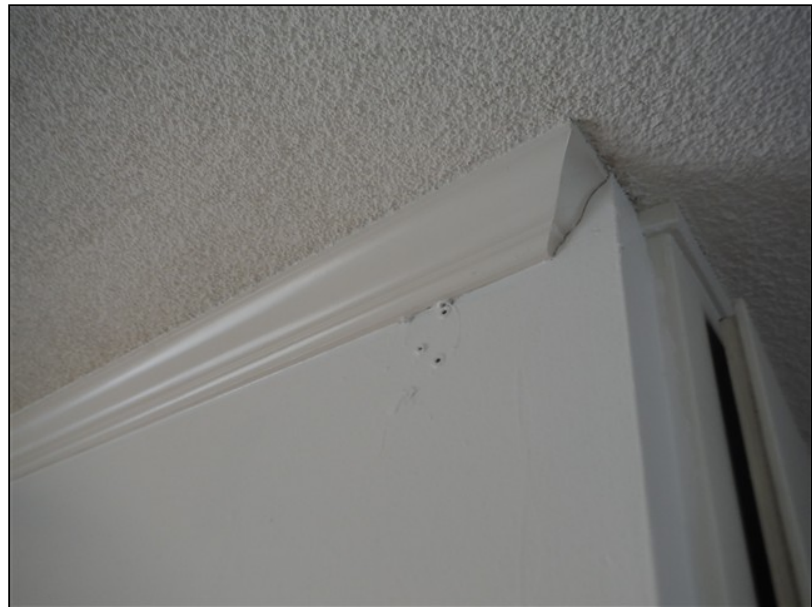
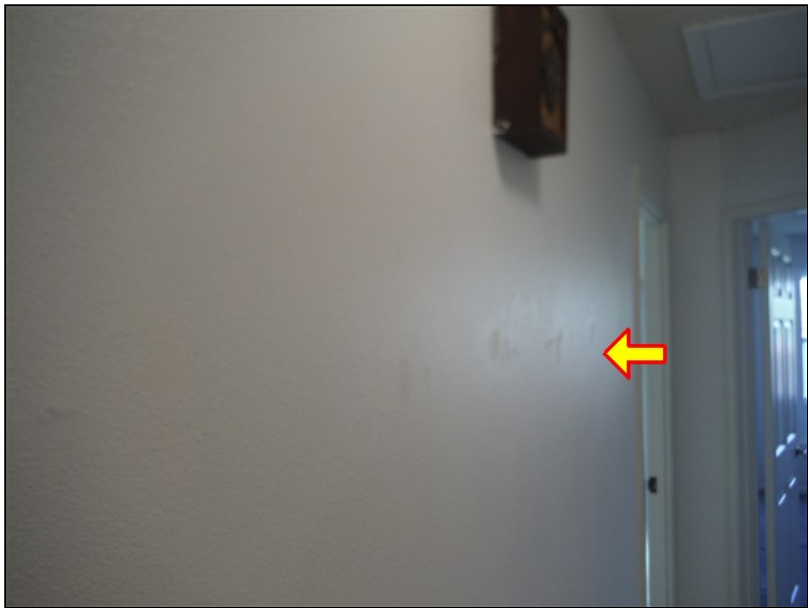
5.2 Item 1(Picture)

(1) The walls have cosmetic damage in several locations. We recommend prep and paint and/or repairs as needed by a qualified licensed drywall contractor.

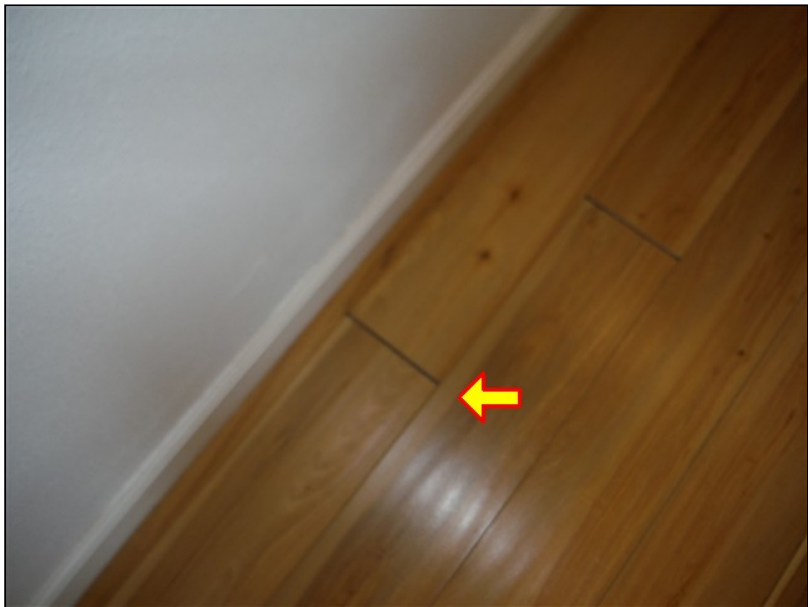
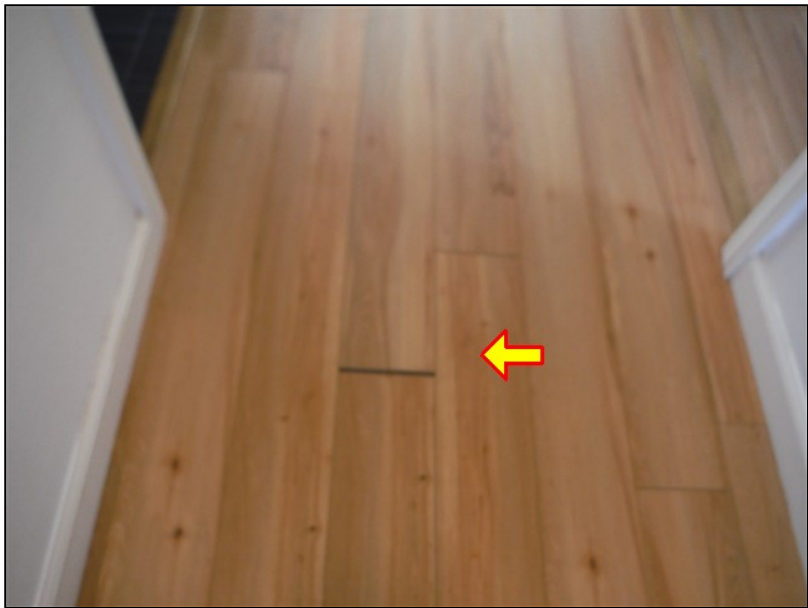
5.3 Item 1(Picture)

(1) Gaps noted in the flooring in several areas. Unworkmanlike finish in these areas. We recommend repairs or replacement by a qualified licensed flooring contractor.

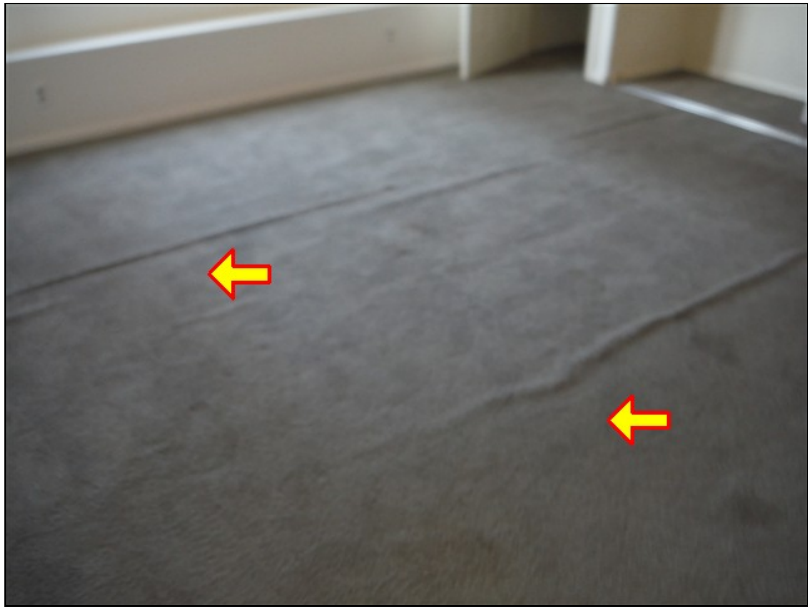
5.3 Item 3(Picture)

(2) The carpet in areas of the house is loose, which could be a tripping hazard and lead to premature wear. We recommend having the carpet stretched by a qualified licensed floor contractor.

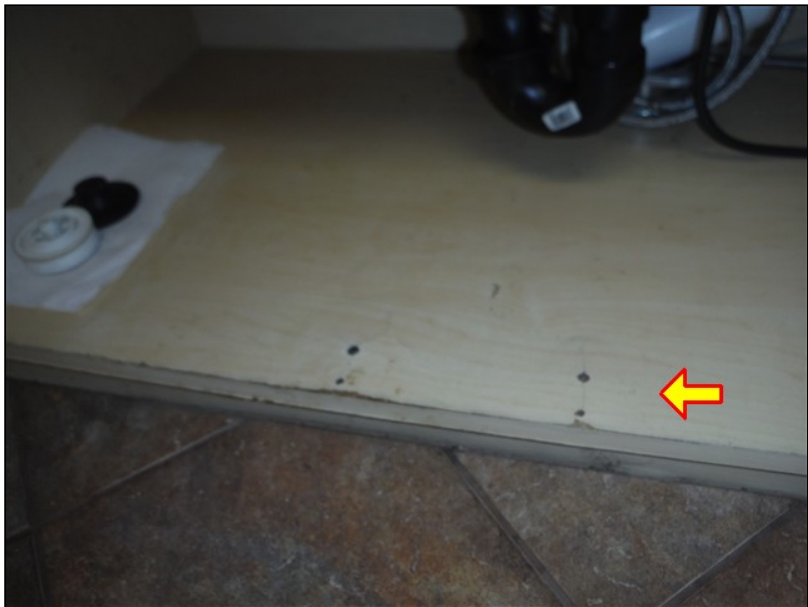
5.4 Item 3(Picture)

(2) The bottom shelf in the cabinet below the kitchen sink is stained, bowed/ damaged. This area was tested for moisture and was found to be dry at the time of inspection. We recommend necessary repairs or replacement by a qualified licensed contractor.

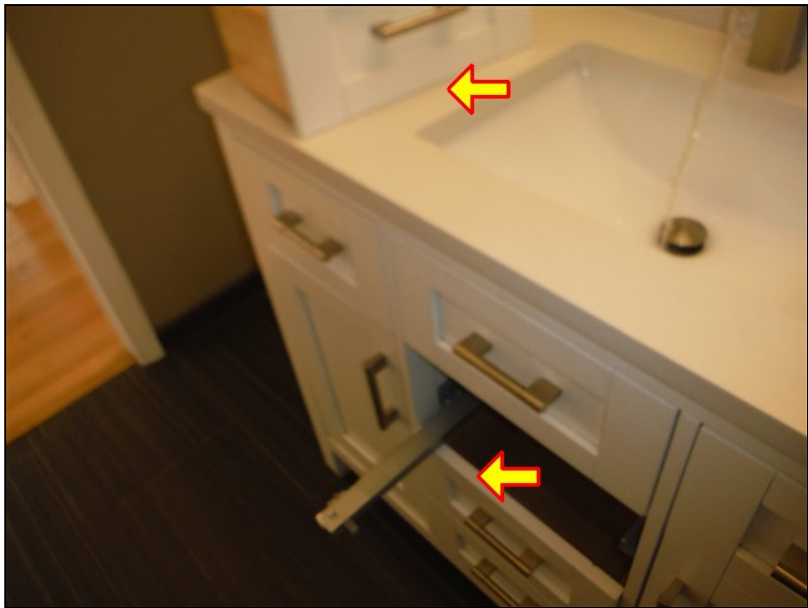
5.4 Item 4(Picture)

(3) Damage/loose drawer guides are noted at the bathroom cabinet drawers. We recommend necessary corrections by a qualified person.

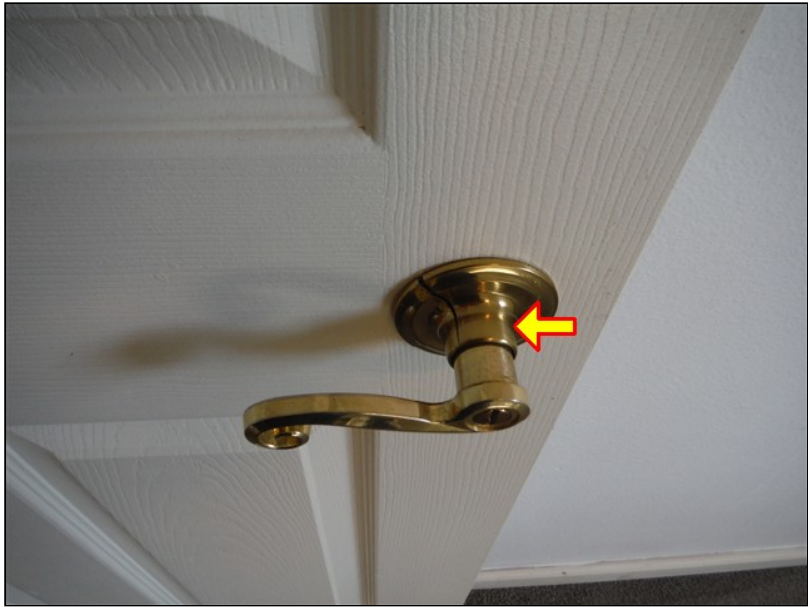
5.5 Item 1(Picture)

(1) The door latching hardware is damaged at one or more areas. We recommend service or replacement by a qualified person.

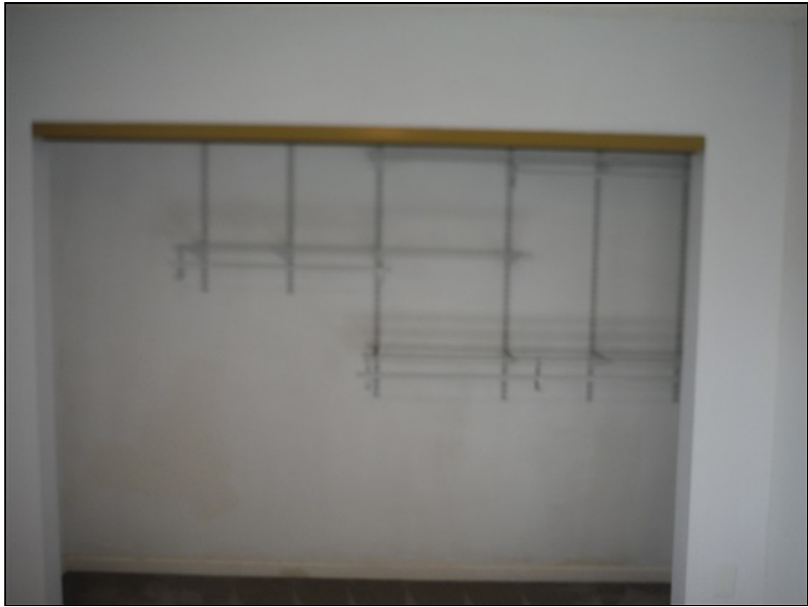
5.5 Item 2(Picture)

(2) There are interior doors that are missing at one or more areas throughout the house. We recommend replacing where needed by a qualified person.

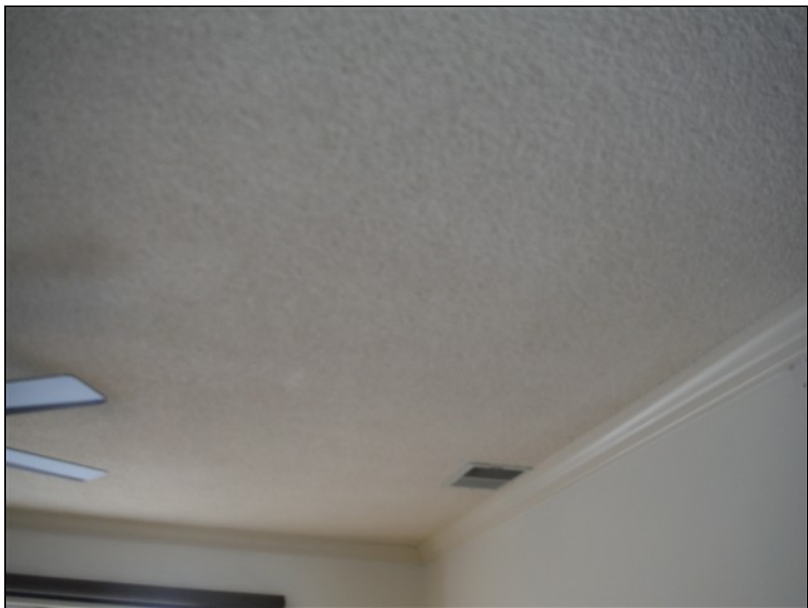
5.8 Item 1(Picture)

(1) There is acoustic texture present at the ceiling. Some of this acoustic texture installed before the 1980's has been known to contain asbestos. It is beyond the scope of this general home inspection for us to test for asbestos. The only way to confirm the presence or absence of asbestos is by having it tested by a qualified person. We recommend having the acoustic texture tested by a qualified person if concerned.

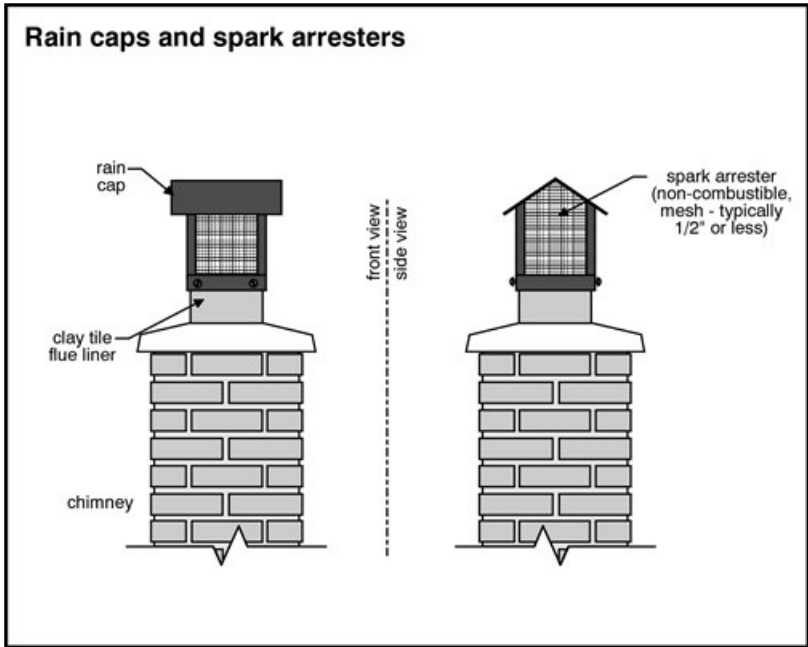
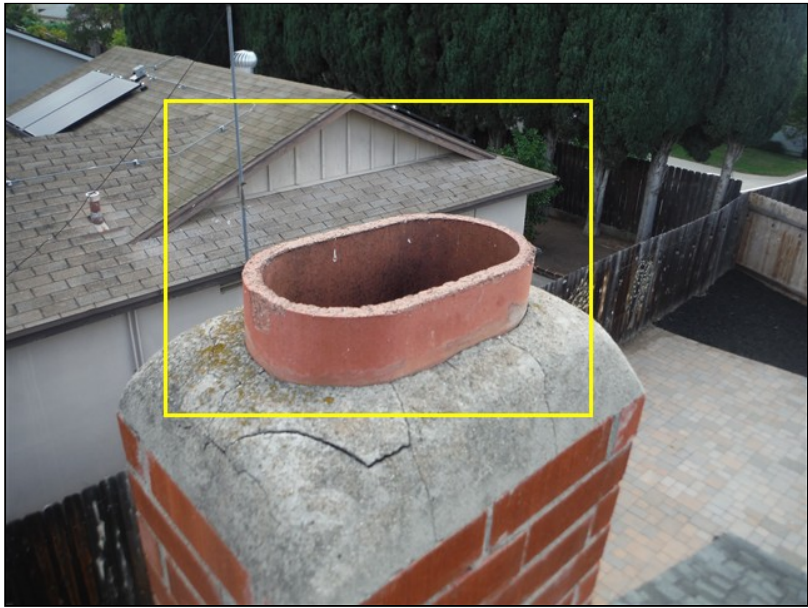
6.0 Item 1(Picture)

**Findings**  
(1) A spark arrester/ rain cap is not present/ installed. This may have been acceptable at the time of construction. Spark arresters prevent cinders from falling onto the roof which is a fire hazard. The rain cap prevents water from entering the chimney flue to help prevent deterioration. We recommend having a spark arrester/ rain cap installed by a qualified person.

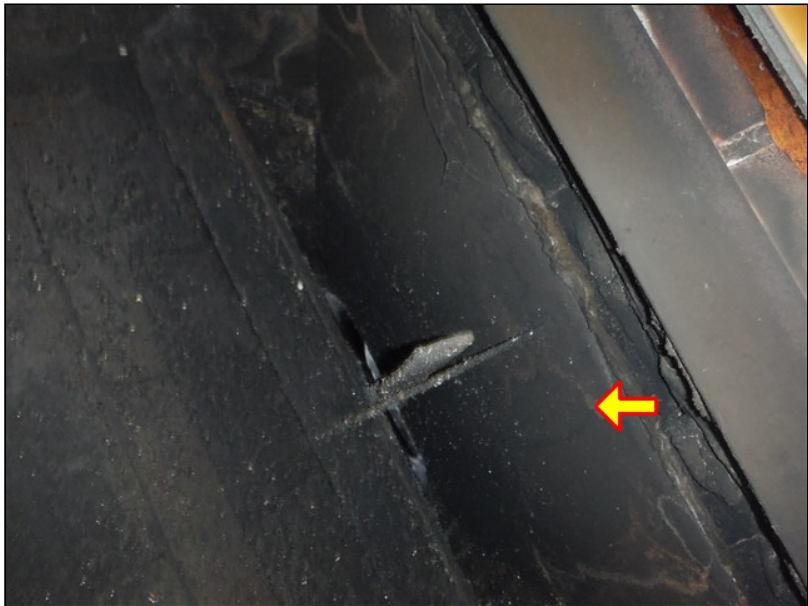
6.0 Item 5(Picture)

(4) Excessive soot and/or creosote was present at the interior of the chimney. This is considered a fire hazard because the creosote is a tar-like material that can burn. The presence of soot/creosote can also conceal defects and prevents a visual inspection of the flue. We recommend having the chimney cleaned and inspected by a qualified licensed chimney sweep for safety due to the presence of soot/creosote.

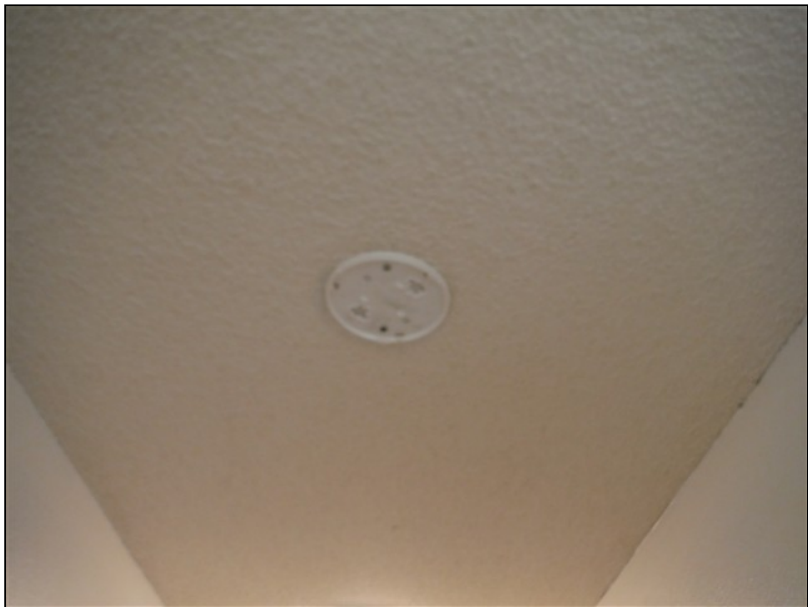
7.0 Item 1(Picture)

(1) There are several smoke detectors missing where required. We recommend installing additional smoke detectors where needed to comply with current fire and safety standards and regulations.

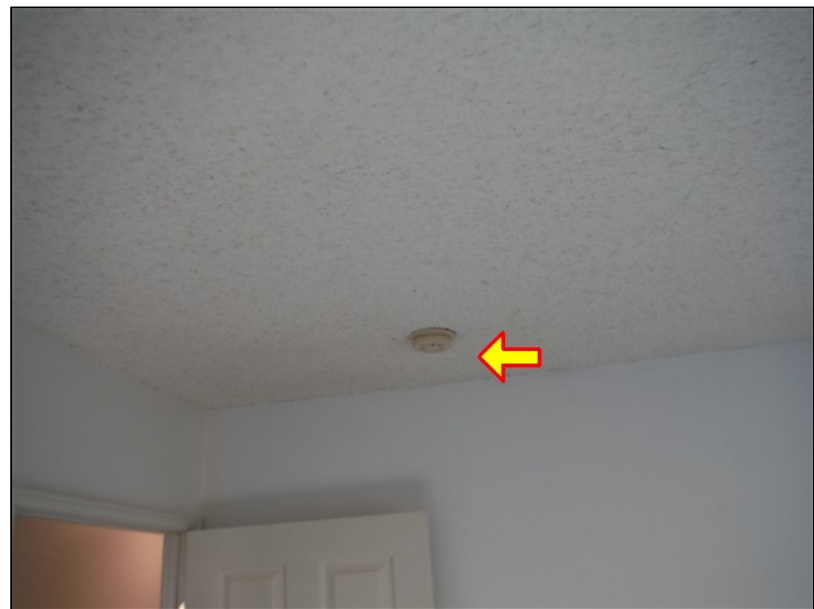
7.0 Item 3(Picture)

(2) One or more of the smoke detectors in the house are older models. Studies show that detectors that are more than 10 years old have a high rate of failure. Many old detectors do not have battery back-up, and will not work if the electricity is off. New requirements for smoke detectors are the sealed 10 year battery life smoke detectors. We recommend that all old detectors be replaced prior to occupancy of the house for safety.

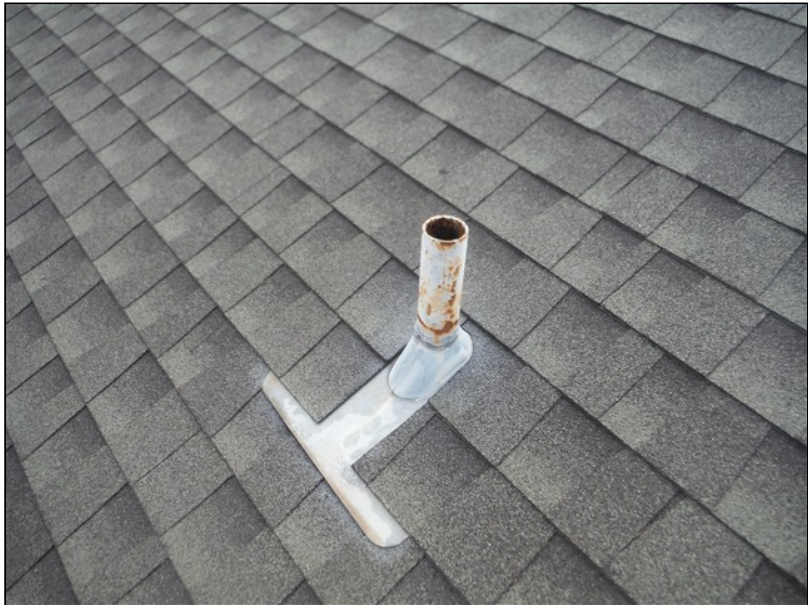
8.0 Item 3(Picture)

(2) Some of the original drain, waste and vent system has been replaced with ABS plastic piping and some of the original cast iron piping is still present. Cast iron lines typically have a life span of about 50-60 years. Due to this fact, we highly recommend that you have the entire waste piping system evaluated by a qualified licensed plumber, **to include a video scope of the main sewer line, prior to the end of your contingency period.**

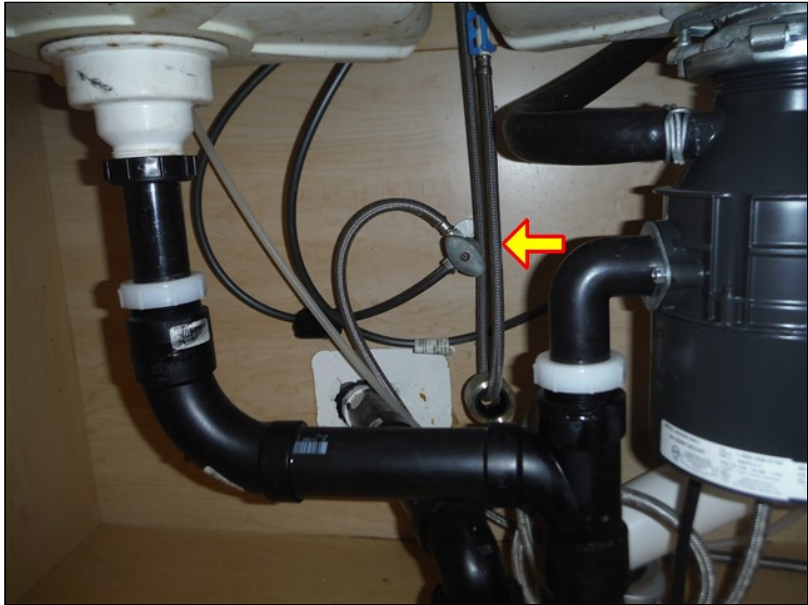
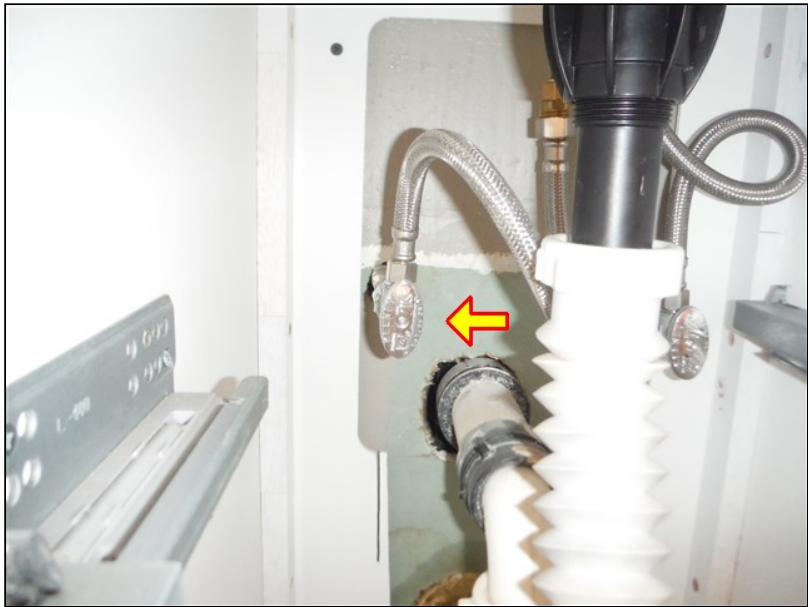
8.2 Item 1(Picture)

(1) Several of the angle stop valves are an older style gate valve. These gate valves can become "seized" due to lack of regular use and/ or calcium build up. We recommend replacing these older style gate valves with ball type water shut off angle stop valves by a qualified licensed plumber.

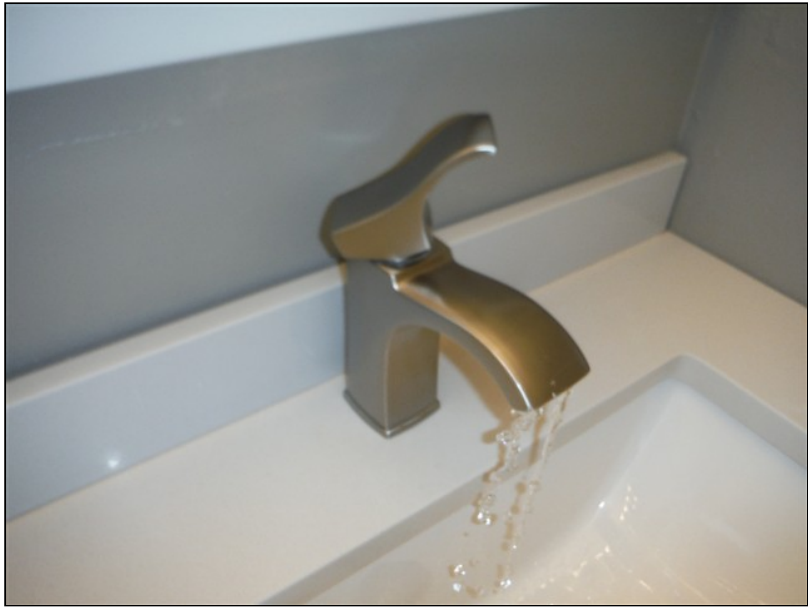
8.2 Item 3(Picture)

(2) The bathroom faucet is loose. We recommend necessary repairs or replacement by a qualified licensed plumber.

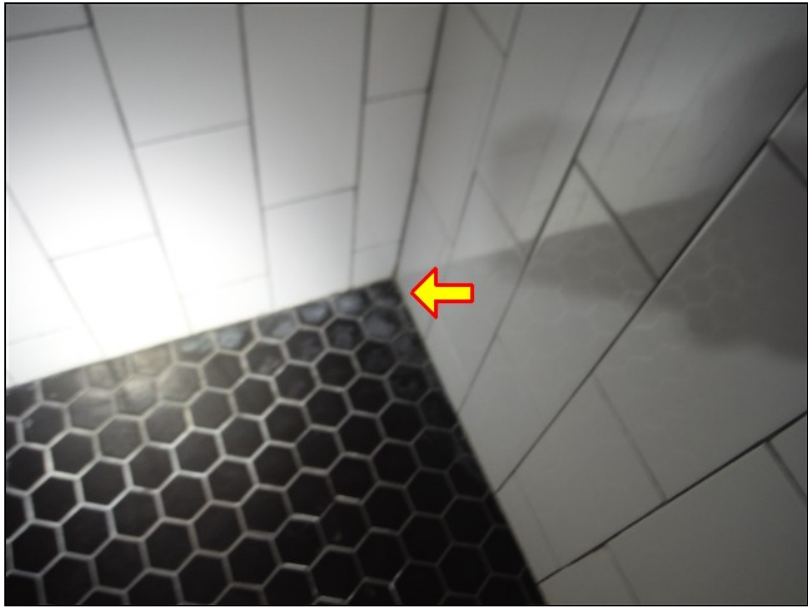
8.3 Item 1(Picture)

(1) Mildew is noted in the sealant at one or more showers. We recommend removing the existing caulking and replacing by a qualified person.

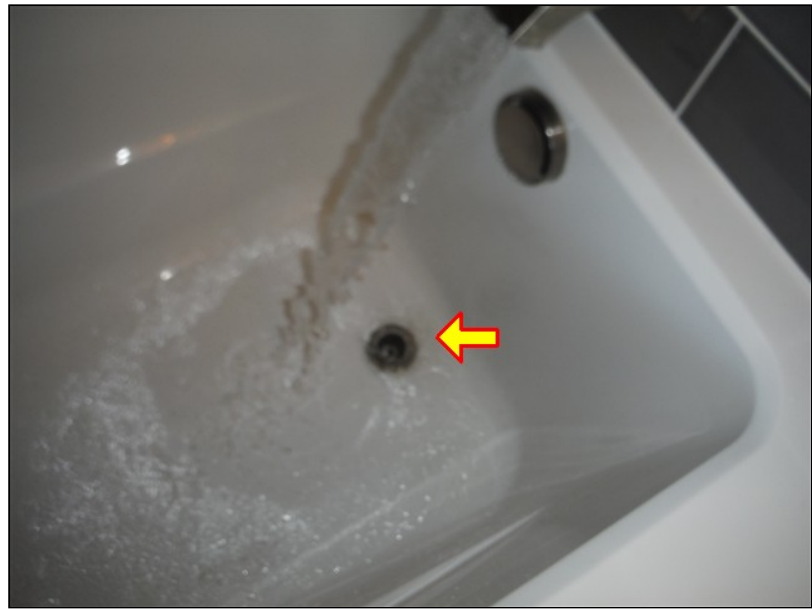
8.3 Item 2(Picture)

(2) The bathroom tub stopper is missing. We recommend replacement by a qualified person.

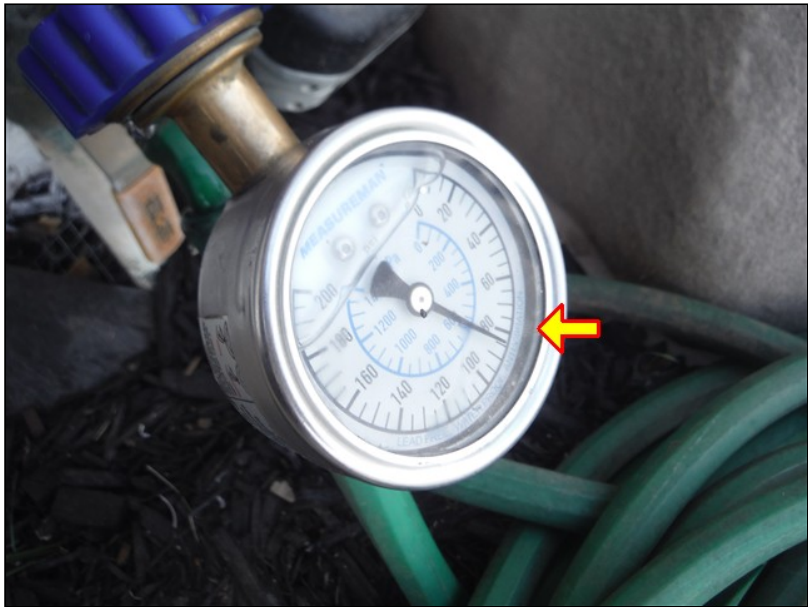
8.5 Item 1(Picture)

The water pressure was checked with a water pressure gauge and was measured to be higher than 80 PSI at the time of the inspection. This is to high and corrections are needed. We recommend further evaluation by a qualified licensed plumber for necessary repairs or corrections.

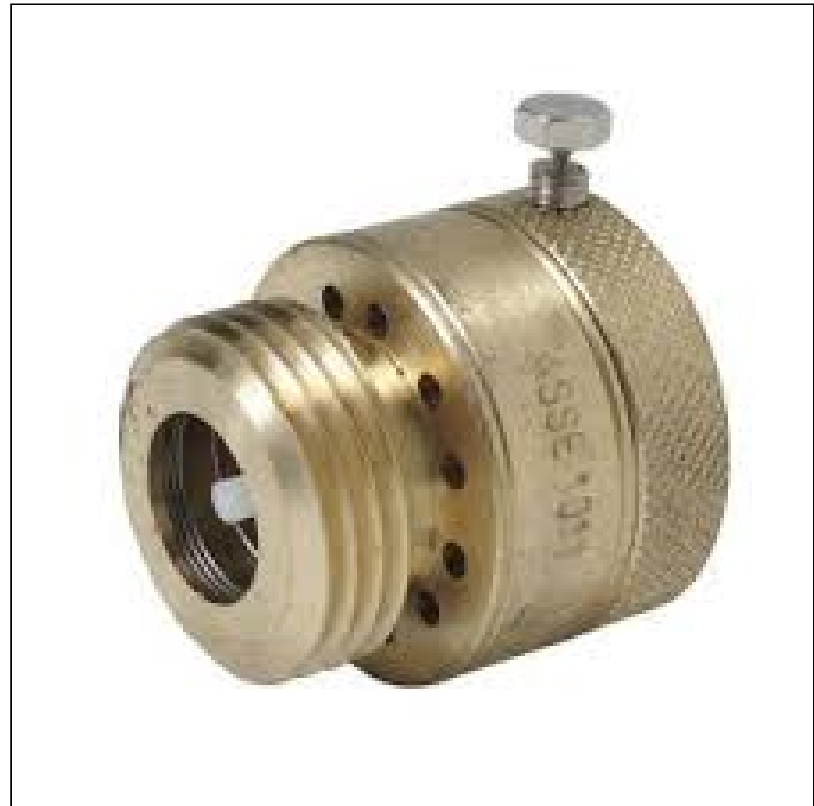
8.6 Item 1(Picture)

(1) The exterior hose spigots do not have anti-siphon or anti-backflow devices installed on them. Theses anti-siphon or anti-backflow devices help prevent contaminated water from flowing back into the the house water supply system. We recommend installing anti-siphon or anti-backflow devices at the every exterior hose spigots by a qualified person.

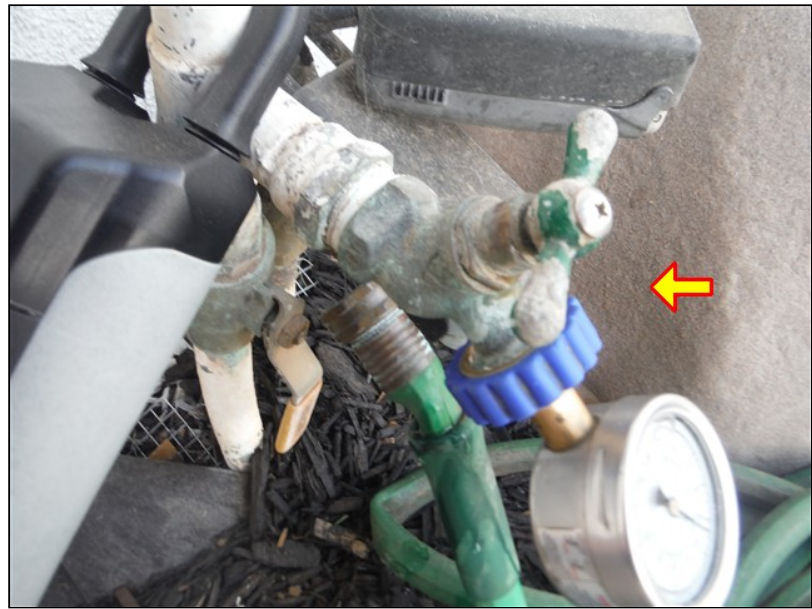
8.6 Item 2(Picture)

(2) One or more hose spigot handles leaked when turned on. We recommend necessary repairs or replacement by a qualified licensed plumber.

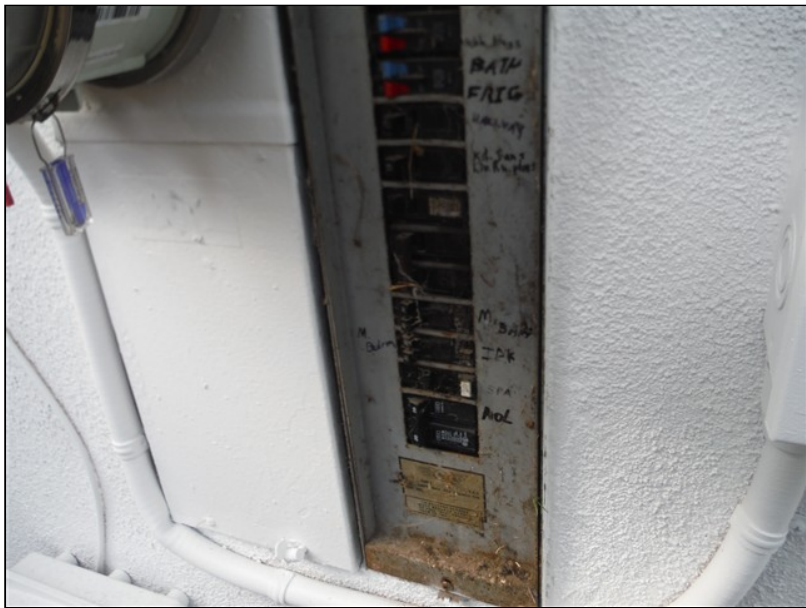
9.0 Item 1(Picture)

(1) There is no space provided for addition breakers in the main panel. I could not inspect the condition of the buss bars. We advise consulting with a qualified licensed electrician if expansion is needed.
