## Inspection Report

**Dong & Justina Nguyen**

840 Paula St  
Escondido CA 92027

**All Pro Property Inspection**

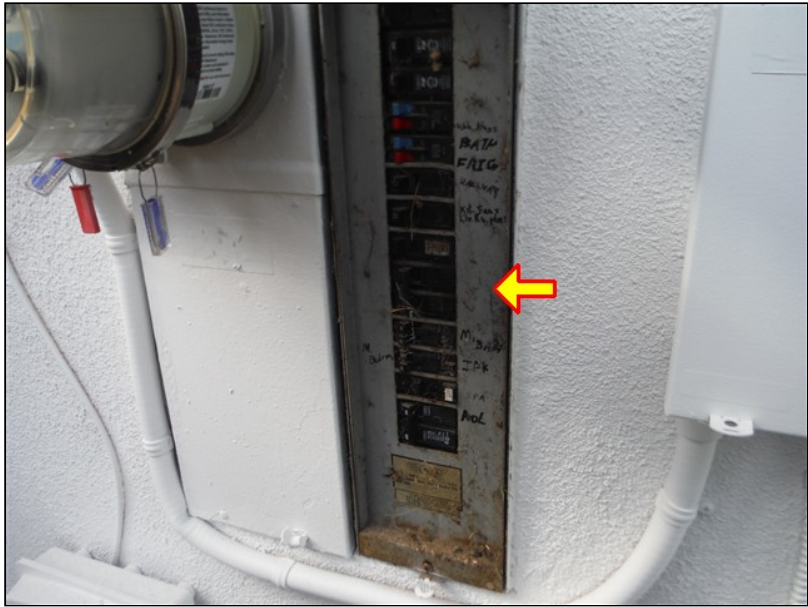
9.0 Item 2(Picture)

(2) The main panel breaker labels are illegible and/or confusing. We recommend having the breakers properly labeled for safety by a qualified person.

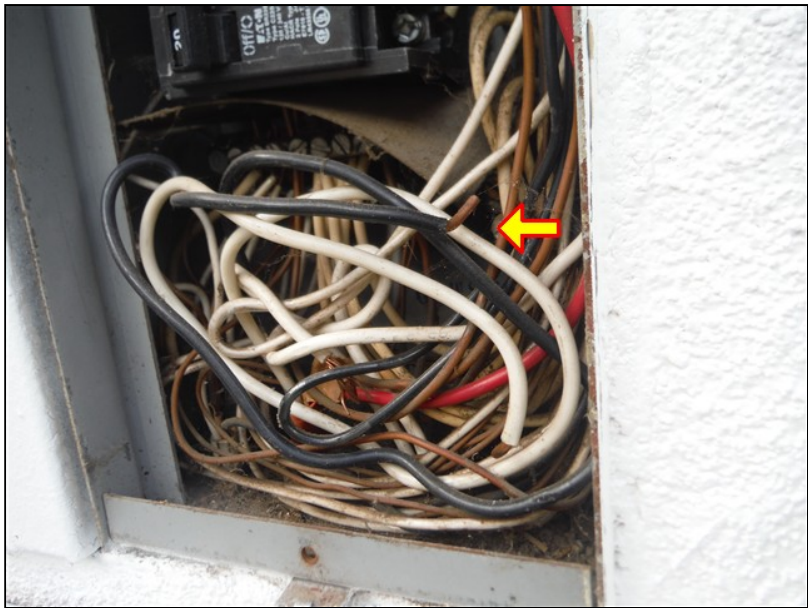
9.0 Item 3(Picture)

(3) There are improperly terminated wires observed in the main electrical panel. These wires must be properly terminated for safety. We recommend necessary corrections by a qualified licensed electrician.

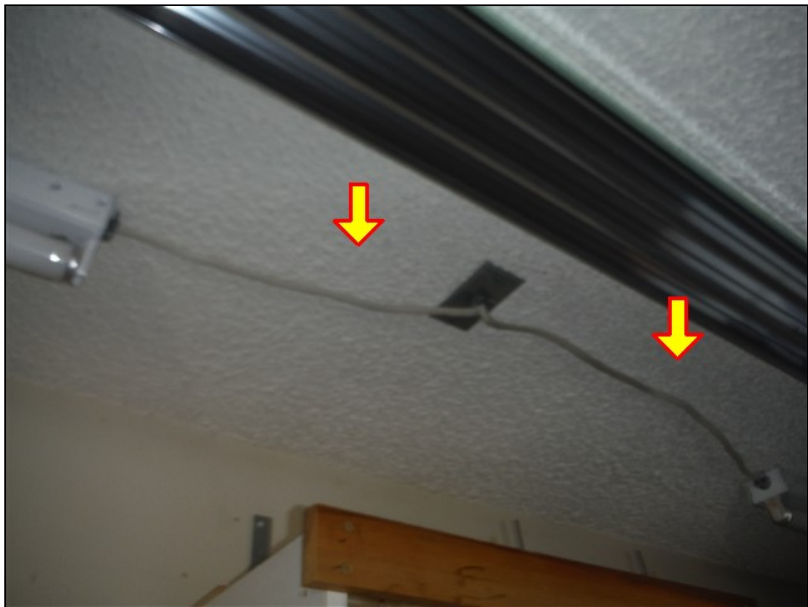
9.1 Item 1(Picture)

concern if used where it could be subject to physical damage. Romex wires are normally used in attics, inside walls, or inside conduit. We recommend necessary corrections by a qualified licensed electrician for safety.

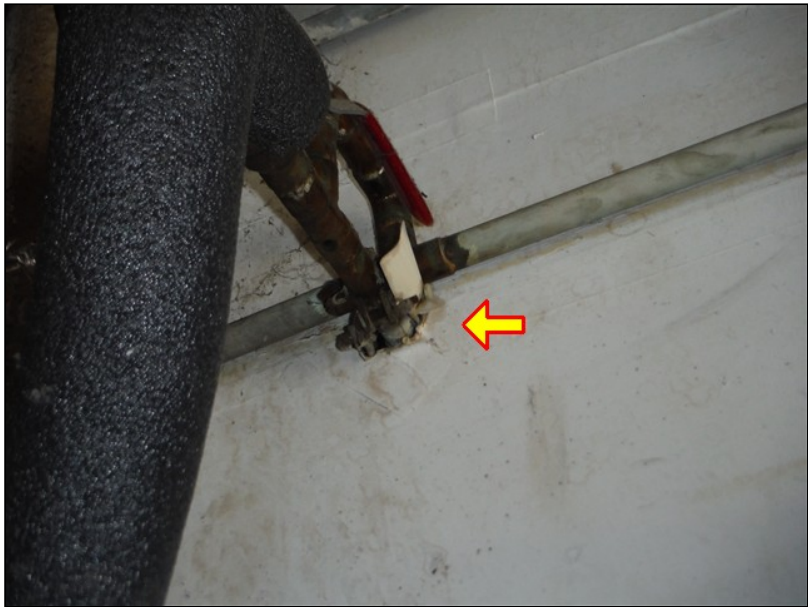
9.3 Item 1(Picture)

**Findings**  
Portions of the electrical system appears to be grounded through the plumbing system only which was standard at the time of construction. Newer homes have a separate ground rod which improves grounding. We recommend having a ground rod and wire installed by a qualified licensed electrician to improve grounding and safety.

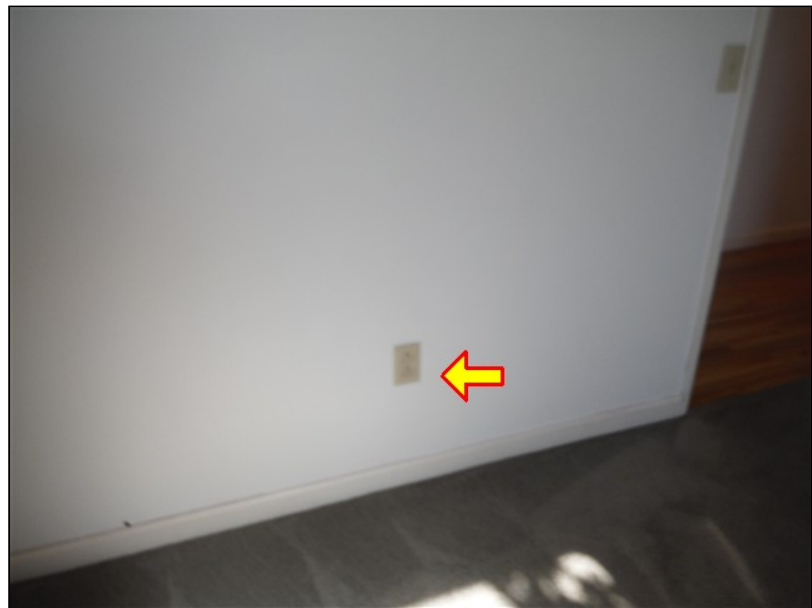
9.4 Item 1(Picture)

Some of the receptacles throughout the house are worn due to use and age. We recommend upgrading receptacles as needed by a qualified licensed electrician.

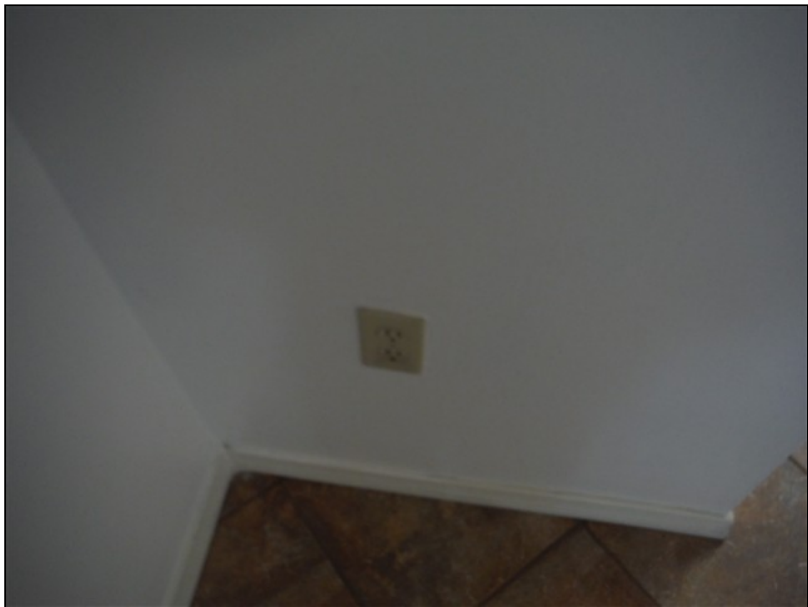
9.8 Item 3(Picture)

(2) Several junction boxes are loose in the wall. This condition could put stress on the conductors which can lead to loose connections. We recommend having these junction boxes secured by a qualified person.

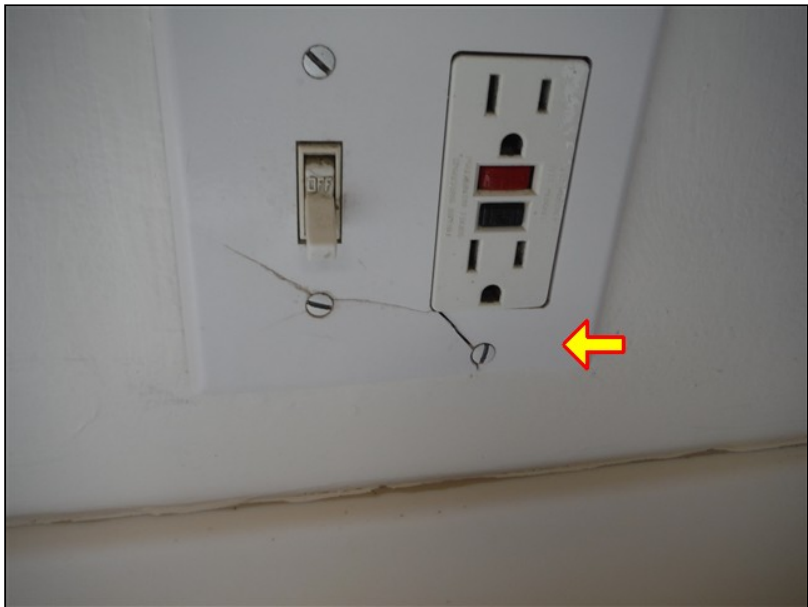
9.8 Item 5(Picture)

(3) There are one or more receptacle/switch covers that are damaged. This is a potential shock hazard. We recommend replacing damaged covers by a qualified person where needed for safety.
