September 17, 2020

Seaview HOA

SB326 Report

May 30, 2020

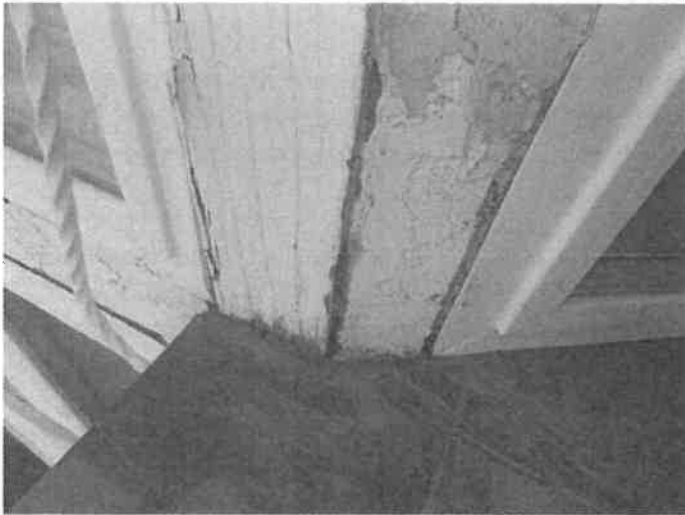
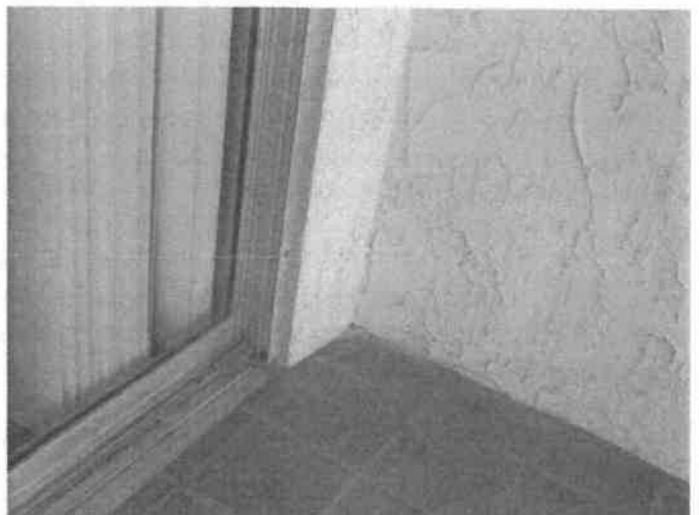
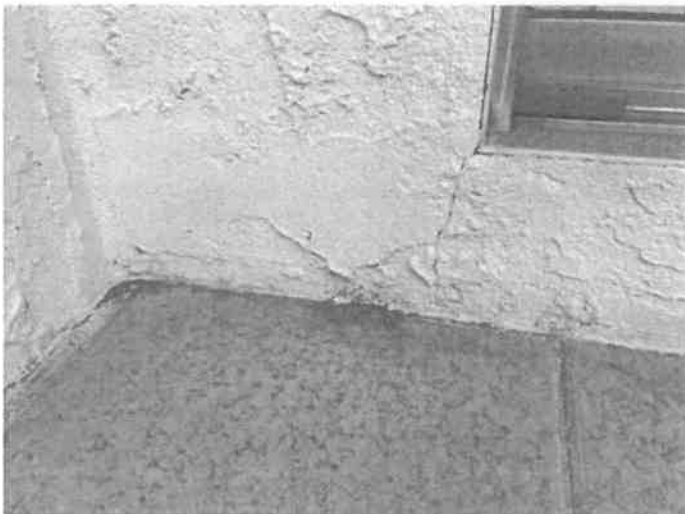
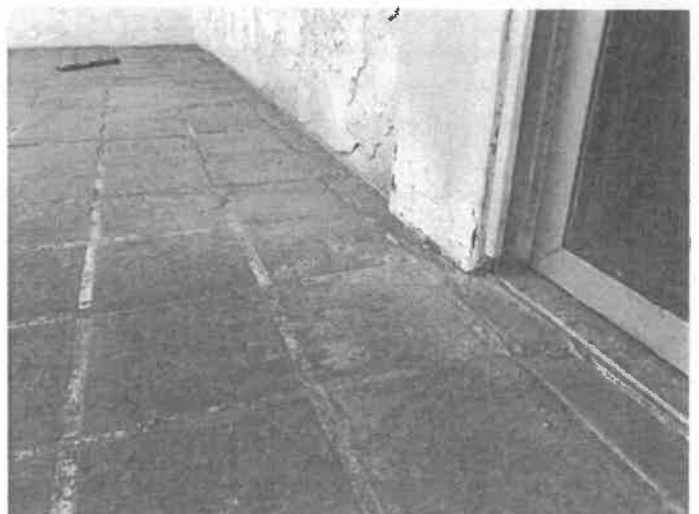
Stucco Weep Screed Missing and/or Buried

A7 observed that the stucco weep screed was either never installed, or is buried beneath the tile finish at the majority of balconies at the Seaview HOA. This condition was observed at 120/121 balconies (99%).

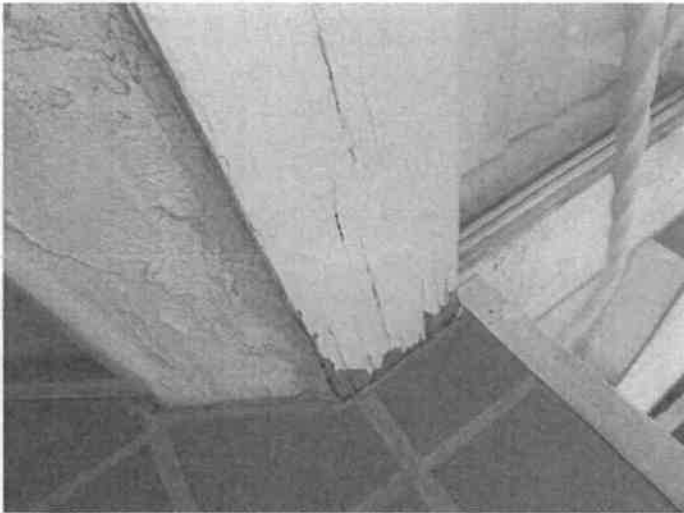
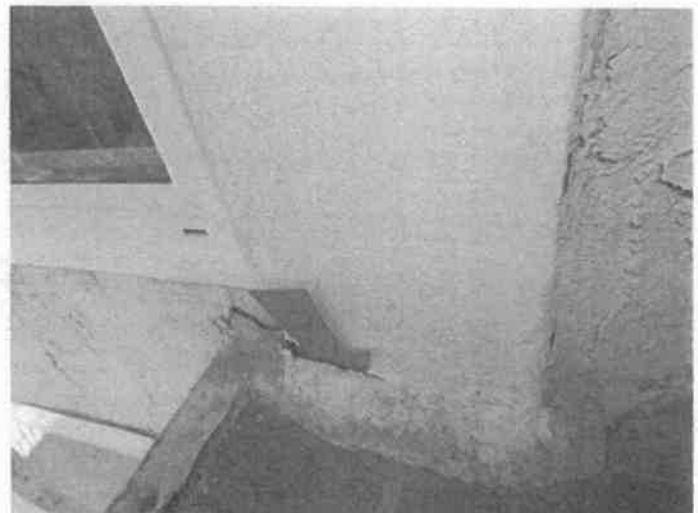
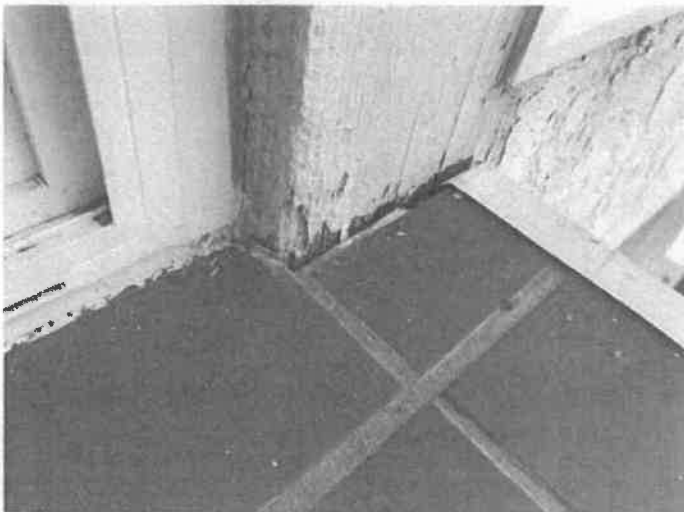
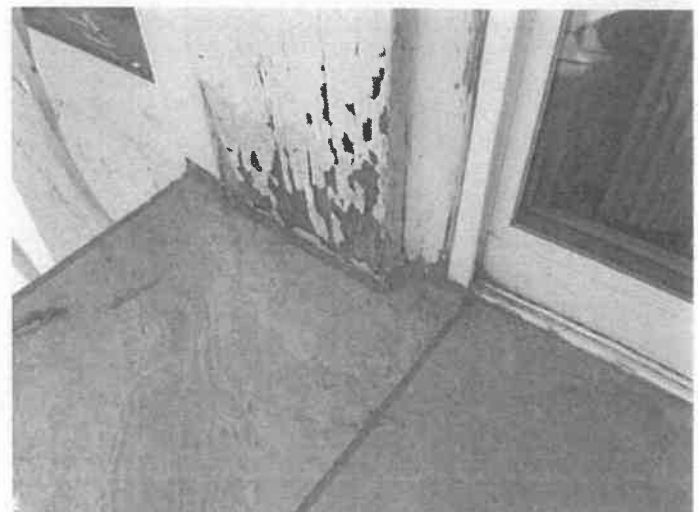
Wood Trim Buried in Tile Finish/ Reverse Lap

A7 observed wood trim boards to be buried beneath the tile finish at the majority of balconies at the Seaview HOA. Additionally, metal flashing was observed over the face of the wood trim which causes a reverse lap condition that may be allowing a direct path of moisture into the balcony cavity. This condition was observed at 120/121 balconies (99%).

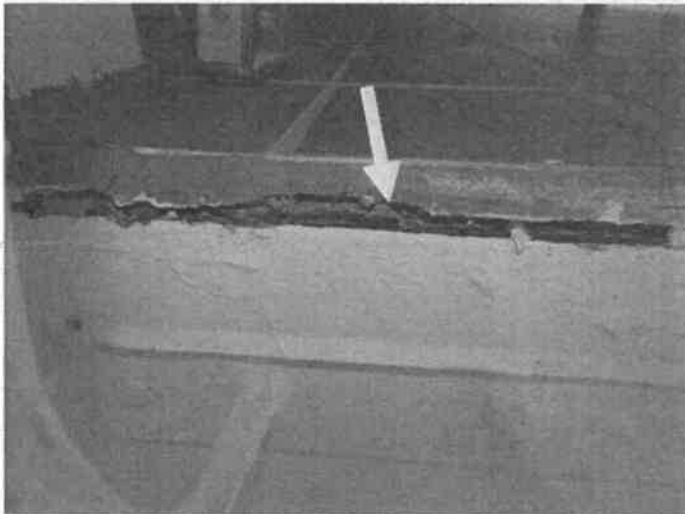
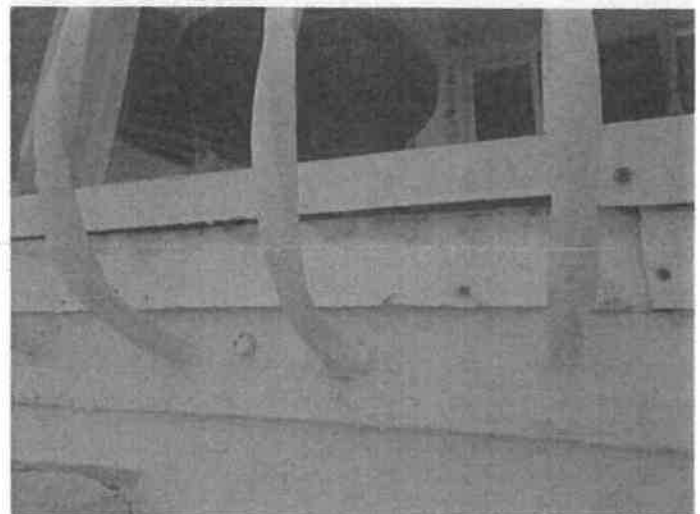
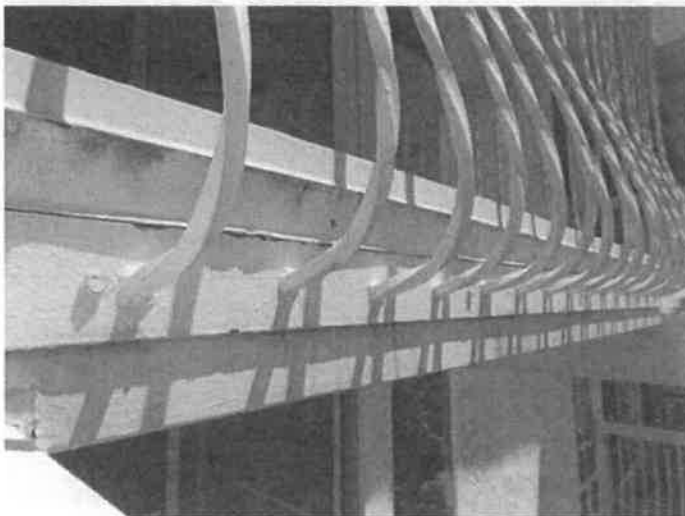
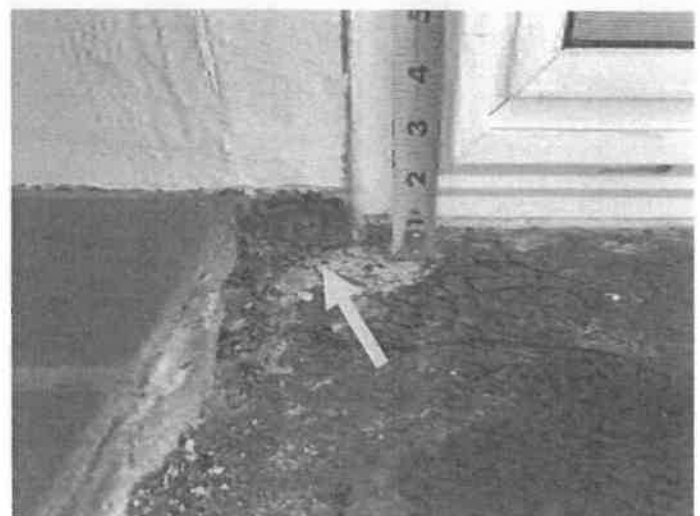
Perimeter Metal Flashings Rusted/ Corrosion

A7 observed severe rust and corrosion at 52 of 121 (43%) perimeter balcony flashings at Seaview. Due to the fact that the majority of the perimeter flashings are covered by other building materials including multiple coats of paint, it's difficult to know the true extent of damage. However, based on the age of the community and the fact that these components are 3x their useful life, one would assume the extent of damage to perimeter flashings to be closer to 100%.

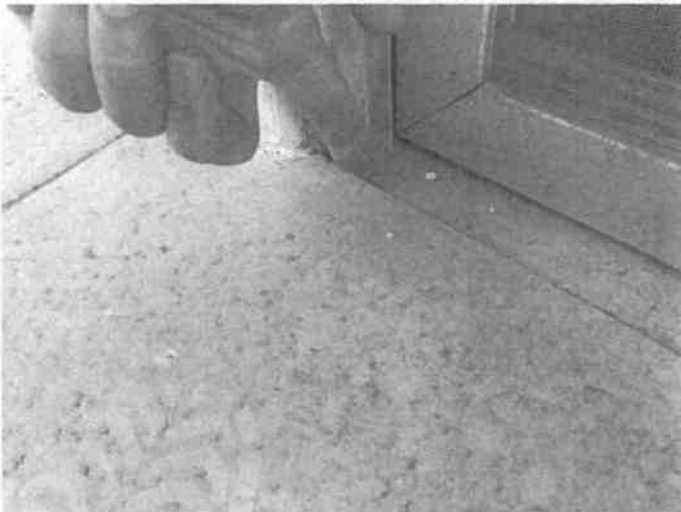
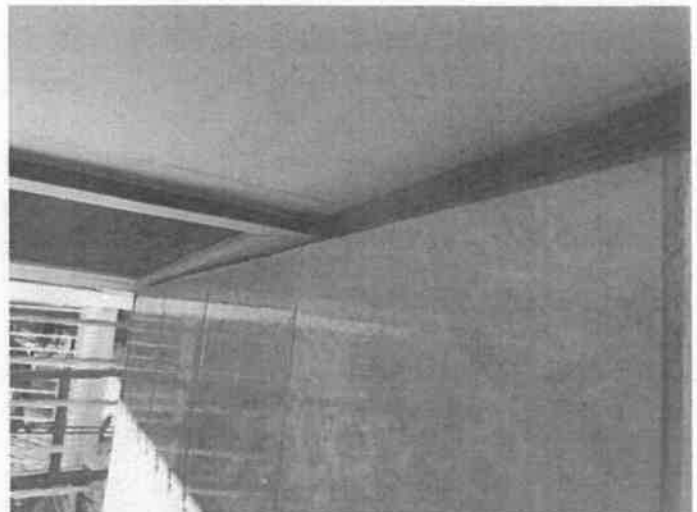
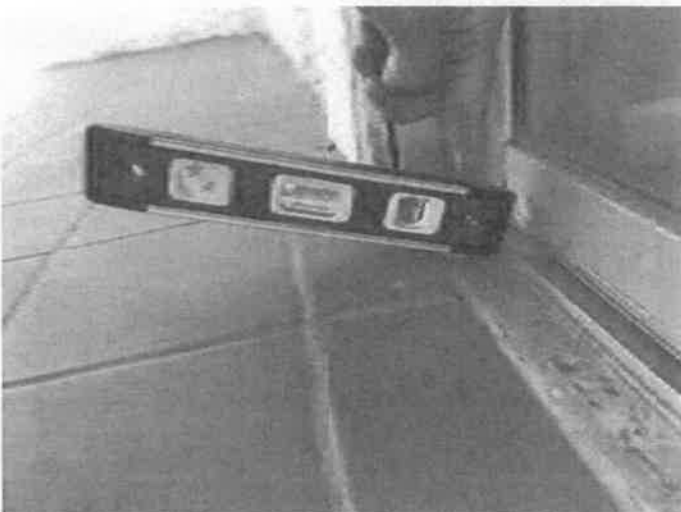
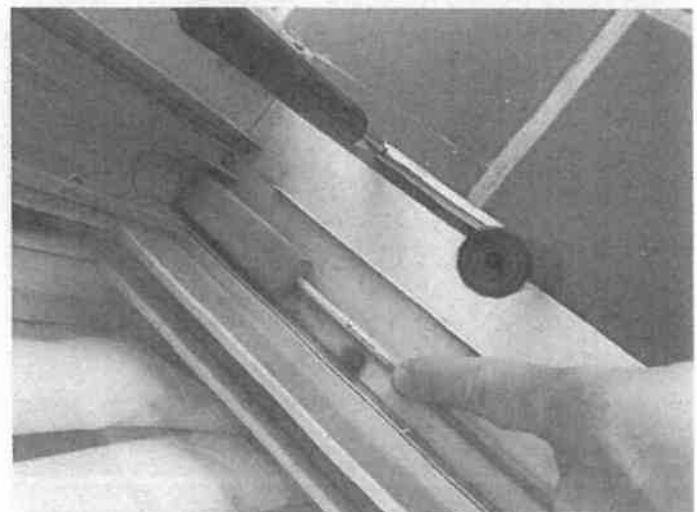
Surface Tile Prevents Proper Drainage

A7 observed surface tiles preventing proper drainage at 52 of 121 balconies (43%) at Seaview. Adding to the problem, A7 also observed several locations with unsealed screw penetrations within the sliding door threshold. This condition, coupled with the surface tile blocking drainage is very concerning, considering the age of the community and potential for moisture to penetrate the building envelope at these locations.

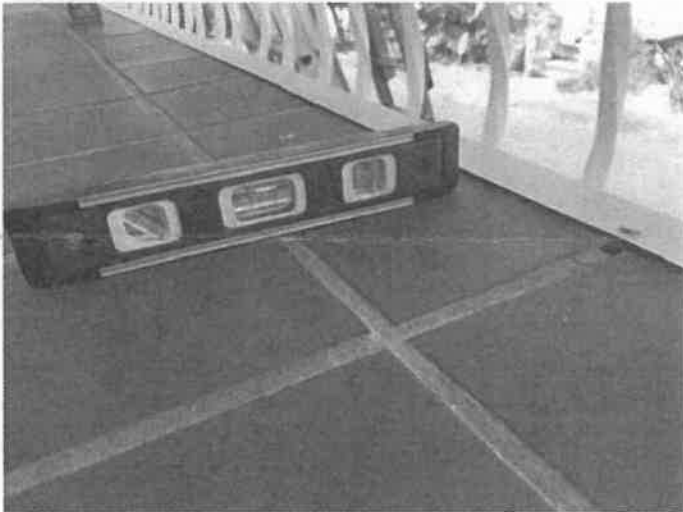
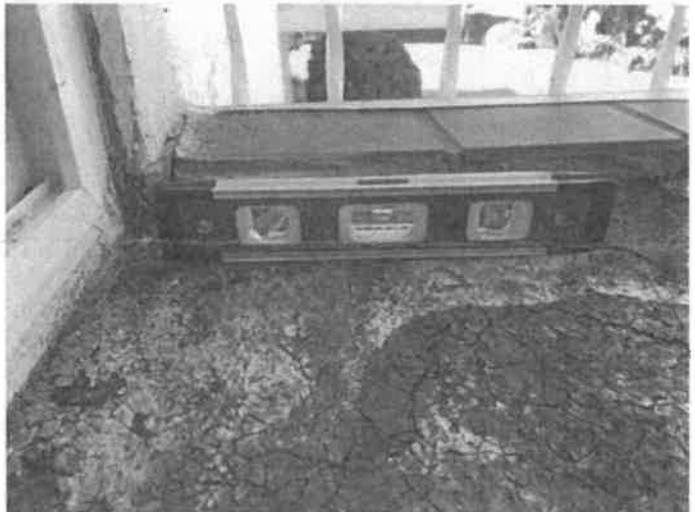
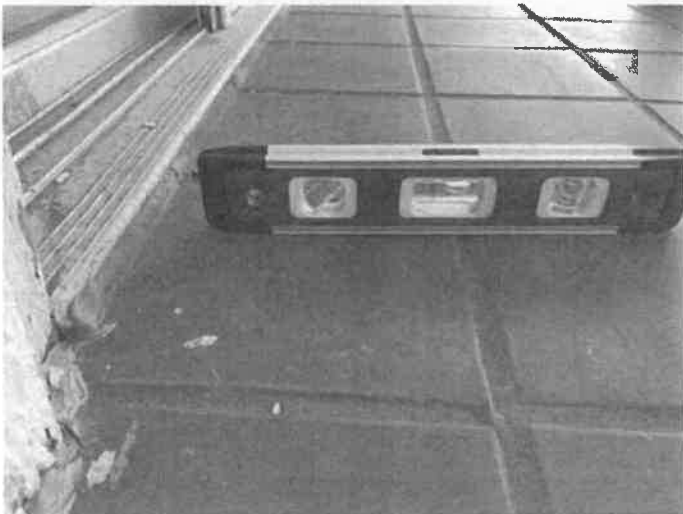
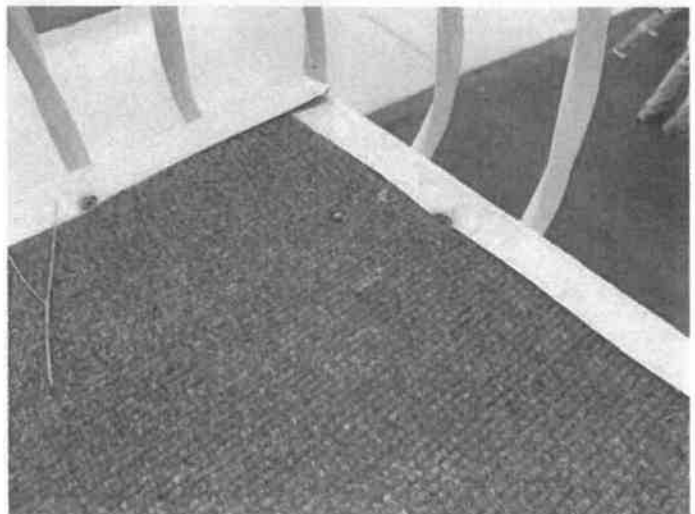
Reverse (or level) Slope on Balcony Surface

A7 observed reverse (or level) slope on balcony surfaces at 59 of 121 balconies (49%) at Seaview. Many of the locations have a metal edging which further prevents water from flowing off the balcony edge.

Additionally, A7 also observed carpet to be installed over the surface tiles at some locations. Depending on the age and condition of balcony weatherproofing assemblies, water saturated carpets exasperate problems due to prolonged exposure to moisture.

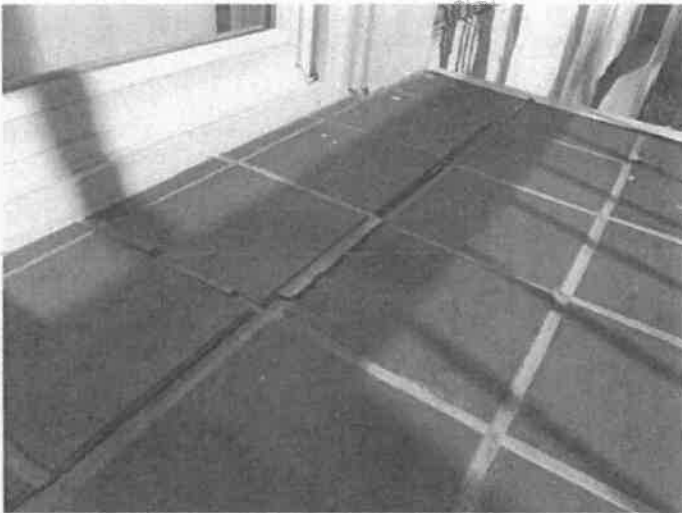
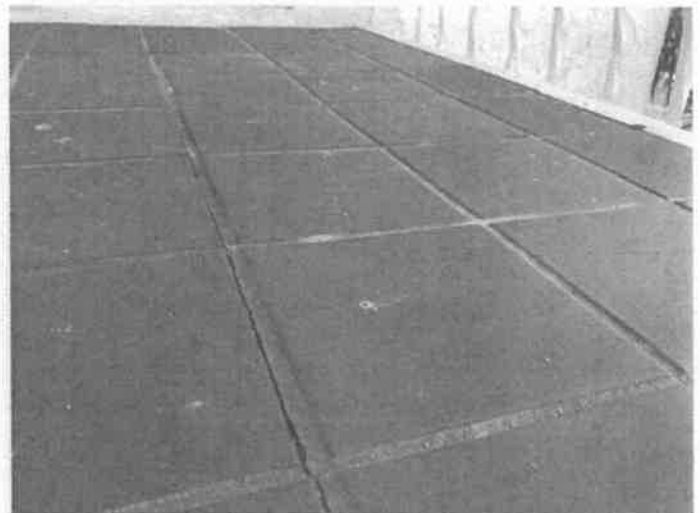
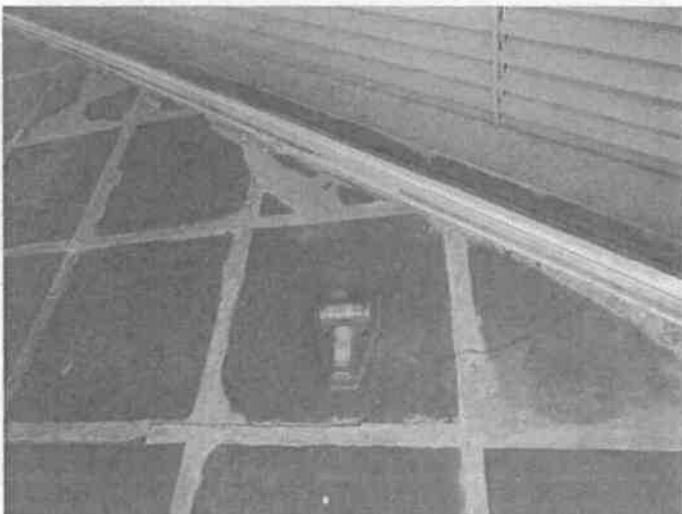
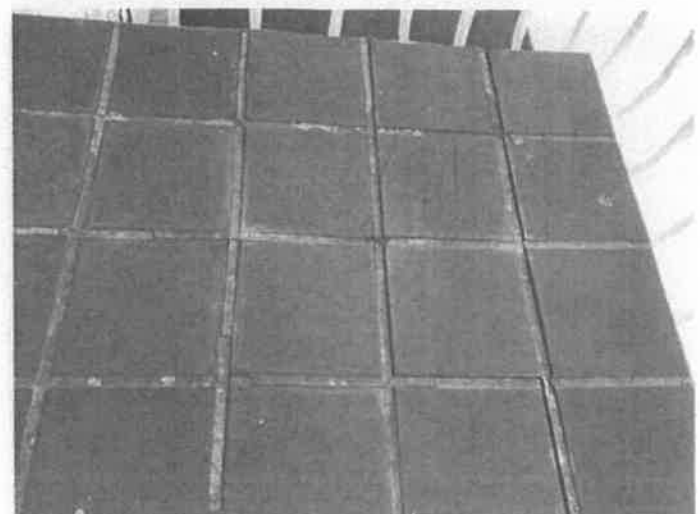
Cracked Floor Tiles/ Cracked Grout

A7 observed cracked floor tiles and/or cracked grout joints at 56 of 121 (46%) balconies at Seaview. Due to the age of the community and other issues outlined within this report, the concern isn't as much the cracked tile, as the stability of the underlying components including the waterproofing membrane and plywood substrate.

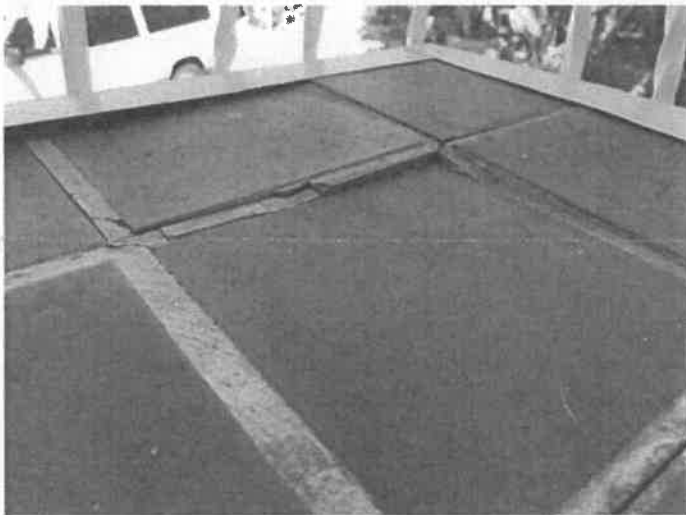
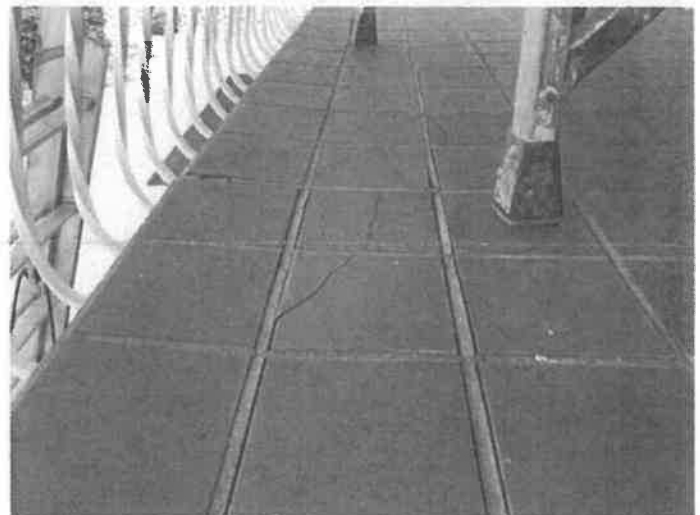
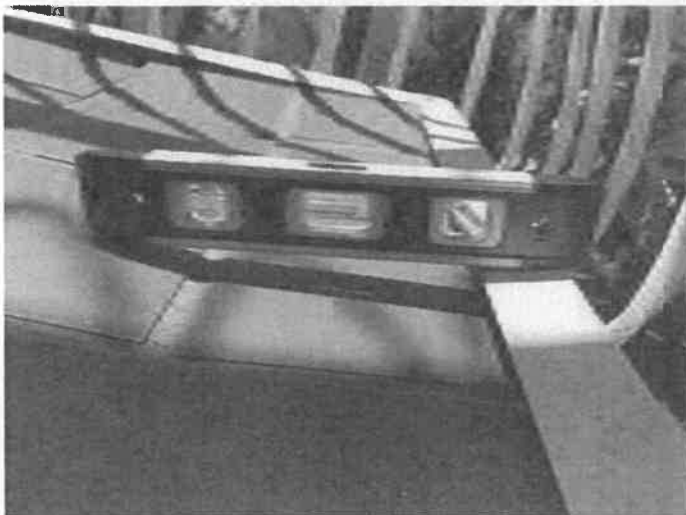
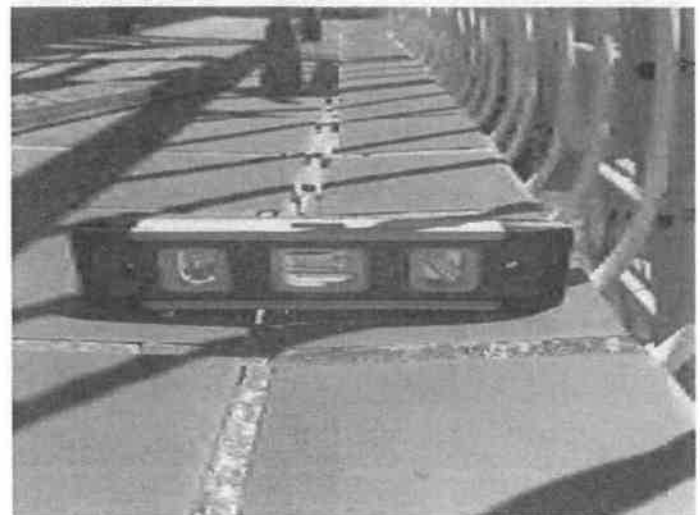
Substrate Deterioration (Surface)

Though this condition may not cause an immediate and urgent life-safety concern, residents should be notified to proceed with caution where there are "soft spots" on balcony surfaces, and repairs should be implemented as soon as possible.

A7 observed substrate deterioration 13 of 121 (11%) balconies at Seaview.

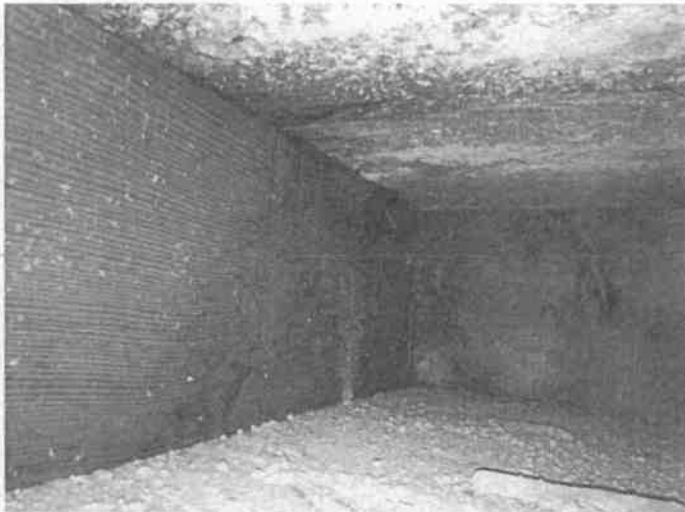
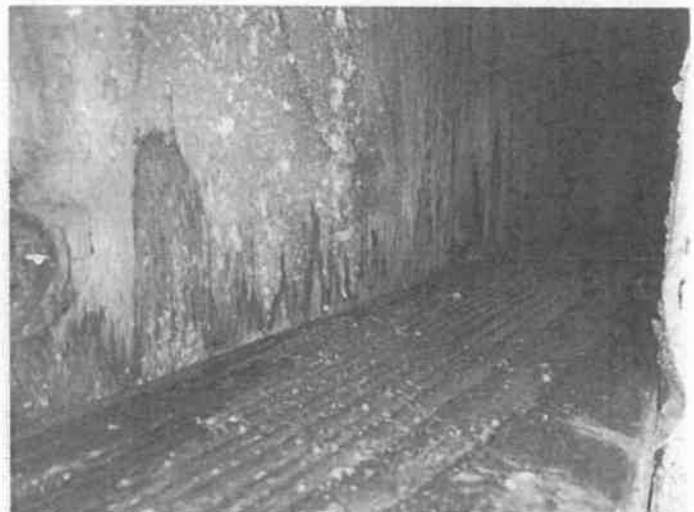
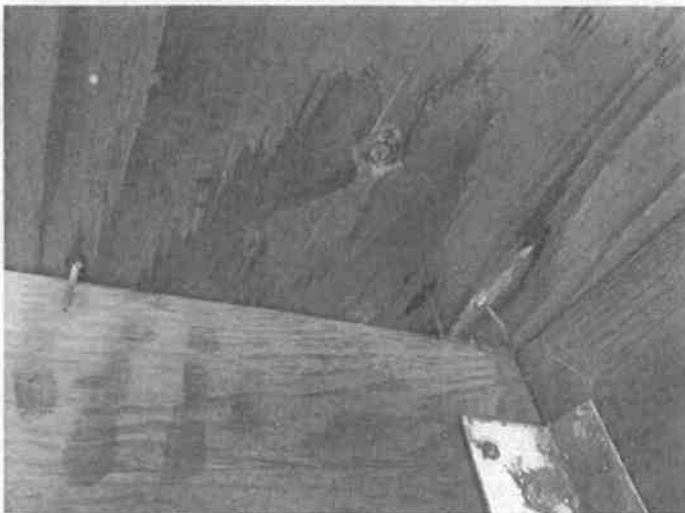
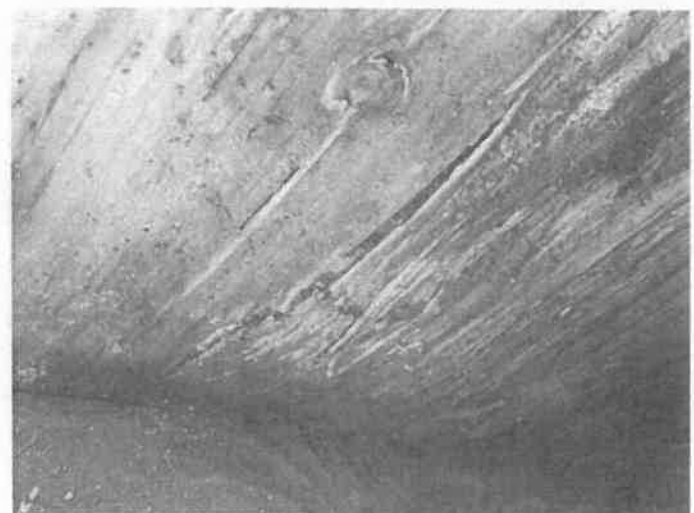
Substrate Deterioration (Plywood) [DT]

A7 coordinated destructive testing at 3 locations within the Seaview HOA to 1) document the existing structural support system for the balconies and 2) determine if water damage is effecting the structural integrity of framing members. Though floor joist members were structurally sound, there were signs of significant water intrusion at all 3 locations, and the plywood substrate at 1 location was observed with significant deterioration.

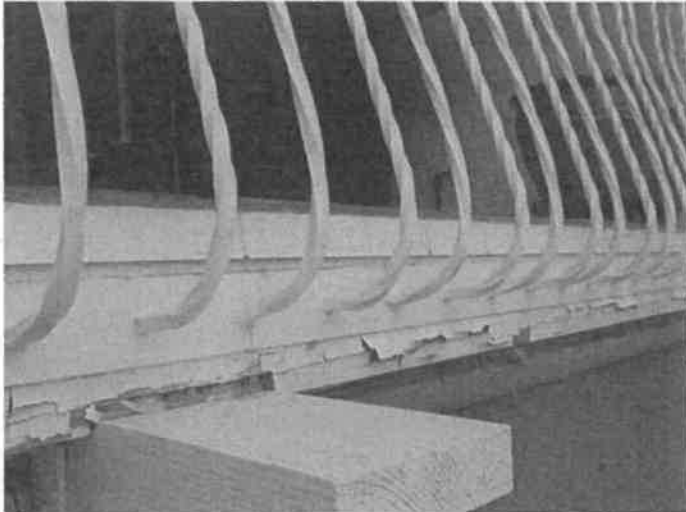
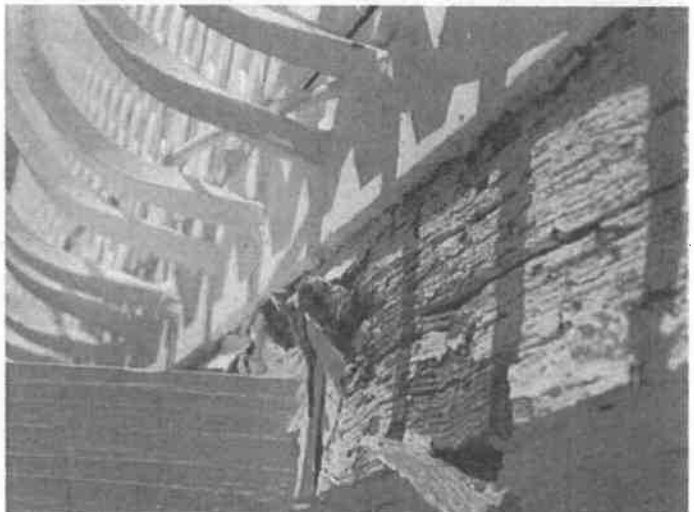
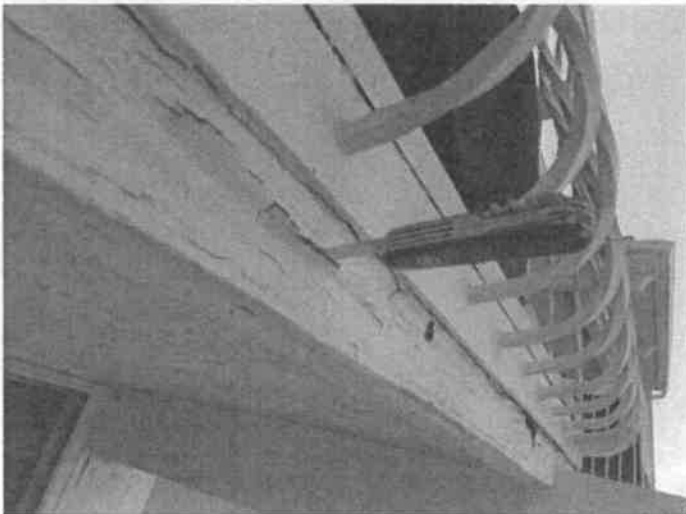
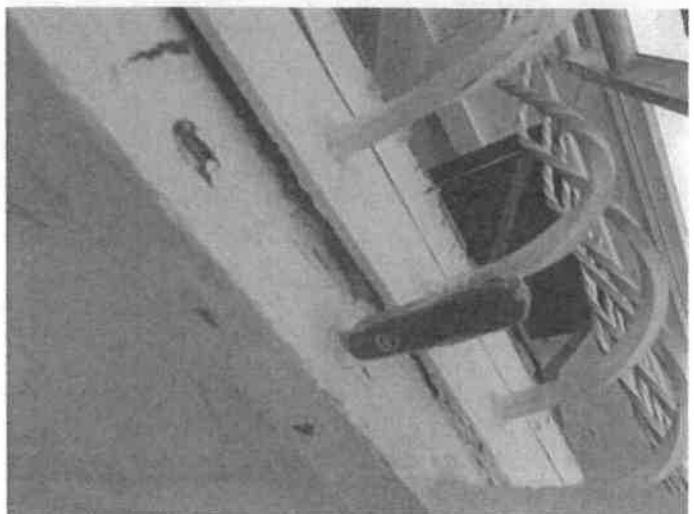
Dry rot - Fascia

A7 observed fascia with dry rot at 28 of 121 (23%) balconies at Seaview. The biggest concern with dry rot in fascia boards is the fact that the fascia is the support for the wrought iron guardrail assembly. Large lag bolt screw fasteners penetrate and secure the guardrail to the fascia board and floor framing beneath. Deterioration and dry rot in the fascia board may compromise the structural integrity and fastening strength for the guardrail above.

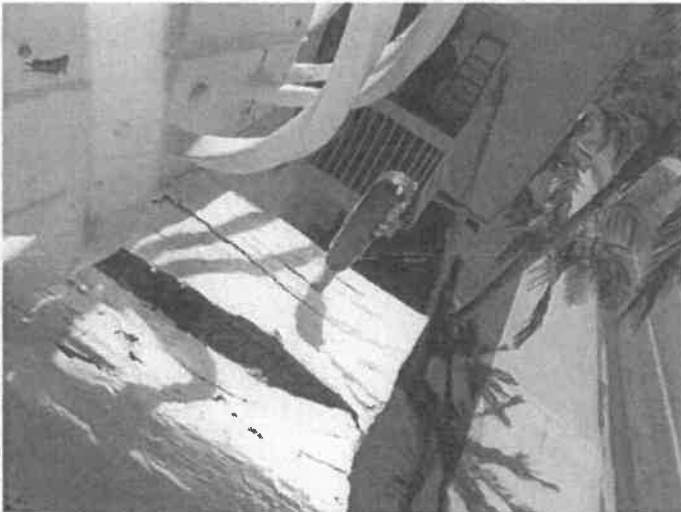
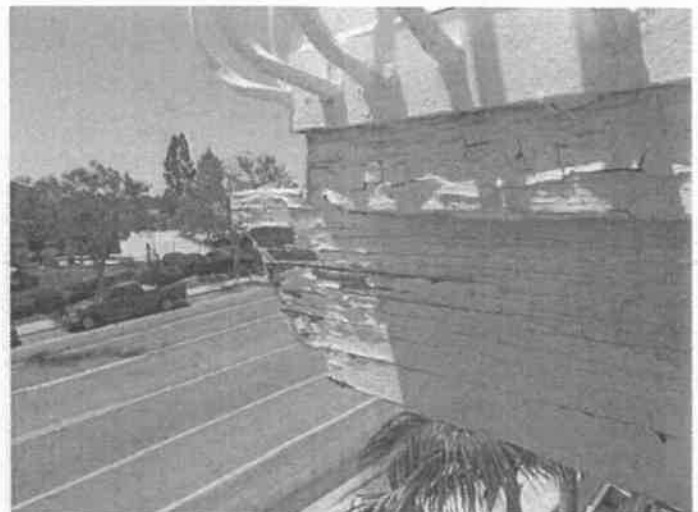
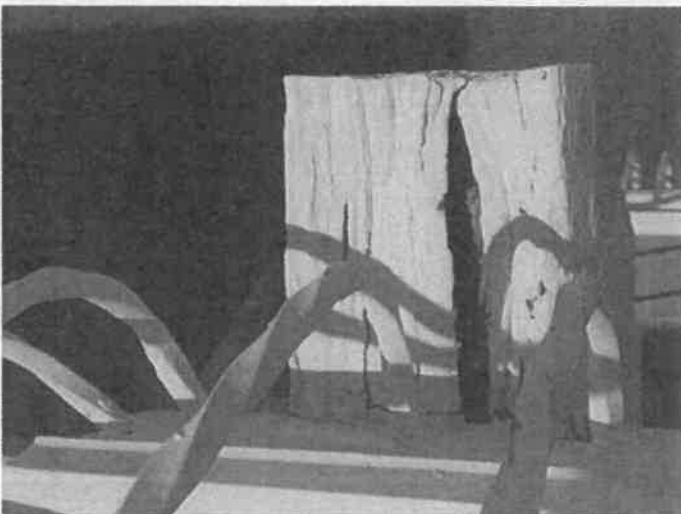
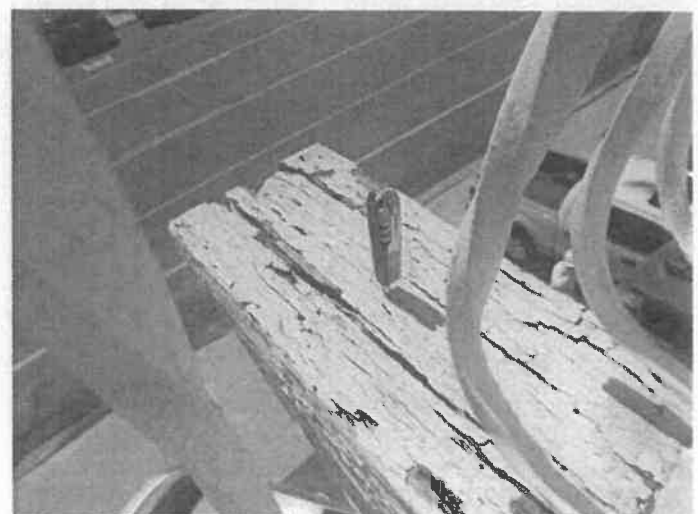
Dry rot - Corbels

A7 observed corbels with dry rot at 17 of 60 (28%) balconies at Seaview. Though A7 has not consulted with a structural engineer to determine if the upper level balcony wood corbels assist with load transfer and support, A7 did not observe signs of excessive movement or structural distress.

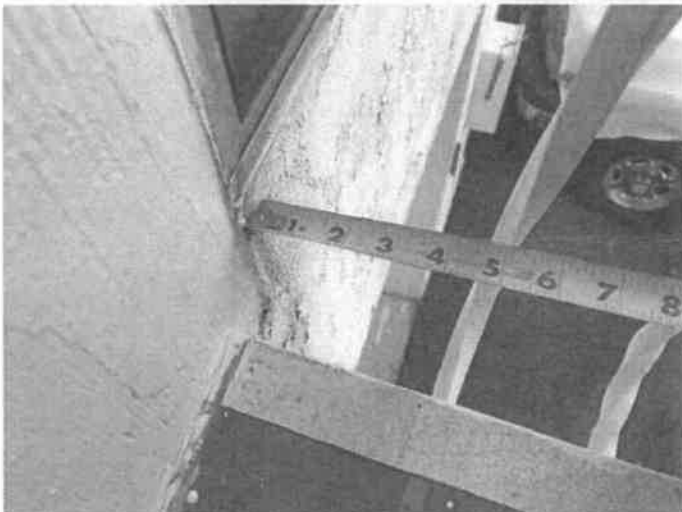
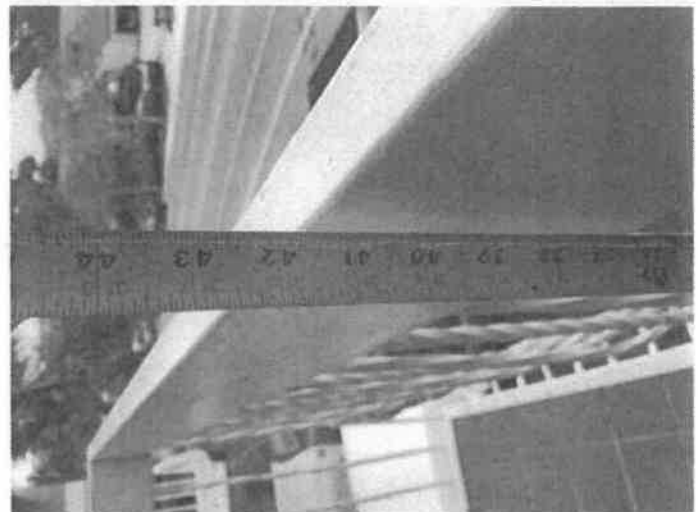
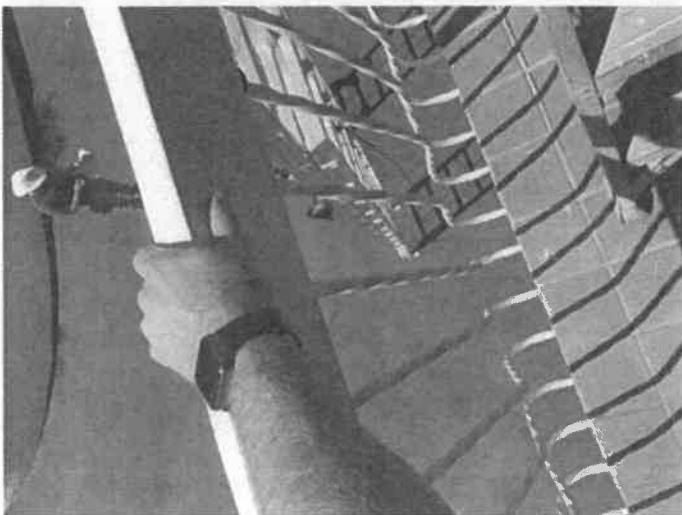
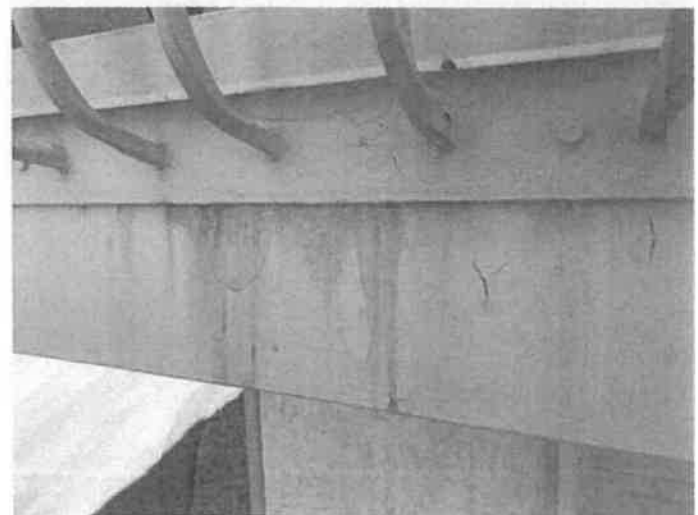
Guardrail - Issues

Though no immediate threat to the life safety of occupants was observed, A7 noted various issues with the wrought iron guardrails at Seaview including:

- 1) Gaps/ baluster spacing exceeding the 4" (min.) requirement
- 2) Guardrail height less than the 42" (min.) requirement
- 3) Potential lateral structural stability concern
- 4) Severe rust and corrosion of wrought iron components

Remove and replace guardrail, remove and replace 12" stucco at balcony perimeter (install weep screed), remove and replace exterior sliding door, remove and replace all perimeter balcony flashings (deck-to-wall, deck edge, door pan), remove and replace waterproofing membranes, remove and replace wood trim and fascia, remove and replace stucco soffit and integrate ventilation component.
