WOOD DESTROYING PESTS AND ORGANISMS INSPECTION REPORT

Building No. 19710	Street Butler Way	City Groveland	Zip 95321	Date of Inspection 02/07/25	Number of Pages 1 of 8
------------------------------	-----------------------------	--------------------------	---------------------	---------------------------------------	----------------------------------

Report # 7082

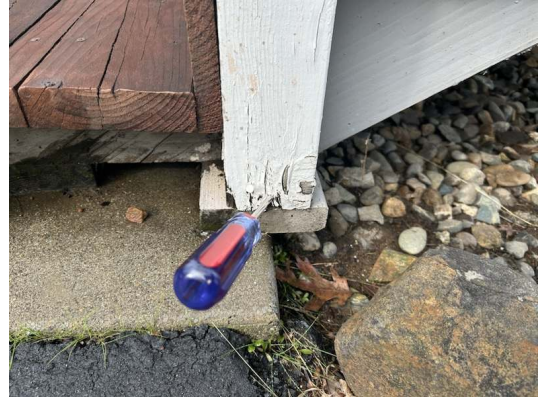
9A:

Wood decay fungus is infecting and damaging the 2x8 joist, 4x4 support post, and 1x4 deck railing trim.

RECOMMENDATION: Remove and replace up to 20 linear feet of damaged 2x8 joist, up to 4 liner feet of damaged 4x4 support post, and up to 15 linear feet of damaged 1x4 trim; price for repairs does not include paint

/ stain. Treat all exposed wood members with (Tim-bor) disodium octaborate tetrahydrate to arrest the growth of wood decay fungi. All chemicals are to be applied by a state licensed applicator in accordance with manufacturer labels. *Upon request, prices can be given for others to perform repairs and Streamline Inspections to chemically treat only.

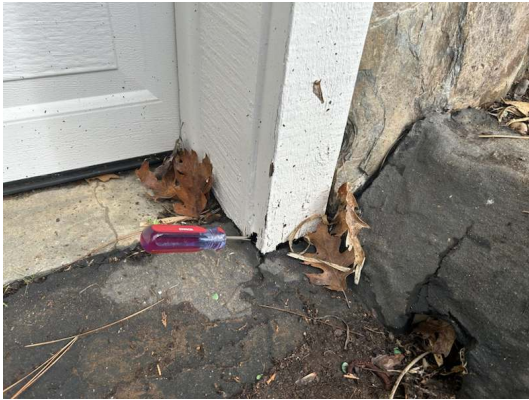
8A:

The base of the garage door trim at both sides is embedded in the asphalt; this has cause excessive moisture conditions at the wood members. Wood deterioration is present.

RECOMMENDATION: Cut up the base of the trim as necessary to break contacts with the asphalt.

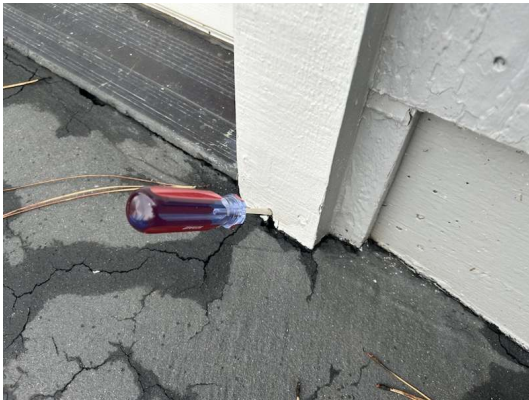
8B:

The base of the trim and door casing are embedded in the asphalt; this can cause excessive moisture conditions at the wood members. Wood deterioration is present.

RECOMMENDATION: Cut up the base of the trim and door casing as necessary to break contacts with the asphalt.
