PROPERTY INSPECTION REPORT

5440 Baltimore Dr #173 La Mesa, CA 91942

> Janet Park FEBRUARY 11, 2025

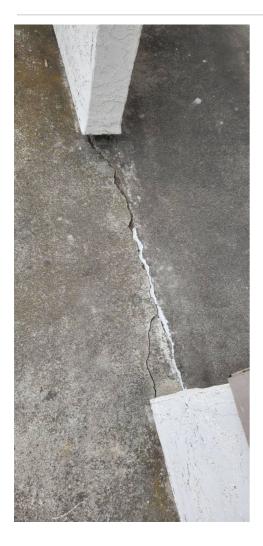
SIDEWALK / PATIO CRACKS / DETERIORATION - REPAIR

Cracks, holes, settlement, heaving and/or deterioration were found in sidewalks and/or patios. Recommend that qualified contractor repair as necessary.

Contact a qualified concrete contractor.

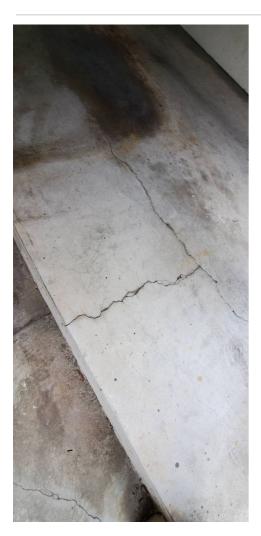
4.3.2 Driveways, Sidewalks, Patios

DRIVEWAY CRACKS / DETERIORATION - REPAIR

Cracks, holes, settlement, heaving and/or deterioration were found in the driveway. Recommend that qualified contractor repair as necessary.

Contact a qualified concrete contractor.

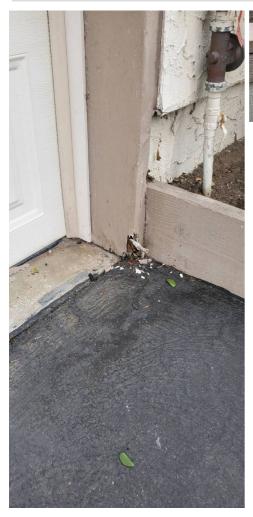
SIDING / TRIM DETERIORATED / DAMAGED / WARPED

One or more sections of siding and/or trim were damaged, loose and/or warped. Recommend that a qualified person repair, replace, or install siding or trim as necessary.

Contact a qualified siding specialist.

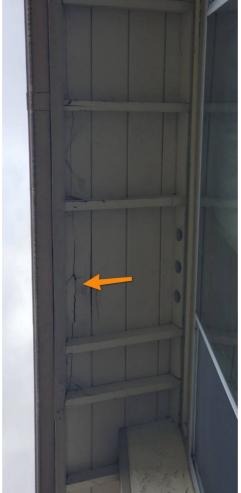
EAVE FRAMING DAMAGED / DETERIORATED

Damaged and/or deteriorated framing was found at one or more eave areas (i.e.fascia, rafter tails, sheathing, soffits etc.). Recommend repairs be made by a qualified contractor. For example, by replacing all deteriorated wood and correct the cause of the damage / deterioration.

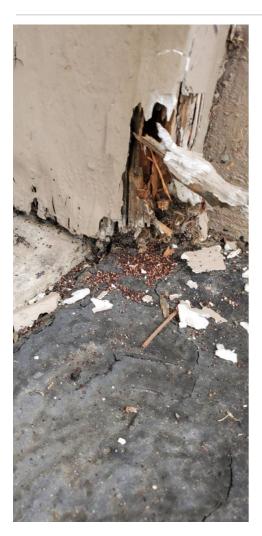
5.2.2 Eaves / Soffits

DRYWOOD TERMITE EVIDENCE

There is evidence of drywood termites or there damage at the exterior trim / eaves - recommend a pest inspection.

Contact a qualified professional.

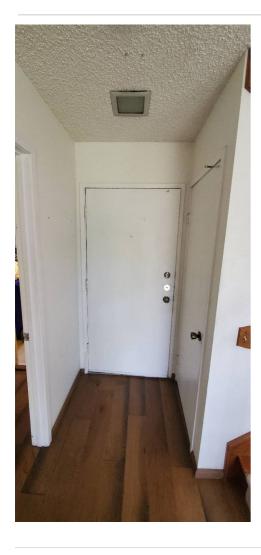
One or more exterior doors were binding and/or dragging the jamb and/or threshold. Recommend that a qualified person repair as necessary. For example, by trimming doors.

Contact a qualified door repair/installation contractor.

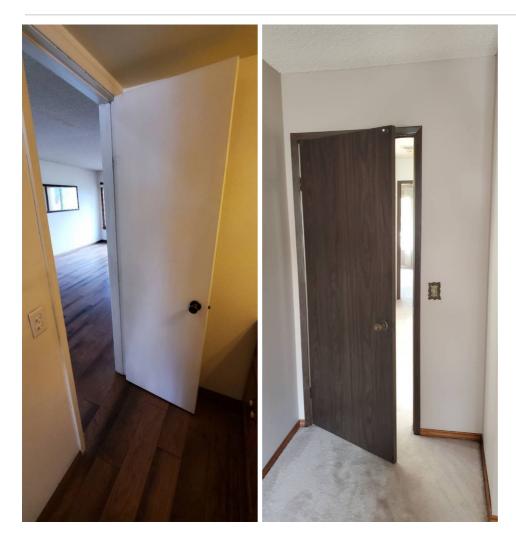
7.2.1 Interior Doors

INTERIOR DOOR WON'T LATCH

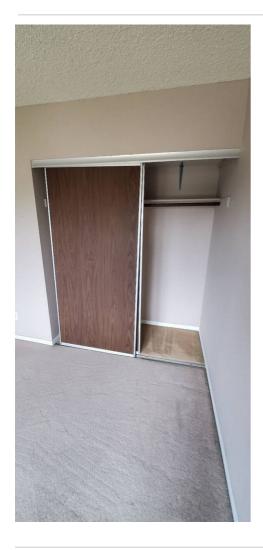
7.2.2 Interior Doors

CLOSET DOORS DRAG / DIFFICULT / OFF TRACT

Closet doors drag, are off tract and/or are difficult to operate. Recommend repair

Contact a handyman or DIY project

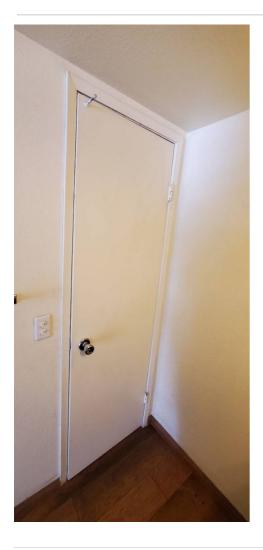
7.2.3 Interior Doors

BINDS IN / DRAGS JAMB

One or more interior doors were binding and/or dragging the jamb. Recommend that a qualified person repair as necessary. For example, by trimming doors.

Contact a qualified door repair/installation contractor.

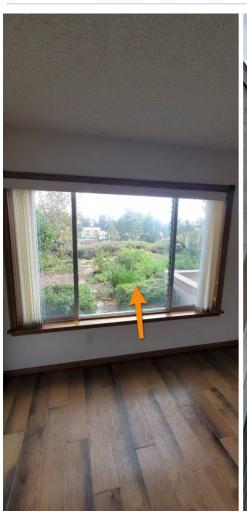
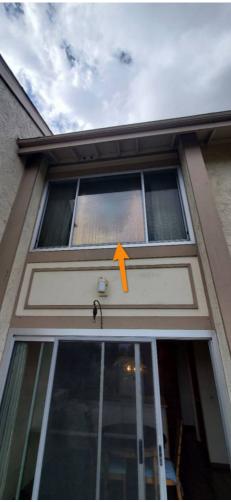
7.3.1 Windows

FOGGING / STAINING / CONDENSATION

Condensation or staining was visible between multi-pane glass in one or more windows. This usually indicates that the seal between the panes of glass has failed or that the desiccant material that absorbs moisture is saturated. As a result, the view through the window may be obscured, the window's R-value will be reduced. Recommend that a qualified contractor evaluate and repair windows as necessary. Usually, this means replacing the glass or the entire window.

Contact a qualified window repair/installation contractor.

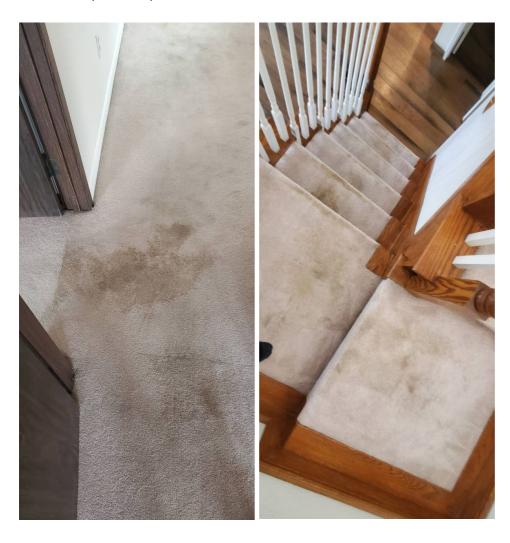
CARPETING STAINED / WORN

The interior carpets appear stained or worn in one or more areas - recommend cleaning and repair or replacement as necessary

Contact a qualified professional.

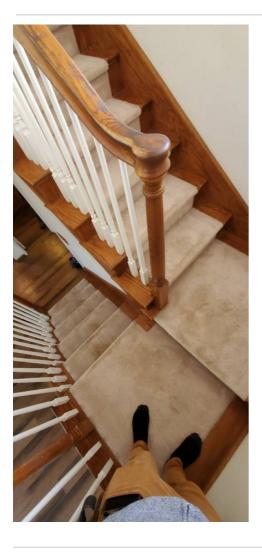
7.6.2 Floors

FLOORS SQUEAKING

Squeaking or creaking noises occur when walking on one or more sections of flooring. This is usually caused by substandard construction practices where the sub-floor decking is not adequately fastened to the framing below. For example, not enough glue was used and/or nails were used rather than screws. In most cases, this is only an annoyance rather than a structural problem. Repairs to eliminate the squeaks or creaks may be more or less difficult depending on the floor covering and the access to the underside of the sub-floor. Recommend that a qualified contractor evaluate and repair as necessary.

Contact a qualified flooring contractor

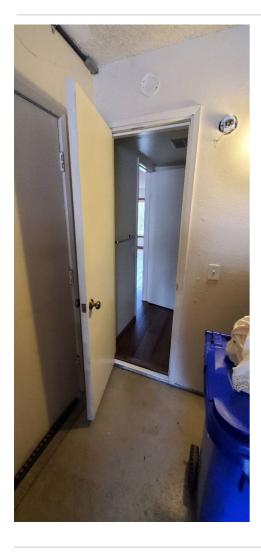
SELF-CLOSING DEVICE NEEDS REPAIR OR REPLACEMENT

The self-closing device on the door between the garage and the house didn't close and latch the door. These devices are installed to keep the door closed to prevent possible fire and fumes from the garage from spreading to the house. Recommend that a qualified person repair as necessary.

Contact a qualified professional.

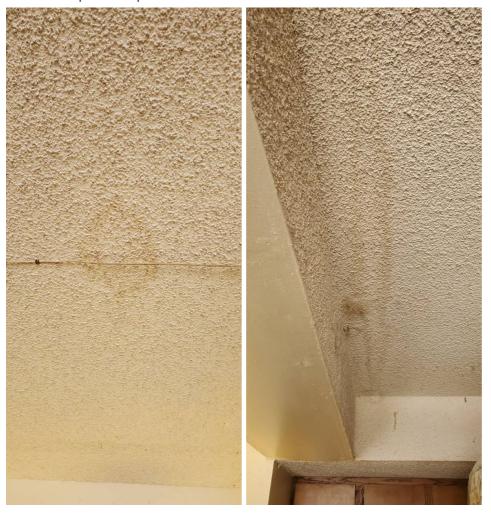
WATER STAINS

Water stains were visible on the roof structure at one or more locations in the garage. However, no elevated levels of moisture were found at these stains during the inspection. The stains may have been caused by a past or current leak. Recommend asking the property owner about the leak evidence. Monitor these areas in the future, especially after heavy rains to determine if active leaks exist. If leaks are found, recommend that a qualified contractor evaluate and repair as necessary.

Contact a qualified professional.

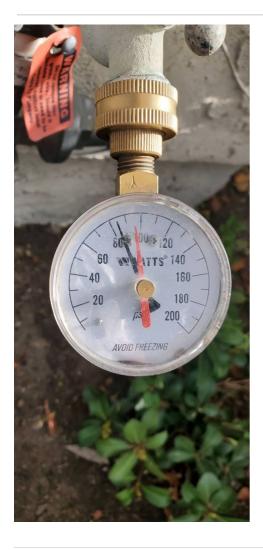
The water supply pressure was greater than 80 pounds per square inch (PSI). Pressures above 80 PSI may void warranties for some appliances such as water heaters or washing machines. Flexible supply lines to washing machines are likely to burst with higher pressures. 50-80 PSI is considered the normal range for water pressure in a home, and most plumbers recommend 60-75 PSI. Typically, the pressure cannot be regulated at the water meter. Recommend that a qualified plumber evaluate and make modifications to reduce the pressure to below 80 PSI. For example, installing a pressure regulator.

Contact a qualified plumbing contractor.

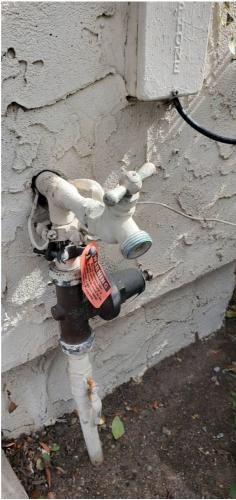
9.3.1 Supply Lines

HOSE BIB MISSING BACKFLOW PREVENTER

One or more hose bibs were missing backflow prevention devices. These devices reduce the likelihood of gray water entering the potable water supply. Recommend installing backflow prevention devices on all hose bibs where missing. They are available at most home improvement stores and are easily installed.

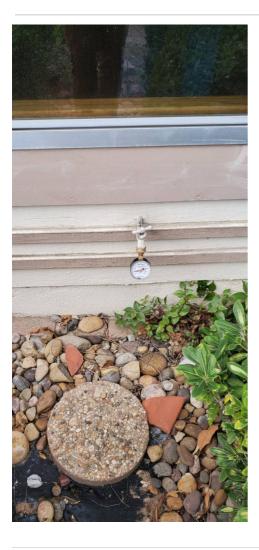
9.3.2 Supply Lines

HOSE BIB NO FLOW

One or more hose bibs (outside faucets) appeared to be inoperable. No water flowed from the bib(s) when turned on. This may be due to a shut-off valve being turned off. Note that the inspector does not operate shut-off valves. Recommend consulting with the property owner about inoperable hose bibs, and if necessary have a qualified plumber make repairs.

Contact a qualified plumbing contractor.
