## Confidential Inspection Report

LOCATED AT:  
2016 Lake Morena Dr.  
Campo, California 91906

INSPECTED ON:  
Wednesday, September 9, 2026

Inspector, Ken Mitchell  
East County Star Home Inspections

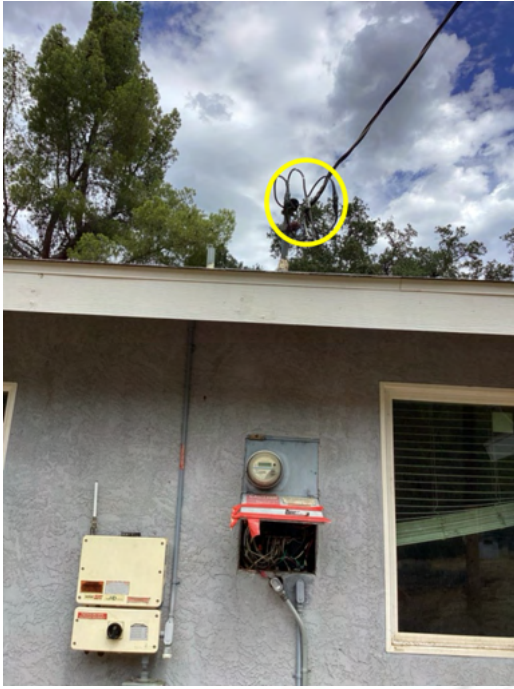
**12:** The service drop appears to be properly installed and in good condition. The drip loop appeared to be properly installed and as circled as shown in picture.

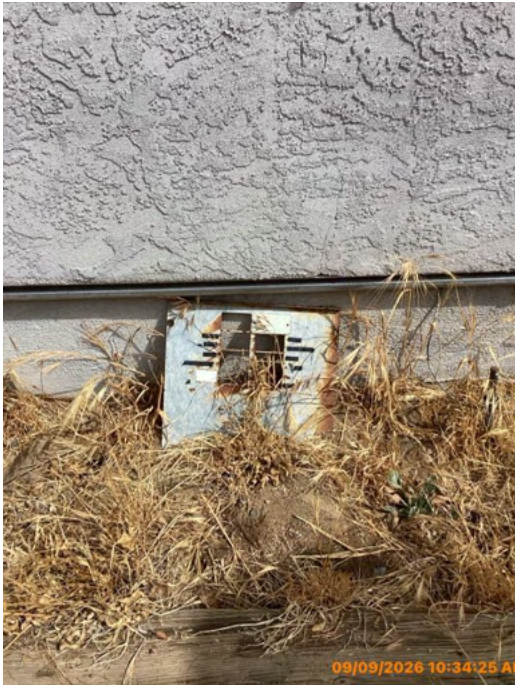
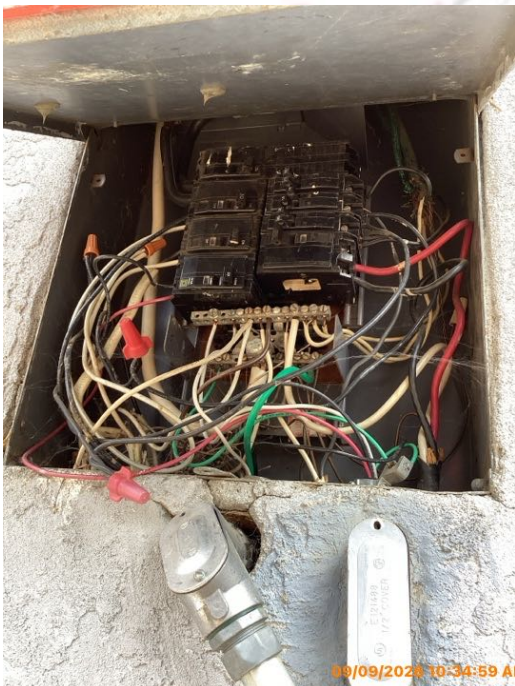
## METER

**WARN DANG 13:** Electric meter is located on rear of the house facing south. The dead front is off of the panel and laying on the ground, exposed wires were observed through the open panel, which is a safety hazard. Service panel had been taped shut with red tape capacity was not visible. Recommend services of qualified electrician.

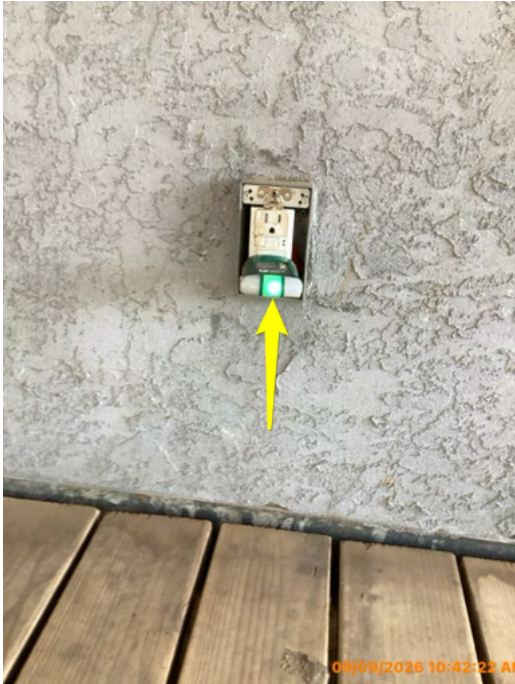
## OUTDOOR RECEPTACLES

**14:** The GFCI protection for the exterior receptacles is provided by an outlet located at the front entry next to the front entry door. We advise testing this device on a monthly basis. The device was tested at time of inspection and appears to be functioning correctly. The cover plate was missing. Recommend replacement. Picture number one is GFIC energized, picture number two is with GFIC tripped by Test button

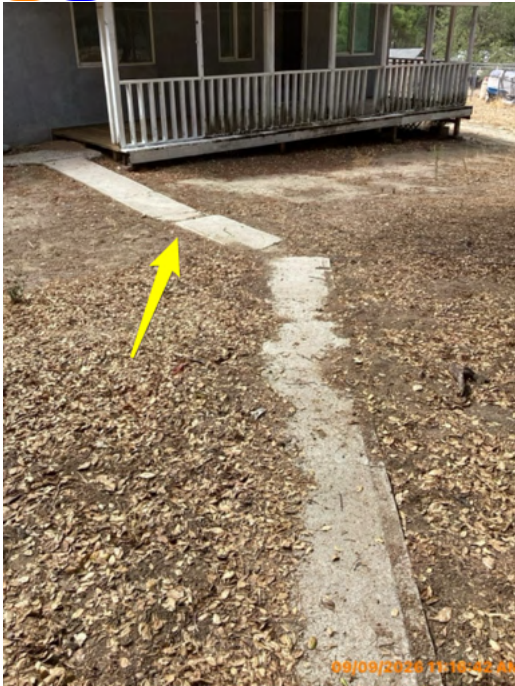
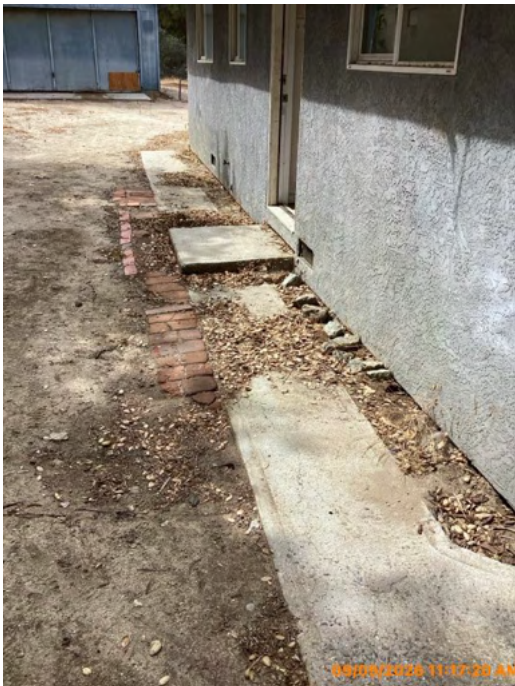
**26:** Walkways are concrete and are in need of some repair

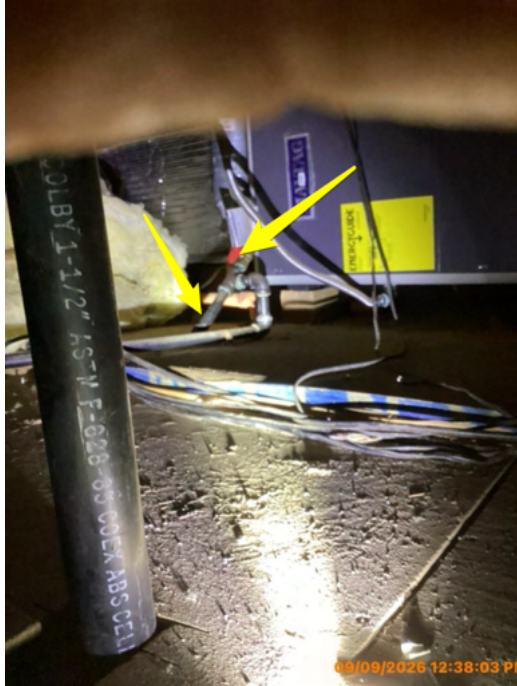
Picture shows shut off to heating unit and drip lead shown by arrows.

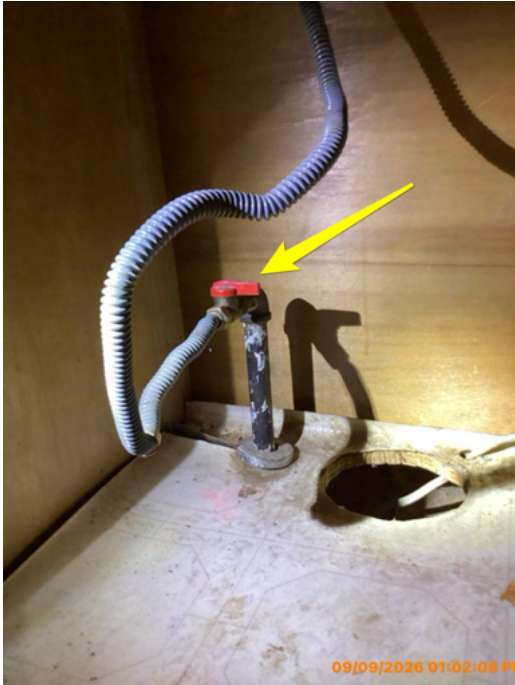
**ACC 97:** The gas piping for the appliance includes a local 90 degree shut-off valve for use in an emergency or in case of repair. The valve was not tested at the time of inspection, but is of a type usually found to be serviceable.

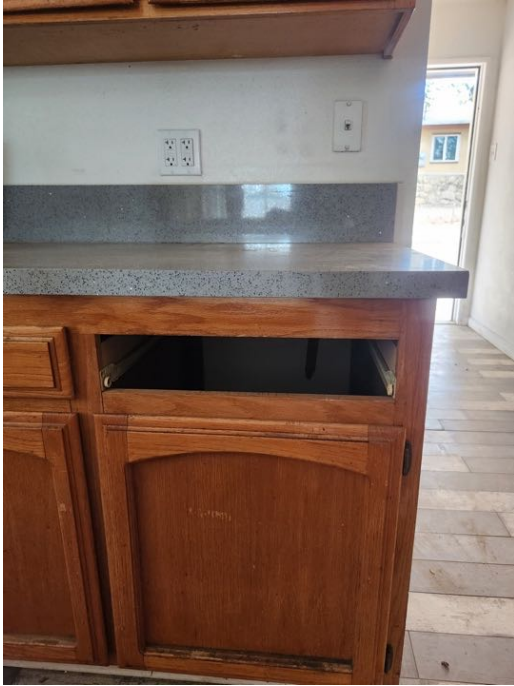
**MAIN** **102:** Cabinets and counter show heavy wear from use overtime and there is a drawer missing on the east corner of the cabinets, replace. These conditions could be addressed through regular maintenance.

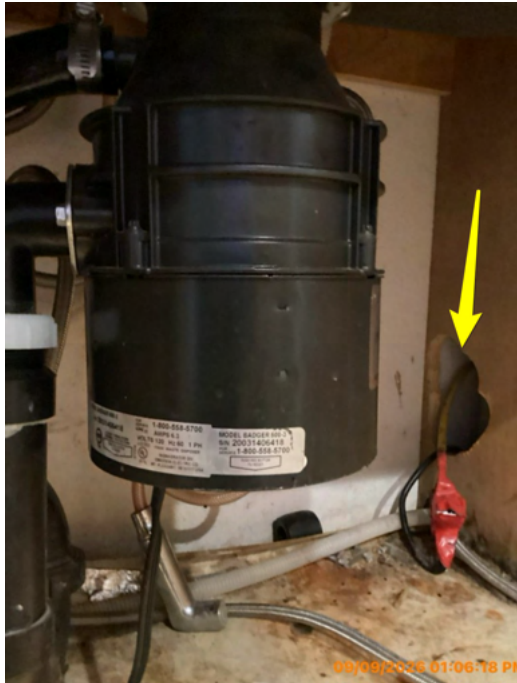
**MAIN** **UPGR** **108:** Manufacturer: Insinkerator. garbage disposal was activated, but makes noise possibly something stuck inside the drain opening. Recommend repair or replace. Face plate is missing off of outlet under sink for garbage disposal ,replace. Also observed hole in wall under sink recommend patching.

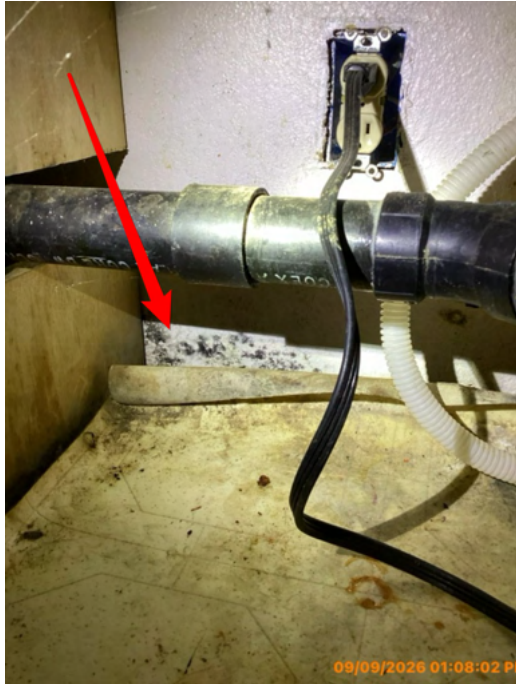
**MAIN 112:** Organic growth was observed under the kitchen sink next to the back wall recommend testing by qualified individual.

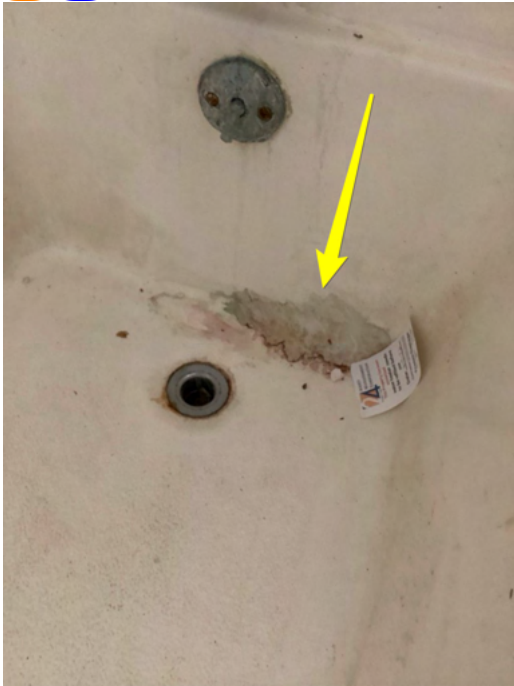
**117:** The surface finish of the bathtub is chipped. We recommend refinishing or replacement.

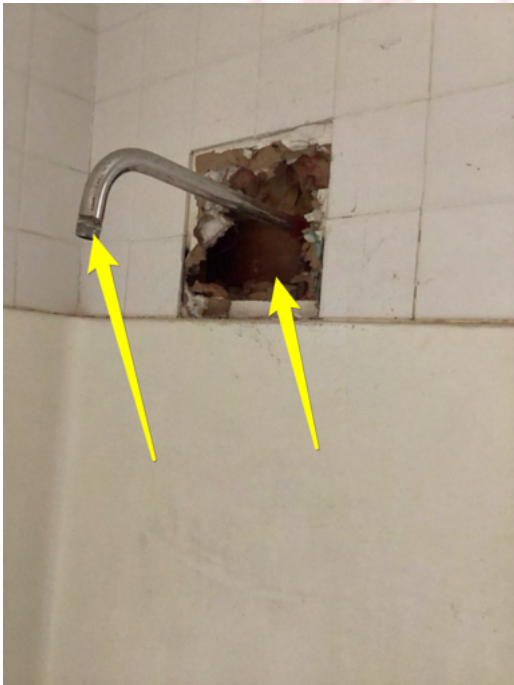
**118:** Bathroom two has a fiberglass tub and surround. The shower and other fixtures were not tested at the time of inspection due to the well-being in operative. The shower was also missing the showerhead and tile was removed around the protruding pipe. Recommend maintenance and repair.

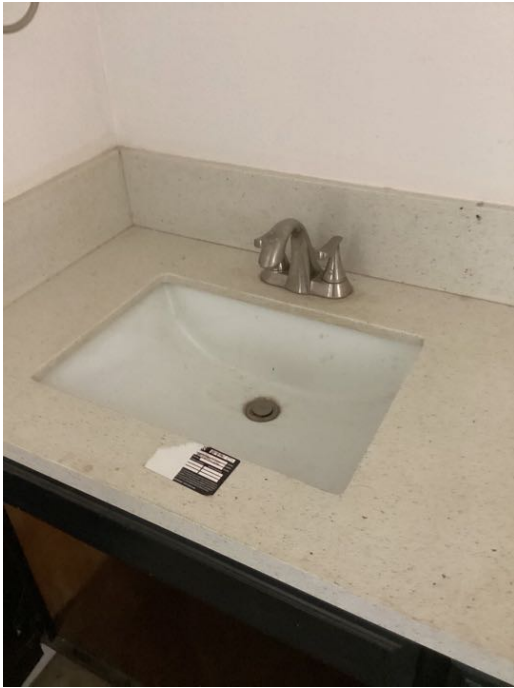
**132:** The wash basins are deteriorated and the basin on the right has a large piece broken out, replace. Remaining useful life is limited.

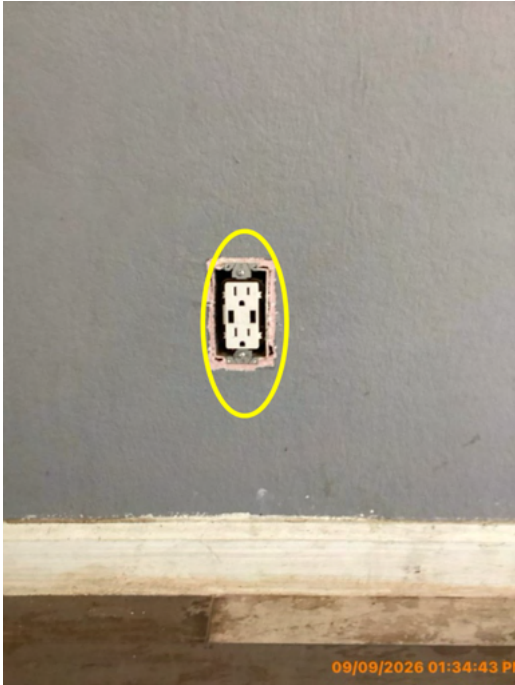
**MAIN** **138:** The east receptacle cover plate is missing We recommend it be replaced during the course of normal maintenance.

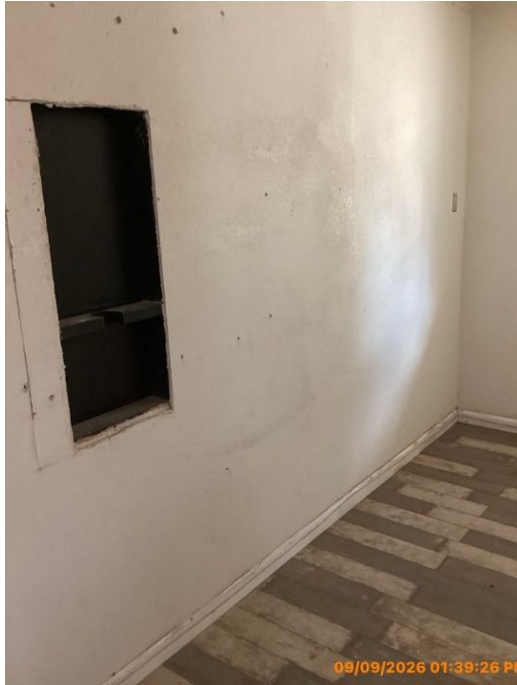
**MAIN 142:** The walls are generally serviceable, except for the item(s) noted. painting in the master bedroom and patching in the master closet are required. In picture #1 below is what would be considered the closet area.

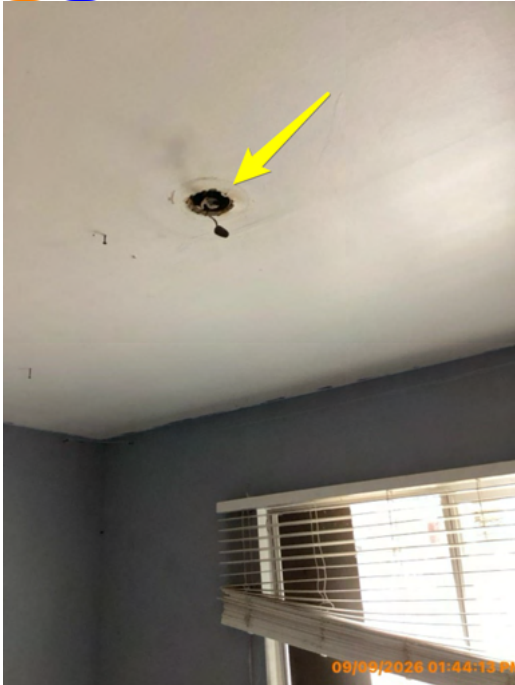
**MAIN** **UPGR** **147:** There were exposed wires where ceiling fixture had been removed, repair replace.

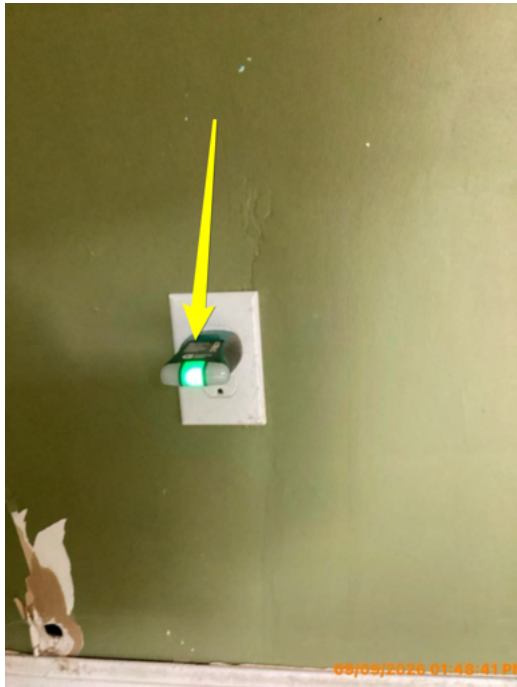
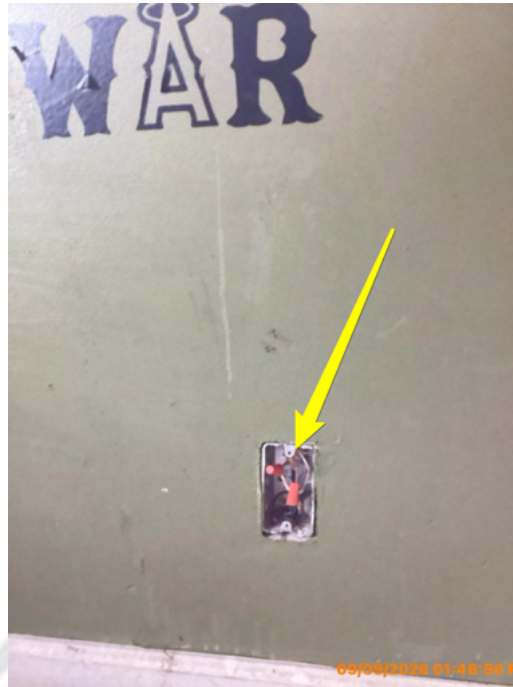
**MAIN** **UPGR** **155:** The receptacles were found to be properly installed and in serviceable condition. The number of receptacles is considered adequate for the size of the room. Cover plate missing on west wall of west bedroom, replace.

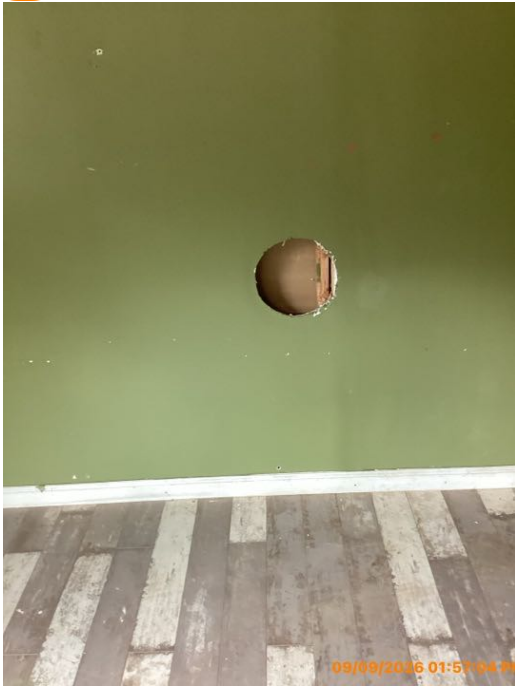
**MAIN** 158: Walls in west bedroom require some patching and general maintenance.

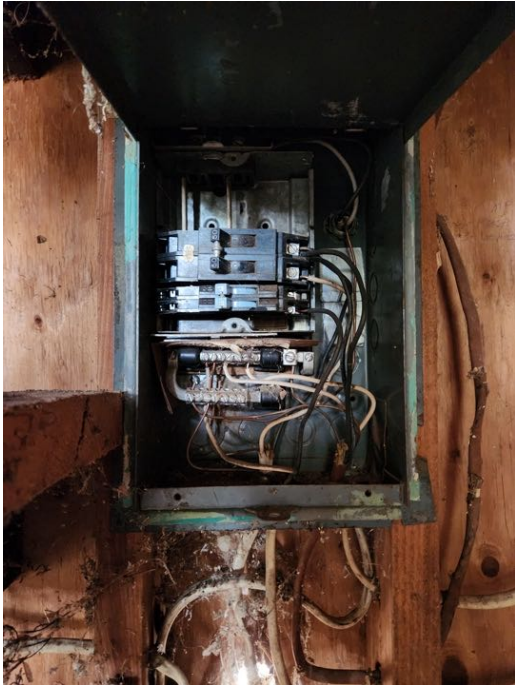
**MAIN** **WARN** **202:** There is a local subpanel located under a bench on the interior south east corner of the garage. The panel front was open and dead front had been removed. The main disconnect is 50 amp.

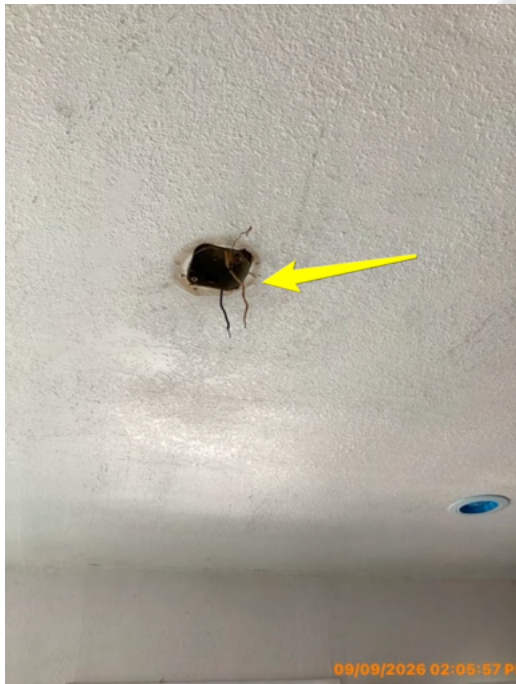
**MAIN** **UPGR** **DANG** **s-175:** Bare wires noted at ceiling in living room where a device or fixture has been removed, bare wires are shown hanging out of electric box, repair or replace.

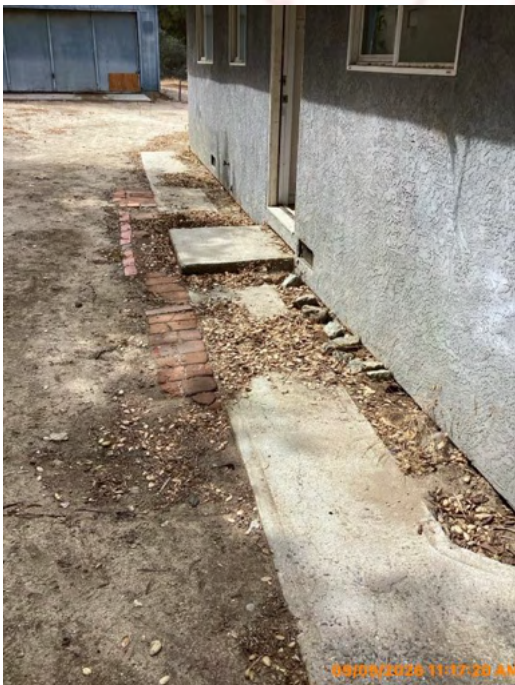
**MAIN** **UPGR** **s-26:** Walkways are concrete and are in need of some repair

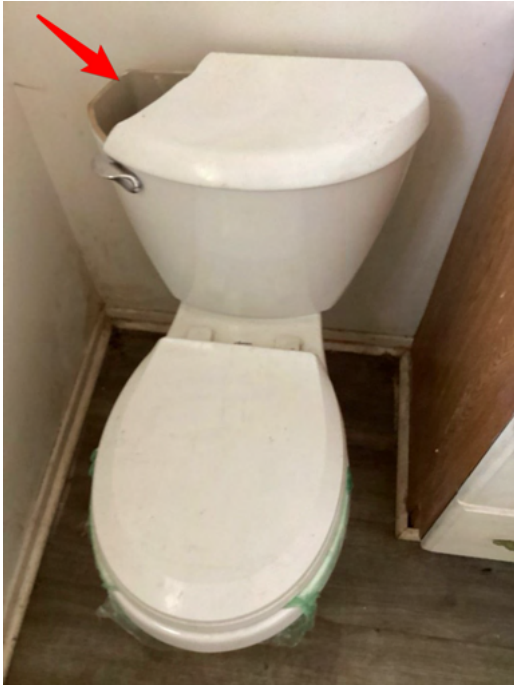
**MAIN** **UPGR** **s-113:** Toilet: Ceramic unit with a porcelain finish. Could not be tested due to lack of water supply.(well was not operating at the time of inspection.)The lid to the tank had one end of it broken off,recommend replacement.

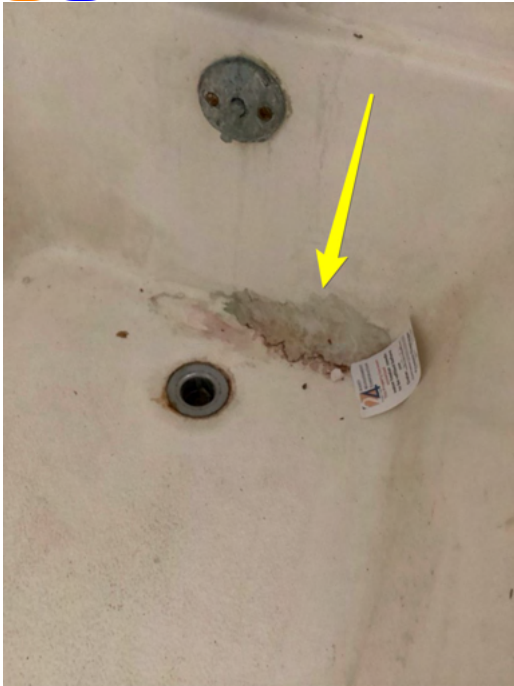
**MAIN** **UPGR** **s-117:** The surface finish of the bathtub is chipped. We recommend refinishing or replacement.

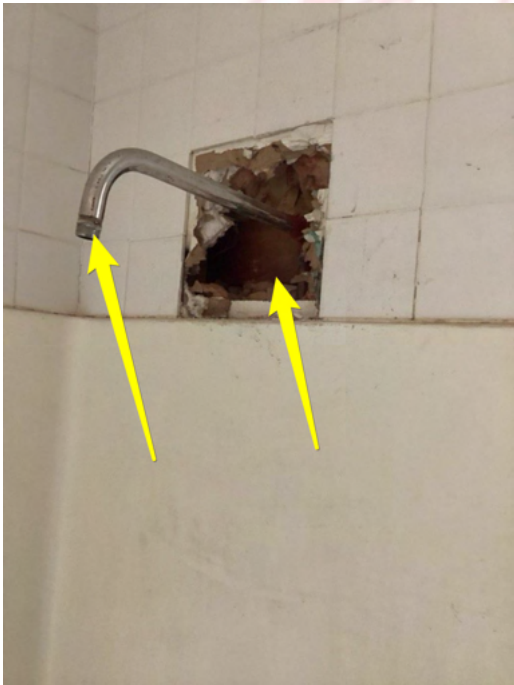
**MAIN** **UPGR** **s-118:** Bathroom two has a fiberglass tub and surround. The shower and other fixtures were not tested at the time of inspection due to the well-being in operative. The shower was also missing the showerhead and tile was removed around the protruding pipe. Recommend maintenance and repair.

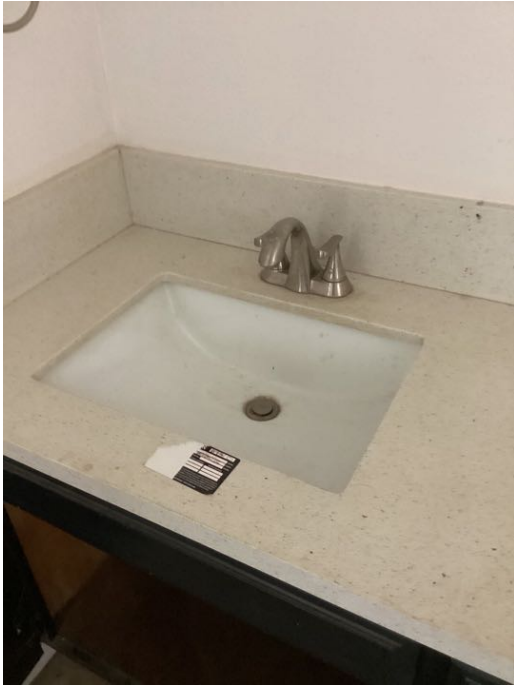
**MAIN** **UPGR** **s-132:** The wash basins are deteriorated and the basin on the right has a large piece broken out, replace. Remaining useful life is limited.

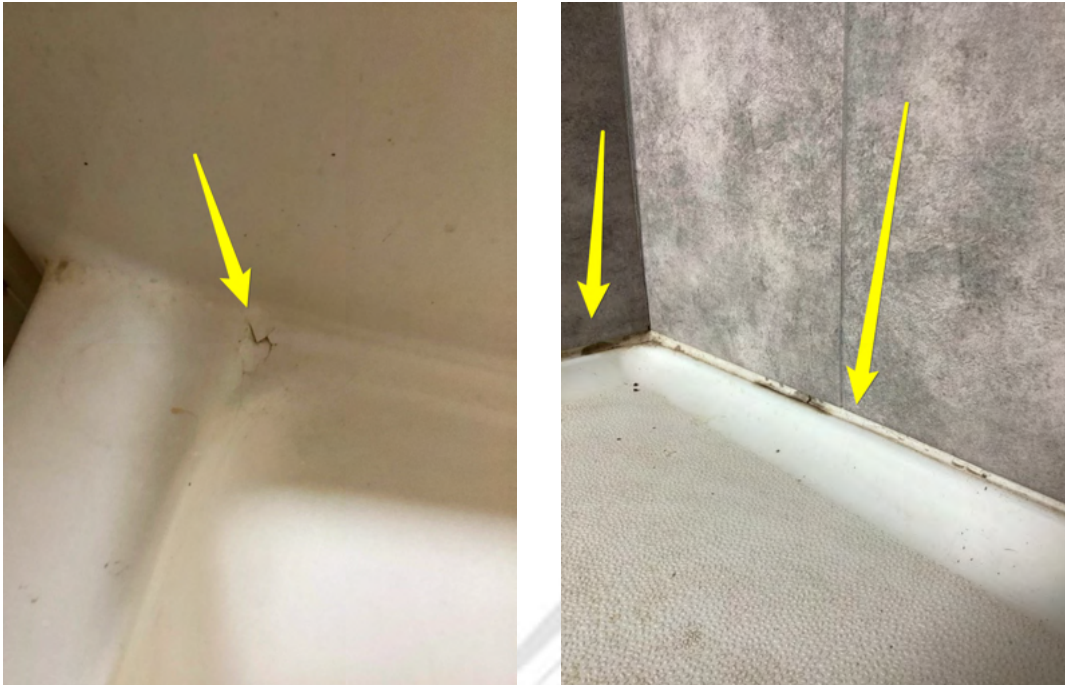
**MAIN** **UPGR** **s-133:** A water test of the shower pan is beyond the scope of this inspection. This test is often performed as a part of a standard pest inspection. The shower pan is constructed of fiberglass and shows signs of wear and tear and damage. Recommend refinishing or replacing. Also recommend removing and replacing old caulking at bottom of shower surround.

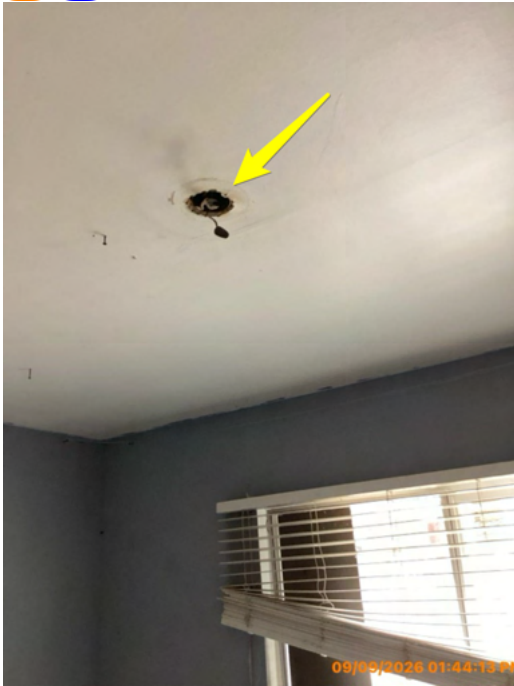
**s-147:** There were exposed wires where ceiling fixture had been removed, repair replace.

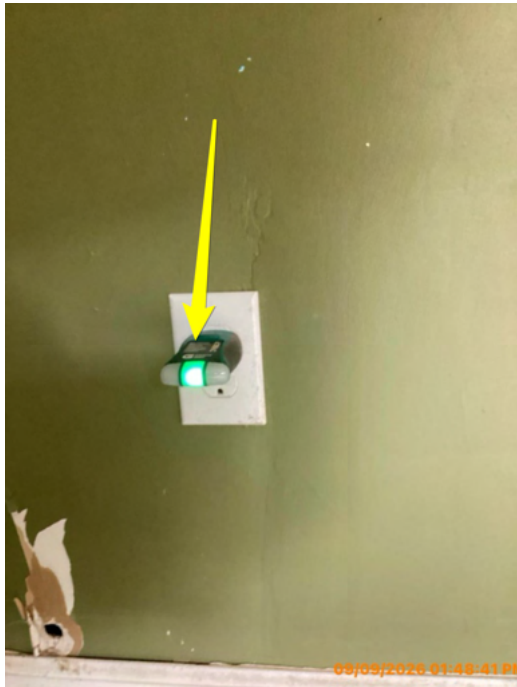
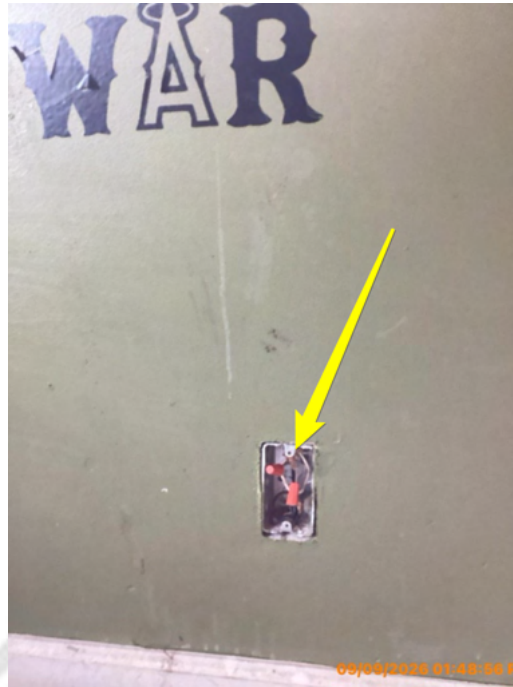
**MAIN** **UPGR** **s-155:** The receptacles were found to be properly installed and in serviceable condition. The number of receptacles is considered adequate for the size of the room. Cover plate missing on west wall of west bedroom, replace.

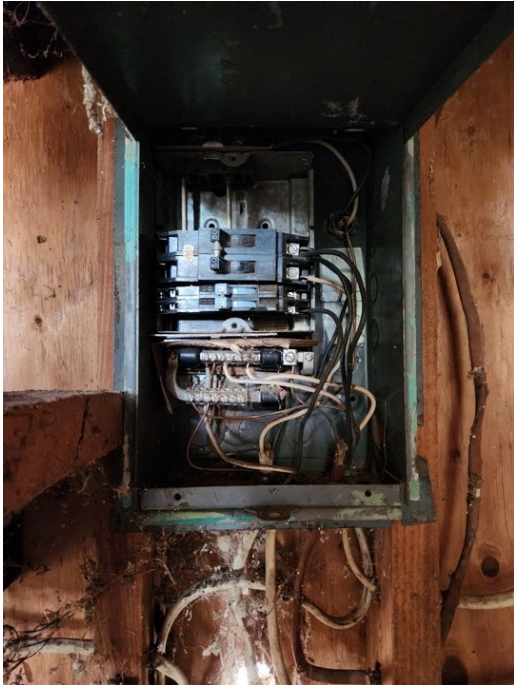
**MAIN** **WARN** **s-202:** There is a local subpanel located under a bench on the interior south east corner of the garage. The panel front was open and dead front had been removed. The main disconnect is 50 amp.

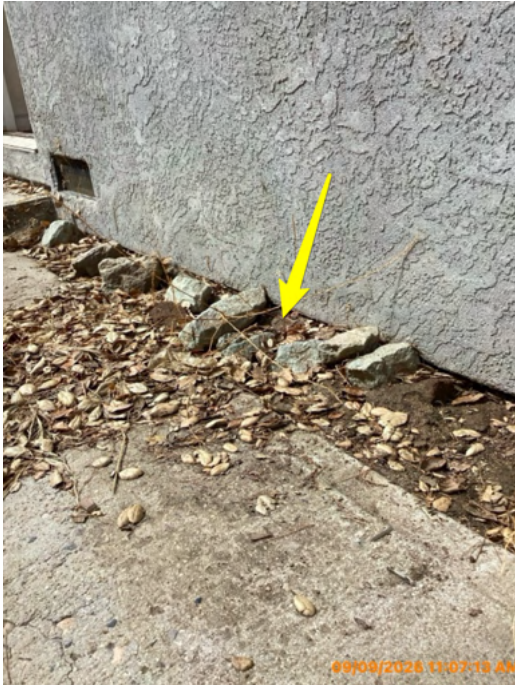
**MAIN s-23:** Proper hard and/or soft scape to weep screed clearances have not been maintained. This may lead to moisture intrusion. Review further for possible moisture issues. Clearance between weep, screed and ground should be 6 to 8 inches.

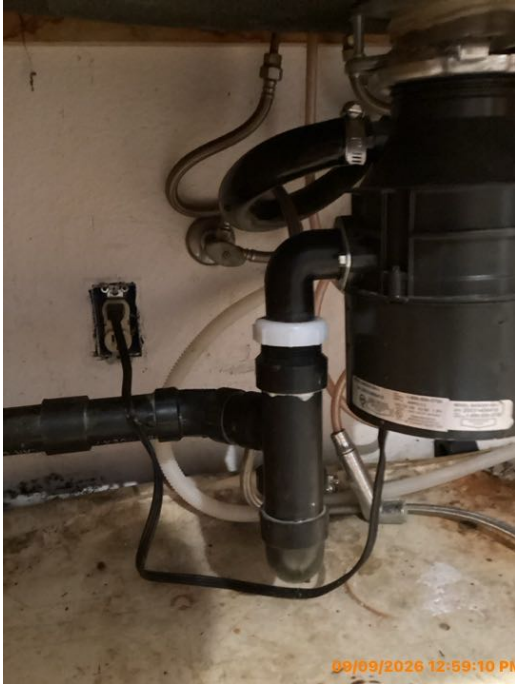
**MAIN** **s-94:** The drain trap and associated piping are ABS plastic. Lack of water is preventing drain system from being tested. Recommend further evaluation went well equipment comes online.

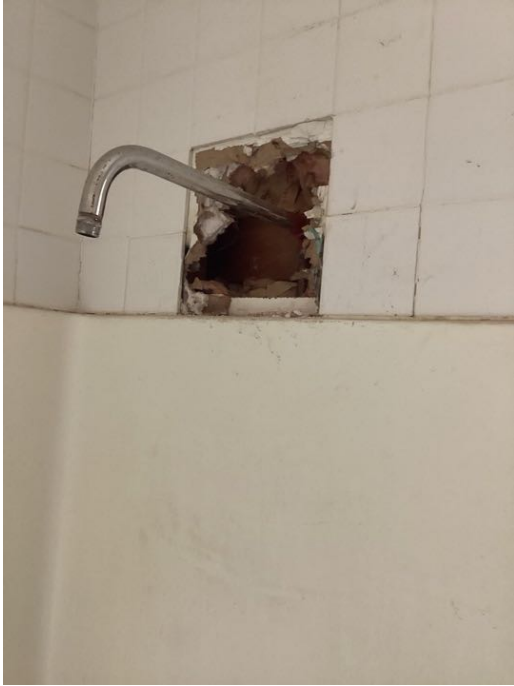
**MAIN** **s-123:** Shower surround and bathroom two is fiberglass and incorporated with the bathtub. The surround show signs of where and tear recommend refinishing or replacing.

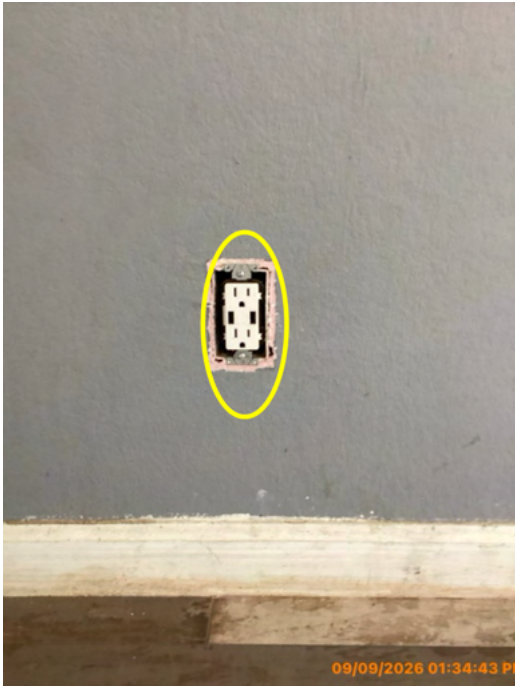
**MAIN** **s-138:** The east receptacle cover plate is missing We recommend it be replaced during the course of normal maintenance.

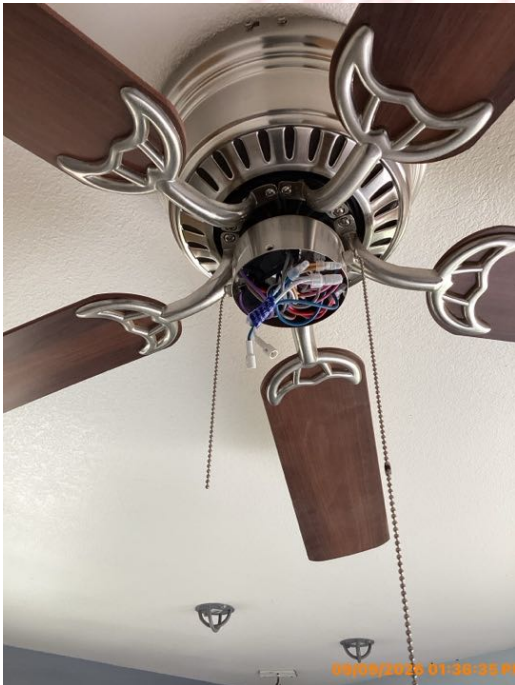
**MAIN** **s-140:** The switches for the fan operated normally and energized the fan. The light in the fan was not installed and it is unknown if the light switch operates normally.

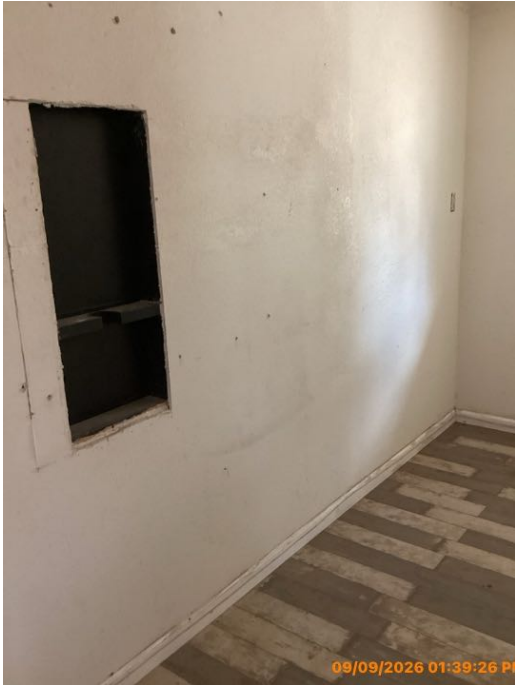
**MAIN s-142:** The walls are generally serviceable, except for the item(s) noted. painting in the master bedroom and patching in the master closet are required. In picture #1 below is what would be considered the closet area.
