GEOTECHNICAL INVESTIGATION REPORT
FOUNDATIONS REPAIR FOR A SINGLE-FAMILY HOME
3120 ELVIDO DRIVE, LOS ANGELES, CA 90049
(APN 4490-004-044)

ZS Engineering #180902

November 19, 2018

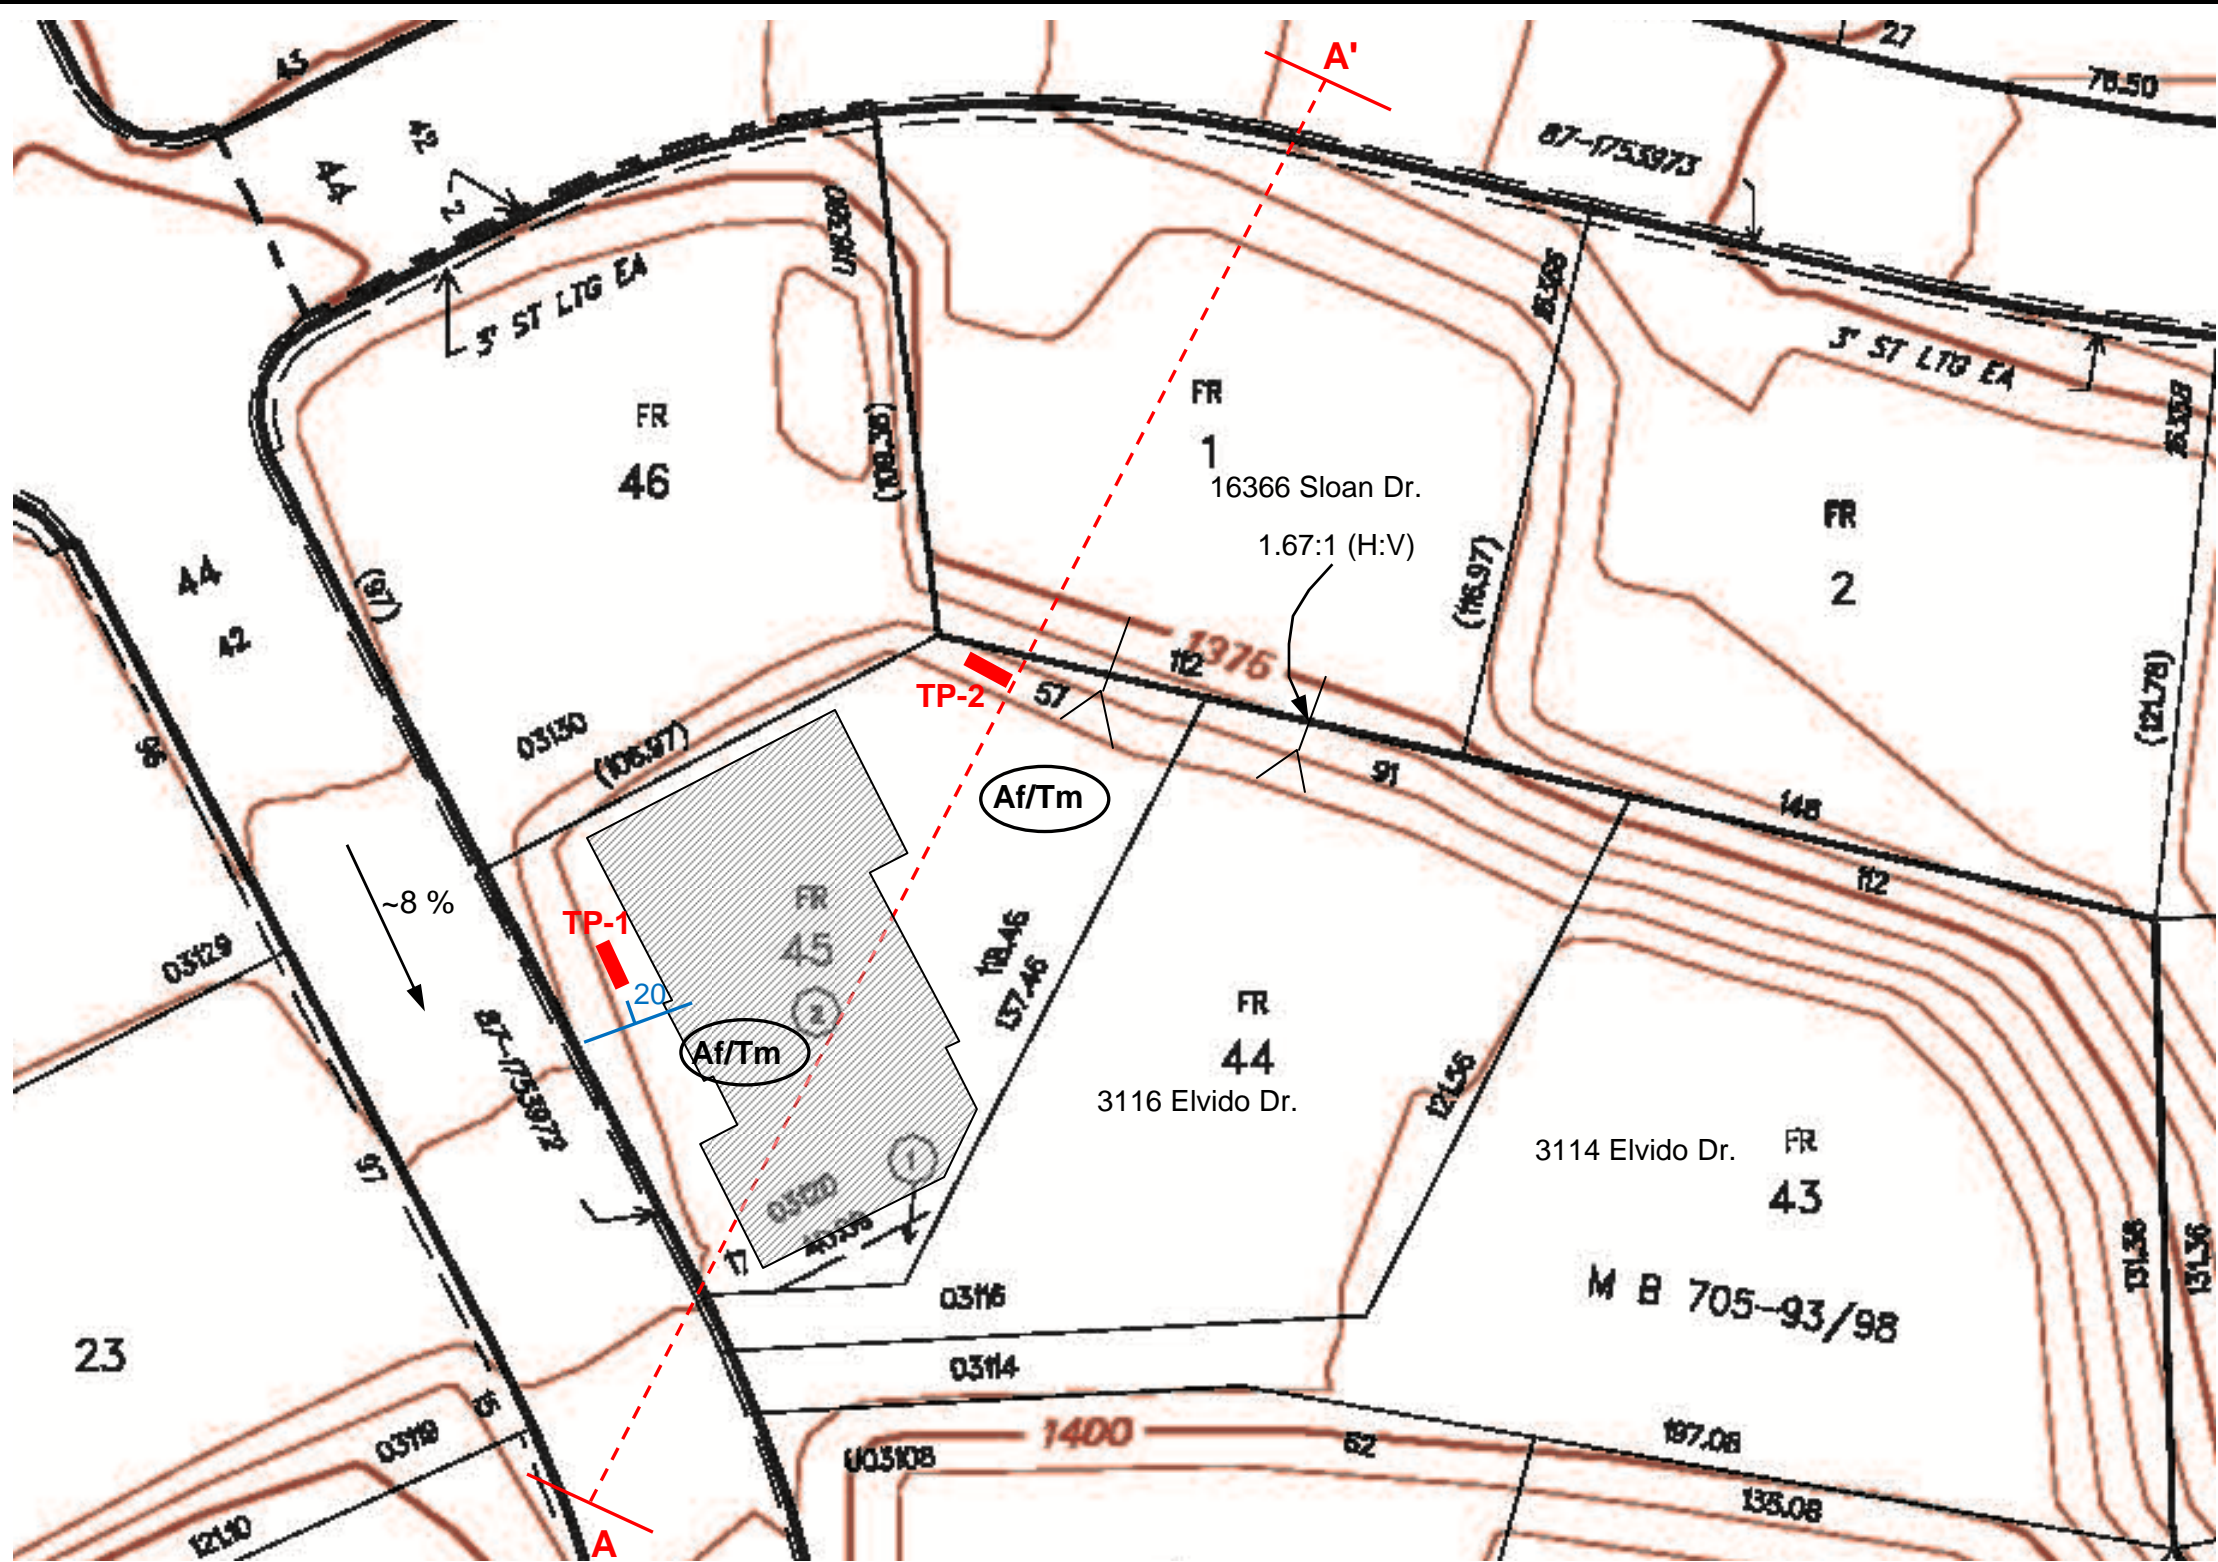
Figure 2 – Site Topography, Exploration & Geology Map
 Residential Lot at 3120 Elvido Drive, Los Angeles, CA 90026

Bedrocks as exposed in the test pits, consist of shaly siltstone with fine grained sandstone interbeds, thinly bedded and moderately hard. Shale units are found to be dark grayish brown with orange stains along bedding, while the sandstone units are found to be light brown. The bedrock structure strikes northeast and dips generally toward northwest at about 20 degree angle.

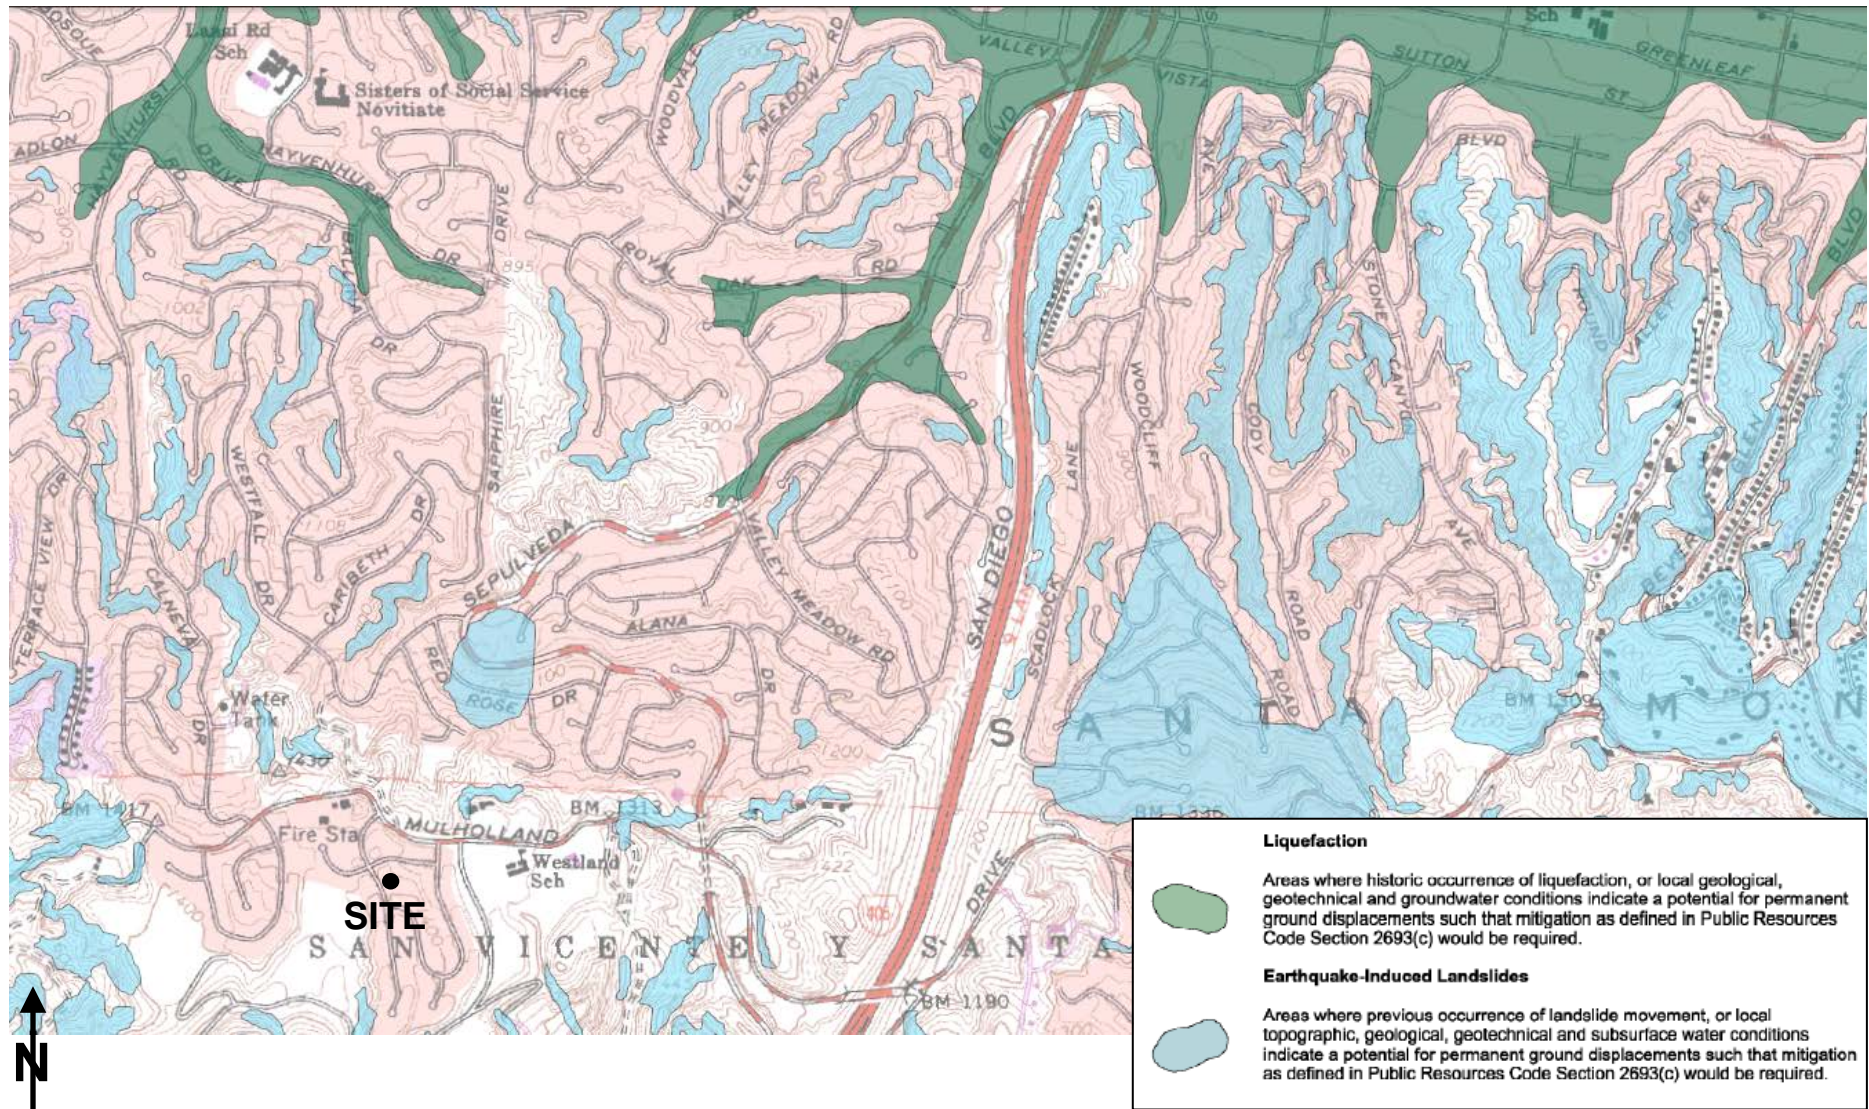
Figure 5 – Seismic Hazard Zones Map

The site is not mapped within a liquefaction hazard zone as shown in Figure 5, *Seismic Hazard Zones Map*, which is excerpted from state's seismic hazard zones map (CGS, 1998). Historic shallow groundwater level at this site and its close vicinities is deeper than 50 feet as documented in the state's seismic hazards report (CGS, 1997). Due to deep groundwater, potential for liquefaction does not exist for this site.

The site is not mapped within any landslide hazard zone as shown in Figure 5, *Seismic Hazard Zones Map*. The building sits on a flat pad at an elevation about 6 to 9 feet above the pavement of Elvido Drive. The downsloping grade on the rear yard of this lot that descends about 15 feet to a neighboring lot at an inclination about 1.67:1 (horizontal:vertical). During this investigation, this slope was found to be vegetated and stable without any sign of surficial failure, distress, creep,

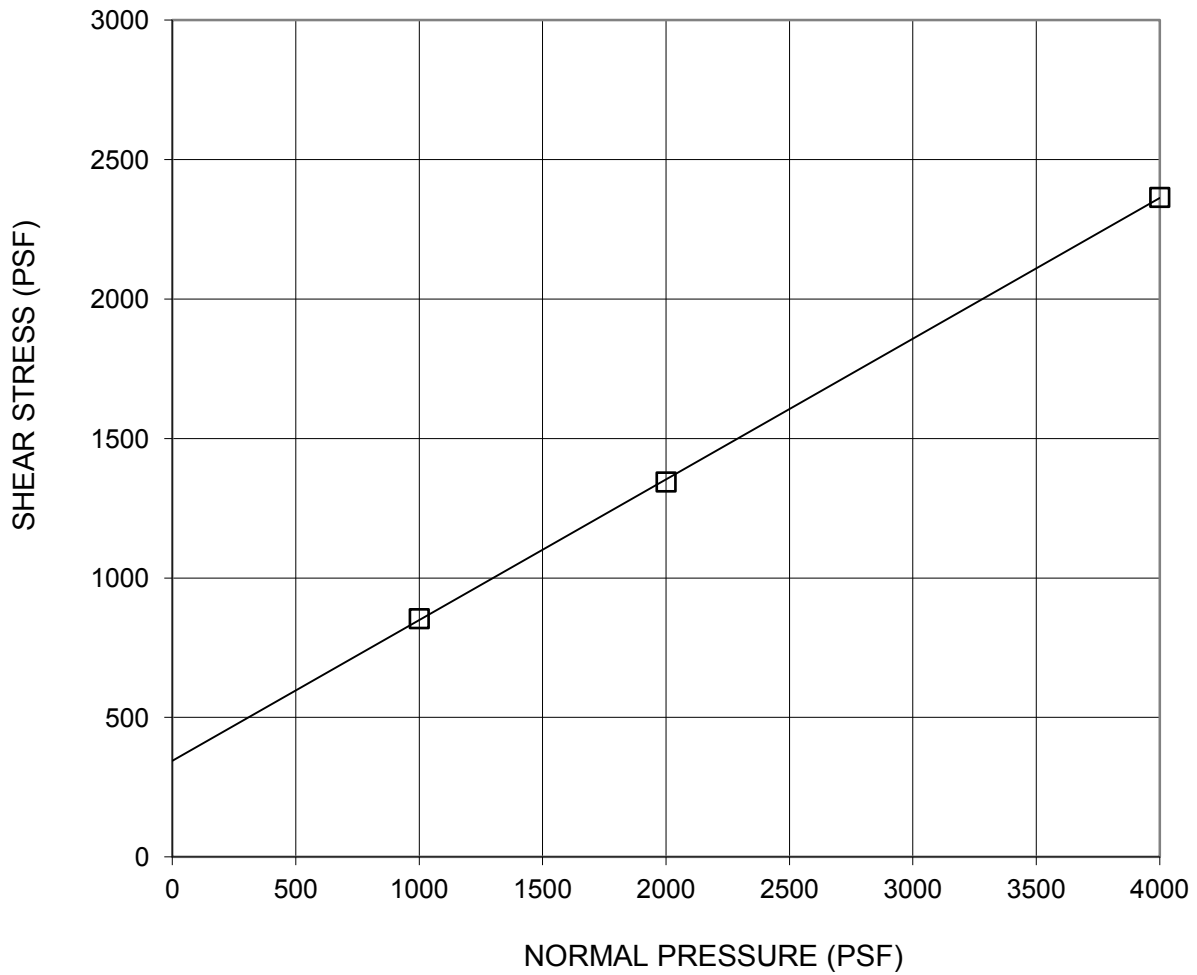
SHEAR STRENGTH	BORING NO.	DEPTH (FT)	SAMPLE TYPE	SOIL TYPE	COHESION (PSF)	FRICTION ANGLE (DEG)
Ultimate	TP-1	4	Undisturbed Ring	Silty Clay (CL)	345	26.7

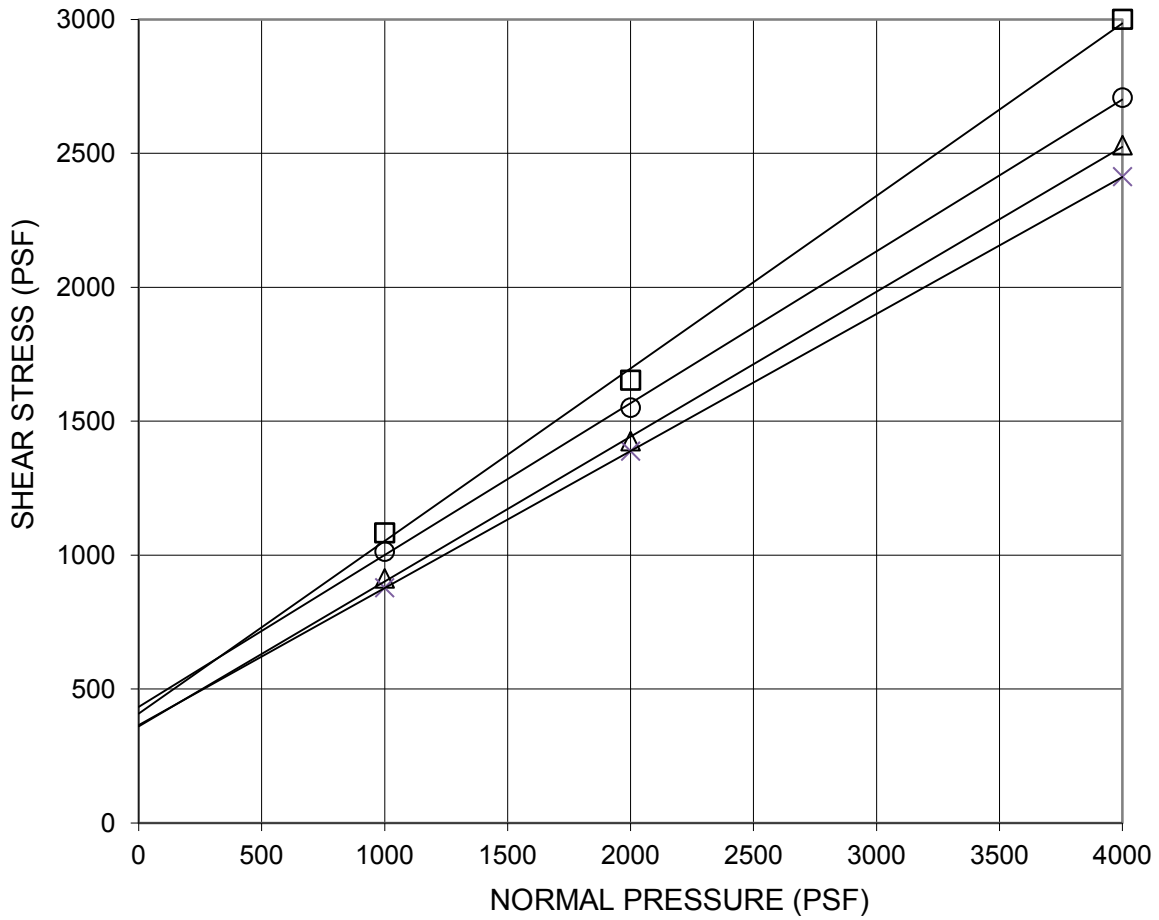
DIRECT SHEAR TEST
(ASTM D3080)

SYMBOL	SHEAR STRENGTH	DEPTH (FT)	SAMPLE TYPE	SOIL TYPE	COHESION (PSF)	FRICTION ANGLE (DEG)
1st Pass □	Residual (Ultimate)	7	Undisturbed Ring	Shaly Siltstone, Bedrock	365	27.1
2nd Pass ○						
3rd Pass △						
4th Pass X
