## HOME INSPECTION

8167 Vista Dr  
La Mesa, CA 91941

09/10/2024

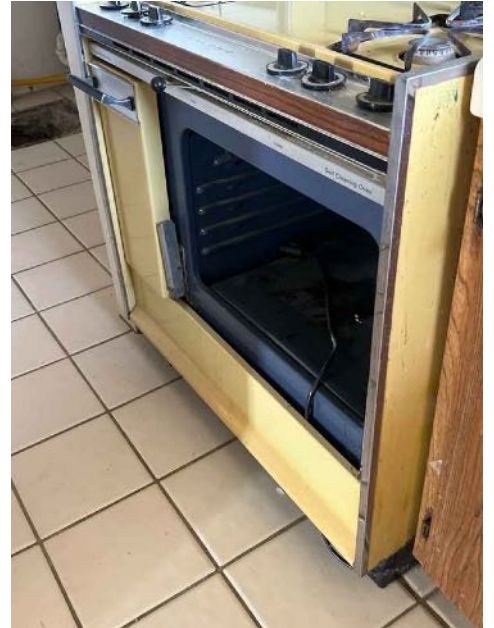
**DOOR - DAMAGED**

The oven door is damaged.

## Recommendation

Contact a qualified appliance repair professional.

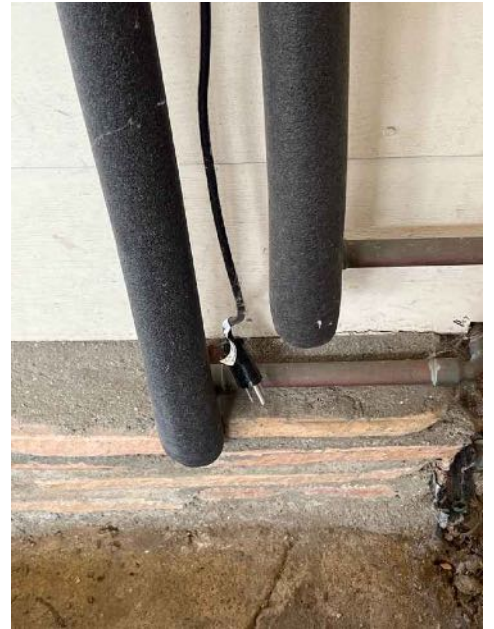
**TANKLESS WATER HEATER**

The tankless water heater was not plugged in at the time of inspection. We recommend having this plugged in in the unit tested for proper function.

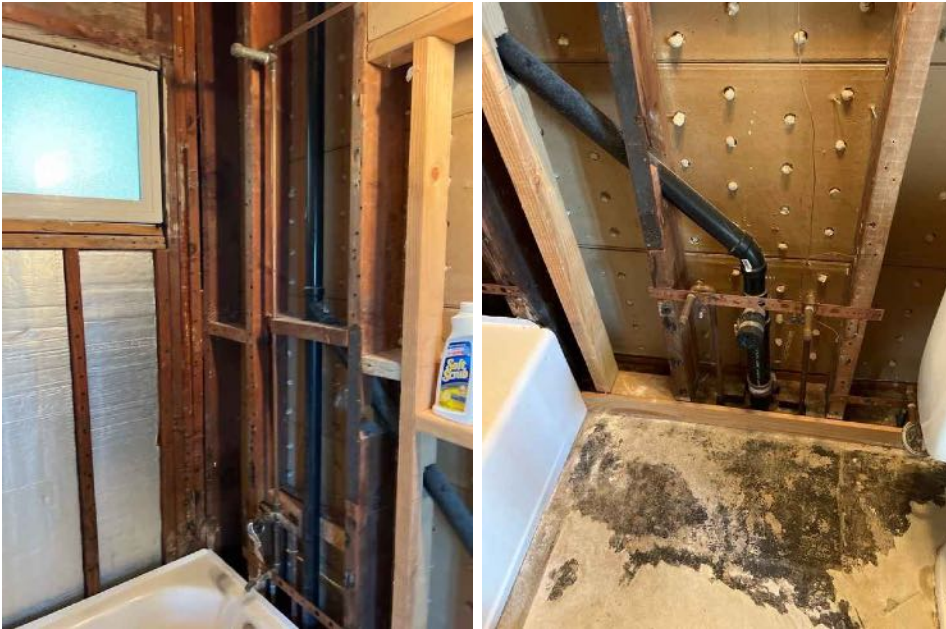
## 3.3.1 FAUCETS, VALVES AND CONNECTED FIXTURES

**PLUMBING FIXTURES**

Plumbing fixtures missing in the hall bathroom. We recommend further review and install installation with a plumbing contractor.

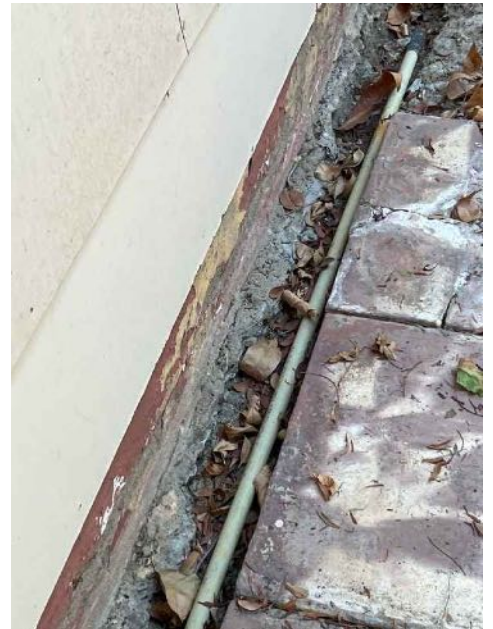
**GAS LINE**

Gas line was abandoned at the rear of the home. We recommend having this removed if not needed.

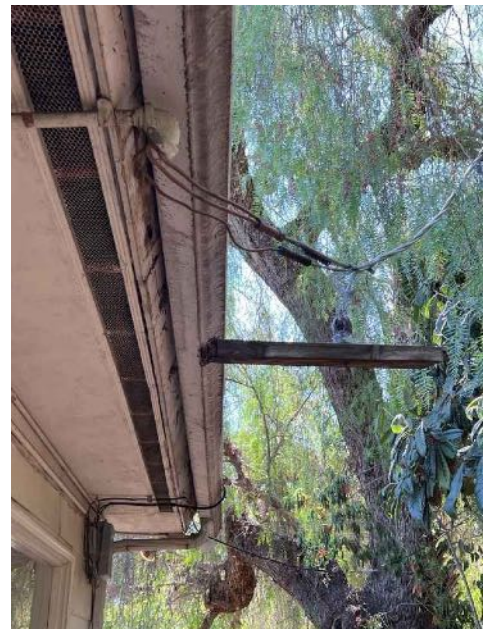
#### 4.3.3 OVERHEAD SERVICE ENTRANCE CONDUCTORS

#### **OVERHEAD SERVICE**

The anchor for the overhead service was damaged. We recommend further review and repair with a qualified electrical contractor.

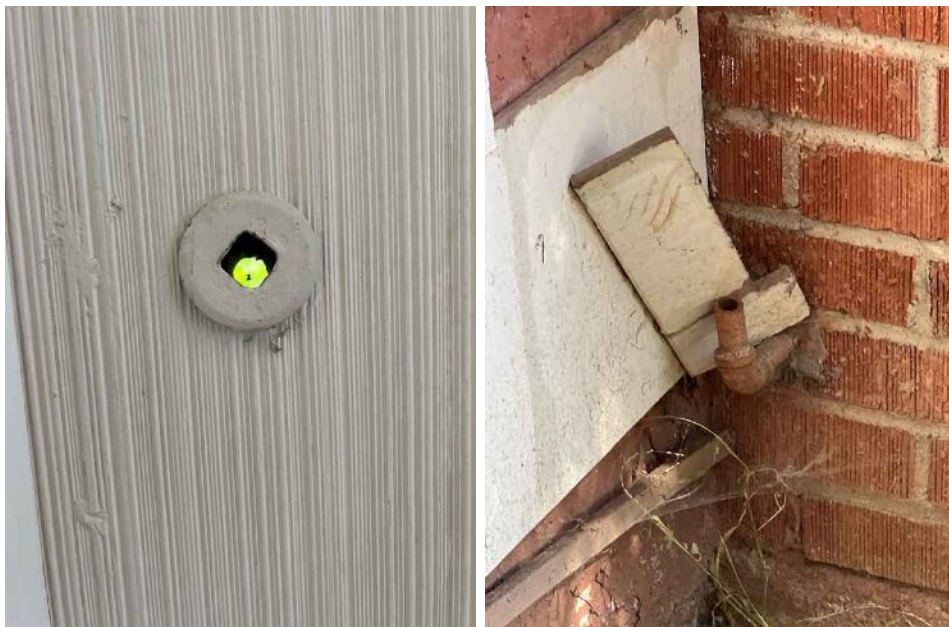
### 7.5.1 OPERATING CONTROLS

#### **FIREPLACE**

The gas valve for the fireplace has been removed. We recommend repair as needed with a qualified plumbing contractor.

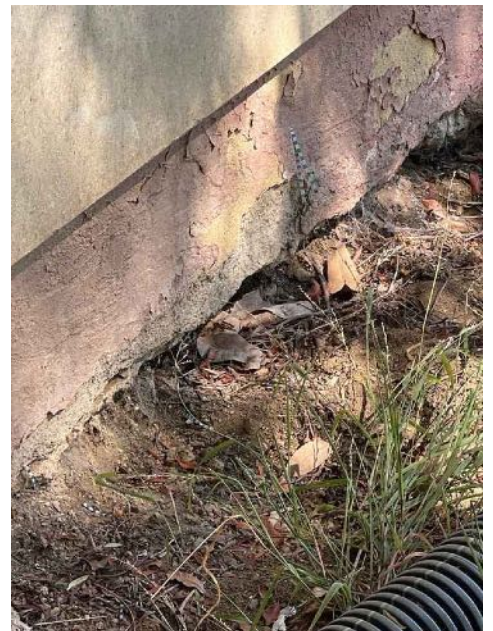
**SLAB**

Slab of the home was being undermined. We recommend further review and repair with a qualified structural contractor.
