Home Inspection Report

22234 Prospect Street #1-3, Hayward

Jose Lares
June 26, 2024

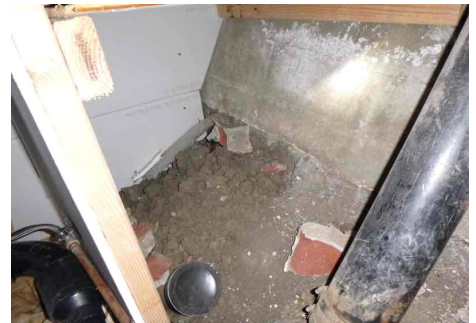
Photo 28

1. Sections of the foundation at the left side of the basement have been undermined. If not addressed, should the soil give way under this area, a significant structural failure could develop. The owner is advised to contact the appropriate tradesperson. (See Photo 28)

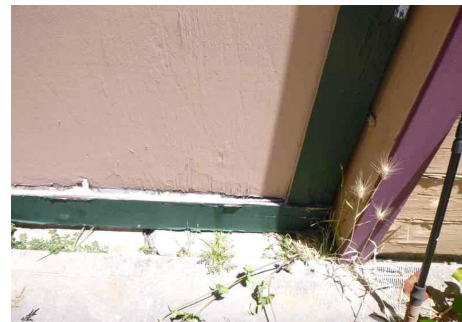
Photo 02

4. The main garage door is water damaged. We recommend the services of a licensed general contractor and/or structural pest control company regarding repairs. (See Photo 2)

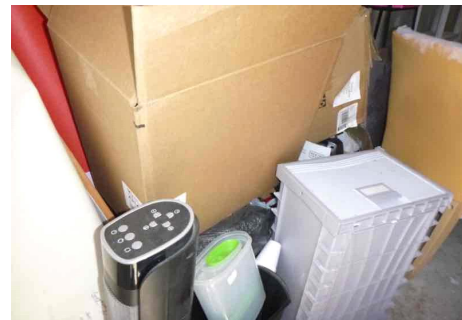
Photo 17

5. Personal storage was blocking access to the interior of the garage. Therefore, the area is considered inaccessible and was not fully inspected. With access and an opportunity for complete inspection, conditions in need of attention may be discovered. Ideally, the personal belongings should be removed so the area may be inspected. (See Photo 17)

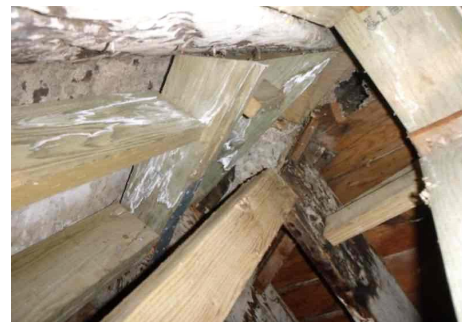
Photo 34

6. Water damage was noted at the front porch. We recommend the services of a licensed general contractor and/or structural pest control company. (See Photo 34)

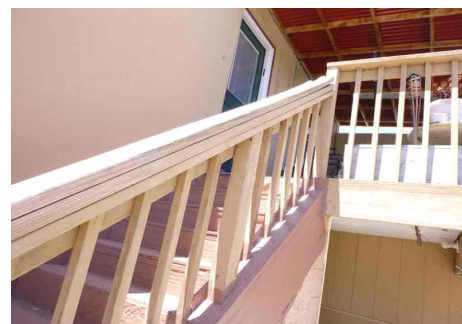
Photo 16

7. The openings in the rear staircase railing(s) are larger than 4" inches. It is recommended that this be corrected for improved safety. (See Illustration 3N) (See Photo 16)

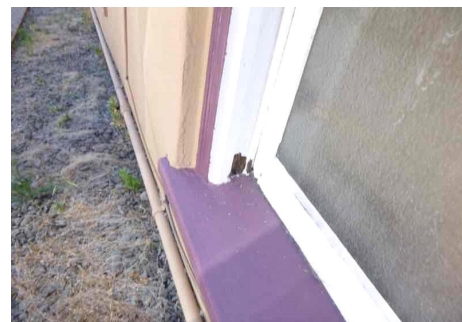
Photo 22

8. One or more windows show evidence of water damage to the sill/jamb. We recommend the advice and services of a general contractor and/or structural pest control company regarding repairs. (See Photo 22)

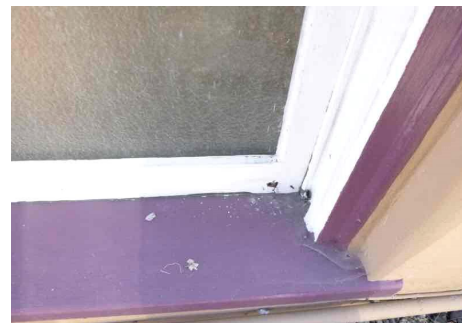
Photo 21

9. Multiple window frames/sashes show evidence of water damage. We recommend the advice and services of a general contractor and/or structural pest control company regarding repairs. (See Photo 21)

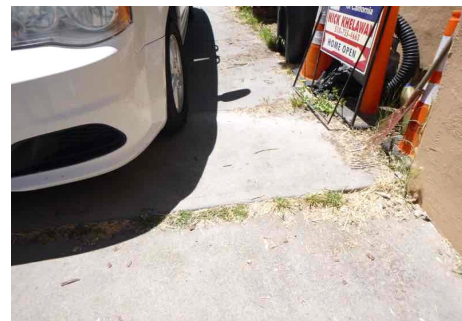
Photo 19

10. The cracked and heaved sections of the driveway present a trip hazard. This condition should be corrected for improved safety. (See Photo 19)

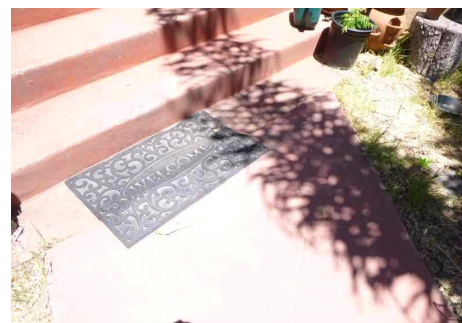
Photo 20

11. The cracked and heaved walkway section(s) at the front present a trip hazard. This condition should be corrected for improved safety. (See Photo 20)

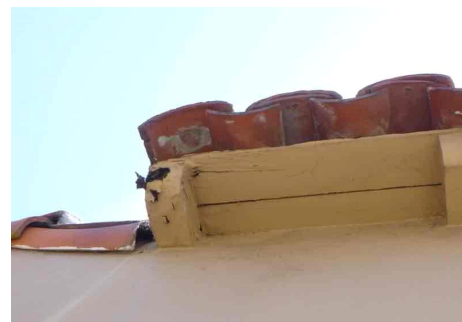
Photo 24

12. Water damage was observed to the roof eaves/sheathing at the left side of the structure. We recommend the services of a licensed general contractor and/or structural pest control company. (See Photo 24)

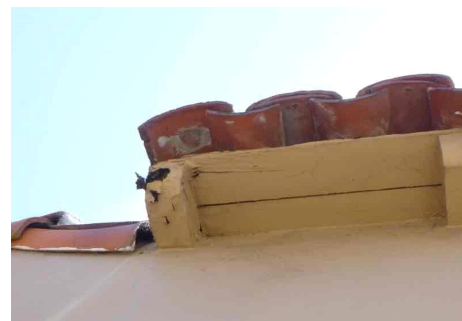
Photo 24

13. Water damage was observed to the rafters at the left side of the structure. We recommend the services of a licensed general contractor and/or structural pest control company. (See Photo 24)

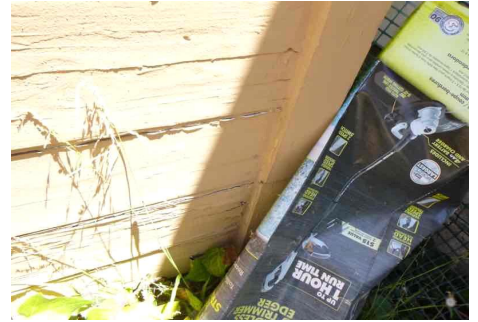
Photo 03

14. Water damage was observed to the wood siding at the garage exterior walls. We recommend the services of a licensed general contractor and/or structural pest control company. (See Photo 3)

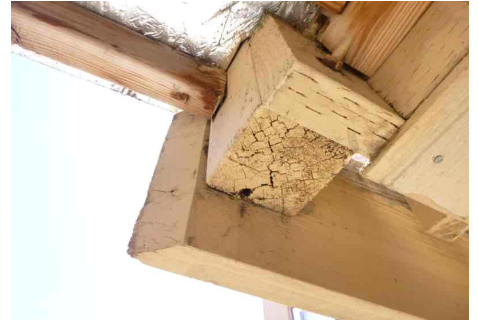
Photo 05

15. The railing at the rear deck is water damaged. We recommend the services of a licensed general contractor and/or structural pest control company. (See Photo 5)

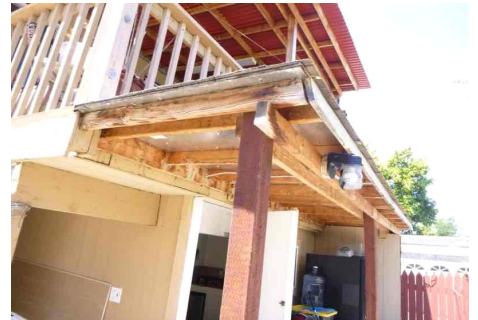
Photo 04

16. The rear patio cover is improperly constructed. The existing configuration indicates improper design and/or workmanship and is a major safety issue should the patio cover give way due to lateral forces or seismic activity. We recommend the patio cover be removed or replaced according to local building codes. (See Photo 4)

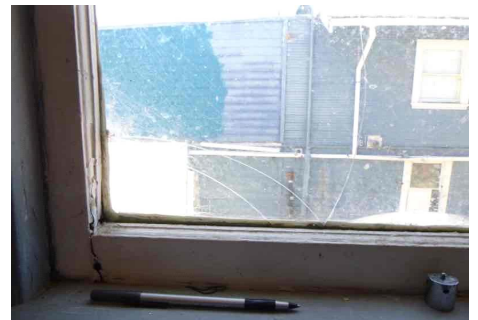
Photo 41

17. Cracked or broken window glass at the upstairs kitchen should be replaced. (See Photo 41)

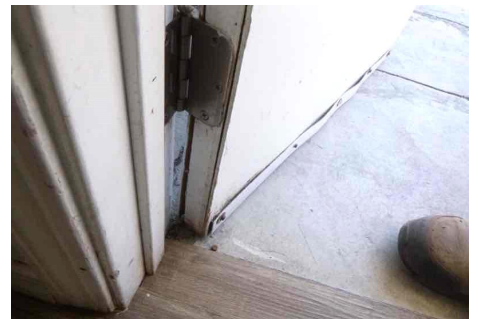
Photo 09

18. Mechanical damage was noted at the downstairs rear left bedroom exterior door. We recommend it be repaired or replaced. (See Photo 9)

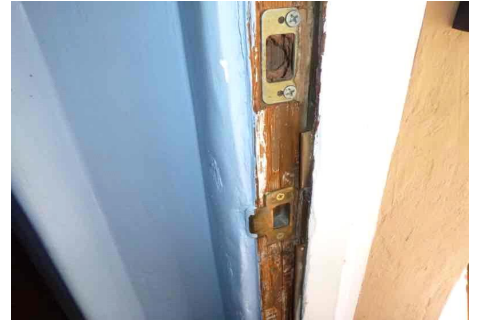
Photo 36

19. The jamb is cracked, split or damaged at the front door. We recommend it be repaired or replaced. (See Photo 36)

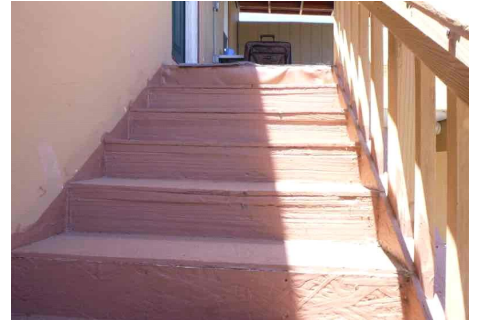
Photo 18

20. Water damage was noted at the rear deck staircase. All damaged wood members should be repaired or replaced as necessary. We recommend the services of a licensed general contractor and/or structural pest control company. (See Photo 18) (See Photo 7)

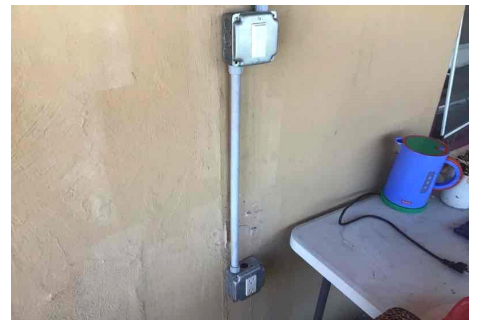
Photo 48

21. Exterior receptacles at the rear wall are missing a weatherproof cover plate. We recommend an approved exterior cover be installed. (See Photo 48)

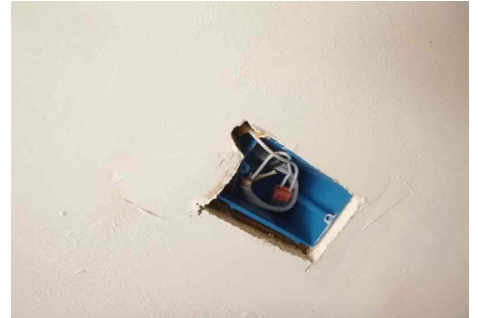
Photo 06

22. Exposed electric connections or open junction boxes at the rear left downstairs bedroom, hallway and basement area should be corrected. All electric connections should be made inside approved junction boxes fitted with proper cover plates. (See Photo 6) (See Photo 27)

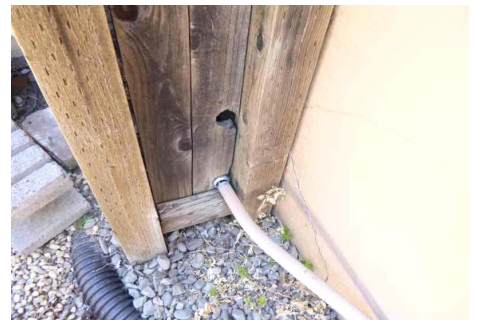
Photo 23

23. The conduit installed at the left exterior wall is damaged. We recommend that this conduit be repaired or replaced. (See Photo 23)

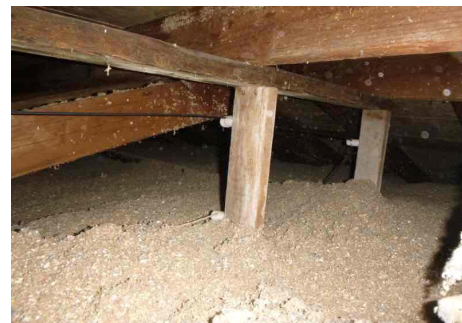
Photo 46

24. Older knob and tube wiring in the attic should not be covered with insulation. Insulation should be pulled back or the knob and tube wiring be replaced. (See Photo 46)

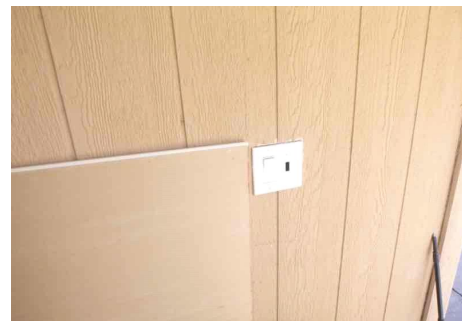
Photo 08

25. An exterior switch at the rear exterior wall is missing a water proof cover plate. We recommend an exterior approved cover be installed. (See Photo 8)

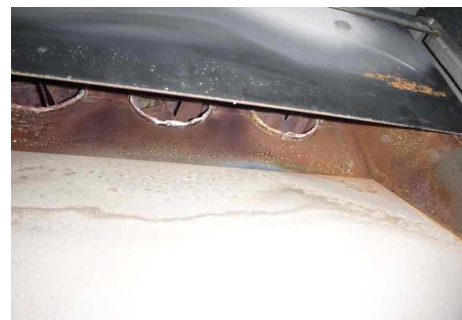
Photo 32

26. The heat exchanger is rusted, streaked and worn where visible from the exterior. These conditions indicate that it is at or near the end of its service life. We recommend inspections of the unit by the local utility company or a licensed heating contractor, to determine if repairs or replacement is necessary. (See Photo 32)

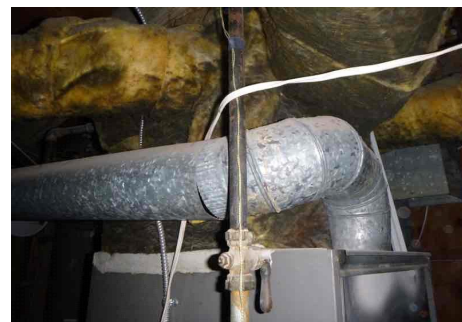
Photo 31

27. For enhanced safety, it is recommended that the loose and leaking connections of the furnace exhaust flue system be corrected. (See Photo 31)

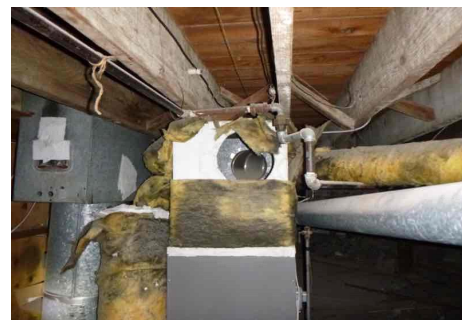
Photo 29

28. One or more of the heating ducts have come apart or have been removed at the plenum. This will allow conditioned air into surrounding area. We recommend they be repaired and secured. (See Photo 29)

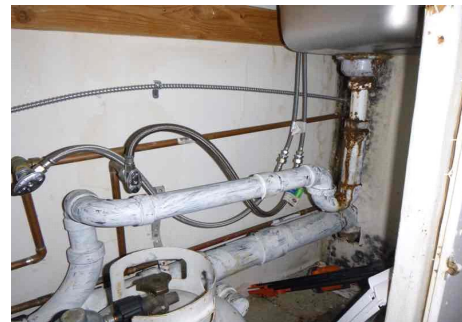
Photo 13

29. The drain systems at the rear downstairs kitchen sink and upstairs laundry sink were improperly installed. We recommend the drains be reconfigured according to industry standards. (See Photo 13) (See Photo 39)

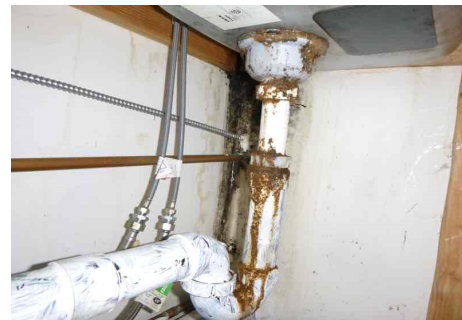
Photo 11

30. The sink drain at the rear left downstairs bedroom kitchenette is leaking. We recommend all leaks be repaired. (See Photo 11)

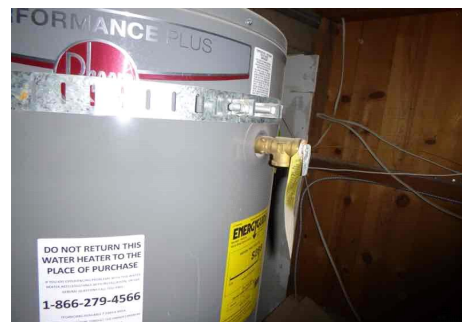
Photo 30

31. The temperature and pressure relief valve for the water heater lacks a proper discharge pipe. We recommend the installation of approved piping to an approved location. (See Photo 30)

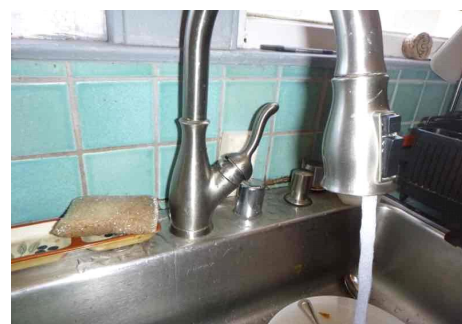
Photo 40

32. Leakage was noted at the sink faucets and/or handles at the downstairs kitchenette and upstairs kitchen. We recommend all leaks be repaired. (See Photo 40) (See Photo 10)

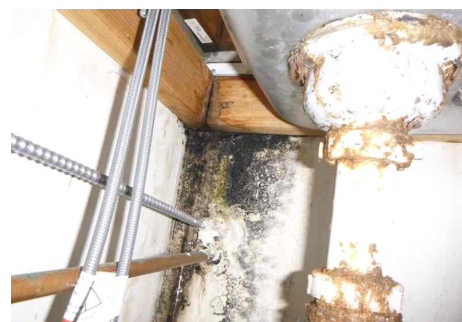
Photo 12

33. The wall at the rear downstairs bedroom kitchenette sink cabinet shows evidence of water damage. We recommend the services of a licensed structural pest control company for investigation. (See Photo 12)

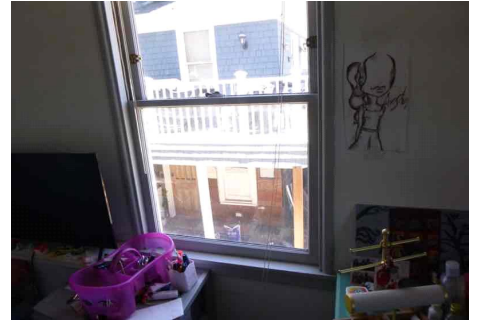
Photo 37

34. Multiple interior windows are inoperable, stuck, or painted shut. We recommend repair or replacement to restore functional use of these areas. (See Photo 37)

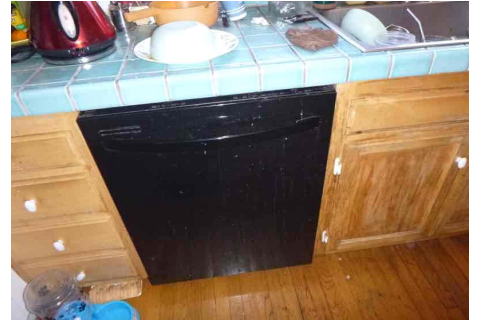
Photo 42

35. At the time of our inspection the dishwasher was inoperative or disconnected therefore was not tested. For attention to the conditions noted and/or cost estimates, if necessary, we recommend the advice of a qualified appliance technician. (See Photo 42)

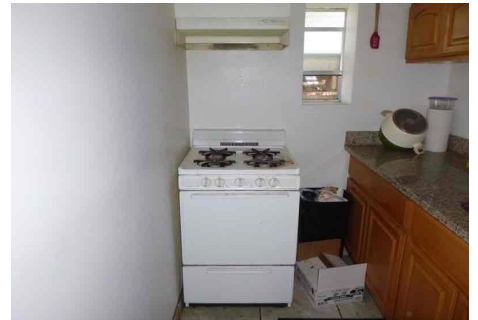
Photo 35

36. One or more of the burners on the downstairs cooktop/range top are inoperative or will not light. The pilot lights or electronic igniters are in suspect. For attention to the conditions noted and/or cost estimates, if necessary, we recommend the advice of a qualified appliance technician. (See Photo 35)

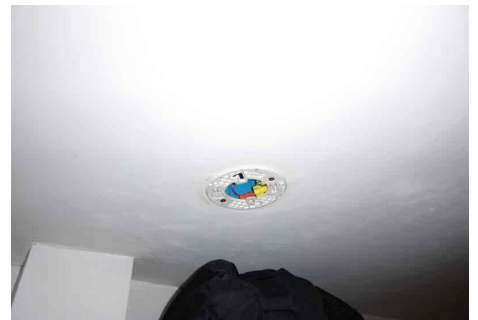
Photo 15

37. This home does not have enough smoke detectors installed. The installation of smoke detectors should be placed on each floor in non-sleeping areas. In addition, one smoke alarm must be installed in each room where sleeping occurs and one smoke alarm should be located in each hallway that leads directly to sleeping rooms. (See Photo 15)

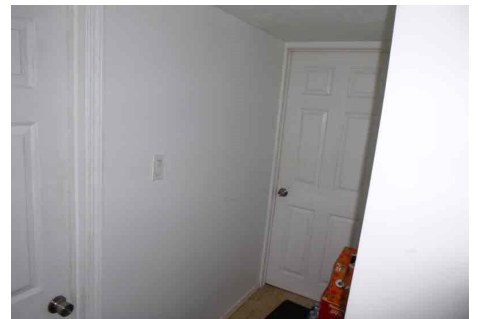
Photo 25

38. The inaccessible areas at the front and middle right side downstairs bedrooms were locked at the time of our inspection. Therefore this area was not inspected. With access and an opportunity for a complete inspection, conditions in need of attention may be discovered. We recommend the areas be made accessible and further inspected. (See Photo 25)

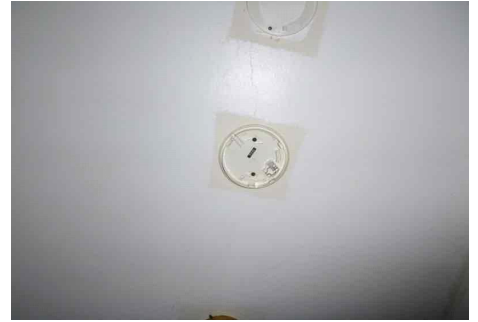
Photo 44

39. California law requires that all homes have a State Fire Marshall approved Carbon Monoxide Detector be installed outside of the sleeping areas in the hallway and on each level of the home including basements. At the time of this inspection a Carbon Monoxide Detector could not be located. We recommend consulting with the owner to see if a Carbon Monoxide Detector exists and if not they should be installed in all required locations. (See Photo 44)

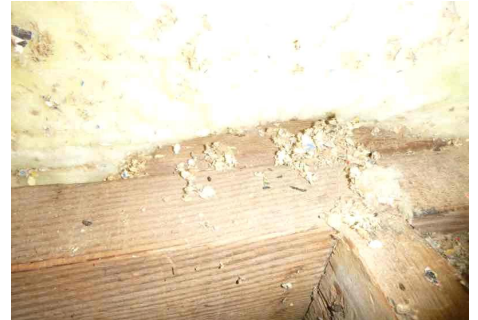
Photo 45

40. Evidence of vermin activity was observed within the structure. It is likely this evidence will extend into inaccessible areas. The owner is advised to contact the appropriate trade for further evaluation and remedial measures if necessary. (See Photo 45)

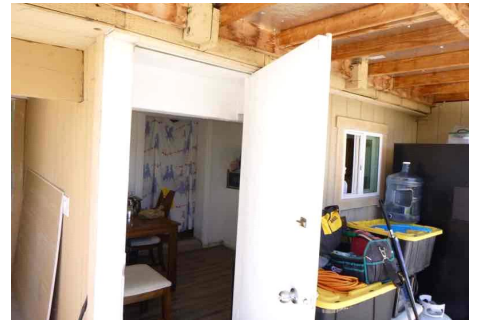
Photo 14

41. Portions of the interior at multiple locations appear to be altered or built to non-conforming standards. The local building official is the final arbiter of standards. We recommend further inspection by appropriate trades and consultation with the owner to determine if all necessary permits were obtained and completed. (See Photo 14) (See Photo 26)

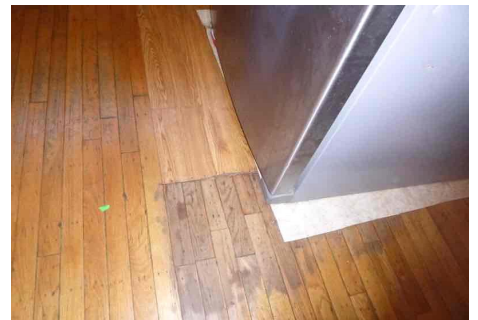
Photo 43

42. Damage to the upstairs kitchen hardwood flooring was observed. It is recommended that the source of the damage be identified and corrected, and the surface be repaired and refinished to restore its appearance. (See Photo 43)

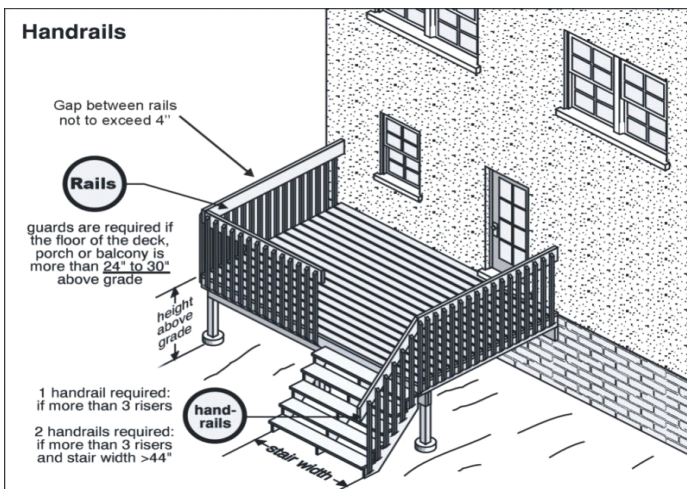
Illustration 3N

- ! 3. The openings in the rear staircase railing(s) are larger than 4" inches. It is recommended that this be corrected for improved safety. (See Illustration 3N) (See Photo 16)
