CAL-WEST PROPERTY INSPECTIONS

CAL-WEST PROPERTY INSPECTIONS HOME MAINTENANCE REPORT

9641 Follett Dr
Santee, CA 92071

Knute Brookshier
JANUARY 15, 2025

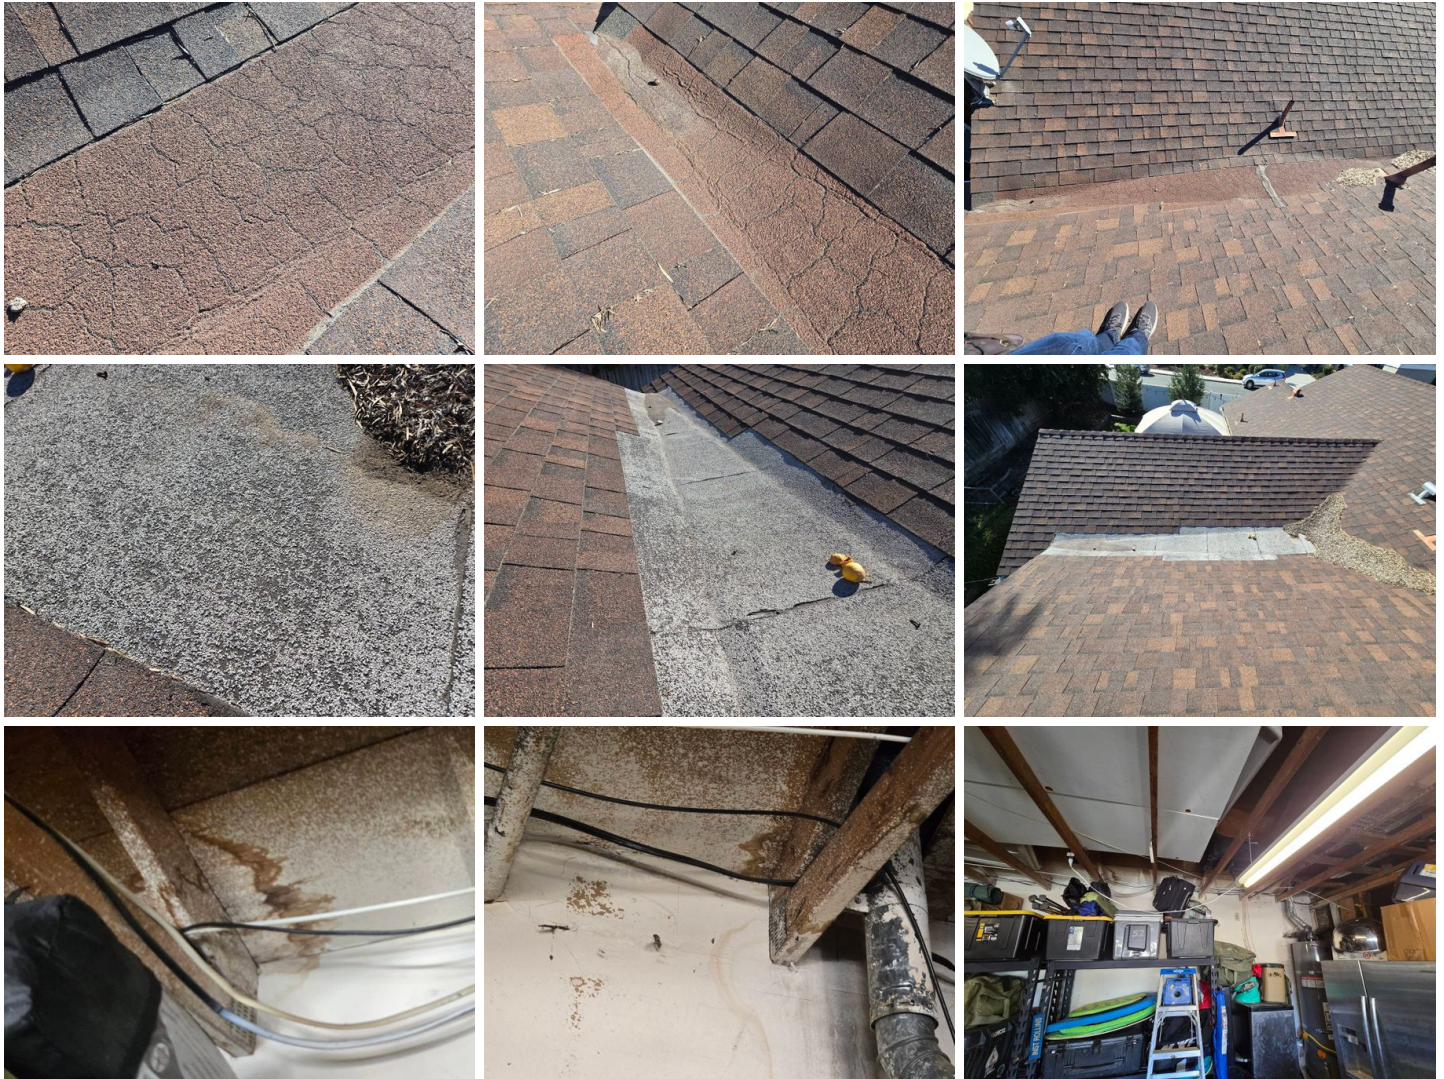
PARTIAL PREVIOUS REPLACEMENT

At the time of the inspection there were one or more areas of the roof with different aged materials present. It is likely the older materials were not part of the most recent repairs and or replacement.

Inspector Notes: Roll roofing materials at the valleys appears to be from previous roof covering. All of the Shingle area of the roof appears to have been recently replaced and in good condition.

Staining present at garage where older roofing material is located

Recommendation

Contact a qualified roofing professional.

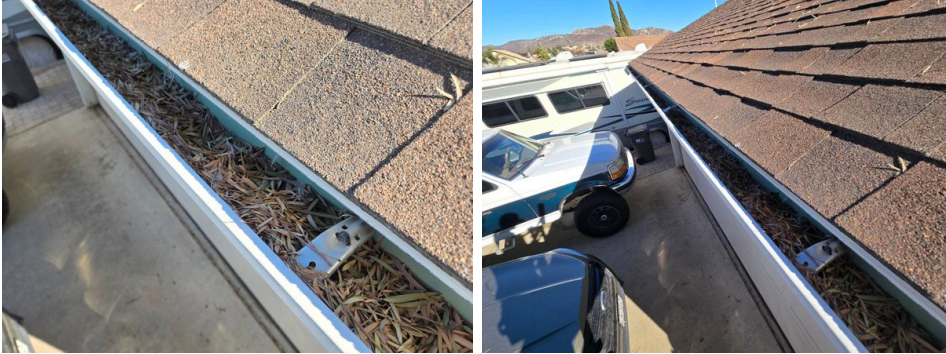
3.3.1 Roof Drainage Systems

At the time of the inspection there was debris present in one or more gutters, affecting the drainage flow. Recommend cleaning gutters to facilitate better water flow. Correction is advised.

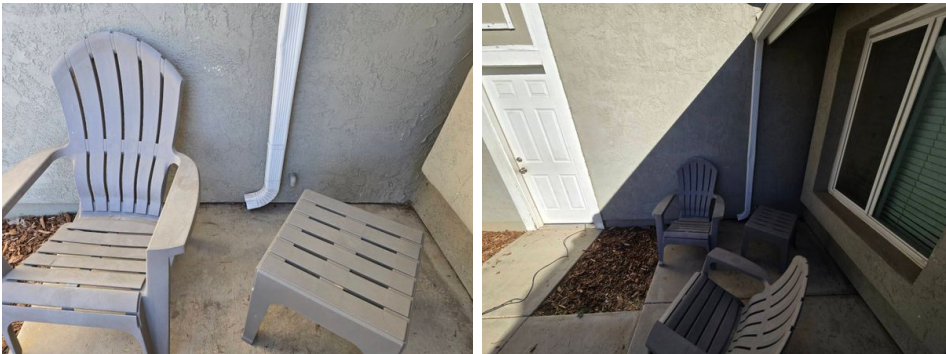
3.3.2 Roof Drainage Systems

At the time of the inspection one or more downspouts drained too close to the building's foundation. It is best to have gutter downspouts connect to landscaping drainlines if possible. Otherwise, 3-6 foot downspout extensions are advised if it is not possible to connect to landscaping drains. Correction is advised.

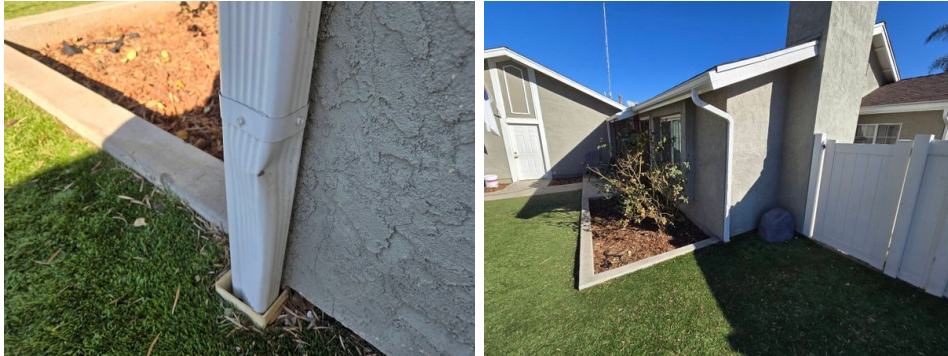
3.3.3 Roof Drainage Systems

DENTED GUTTER SECTION

At the time of the inspection there were one or more sections of the gutters suffering from dents or minor damage. Correction is advised.

Recommendation

Contact a qualified professional.

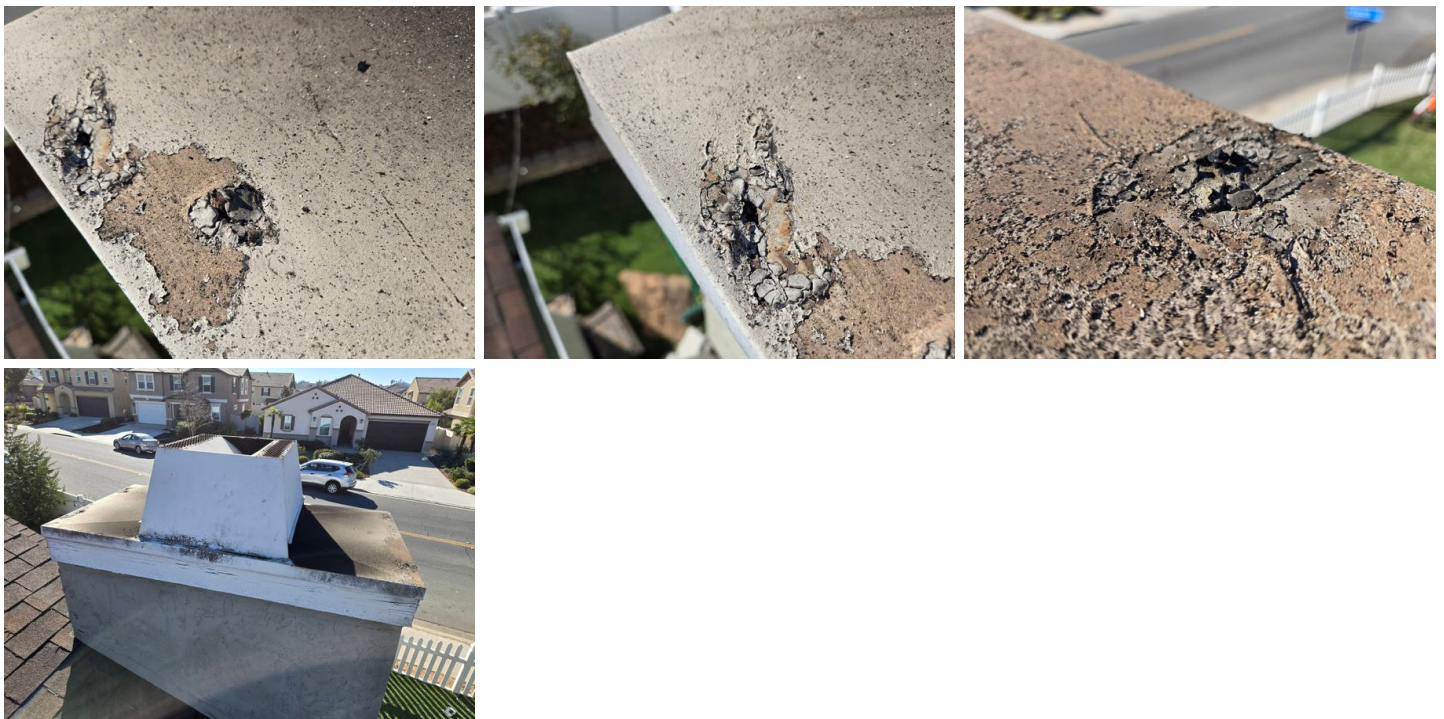
3.4.1 Chimneys

CHIMNEY FLASHING SEALANT IS CRACKED OR DETERIORATED

Chimney flashing sealant is cracked or deteriorated likely from age and differed maintenance. Applying new sealant is suggested to prevent further deterioration and water intrusion. Further evaluation and repair by a qualified professional is advised.

Recommendation

Contact a qualified professional.

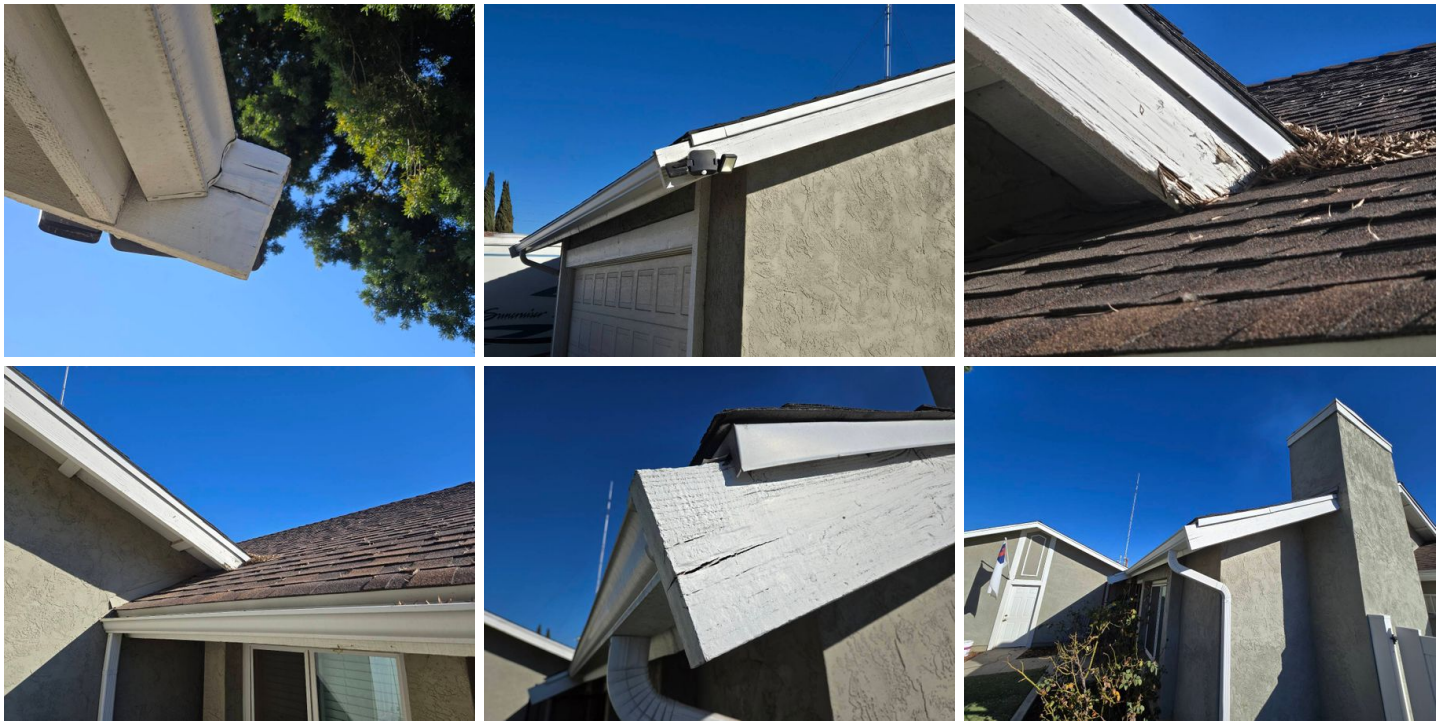
WOOD ROT DAMAGE

At the time of the inspection there were one or more areas of the exterior wood products suffering from wood rot deterioration. Correction is advised.

Recommendation

Contact a qualified roofing professional.

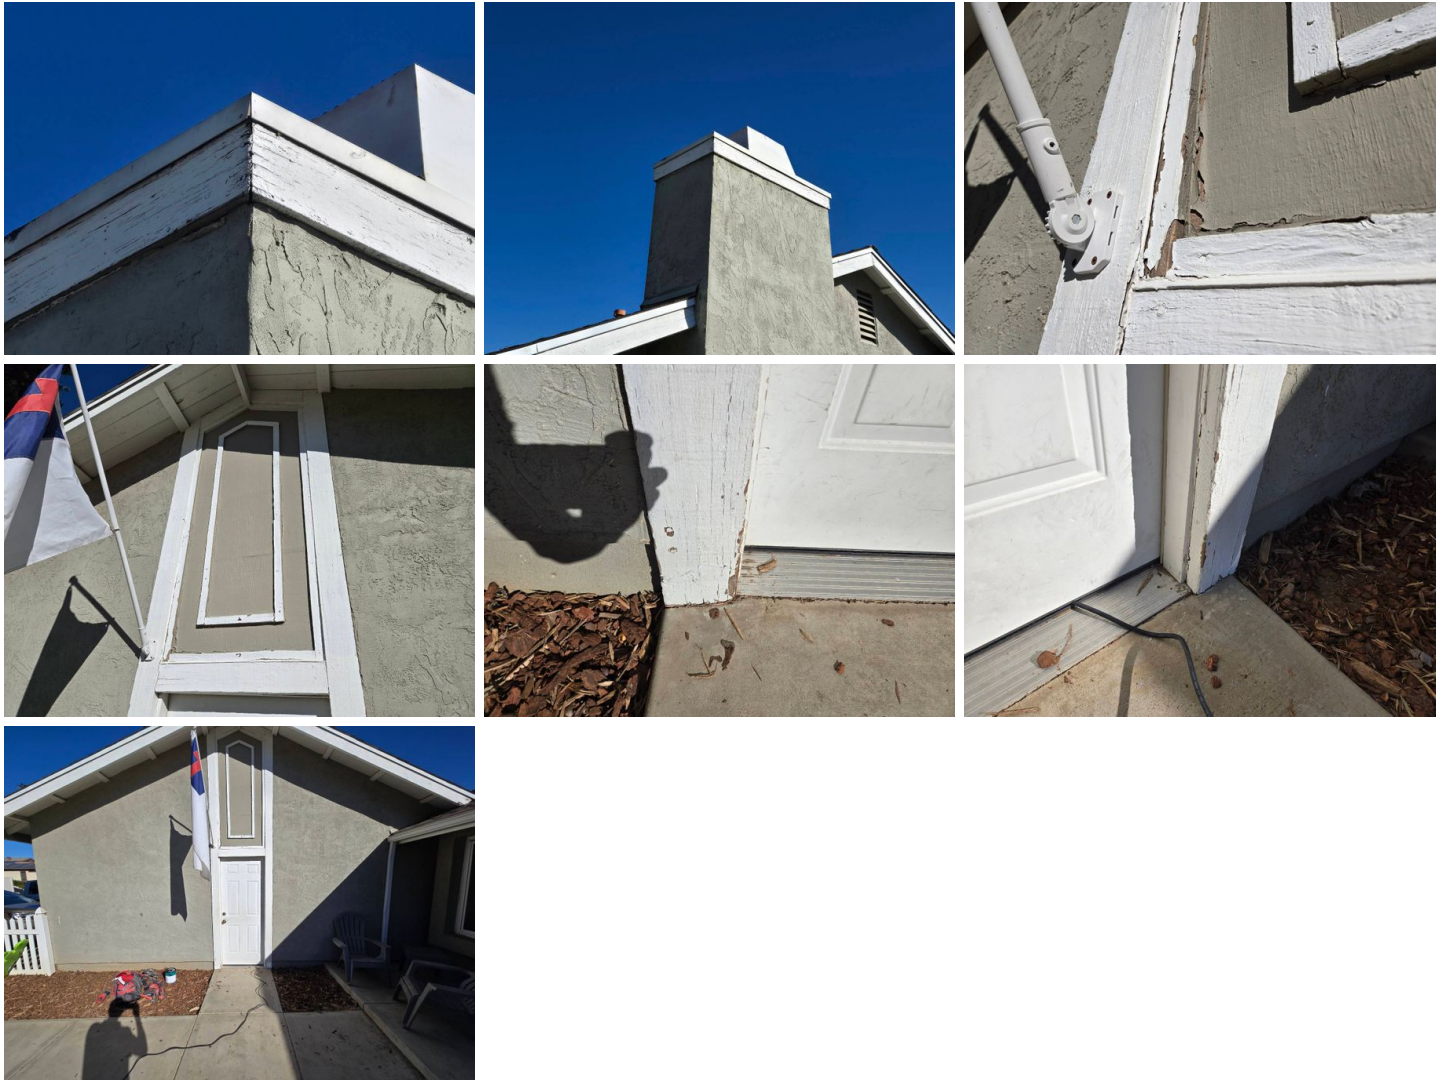
5.2.1 Siding, Flashing & Trim

The exterior wood products and trim on the building were in need of paint at the time of inspection. Differed paint maintenance can lead to deterioration of siding and trim products. It is recommended to paint the exterior wood products of the building to prevent future damage to the siding materials. Further evaluation and correction by a qualified painting contractor is advised.

Recommendation

Contact a qualified painting contractor.

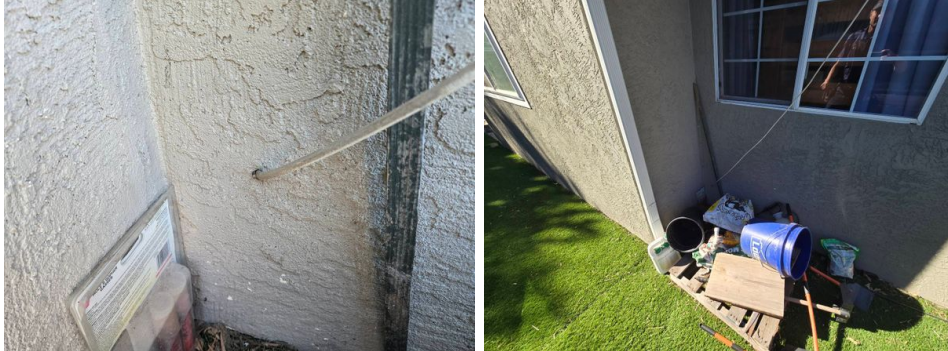
5.2.2 Siding, Flashing & Trim

OPEN STUCCO PENETRATIONS

At the time of the inspection there were one or more open stucco penetrations at the exterior of the building. Open stucco penetrations can allow for unwanted pests and or water intrusion to the interior of the wall. Correction is advised.

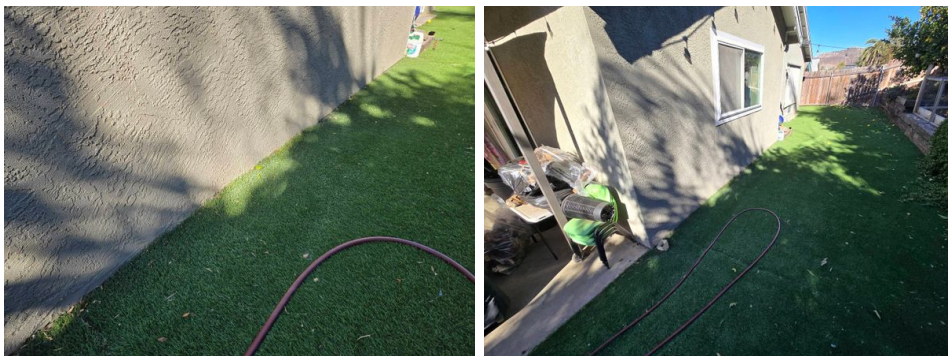
5.2.3 Siding, Flashing & Trim

Inspector Notes: Recommend lowering landscaping material for proper ventilation of weep screed

Recommendation

Contact a qualified professional.

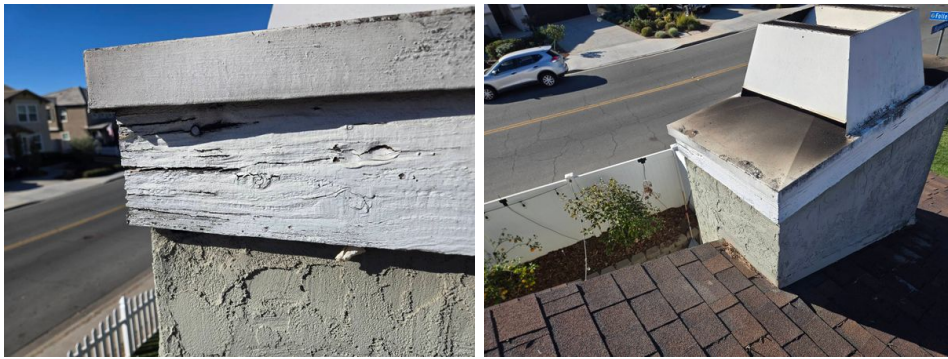
5.2.4 Siding, Flashing & Trim

WOOD ROT/DETERIORATION

At the time of the inspection there were one or more areas of the exterior wood siding that suffered from wood rot or deterioration. It is advised remove the affected wood and make the appropriate repairs to prevent further deterioration.

Recommendation

Contact a qualified professional.

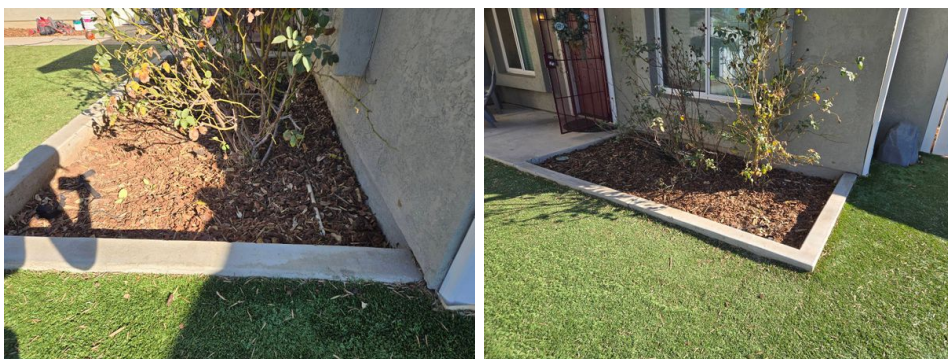
5.4.1 Vegetation, Grading, Drainage & Retaining Walls

POOR DRAINAGE IN PLANTER AREA NEXT TO HOUSE

At the time of inspection there was a planter area with poor draining next to the house. It is important to have adequate drainage in planters around building footings to prevent saturation of the soil which will cause expansion and contraction of the soil as it goes from wet to dry

Recommendation

Contact a qualified landscaping contractor

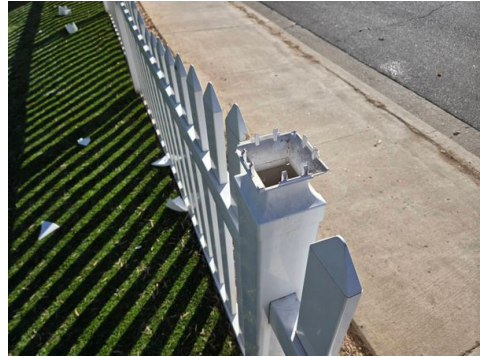
5.7.1 Fencing

FENCE POST MISSING CAP

At the time of the inspection there were one or more fence posts missing the appropriate post caps to prevent water intrusion during rains and wet weather. Correction is advised.

Recommendation

Contact a qualified professional.

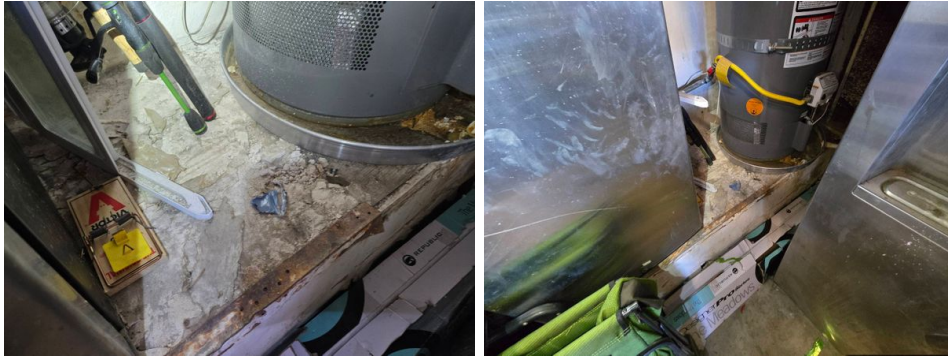
WATER STAINS/DAMAGE FROM PREVIOUS LEAK

At the time of inspection the area around the water heater suffered from moisture damage from a prior water heater leak that has since been repaired.

Inspector Notes: Drywall damage at water heater base

Recommendation

Contact a qualified professional.

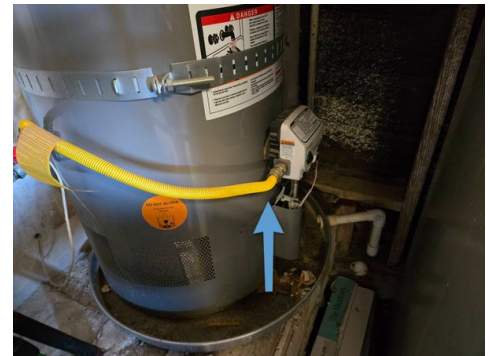
6.1.2 Water Heater

SEDIMENT TRAP MISSING

Recommendation

Contact a qualified professional.

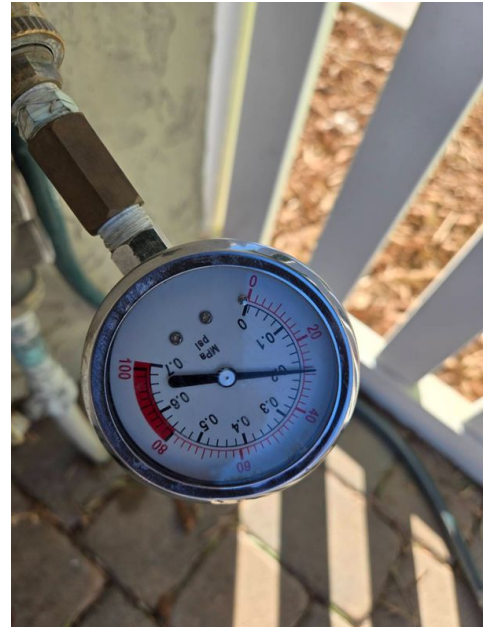
At the time of the inspection the water pressure was lower than the suggested range when tested. The recommended range is between 40-80 psi. Correction by a licensed plumber is advised.

Recommendation

Contact a qualified professional.

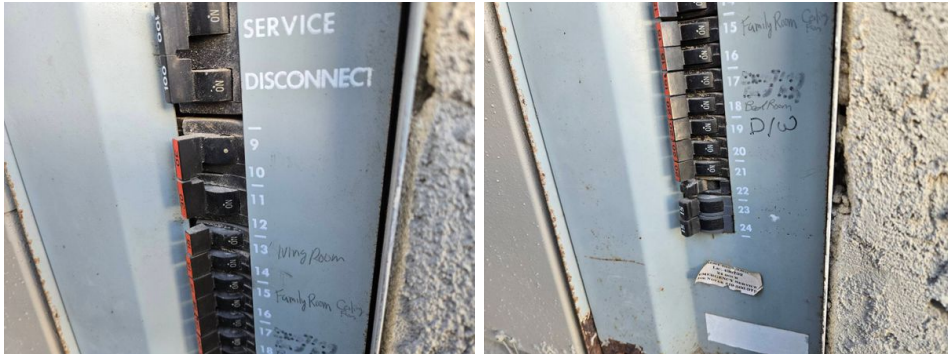
MISSING/INACCURATE LABELS ON PANEL

At the time of inspection, panel was missing appropriate circuit labeling or labeling was inaccurate. Recommend a qualified electrician identify circuit locations.

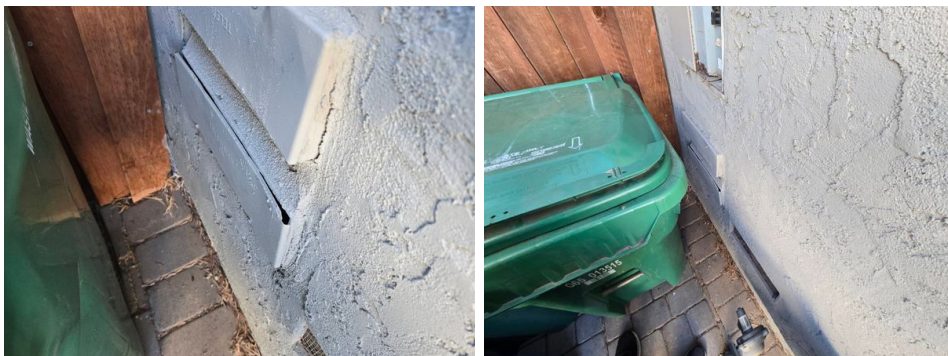
8.1.2 Main Breaker Panel/Meter

At the time of the inspection the door covering the telephone box was loose and or unsecured. Correction is advised.

Recommendation

Contact a qualified professional.

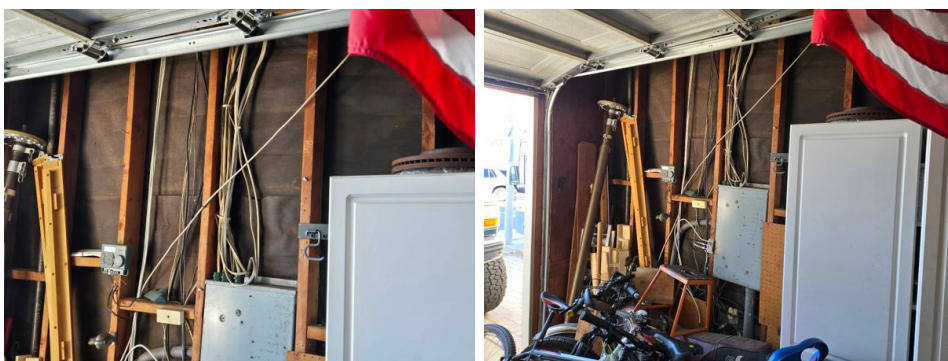
8.5.1 Branch Wiring Circuits, Breakers & Fuses

At the time of the inspection there were one or more areas where the romex wires were exposed and unprotected. Code requires that electrical wires be protected from physical damage with the use of conduit or placement in the wall cavity protected by drywall. Correction is advised.

Recommendation

Contact a qualified professional.

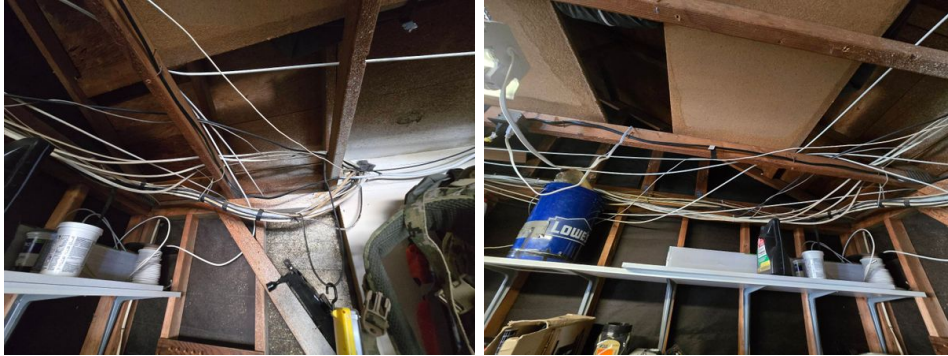
8.5.2 Branch Wiring Circuits, Breakers & Fuses

UNSECURE WIRE INSTALLATION

At the time of the inspection there were one or more issues with loose wires that were not properly secured. Correction is advised.

Recommendation

Contact a qualified electrical contractor.

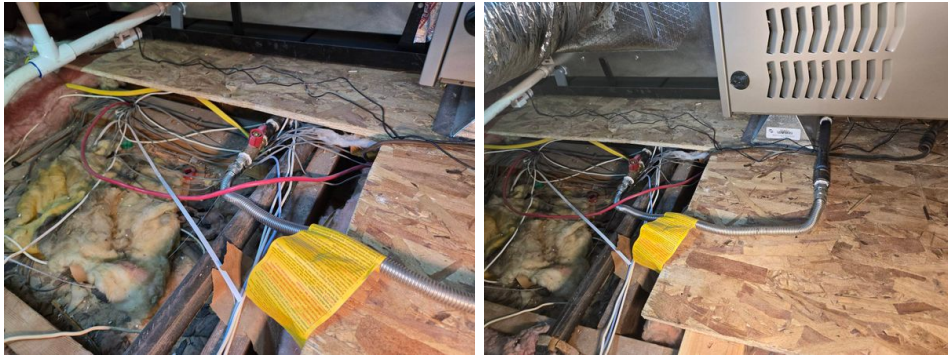
SEDIMENT TRAP MISSING

Recommendation

Contact a qualified heating and cooling contractor

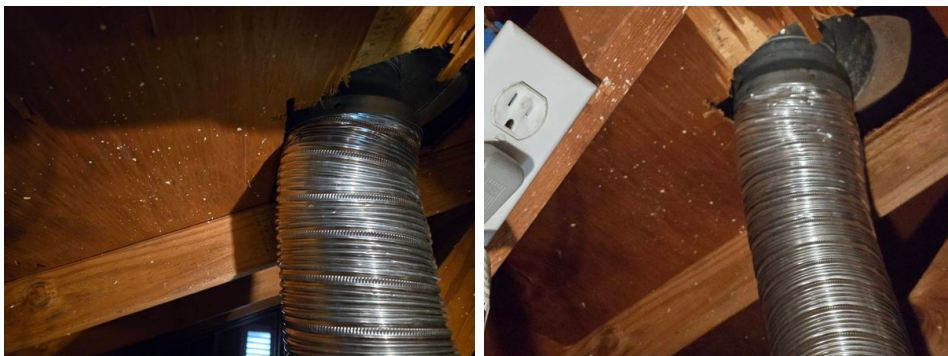
9.2.3 HVAC Equipment

EXHAUST DUCTING CLEARANCE

Recommendation

Contact a qualified HVAC professional.

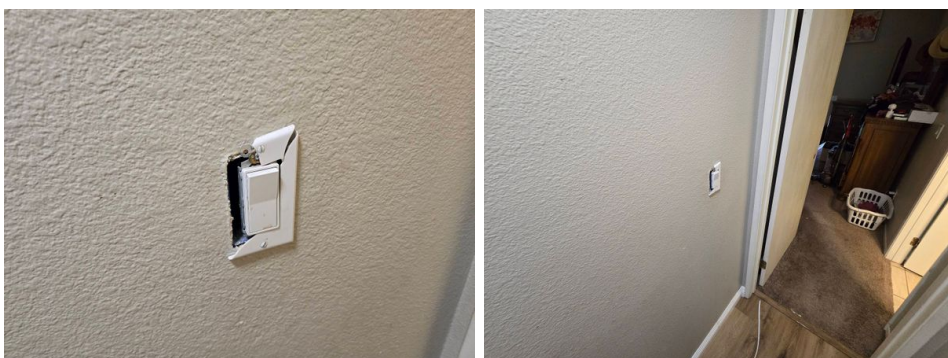
10.3.1 Lighting Fixtures, Switches & Receptacles

HALL

One or more receptacles and or switches had a damaged cover plate at the time of the inspection. Recommend replacement.

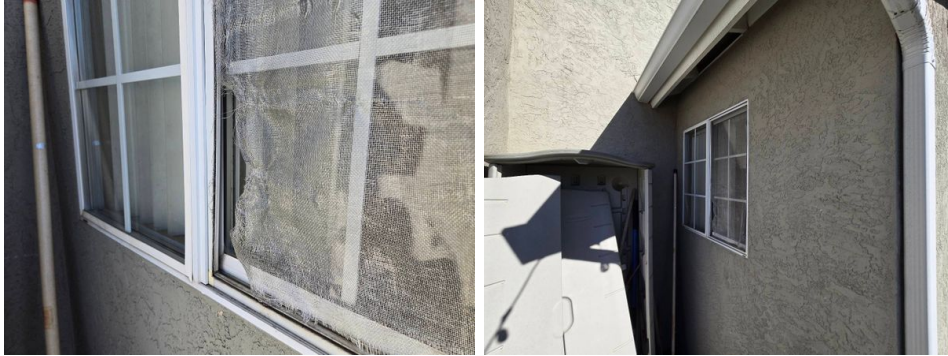
10.4.1 Windows

WINDOW SCREEN MATERIAL DAMAGE

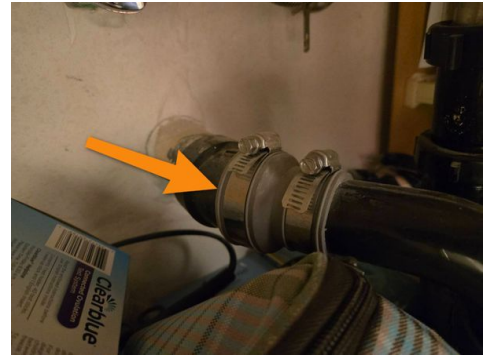
At the time of the inspection there were one or more improper connection observed at a drain, waste or vent pipe. Correction is advised.

Inspector Notes: Felxible Rubber coupler installer. ABS plastic is preferred throughout the P-trap and Drainline system below the sinks.
