SUMMARY REPORT

Client: Max Byfurlin
Inspection Address: 41648 Comstock Ln., Big Bear Lake, CA. 92315
Inspection Date: 2/17/2024 Start: 7:30 am End: 10:00 am
Inspected by: Sean Treguboff

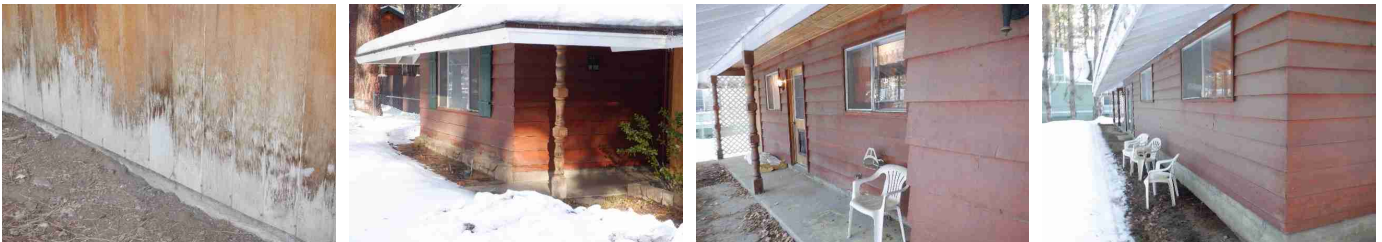
- Sanding and repainting needed on the wood siding and trim around the house and garage doors

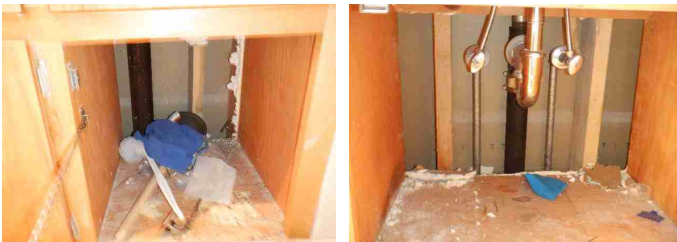
- Sections of walling have been removed beneath cabinetry- replacements needed
