SUBJECT PROPERTY:
1175 Camino Del Sol, San Marcos, CA 92069

INSPECTION DATE:
02/12/2025

INSPECTOR:
Greg Campbell, CCI
Cell: 858.335.1279
Email: greg@InspectRite.com

InspectRite

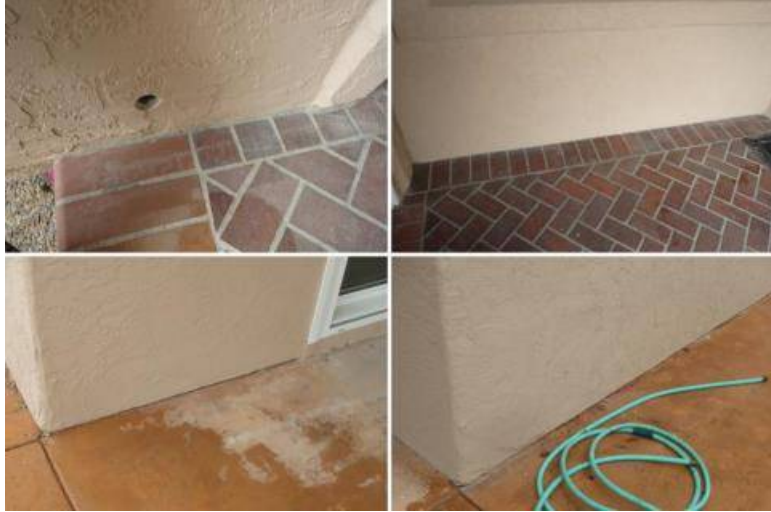
3.3 Exterior Grade at Foundation:

Marginal - The finished grade level of exterior flatwork was too high against the building. Flatwork was in contact with siding material. Ideally, the exterior flatwork should be held at least 2" below the bottom edge of the siding to help protect the siding and structure against moisture damage and termite infestation. Condition was observed at: various places around the building.

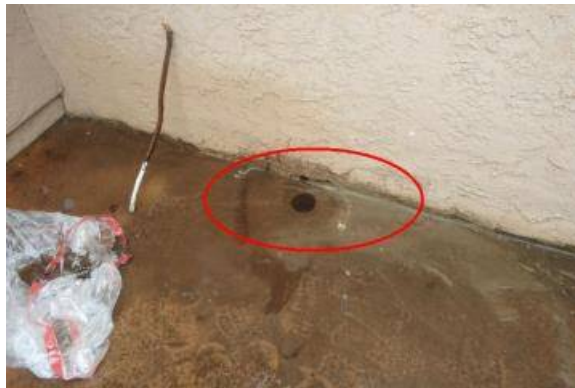
3.6 Underground Drains:

Maintenance - Drain inlets were observed to be clogged or partially clogged. Flushing out drains may also be needed.

Maintenance - Drain cover(s) were missing / damaged. Improvements are needed to keep debris out of the drain pipes. Condition was observed at: left.

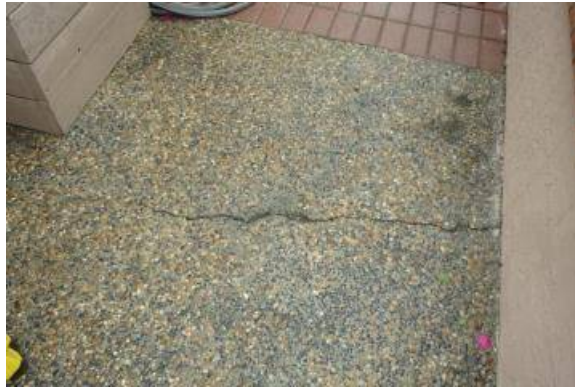
3.11 Maintenance:

Maintenance - Cracks and gaps in paving should be sealed/repared to stop water infiltration, which can help prevent further damage. Condition was observed at: right front.

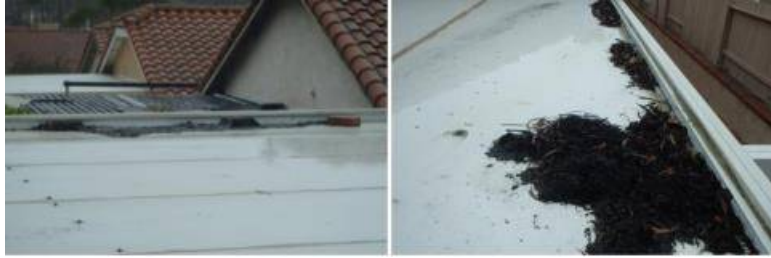
3.15 Roof Covering:

Maintenance - Debris is in need of clearing from the roof.

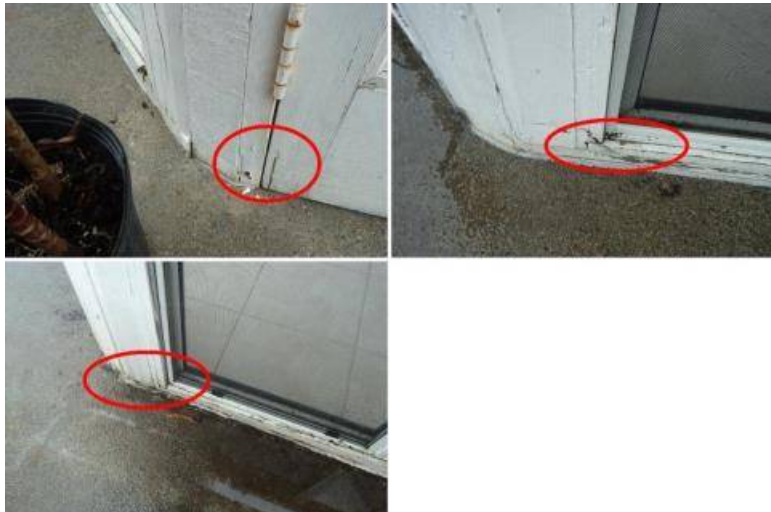
3.18 Damage:

Further Evaluation - Damage/Deterioration was noted. We recommend further evaluation from a licensed pest inspection company. If a pest inspection has already been performed than refer to that report for additional information regarding damage to wood members.

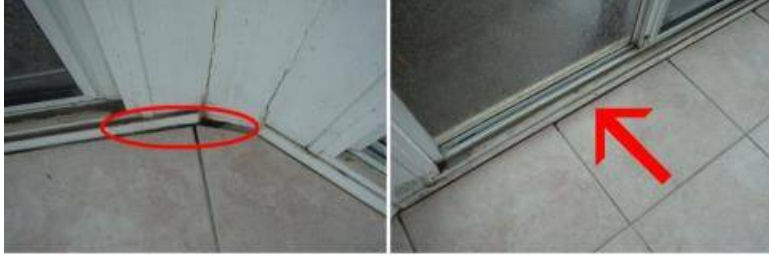
3.19 Moisture Concerns:

Marginal - Evidence of moisture intrusion was noted at the framing to floor transition in places.

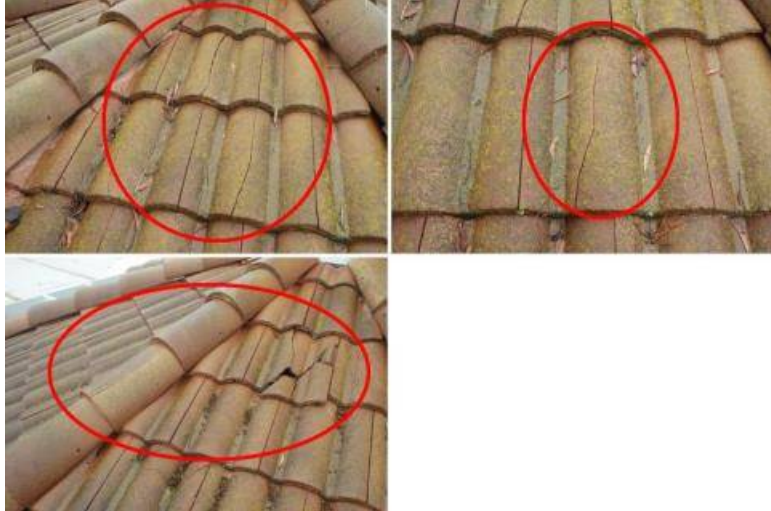
3.20 Roof Covering:

Repair - Broken tiles were observed. We recommend repair/replacement by a licensed roofing contractor.

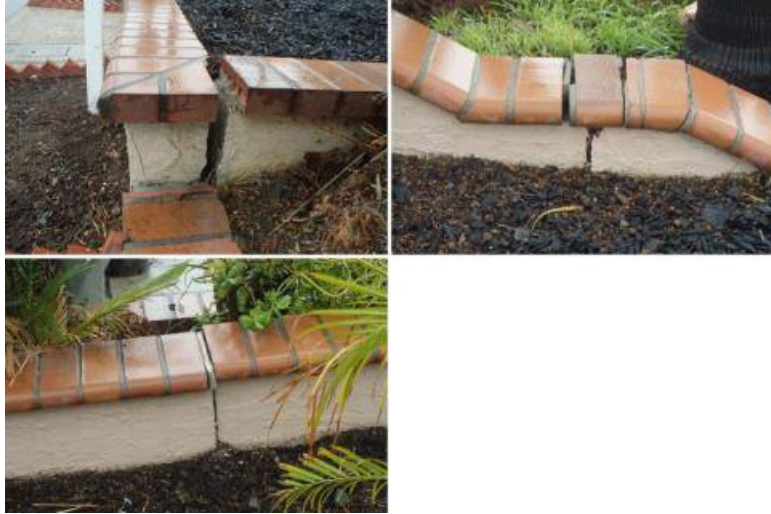
3.23 Damage:

Further Evaluation - Displacement / rotation of the wall was present. Recommend further evaluation and repair of this condition by a masonry contractor. Condition was observed at: Front.

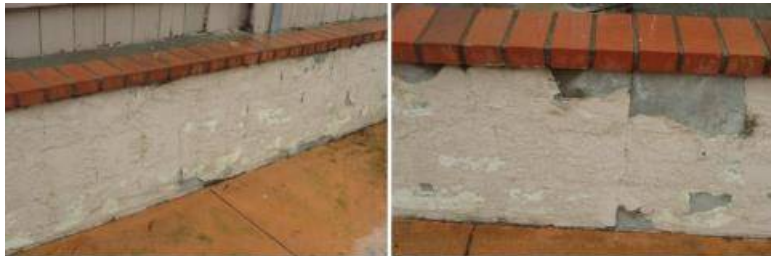
3.24 Moisture/Drainage:

Marginal - No drain or weep holes were visible for this wall. We did not observe any other means of drainage behind this wall such as a discharge point of an underground drainage system. Retained moisture can have an adverse affect on the structural properties of retaining walls. Recommend asking the owner if a drainage system is installed and the termination point where collected waters discharge. Also, you may need to conduct further evaluation by a masonry or drainage contractor to determine is a drainage system is present.

Marginal - Mineral deposits and water stains noted at lower areas of the wall. This is usually an indication that the waterproofing and/or drainage system behind the wall is damaged or insufficient.

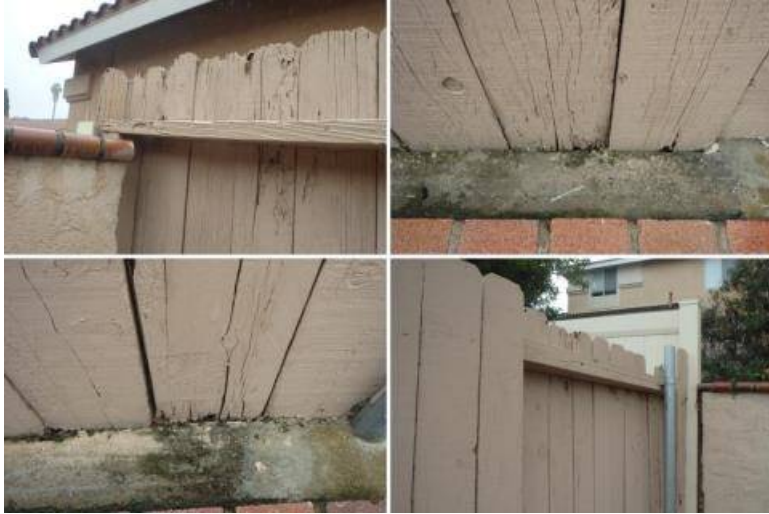
3.26 Wood Fencing:

Repair - Damage/Deterioration was noted. Condition was observed at: Left.

Repair - Loose/Rotted post(s) were found. Condition was observed at: Left.

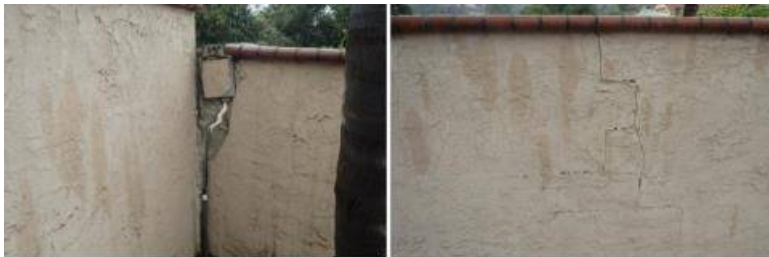
3.27 Masonry Walls:

Further Evaluation - Displacement / rotation of the wall was present along with stair step cracks indicating differential settlement. Recommend further evaluation and repair of this condition by a masonry contractor. Condition was observed at: along right side.

Marginal - Vertical cracks noted at various locations. The wall appeared to be constructed without vertical relief joints or expansion joints. Without relief joints, vertical cracks in masonry walls can be expected due to thermal expansion and contraction.

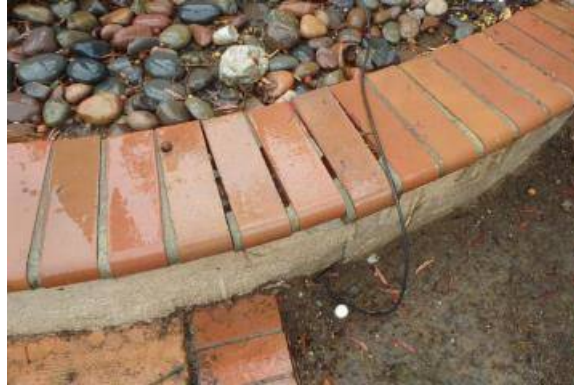
3.29 Plantings:

Repair - Damaged/loose cap bricks and damaged/missing mortar were noted at the planter. Condition was observed at: rear.

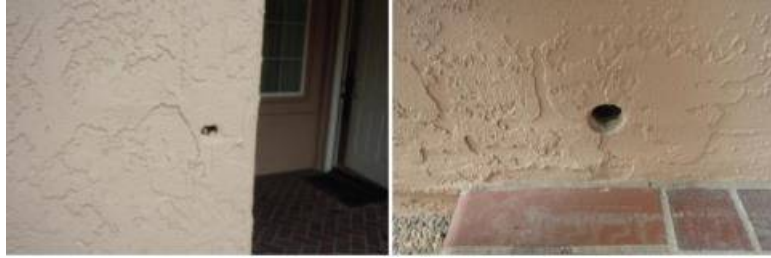
4.6 Maintenance:

Repair - Gaps/Openings were present at the exterior of the building that could allow pests and/or small animals to enter. Sealing openings are recommended. Condition was observed at: Right.

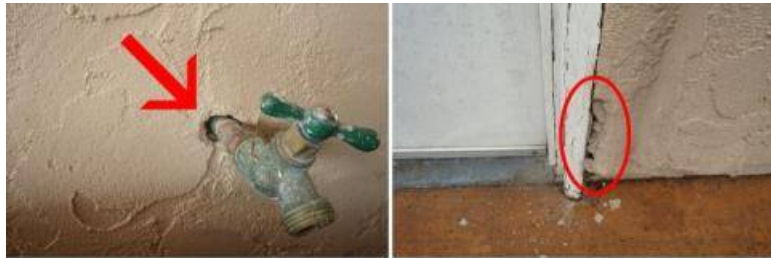
Maintenance - Small areas, typically at corners or bottom edge of the stucco siding, were chipped, loose or missing. Routine repairs recommended. Condition was observed at: spot locations.

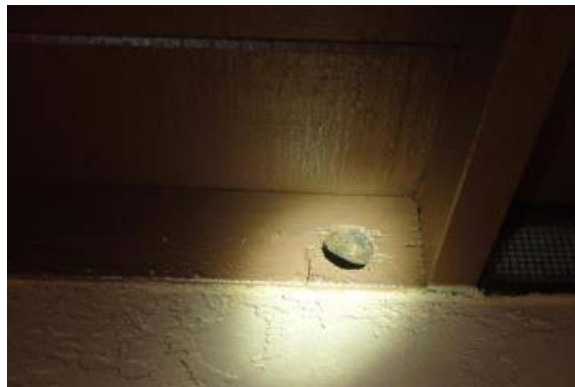
4.9 Maintenance:

Maintenance - Gaps/Openings were present at the exterior of the building that could allow pests and/or small animals to enter. Sealing openings are recommended. Condition was observed at: Right.

Maintenance - Faded and/or peeling paint was noted. Painting is needed at this time to preserve the condition of the exterior wood. Paint helps to protect exterior wood from weathering and dry rot. Condition was observed at: Door surrounds.

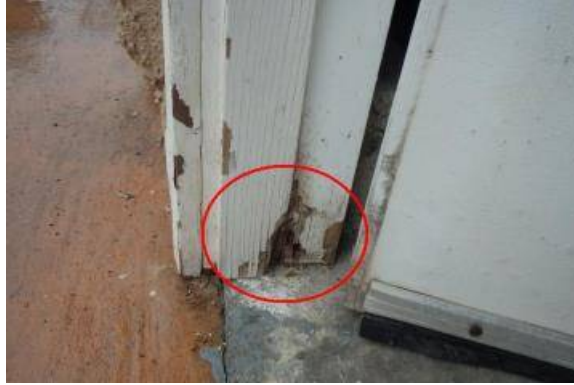
4.10 Damaged Wood:

Further Evaluation - Damage/Deterioration was noted. We recommend further evaluation from a licensed pest inspection company. If a pest inspection has already been performed than refer to that report for additional information regarding damage to wood members. Condition was observed at: Garage pedestrian door.

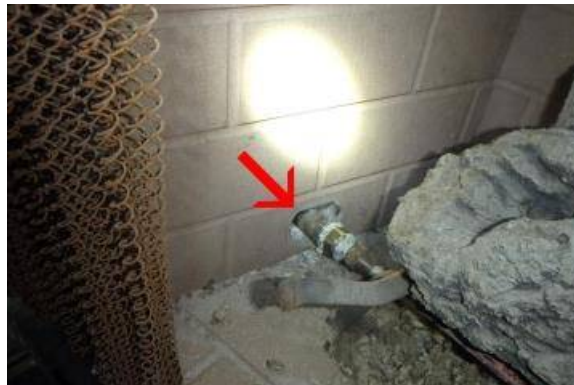
5.7 Fireplace Maintenance:

Maintenance - The log lighter entrance into the firebox was not sealed with grout or fire caulking. The present condition is a safety concern.

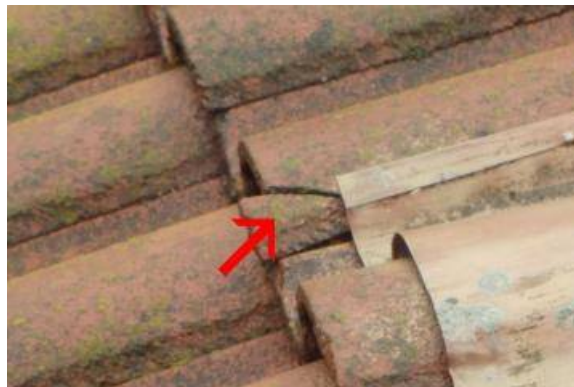
7.8 Tile Roof Damage:

Repair - Broken tile (1) were observed. This condition allows rain water and/or UV light to infiltrate under the roof covering, which over time can prematurely erode/damage the roof underlayment. Any opening in the roof covering is considered an active leak. Corrections are needed to ensure adequate weather protection. Condition was observed at: Left side.

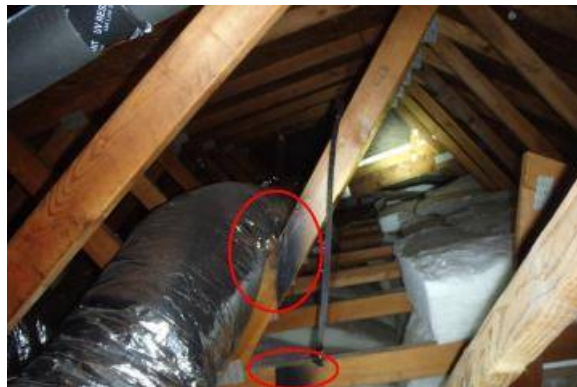
8.5 Attic Space:

Advisory - Evidence of the previous fire was noted where heat marks were noted in a spot location. This condition does not appear to be structurally significant and

requires no action.

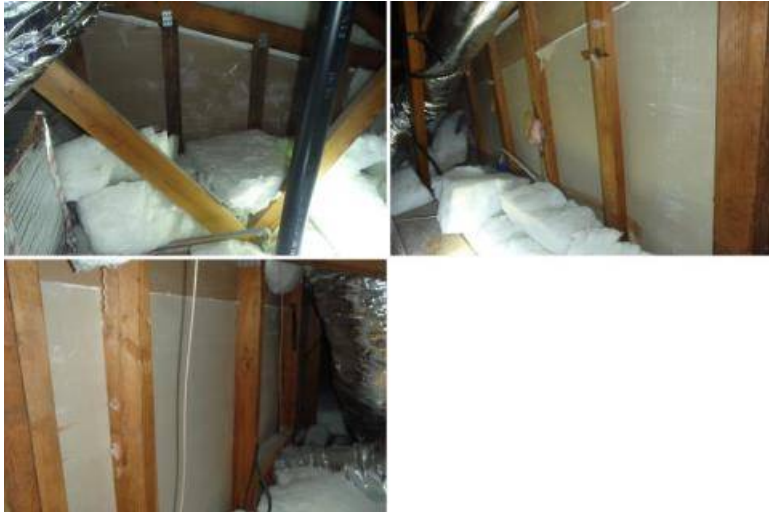
8.8 Energy Loss:

Maintenance - Insulation was missing or fallen out of place at a spot areas.

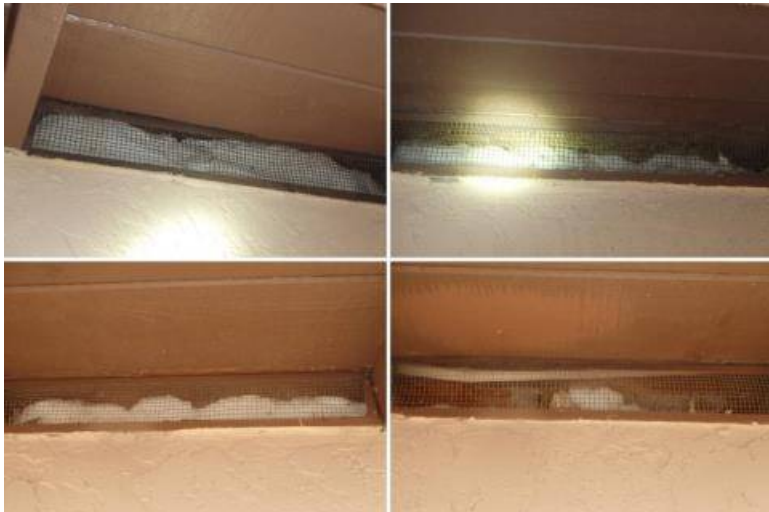
8.11 Deficiency(s):

Maintenance - Ventilation was blocked at the eaves by insulation. Insulation should be moved away from the eave vents to increase attic ventilation. This will help to reduce attic temperatures in the summertime, which is beneficial to the life of the roof covering and can reduce heat transfer to the interior. The condition was observed at: Eave vent(s)

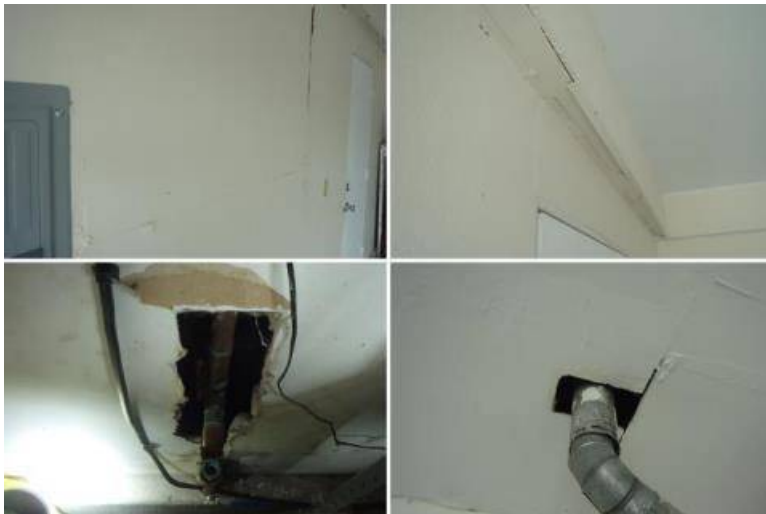
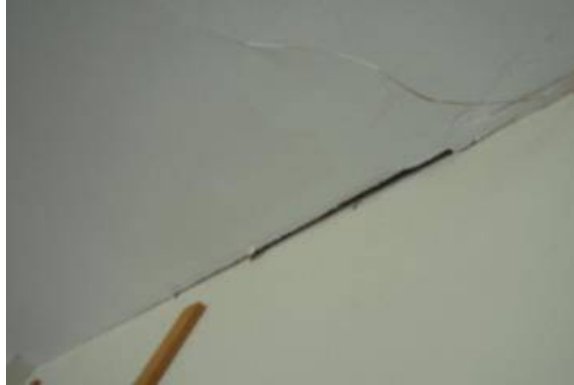
9.4 Garage Interior:

Repair - Damage was noted to finish surfaces. Loose drywall tape and holes were noted in places.

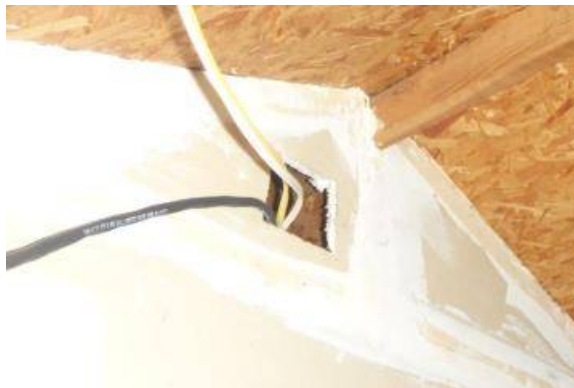
9.5 Fire Separation:

Safety - Hole(s) were noted in the drywall between the garage and living space. This interrupts the integrity of the fire separation wall. Condition was observed at: Garage attic.

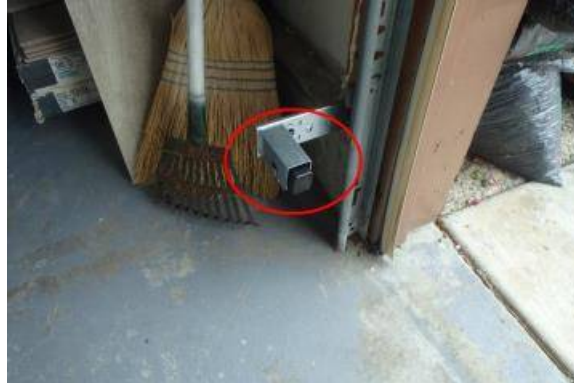
9.10 Automatic Door Opener(s):

Safety - The sensors for the motion safety reverse are installed higher than the recommended maximum height of 6 inches. Consequently, the safety reverse mechanism may not provide the protection as it was intended.

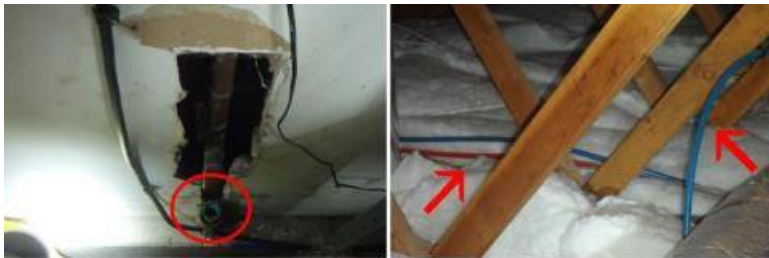
10.6 Water Supply Pipes:

Advisory - Abandoned line(s) and/or replacement line(s) were noted. This could be an indication of a past plumbing failure with the water supply line(s). Condition was observed at: Garage and attic.

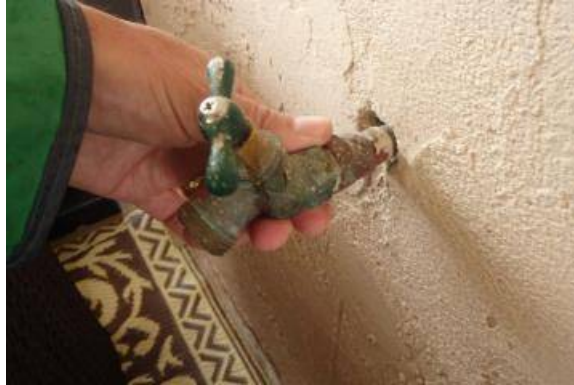
Maintenance - The faucet piping was loose through the wall. Recommend securing. Condition was observed at: Rear.

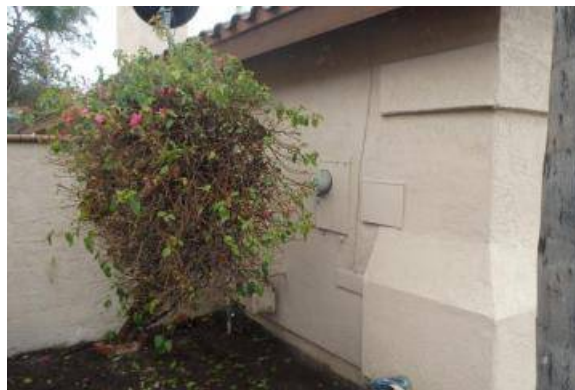
13.7 Panel Access:

Maintenance - Stored items/foilage or other obstruction prevents free access to this panel. Proper clearance in front of and around the electrical panel is required for emergency needs and workers' safety.

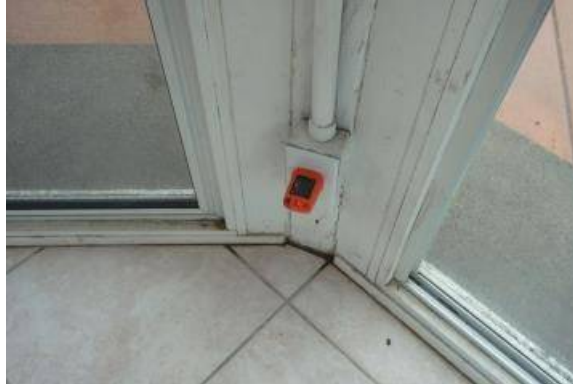
13.21 Outlets Hazardous:

Safety - Outlet(s) were ungrounded. We suspect a ground wire is present inside the j-box, but maybe loose or disconnected. An outlet with an open ground doesn't safeguard equipment and can be shock hazard. Condition was observed at: Gazebo (1 outlet).

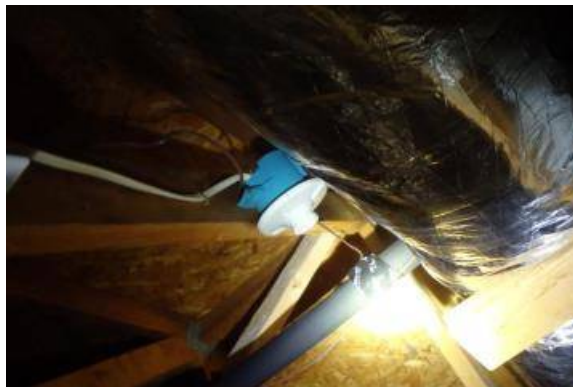
13.23 Lights Not Working:

Maintenance - Light(s) were not working or missing bulb(s). Recommend installing new light bulb(s) to test if the light fixture(s) are working. Condition was observed at: attic.

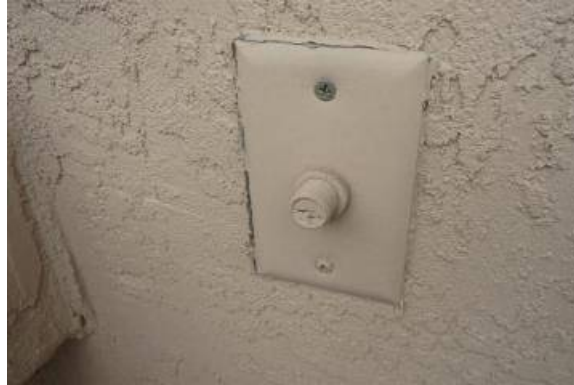
13.25 Associated Comments:

Advisory - A photo cell was painted over. This will prevent proper operation of dusk to dawn lighting.

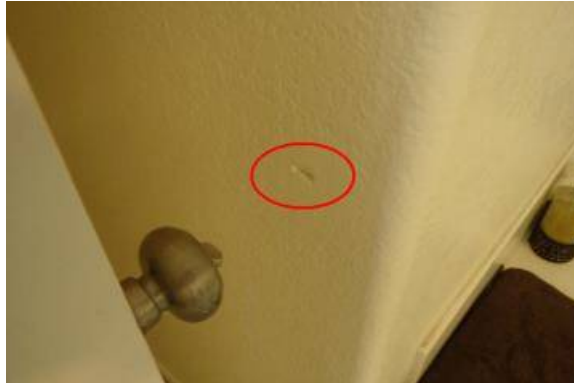
14.6 Damage:

Maintenance - Minor damage was noted to wall surfaces in places.

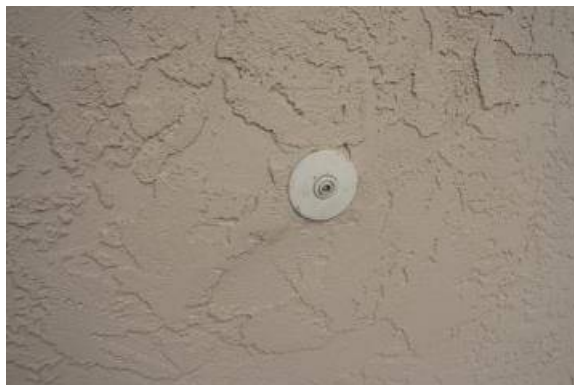
14.12 Entry Door:

Advisory - The doorbell was damaged/not operational. Additional doorbells were present.

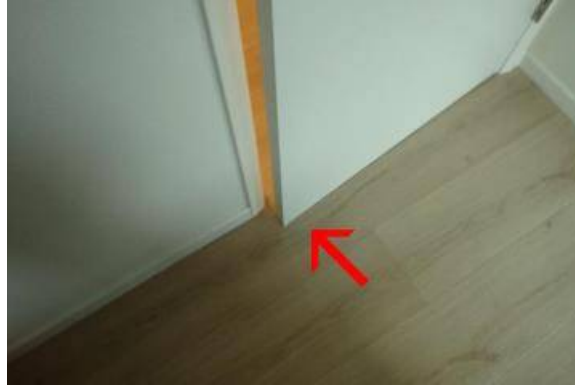
Maintenance - Door(s) did not open and close properly. Door rubs on flooring. This can damage the flooring material. Condition was observed at: Secondary bedroom.

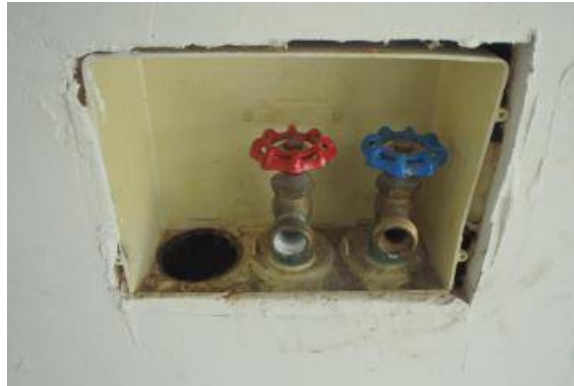
16.4 Water Supply:

Marginal - Older water shutoff valves were noted serving the washer. Be aware that old components are at a higher risk of leaking and valves may fail when turned closed, either leaking or not shutting off the flow of water. Recommend installing new shutoffs.

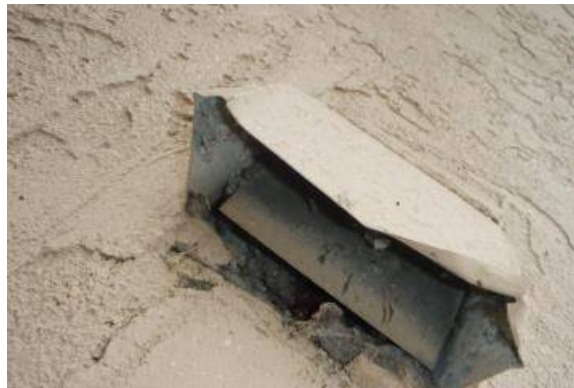
16.6 Dryer Vent:

Maintenance - The dryer vent had an lint build-up as seen from one of its ends. This can be a fire hazard. We recommend cleaning the dryer vent at this time and on a regular basis.

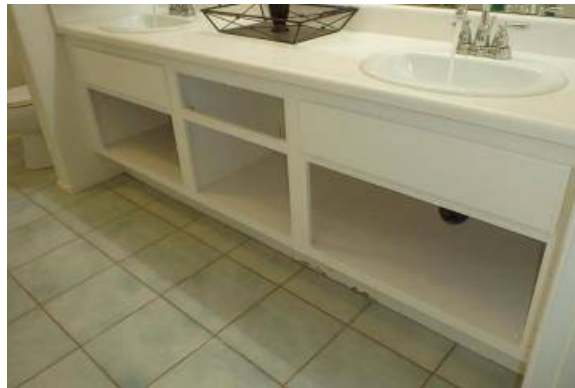
17.8 Cabinets:

Advisory - Drawer and cabinet doors were removed. In process of painting.

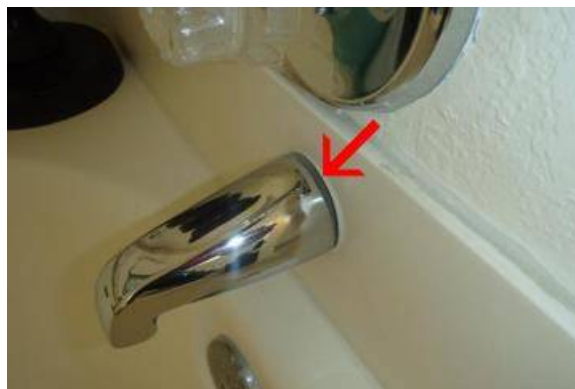
17.10 Bathtub Plumbing:

Maintenance - A wide gap was noted between the tub spout and wall. Adjustment of the tub spout is needed to prevent against water infiltration.
