## RESIDENTIAL INSPECTION REPORT

1325 5th St  
Imperial Beach, CA 91932

07/25/2025

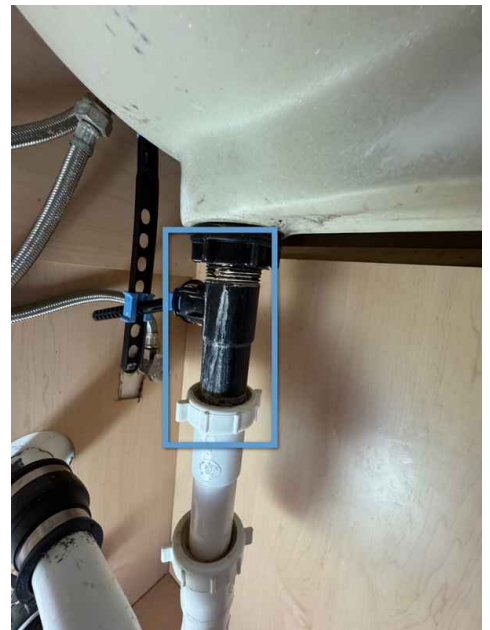
Example noted at Primary Bathroom Sink

Contact a qualified plumbing contractor.

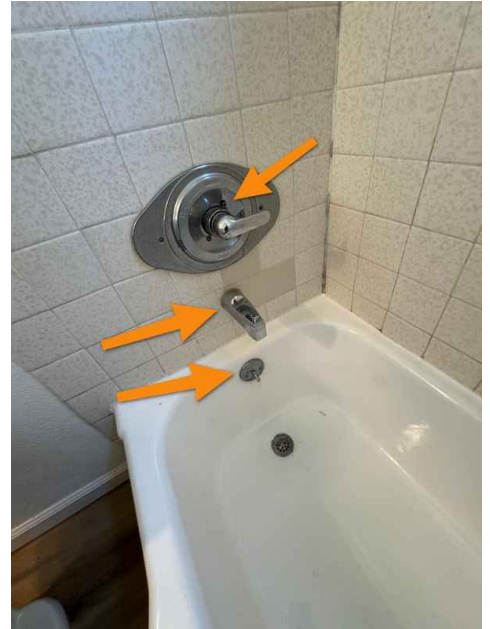
Example noted at Hall Bathroom  
Shower Bathtub

Contact a qualified plumbing contractor.

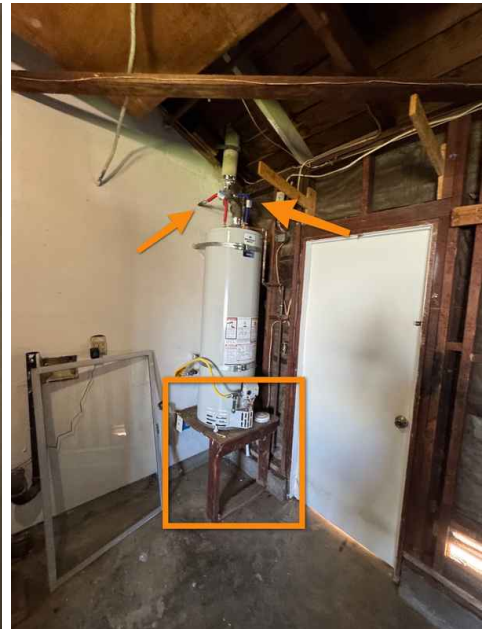
Water Heater missing expansion tank, loose water pipes,, Garage Rear

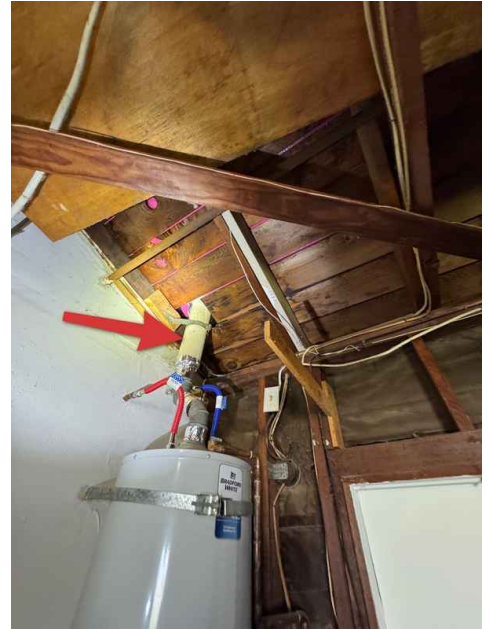
Example noted at Garage Rear, Above Water Heater

Contact a qualified professional.

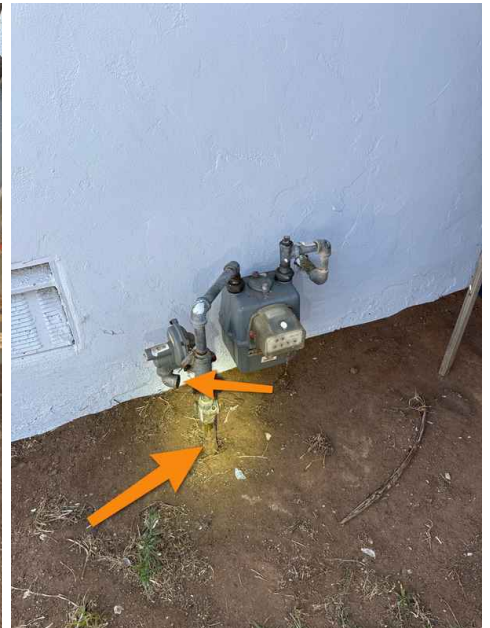
Example noted at Main Gas Shut-off, pipe noted loose

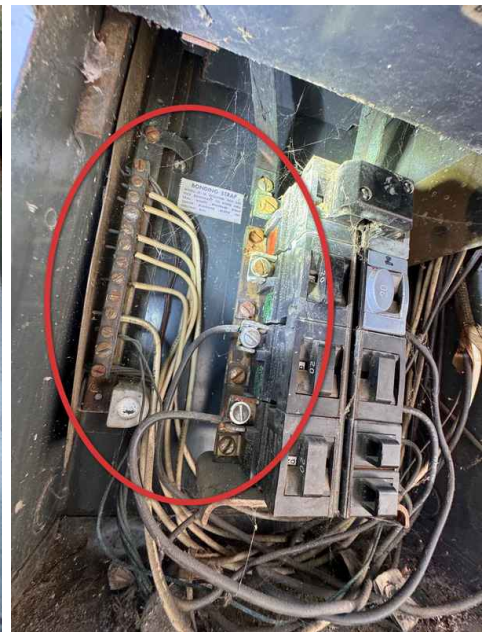
Example of rust noted Inside Main Panel

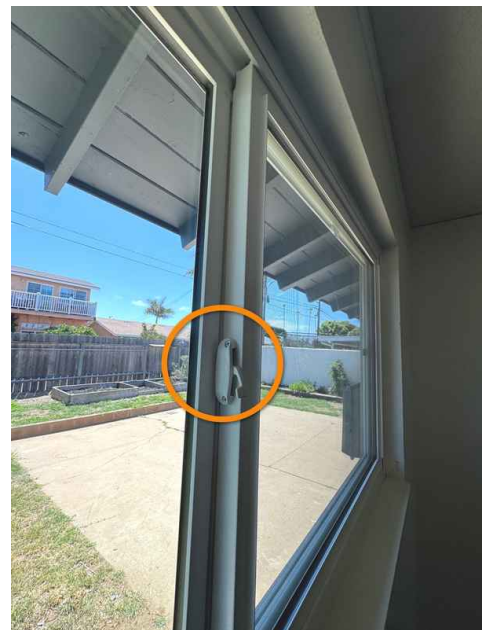
Example noted at Bedroom #3, lock sticks

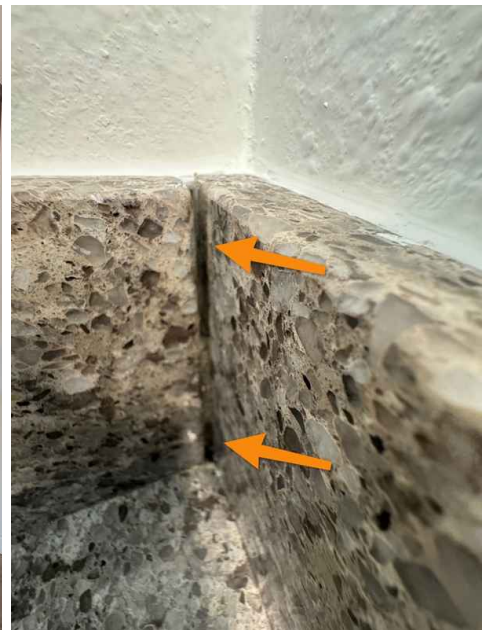
Example of missing grout noted

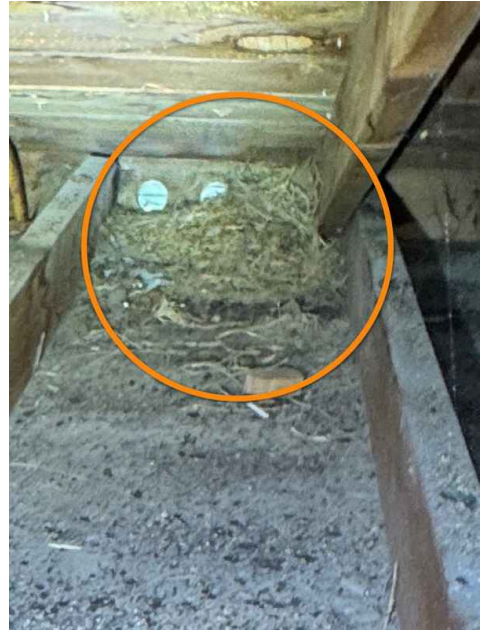
Example of pest nest noted

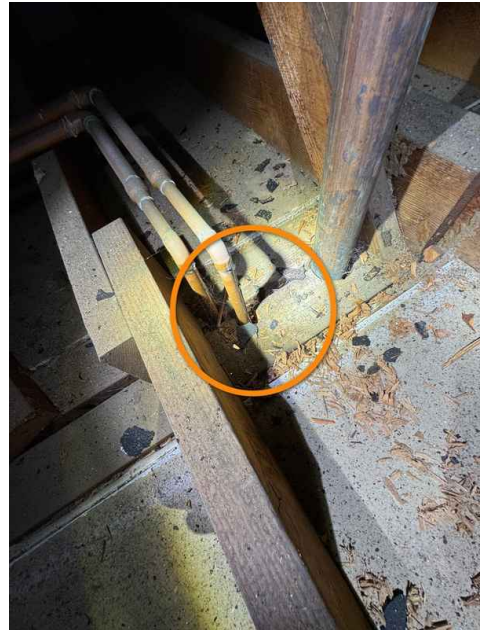
Example of moisture damage noted at Attic, Above Bathrooms

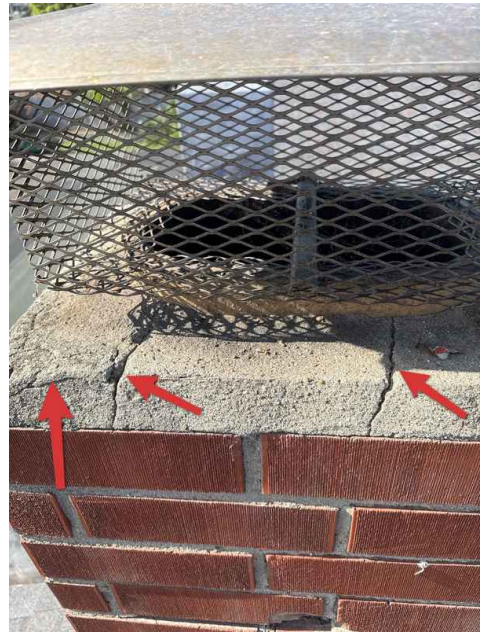
Example of cracking at crown noted

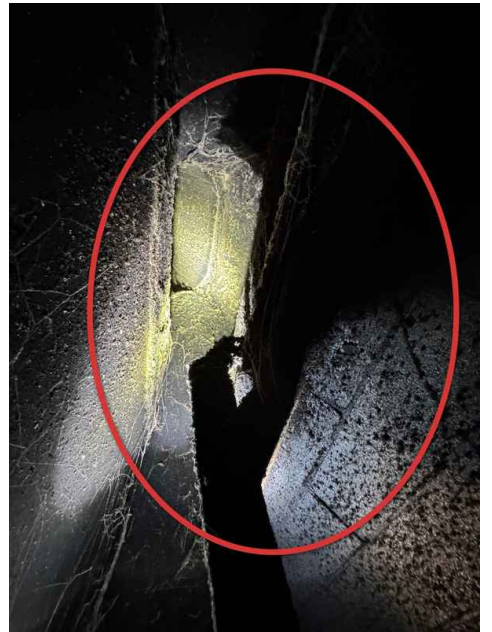
Creosote visible Inside Fireplace, Chimney

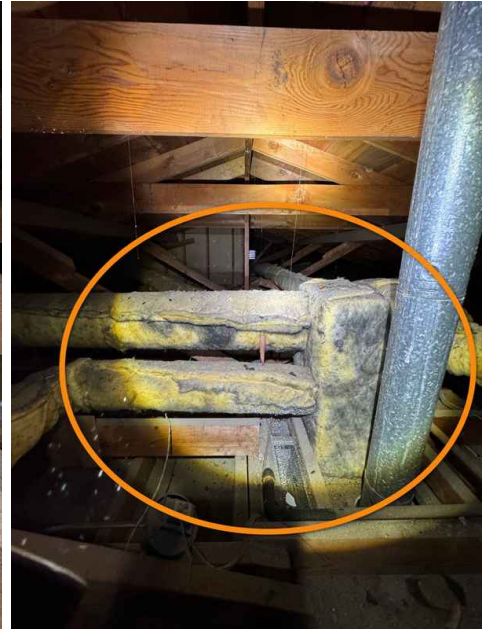
Example of shed ducting noted at Attic

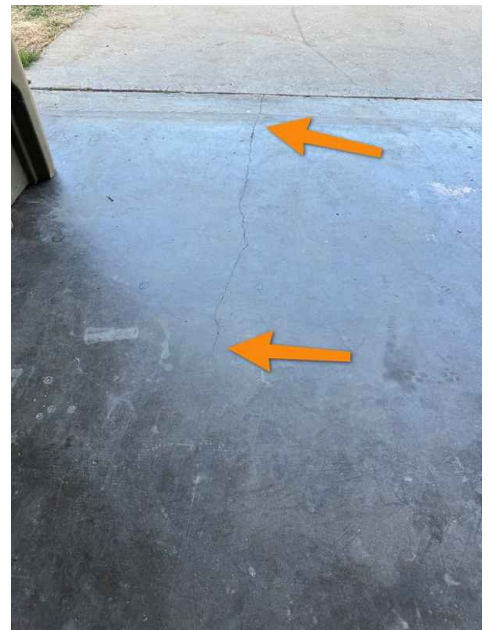
Example of crack noted, Garage, Front Left Side facing outwards

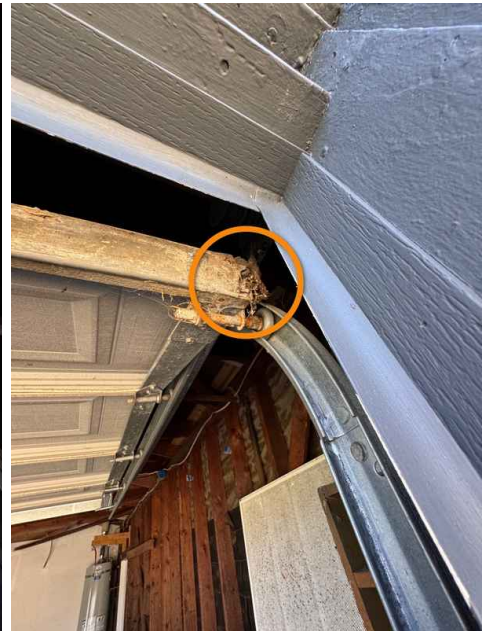
Example of damaged weather stripping noted

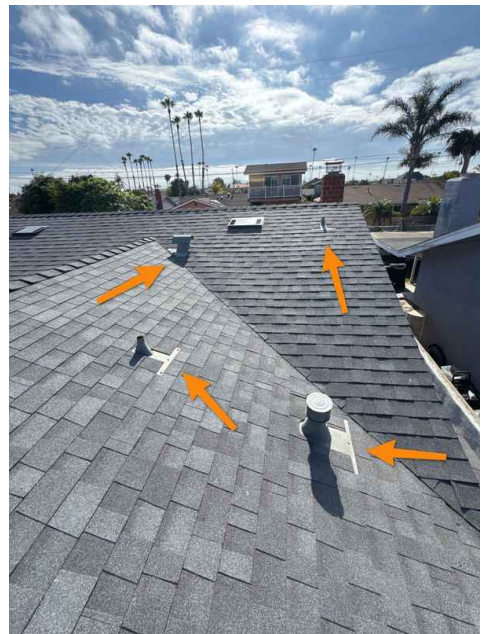
Example of exposed nail heads noted at Roof flashings

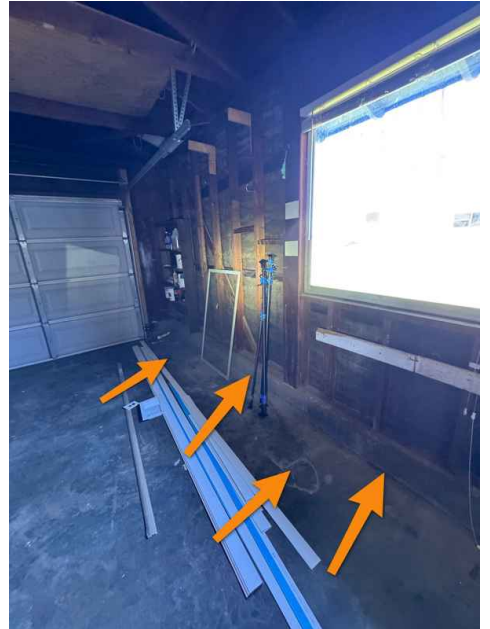
Example of efflorescence noted,  
Garage, Right Side facing outwards

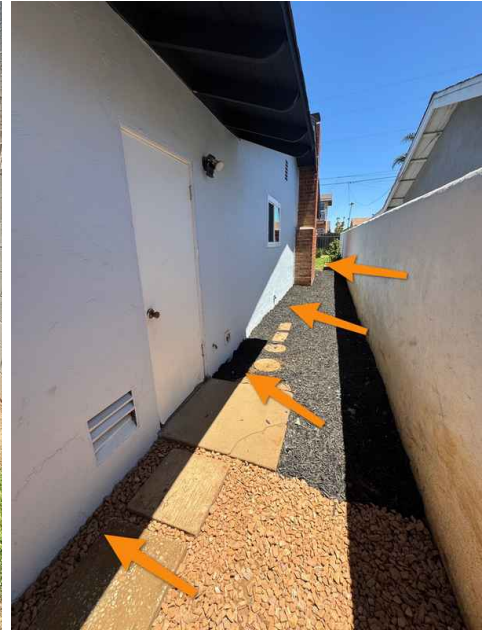
Example of siding to ground contact noted at Right Side

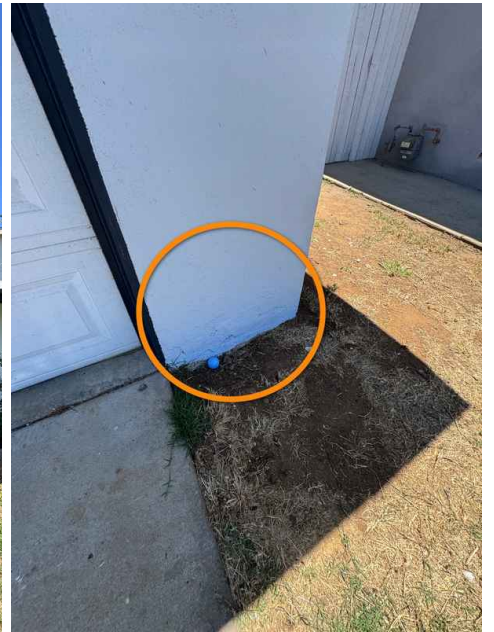
Example of damage noted

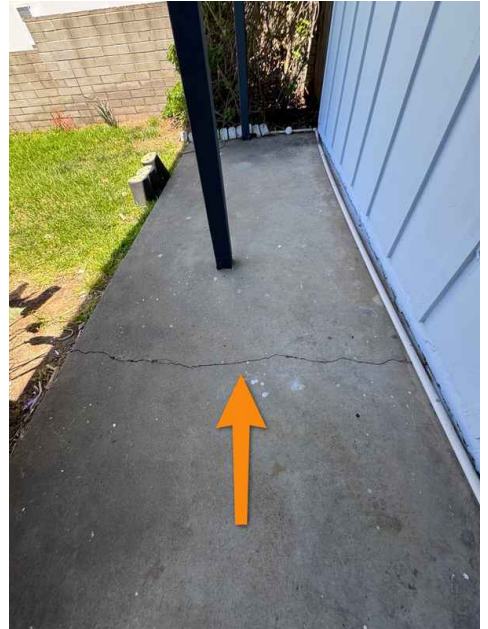
Example of crack noted, Front Left Side of Home

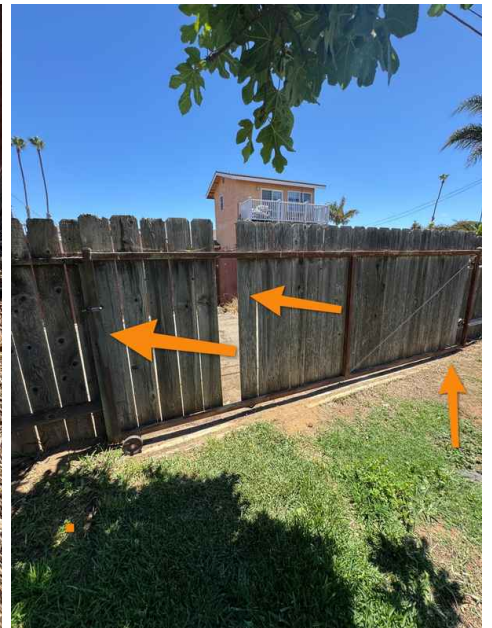
Example noted at Rear Yard, gate difficult to operate
