## **HOME INSPECTION REPORT**

**5700 Baltimore Dr, #66, La Mesa, CA 91942**

Inspection Date: 2/20/2026  
Report Number: 2026010220JO  
Real Estate Agent: Diana Culver  
Home Inspector: William Buendia Maturana

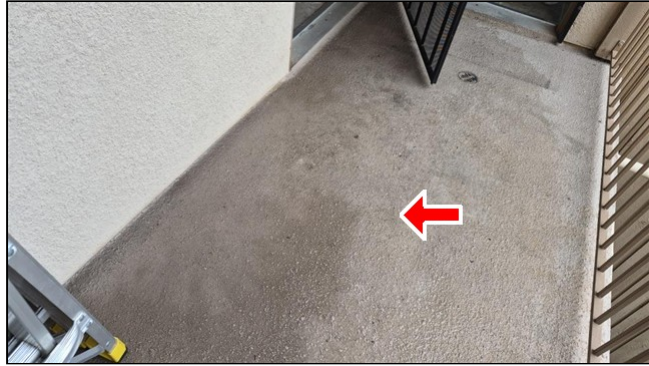
2.1 Item 1 (Picture)

Missing or inadequate drainage observed at front exterior. Suggest further review by a qualified contractor, prior to the end of the contingency period.

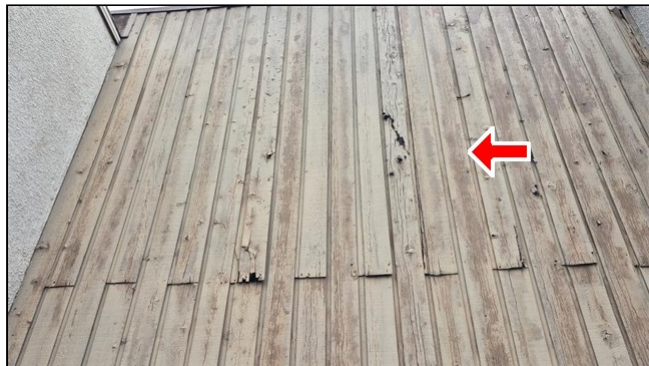
2.2 Item 1 (Picture)

Deterioration observed at wall cladding at exterior walls. Suggest maintenance.

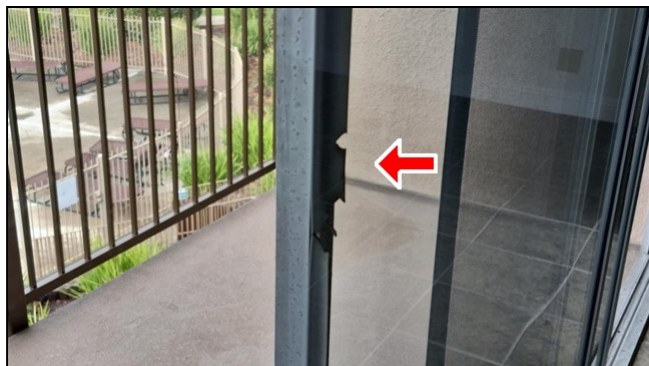
2.4 Item 1 (Picture)

(1) Door frame is damaged at balcony front. Recommend repair.

🏠 (1) Door frame is damaged at balcony front. Recommend repair.

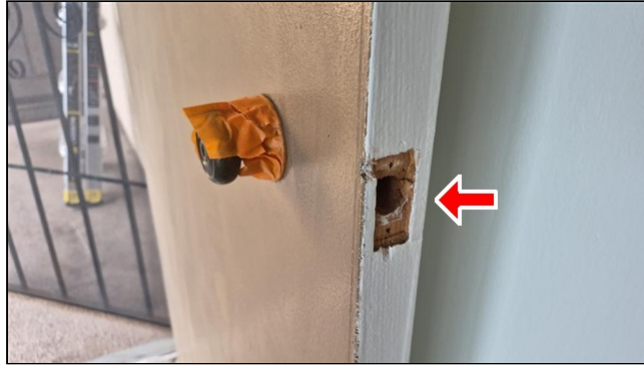
2.4 Item 2 (Picture)

(2) Door knob/latch hardware lock is inoperable at front exterior. Recommend repair.

🏠 (2) Door knob/latch hardware lock is inoperable at front exterior. Recommend repair.

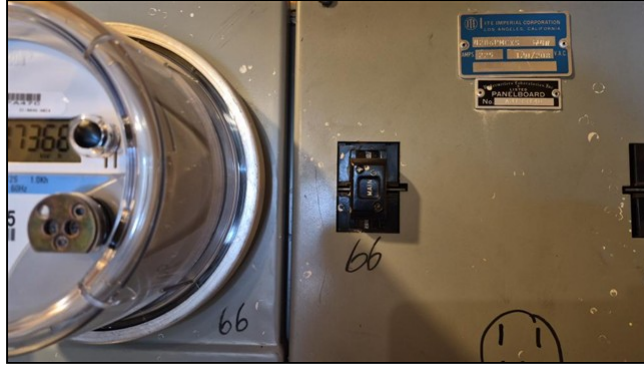
3.1 Item 1 (Picture)

(1) Push-O-Matic type breakers observed. These types of breakers have internal components that are spring loaded and are beyond their estimated service life. The main service entrance and wiring are

typically association maintained. Recommend contacting the homeowner association regarding responsibility, condition, and maintenance schedule.

🏠 (1) Push-O-Matic type breakers observed. These types of breakers have internal components that are spring loaded and are beyond their estimated service life. The main service entrance and wiring are typically association maintained. Recommend contacting the homeowner association regarding responsibility, condition, and maintenance schedule.

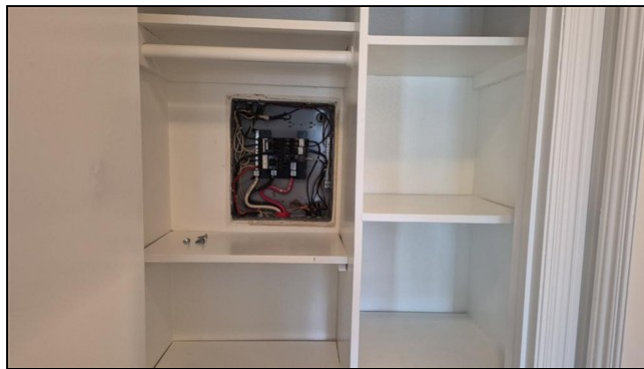
3.1 Item 2 (Picture)

(2) Sub panel is installed in a closet. Recommend relocating.

🏠 (2) Sub panel is installed in a closet. Recommend relocating.

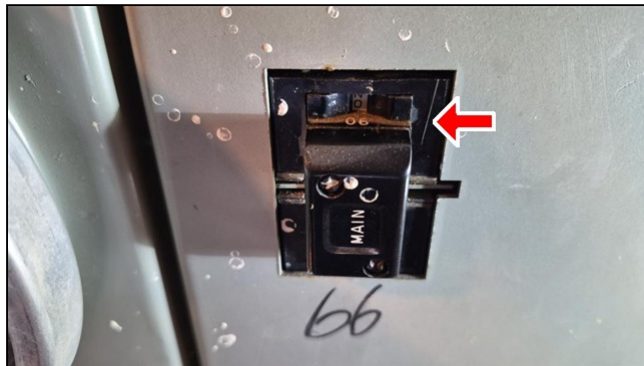
3.2 Item 1 (Picture)

(1) When the main shut-off is under 100 amps, an upgrade may be required if additional electrical appliances or circuits are installed.

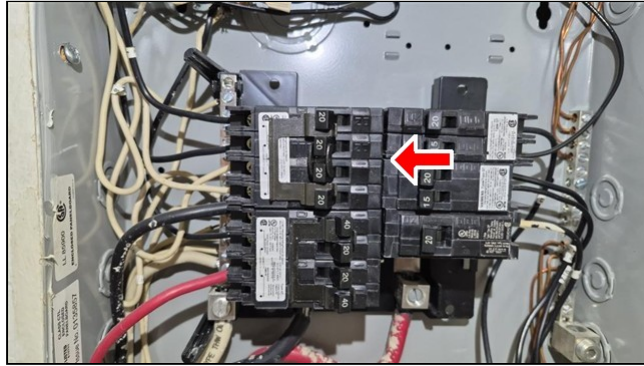
3.2 Item 2 (Picture)

(3) Breaker(s) observed in the off position at time of inspection. Suggest verifying the condition and location of circuit wiring with a qualified electrician prior to energizing.

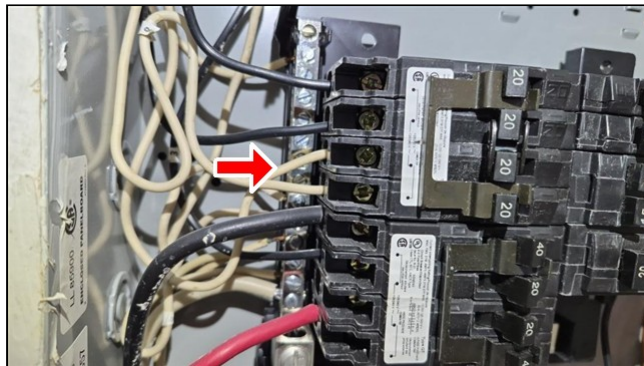
3.3 Item 1 (Picture)

(2) White wire observed at breaker or busbar is not identified with black tape to signify a hot wire. Suggest correction.

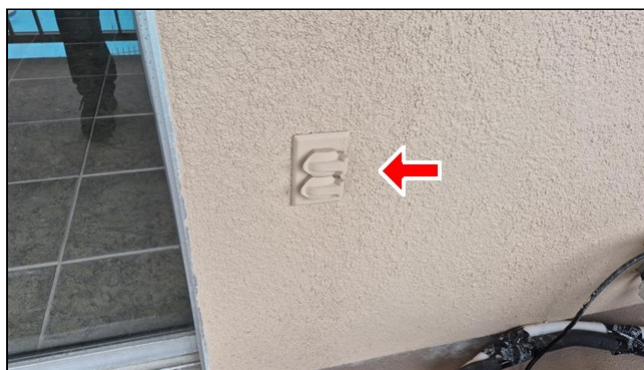
3.4 Item 1 (Picture)

(1) Ground fault circuit interrupter(s) are not installed at front (exterior). Recommend installing.
-

(1) Ground fault circuit interrupter(s) are not installed at front (exterior). Recommend installing.

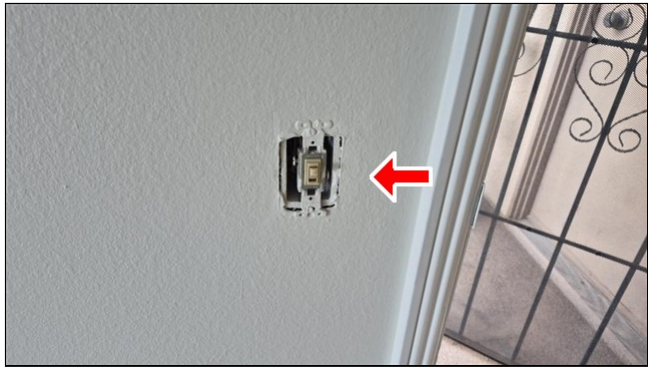
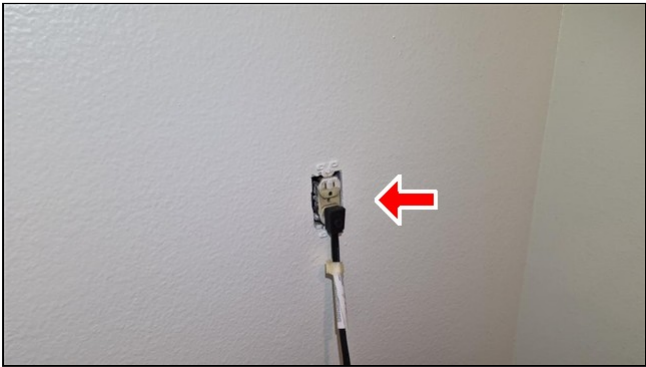
3.4 Item 2 (Picture)

(2) Cover plate is missing at living room and behind refrigerator. Recommend correcting.

🏠 (2) Cover plate is missing at living room and behind refrigerator. Recommend correcting.

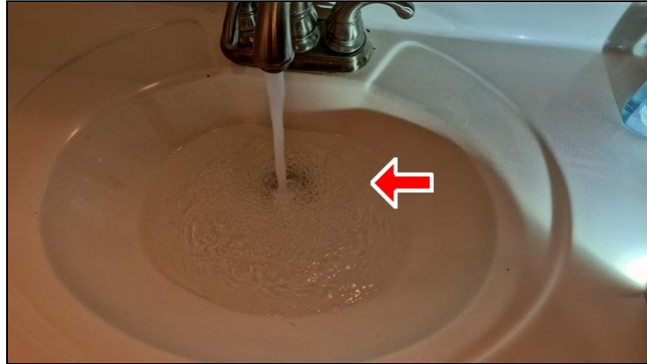
4.3 Item 1 (Picture)

(3) The sink drain drains slowly at bathroom. Recommend correcting.
-

🏠 (3) The sink drain drains slowly at bathroom. Recommend correcting.

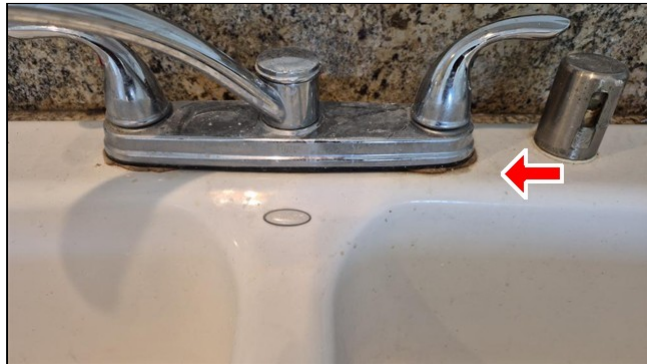
4.3 Item 2 (Picture)

(4) Fixtures are loose/unsealed at kitchen sink. Recommend correcting.

🏠 (4) Fixtures are loose/unsealed at kitchen sink. Recommend correcting.

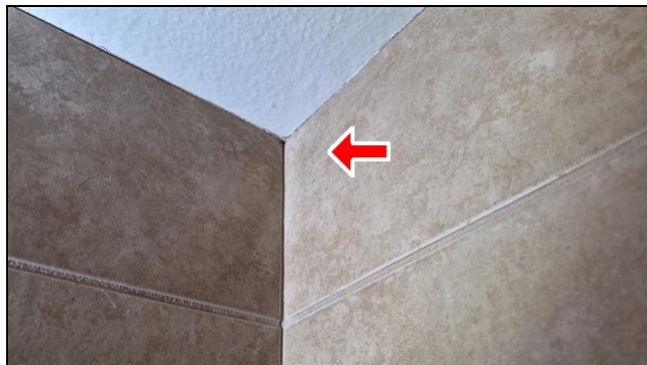
4.4 Item 1 (Picture)

(1) Cracked/missing grout observed at bathroom tub/shower surround. Recommend repair.
-

🏠 (1) Cracked/missing grout observed at bathroom tub/shower surround. Recommend repair.

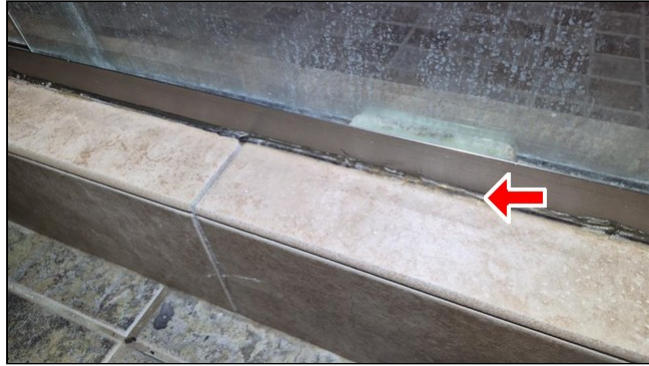
4.4 Item 2 (Picture)

(2) Caulking/grout at the bathroom shower is deteriorated or missing. Recommend repair.

🏠 (2) Caulking/grout at the bathroom shower is deteriorated or missing. Recommend repair.

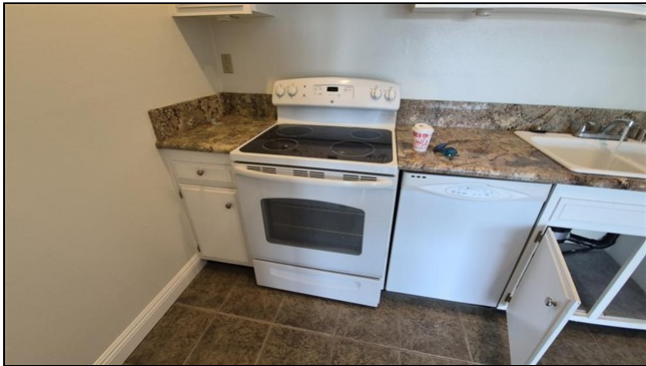
7.2 Item 1 (Picture)

A stove cook-top exhaust fan is not installed. Recommend installing.

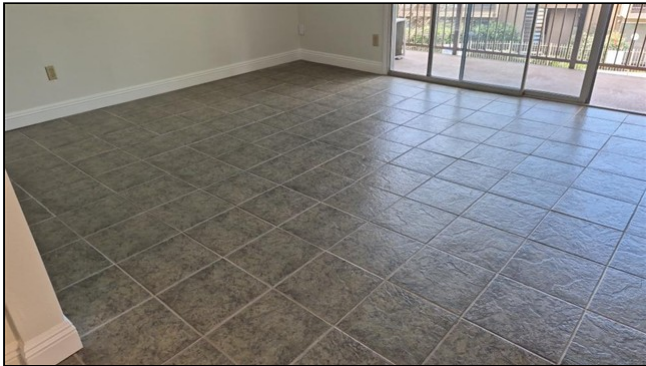
8.0 Item 1 (Picture)

Un-level tile observed at living room. Hidden damage may not be observable. Suggest correcting.

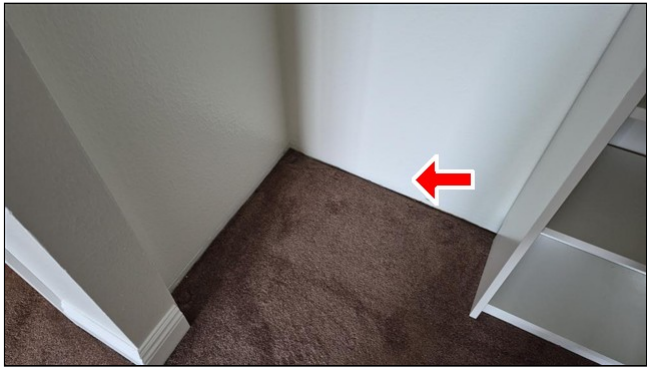
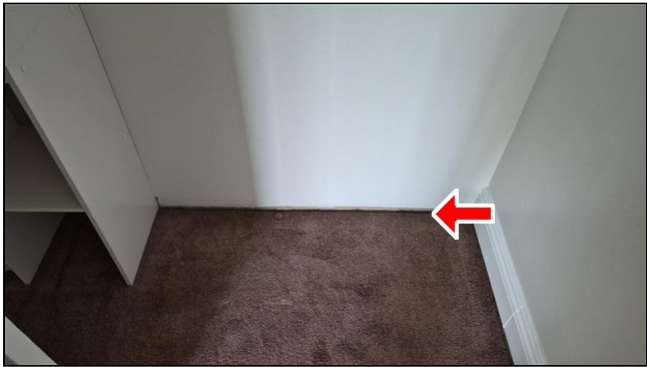
8.1 Item 1 (Picture)

(1) Baseboard(s) are missing at bedroom closet. Suggest installing.

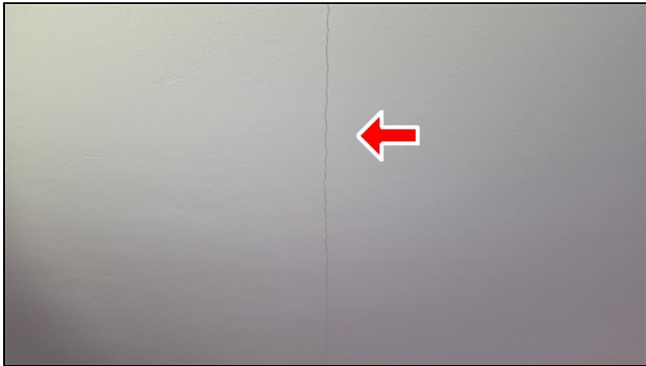
8.1 Item 3 (Picture)

(2) Cracks observed at bedroom ceiling. Suggest repair.

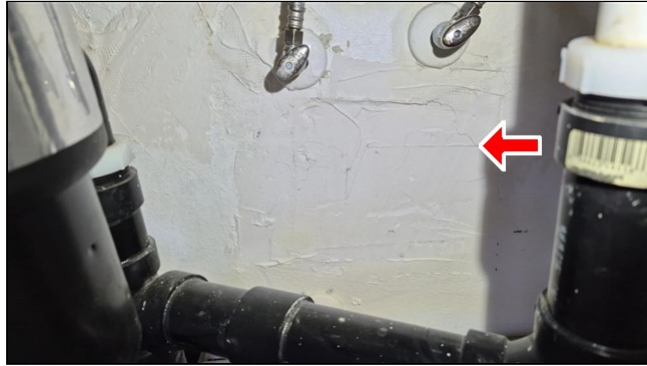
8.1 Item 4 (Picture)

(4) Evidence of repairs observed underneath the kitchen sink. We are unable to determine the cause or effectiveness of these repairs. Suggest verifying condition with seller or a qualified professional.

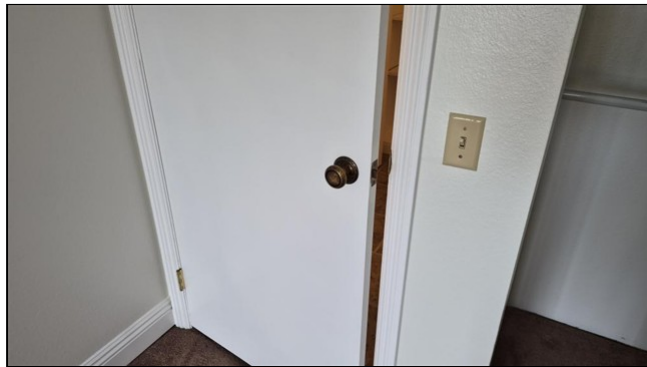
8.2 Item 1 (Picture)

The door at bedroom does not latch shut. Suggest repair.

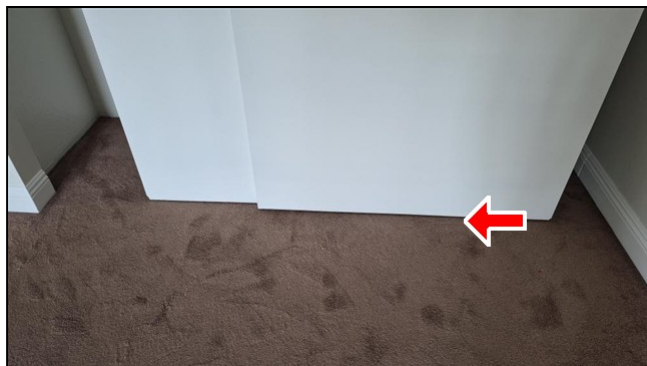
8.3 Item 1 (Picture)

Bypass tracks are not installed at the bedroom sliding closet doors. Recommend installing.

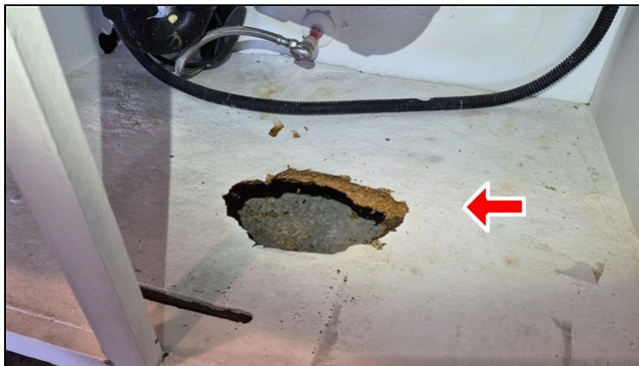
8.4 Item 1 (Picture)

Moisture damage/hole observed at kitchen cabinetry. Hidden damage may not be observable. Recommend further review by a qualified professional, prior to the end of the contingency period.
