KEEN EYE PROPERTY INSPECTIONS

## KEEN EYE PRE-LISTING INSPECTION

5643 Bloch St  
San Diego, CA 92122

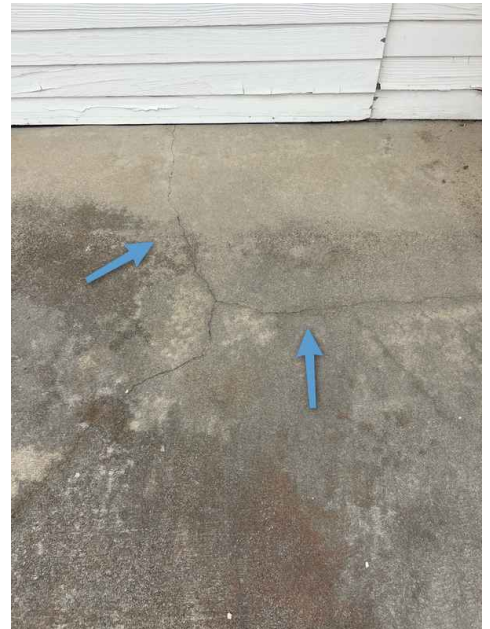
#### MINOR DETERIORATION - MONITOR

Minor deterioration such as cracks, deterioration and or gaps were noted in one or more areas. Corrections may be desired, mainly for cosmetic reasons. We recommend monitoring these conditions and making repairs if conditions worsen.

Recommend monitoring.

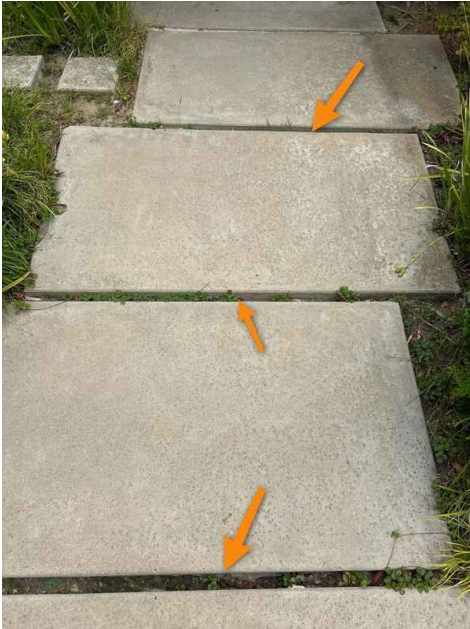
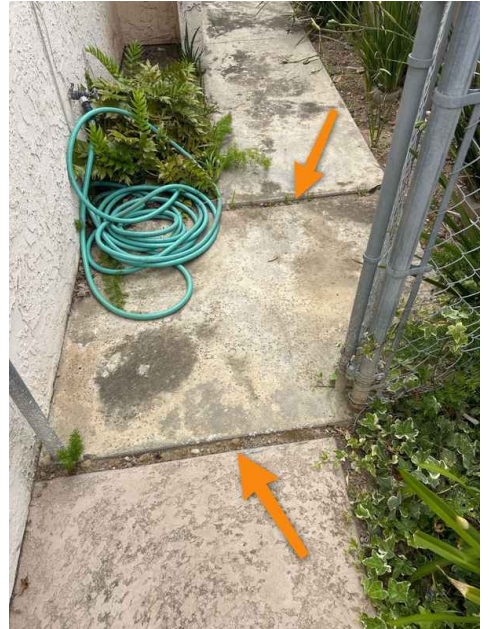
##### **MISSING EXPANSION JOINTS**

Missing expansion joints were noted in one or more areas. Correction is recommended.

Contact a qualified professional.

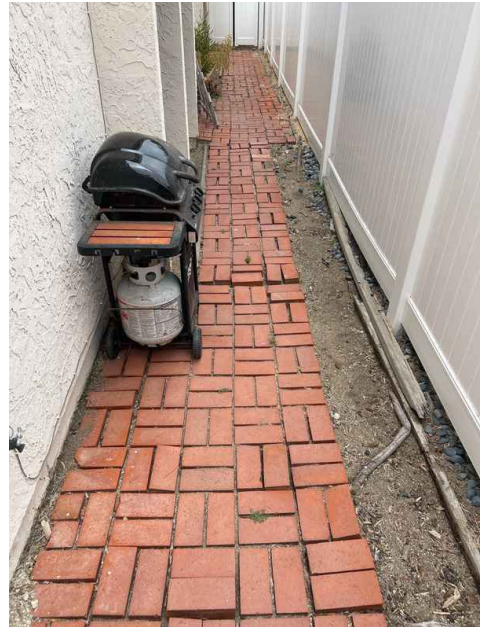
#### 2.1.4 Driveways, Sidewalks, Patios

### **LOOSE / SETTLED / SEPARATING PAVERS**

Loose, settled, uneven and/or separating pavers/tiles were noted in one or more areas. Trip hazards were present. A qualified professional is recommended to make repairs as needed for improved safety.

Contact a qualified professional.

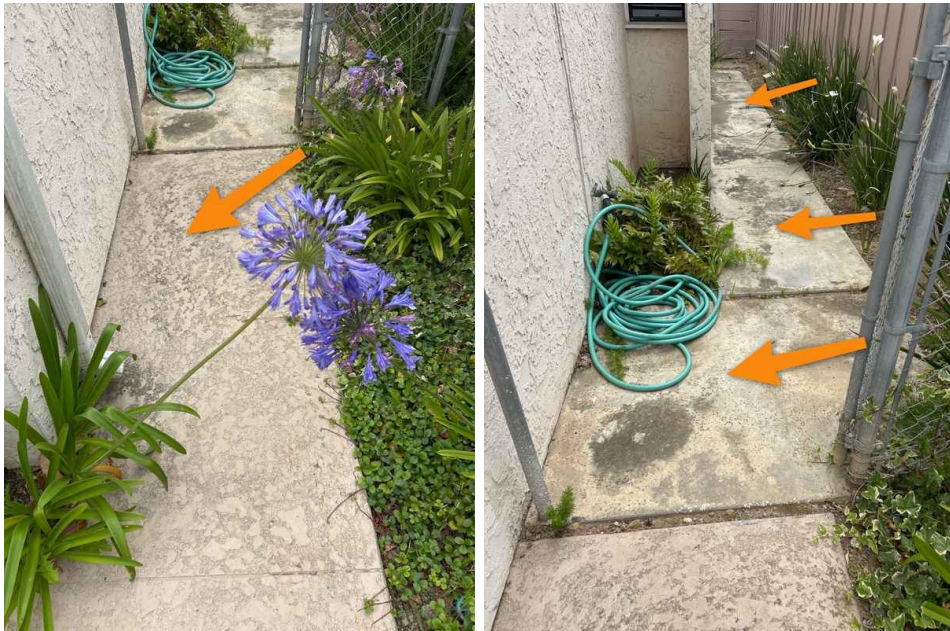
#### 2.2.1 Drainage or Grading

### **IMPROPER GRADING / DRAINAGE AWAY FROM STRUCTURE**

The perimeter grading does not slope down and away from the structure in one or more areas. No drainage was visible. This could trap water near the structure. Inquire with the seller to verify that drainage has been installed that is not visible or underground. Wet soil may cause the foundation to settle and possibly fail over time. Recommend having all soil and or hardscape so it slopes down and away from the structure properly or adding drainage as necessary using standard building practices.

Contact a qualified professional.

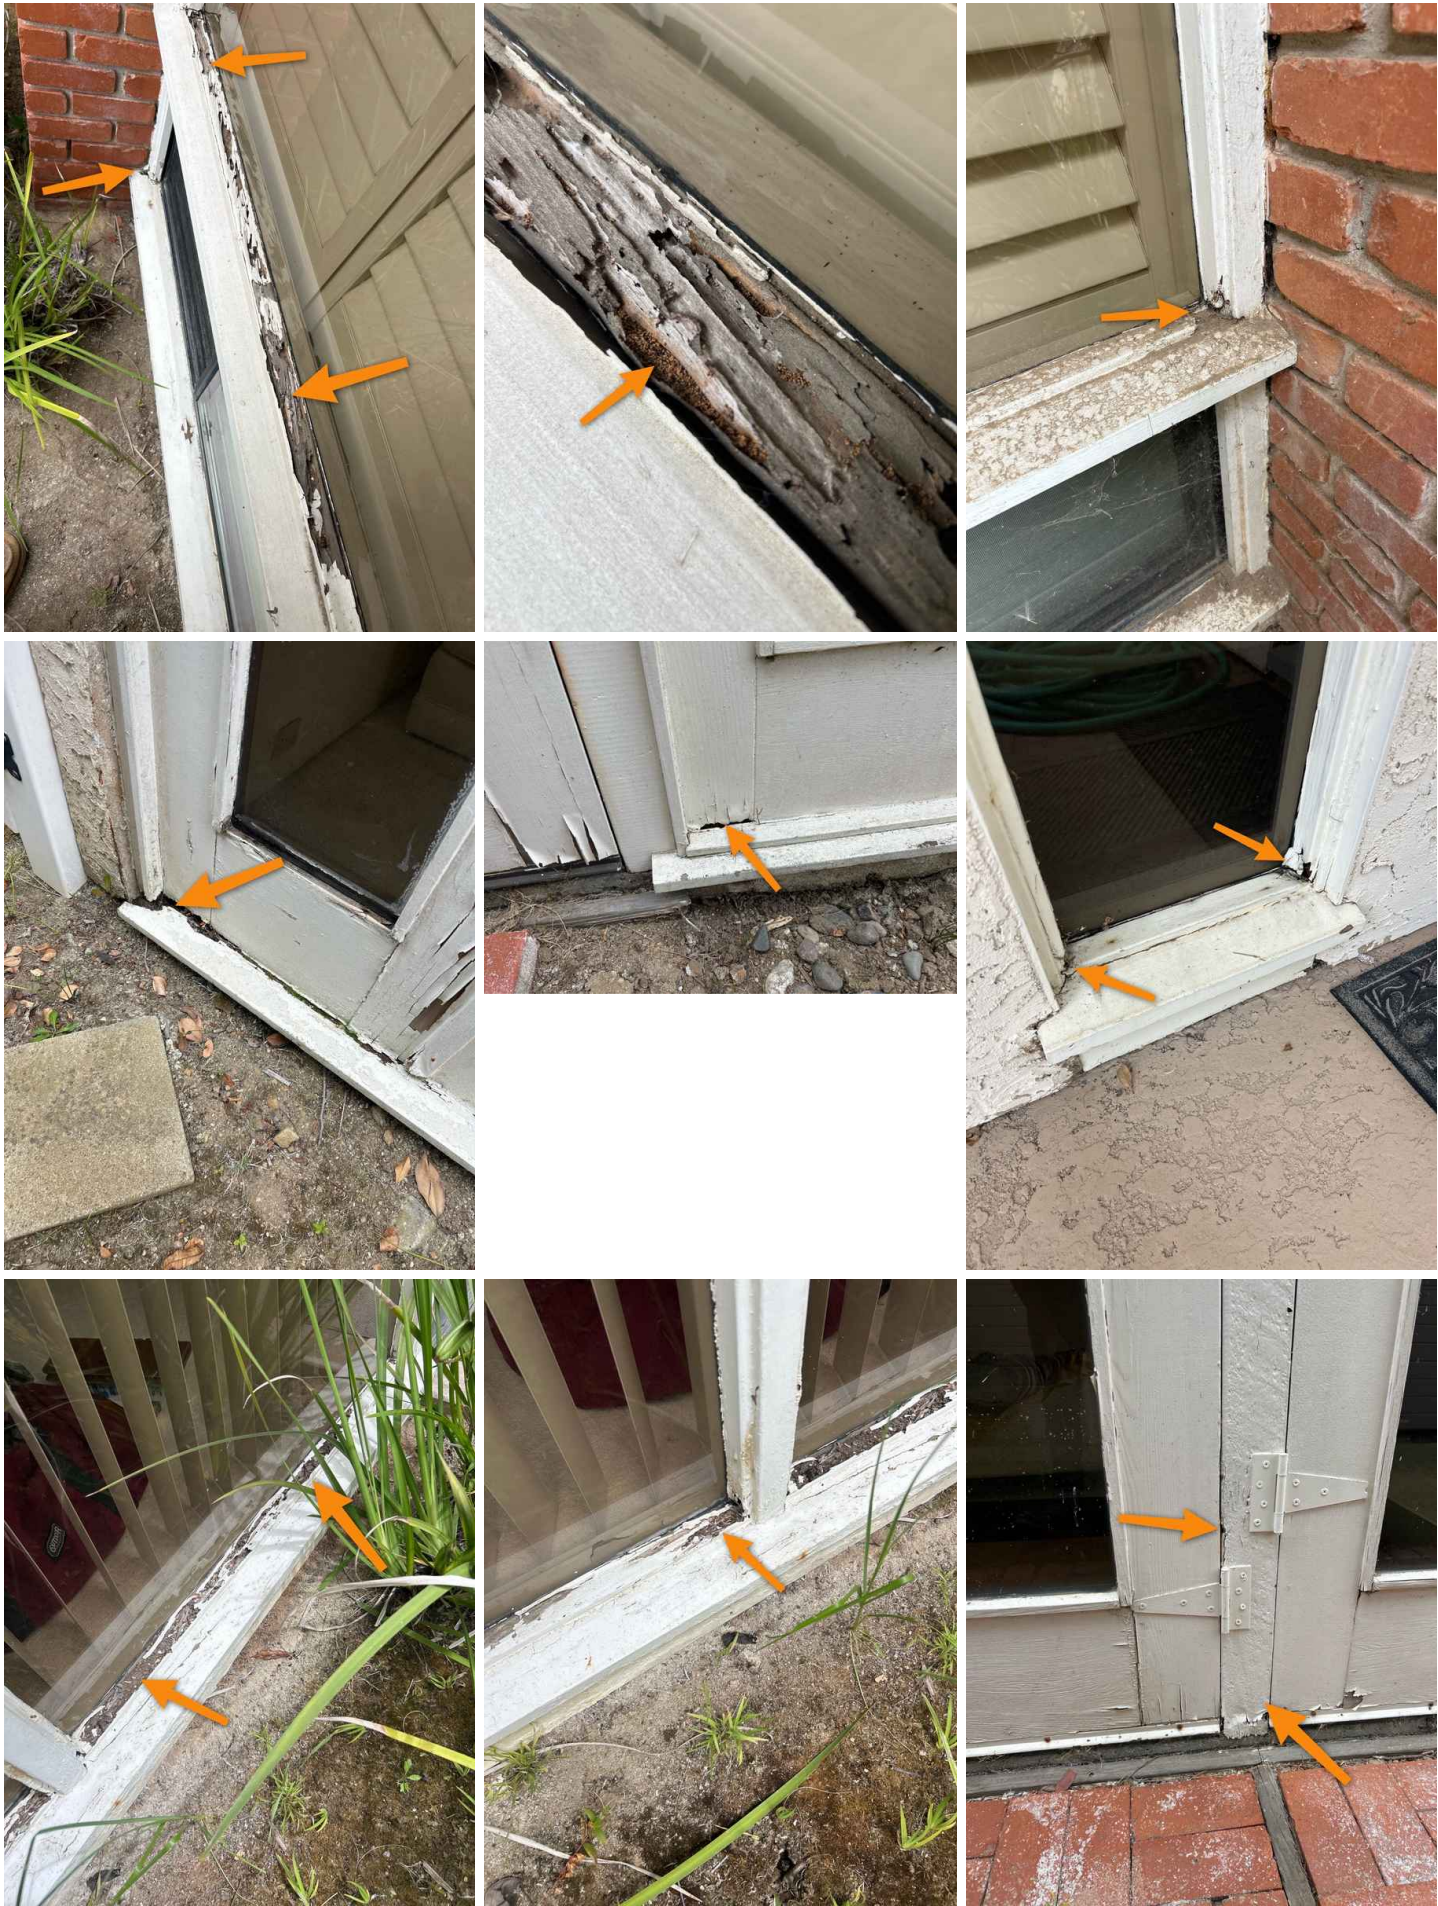
### TERMITE DAMAGED WOOD

Damaged, soft and/or deteriorated wood was noted in one or more areas. A qualified pest control professional is recommended for further evaluation and repairs.

Contact a qualified professional.

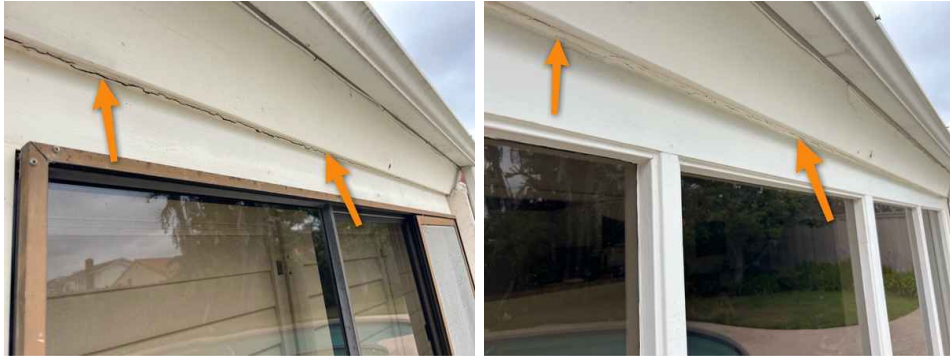
## 2.4.3 Exterior Walls / Trim

**CAULKING/SEALANT NEEDED**

Caulk and/or silicone was substandard and/or missing in some areas. A qualified person is recommended to renew or install caulk as necessary. This is a possible water intrusion area and/or rodent intrusion concern. Where gaps are wider than 1/4 inch, an appropriate material other than caulk should be used.

Contact a handyman or DIY project

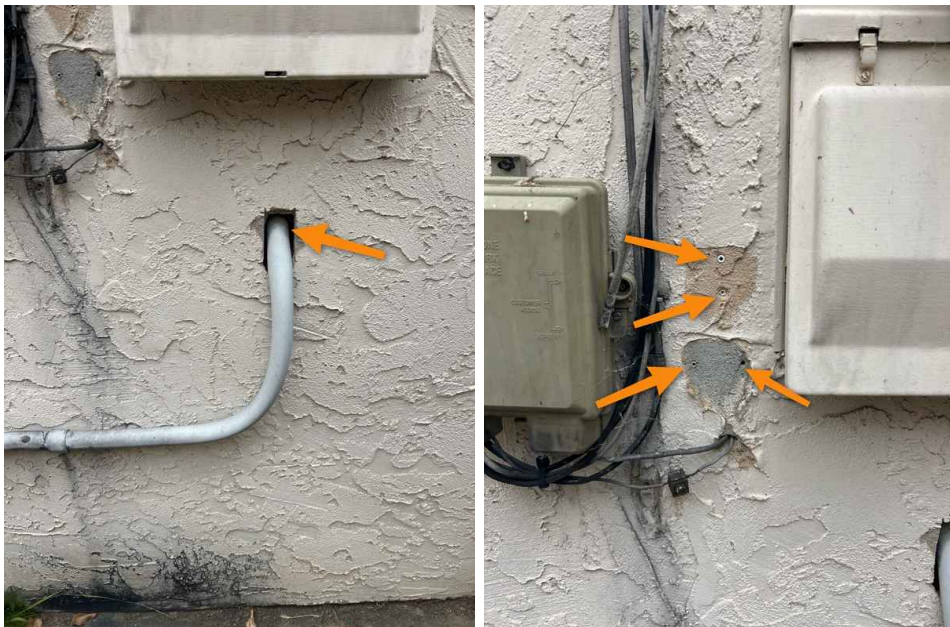
## 2.4.4 Exterior Walls / Trim

**HOLES / GAPS**

Holes or gaps were noted at the exterior siding in one or more areas, which may allow for pest and/or moisture intrusion. A qualified handyperson is recommended to repair as necessary.

Contact a qualified handyman.

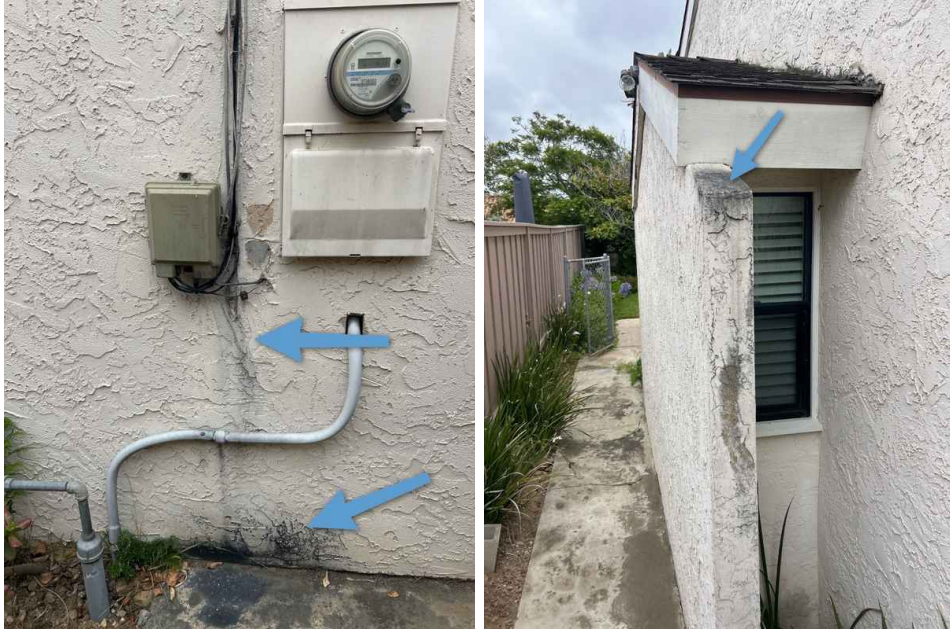
## 2.4.5 Exterior Walls / Trim

**STAINS ON BUILDING**

Stains were present at one or more areas of the exterior. It appears that exterior of the home needs cleaning and/or paint. A qualified professional is recommended for the maintenance.

Contact a qualified professional.

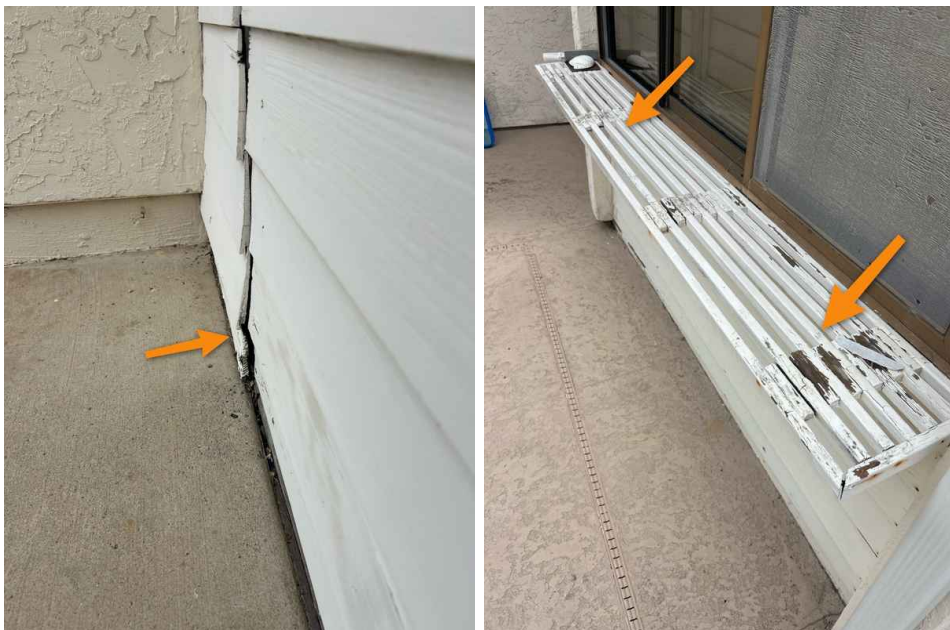
## 2.4.6 Exterior Walls / Trim

**LOOSE/DAMAGED TRIM / SIDING**

Exterior trim and/or siding was loose/damaged at one or more locations. A qualified professional is recommended to make repairs as needed.

Contact a qualified professional.

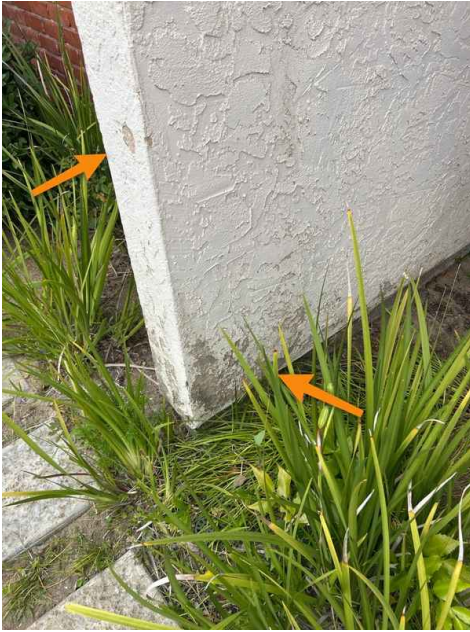
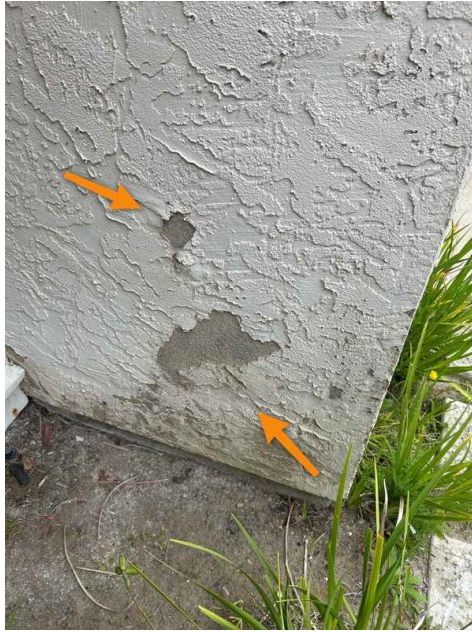
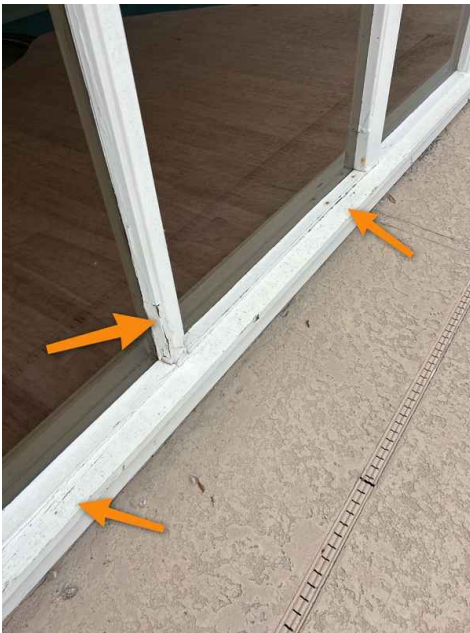
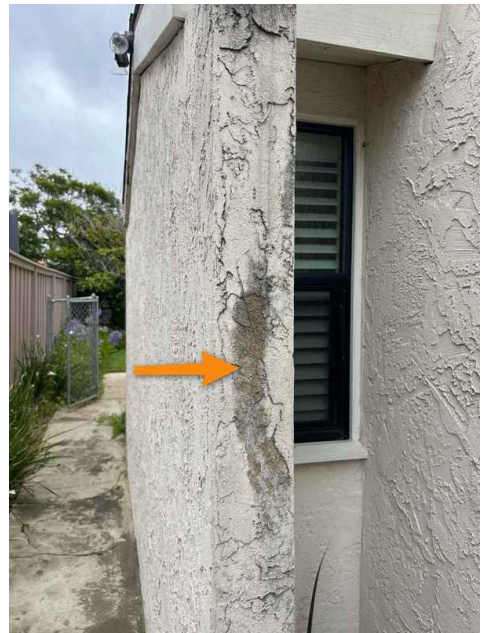
## 2.4.7 Exterior Walls / Trim

**PAINT DETERIORATION NOTED**

Paint was flaking and/or deteriorated in one or more areas. Touch up paint is recommended

Contact a qualified professional.

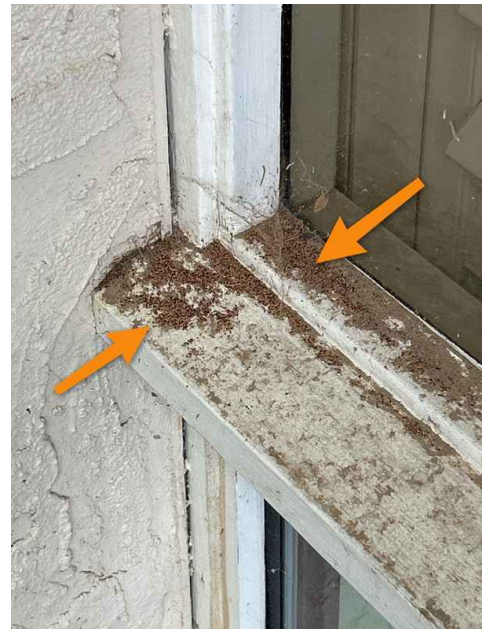
#### 2.4.8 Exterior Walls / Trim

What appeared to be termite droppings were noted in one or more areas. These could be from prior activity. A qualified pest control professional is recommended for further evaluation.

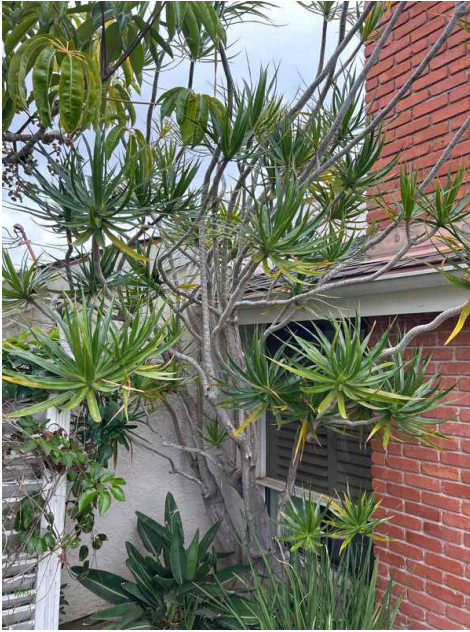
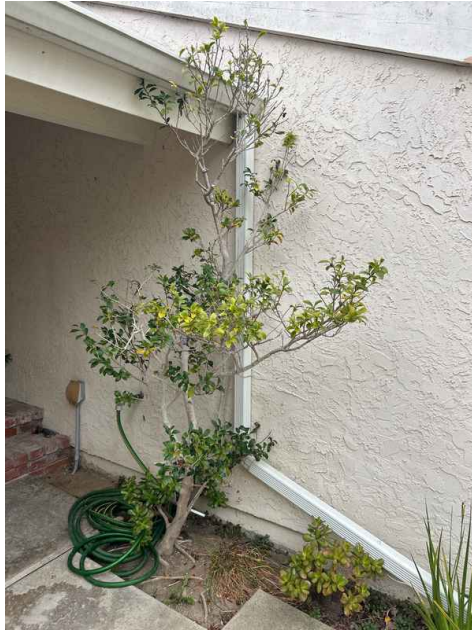
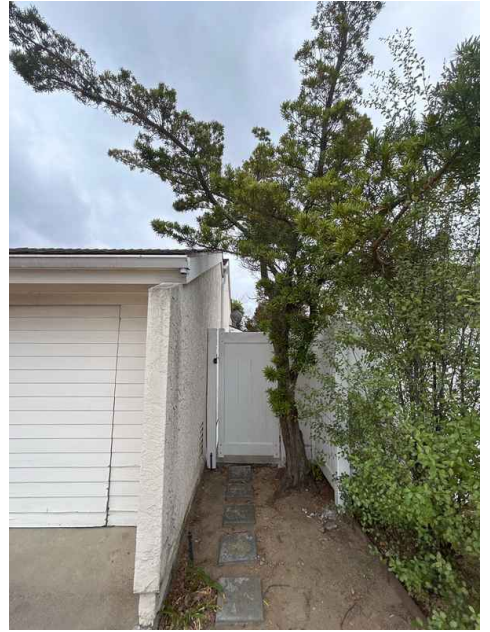
Tree(s) were in contact or in very close proximity to the structure in one or more areas. A qualified tree service contractor is recommended for pruning/trimming or removal to prevent future damage to the structure.

Contact a qualified tree service company.

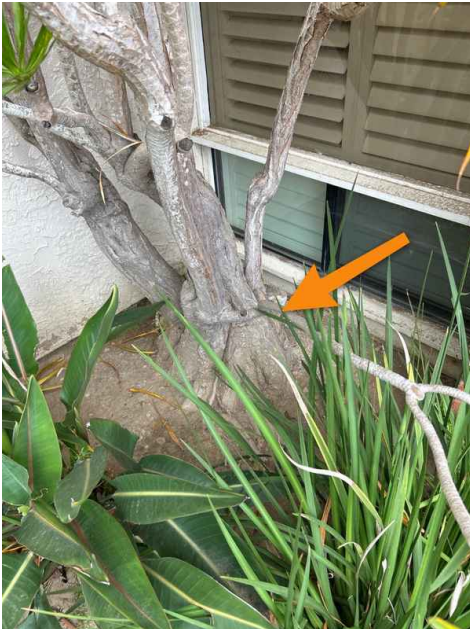
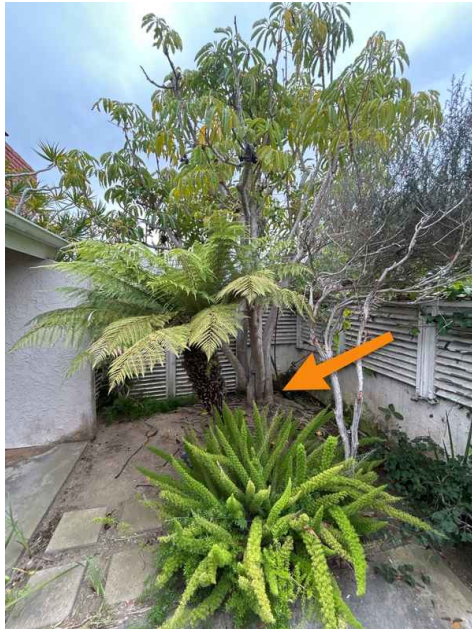
### 2.6.2 Vegetation

#### **TREE NEAR FOUNDATION**

Tree(s) were noted in close proximity to the foundation. Tree roots can cause significant damage to foundations. A qualified tree service contractor is recommended for evaluation and repairs as necessary.

Contact a qualified tree service company.

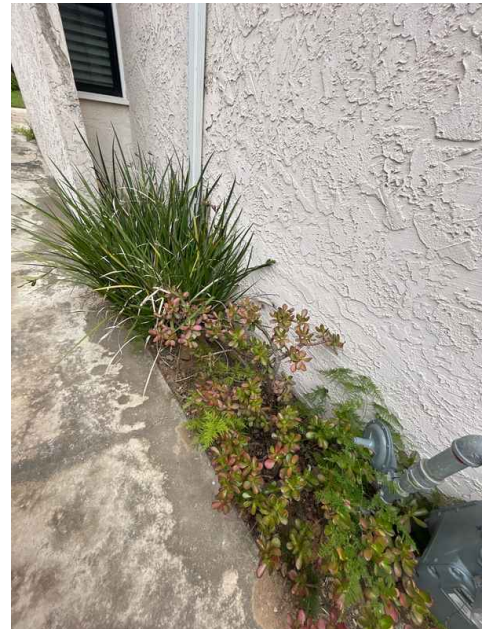
### 2.6.3 Vegetation

#### **VEGETATION CONTACT / CLEARANCE**

Vegetation was in contact with and/or too close to the structure's exterior. This is a conducive condition for wood destroying organisms. Recommend pruning or removing vegetation as necessary so there is at least a one foot gap between all vegetation and the structure's exterior.

Contact a handyman or DIY project

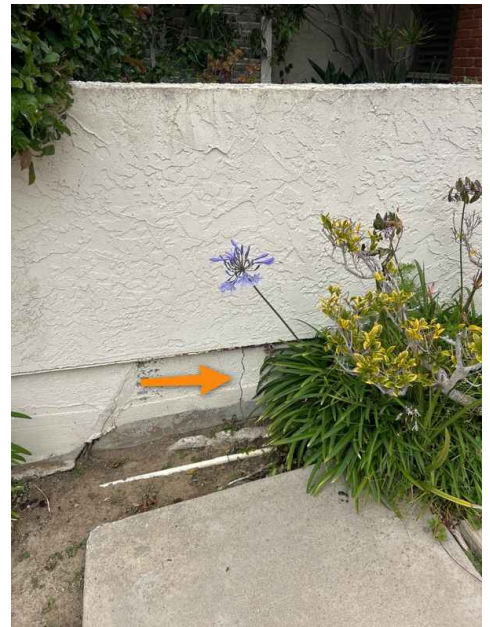
2.7.1 Retaining Wall(s)

**RETAINING WALL CRACKS / DETERIORATION**

Cracks and/or damage was noted in one or more retaining walls. A qualified professional is recommended to repair cracks/damage. Monitoring the cracks moving forward is needed.

Contact a qualified professional.

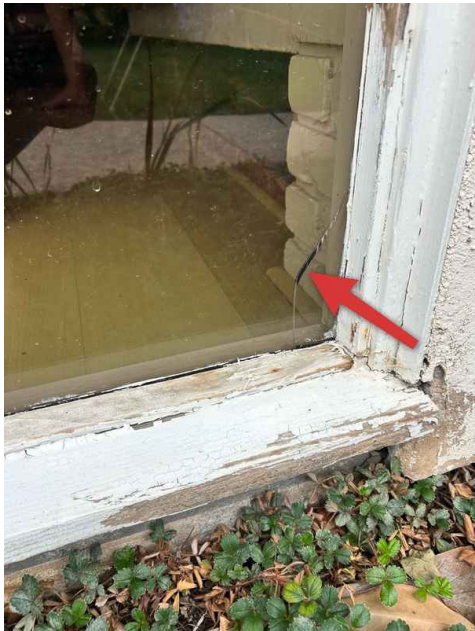
2.8.1 Exterior Windows

**DAMAGE / DETERIORATION - REPAIR**

Cracking to the glazing was present at one or more windows areas. Correction is recommended. Seek a licensed window contractor to repair and or replace.

Contact a qualified professional.
