## Roof Inspection Report

**4506 Lilac Ridge Road, San Ramon**

Kane Howell  
May 2, 2024  
Reg No. 121052 SP

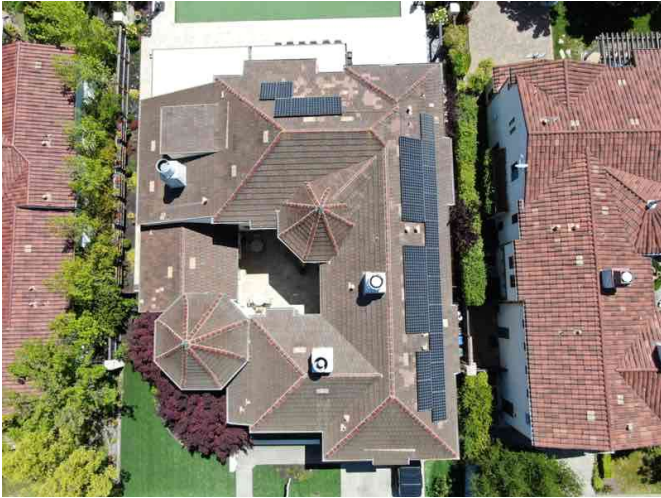
Photo 01

1. Birds eye view (See Photo 1)
2. The plumbing vent flashing is not properly integrated into the roofing system, the water shedding ability of this area cannot be guaranteed. (See Photo 2)

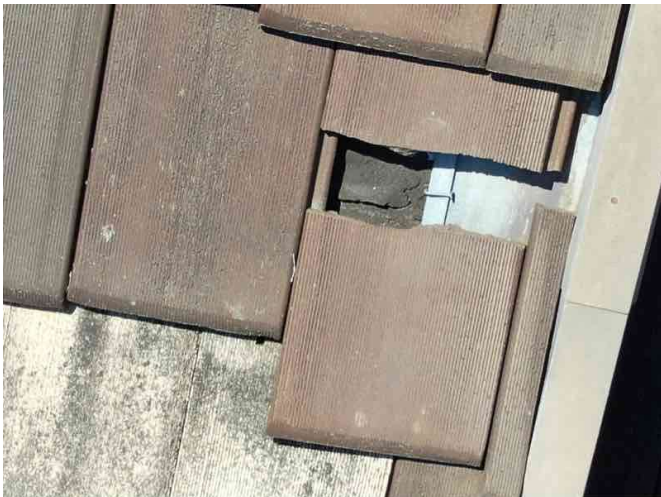
Photo 03

3. During the course of this inspection we noted broken field tile(s). (See Photo 3) (See Photo 4) (See Photo 5)
4. The ridgeline mortar seal is broken and cracked in several places, this condition may allow water intrusion into the structure. (See Photo 6)

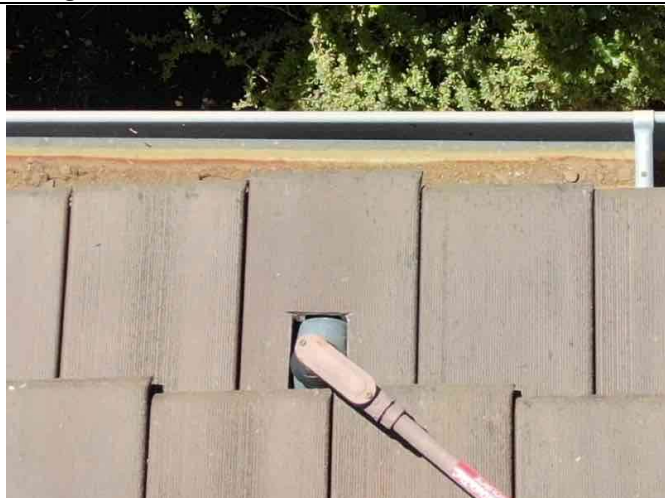
Photo 07

5. The pipe flashing is not properly integrated into the roofing system, the water shedding ability of this area cannot be guaranteed. (See Photo 7)
6. Debris has collected behind the chimney and may cause water to backup into the structure. Poor drainage can cause premature wear and tear and subsequent leakage. (See Photo 8) (See Photo 9) (See Photo 10)

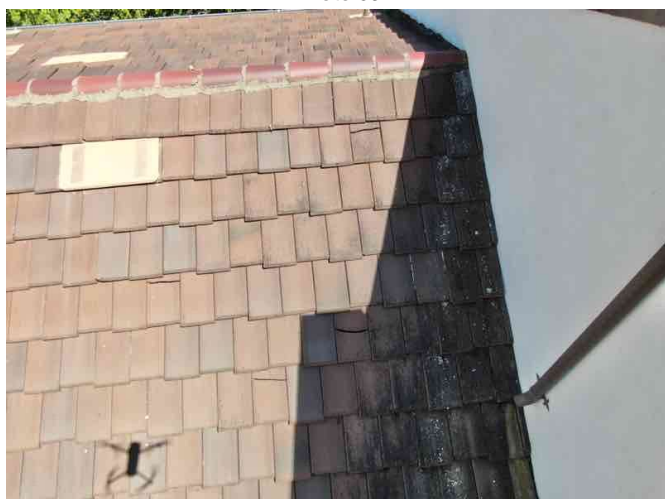
Photo 11

7. During the course of this inspection we noted broken field tile(s). (See Photo 11) (See Photo 12) (See Photo 13)
8. This roof has been previously serviced; the performance of these repairs were not verified.
