Inspection Report

2533 Geranium St San Diego California 92109

Nation Wide Inspections

Date: 10/27/2025	Time: 09:01 AM	Report ID: J102725A
Property:	Customer:	Real Estate Professional:
2533 Geranium St	Geoff Pasqua	Diane Sullivan
San Diego California 92109		Diane Sullivan Realty

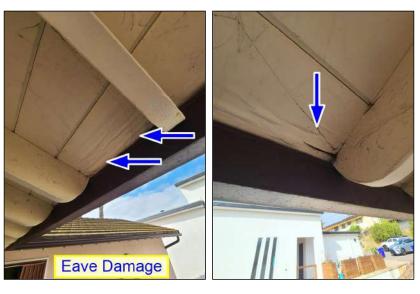
(3) Eave Damage. There was some wood damage at some of the eaves at the front of the property. It is recommended that you read your termite report thoroughly and that any damaged wood be repaired or replaced by a licensed contractor if needed.

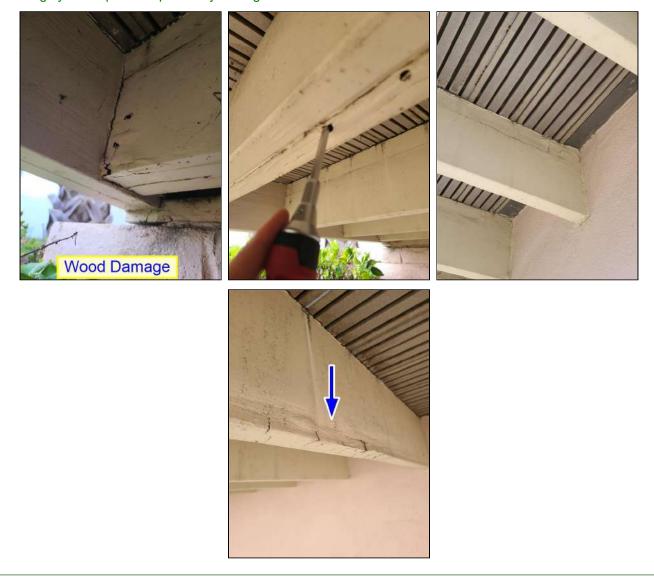
(3) Wood Damage. There was some wood damage to some of the wood joists at the front and rear balconies. **There were also areas of patching noted.** It is recommended that you read your termite report thoroughly and repair or replace any damaged wood.

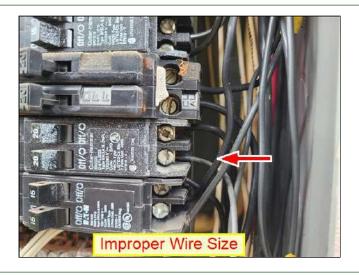
Improper Wire Size. The main panel has an undersized wire for the breaker. 20 amp breakers need to be sized with a minimum of a #12 AWG copper wire. It is currently wired with a smaller #14 AWG copper wire. Improper wire sizing causes the wires to over heat increasing the risk of fire and damage.

Recommend that this be further evaluated and corrected by a licensed electrician.

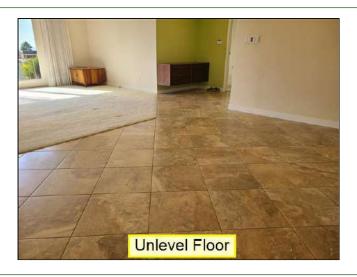
(1) NOTE: Unlevel Floor. There are a few areas in certain rooms where the flooring is not level, and you may notice a rise, or drop in the flooring. This is common in older homes with raised foundations. The cause of this was not determined but is often the result of settlement and is not necessarily a sign of a structural issue. (Please refer to the section "Structural Components" for more information).

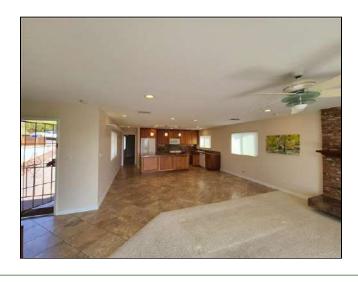
Verify Permits for Alterations. It appears that there were walls removed to the original structure of this house. It is recommended that you check to see if all required permits were pulled to complete this structure, and the final was signed. The structural integrity of the components are not all visible due to wall, floor and ceiling coverings. Because of the inability to structurally analyze this addition, we cannot verify, at time of inspection, that the standards of practice, and compliance of codes have been followed. If unpermitted, we will not be held liable for unseen conditions. It is recommended that all modifications be verified as having necessary permits, and if not, structural analysis be further conducted by a licensed contractor or engineer before the end of the contingency period.

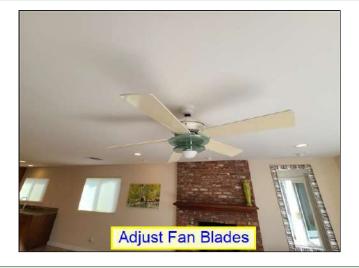
(4) Adjust Fan Blades. The fan blades for this fan rub. It is recommended that this be corrected as needed to ensure proper working order.

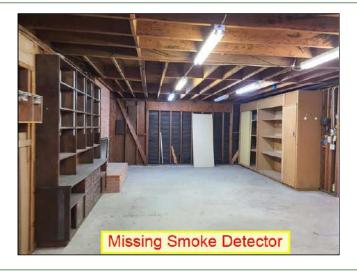
be located at each level, in each bedroom and in the room outside the bedroom (hallway). Currently there was/ were missing detector(s) downstairs. It is recommended that smoke detectors are present at these locations.

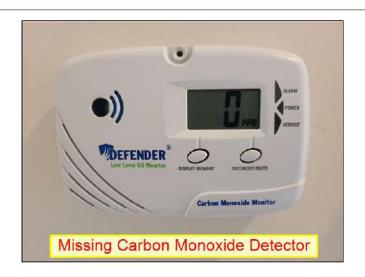
(2) Missing Carbon Monoxide Detector. A carbon monoxide detector was not identified under the house during the inspection. As of July 01, 2011 a Carbon monoxide detector is required to be installed in all new and existing single family homes. Carbon monoxide is an odorless, tasteless lethal gas which is created by combustion particles. These detectors act like a smoke alarm, and makes an audible warning to alert you if particles are detected. These need to be installed at each floor level including basements and or crawlspaces. It is a safety requirement that a working carbon monoxide detector be installed in this property.

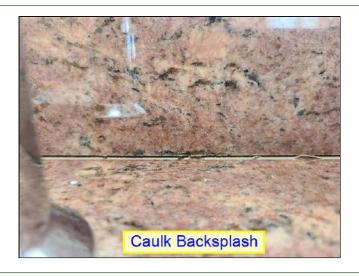
Caulk Backsplash. The grout at the backsplash has some areas that have cracked and should be caulked to inhibit the possibility of water intrusion. It is recommended that these areas be properly sealed.

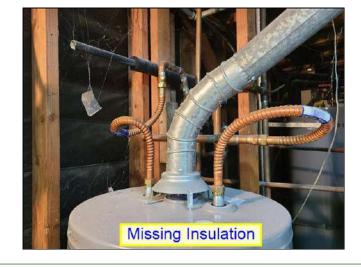
(3) Missing Insulation. The water supply lines were not insulated. The first 5 feet of hot and cold water pipes are required to be insulated if they are exposed in unconditioned space. It is recommended that these lines be properly insulated.

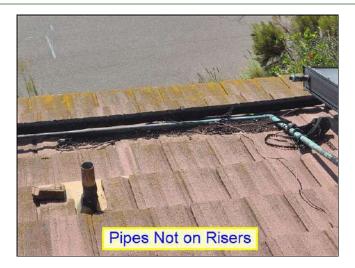
(5) Pipes/ Conduit On Roof. There are some pipes located on the roof. These pipes were not set on risers. This can create a dam like feature that can allow water and debris to pool and increase the risk of roof leaks. It is recommended that this area be cleared of debris.

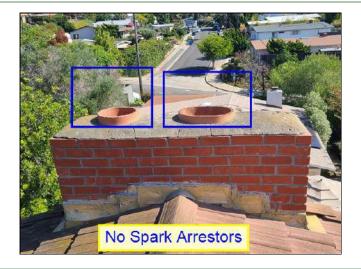
(2) No Spark Arrestor. Spark arrestors are metal screens which are attached to the chimney flu at the cap to keep large embers from escaping and landing on combustible material. This is a safety measure to decrease the risk of fire. Recommend installation of spark arrestor.

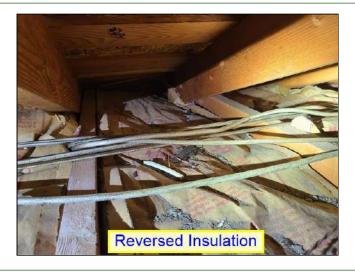
(1) Improper Installation of Insulation. The insulation in the attic was improperly installed. The paper or vapor barrier should be faced towards the interior of the home. In this application the paper was faced up, towards the exterior of the house. It is recommended that this be repaired or replaced by a licensed contractor.
