HomePro Inspections

Residential Pre-Listing Inspection Address:

3828 Keswick Road

Report Prepared for: Sonia Chang

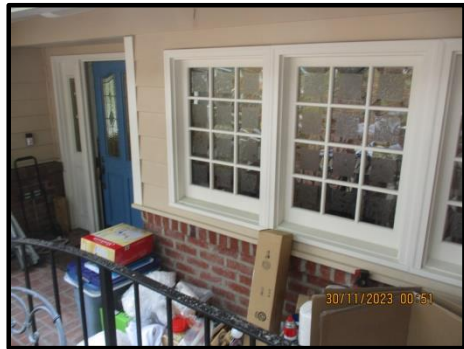
Condition: lifting with some displacement observed

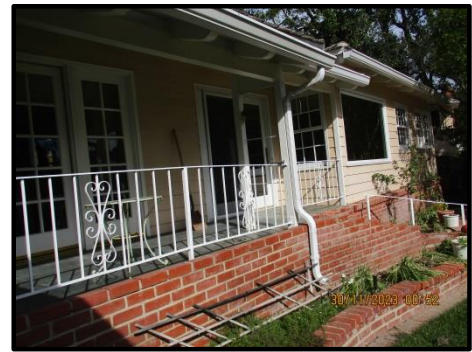
Efflorescence was observed on the exterior stucco siding/slab. Efflorescence is the migration of salt to porous materials such as stucco cladding and concrete. Efflorescence is not considered a health concern and it is common on virtually all structures with stucco and concrete. The efflorescence can be washed off using a number of cleaning agents but keep in mind that it will return over time.

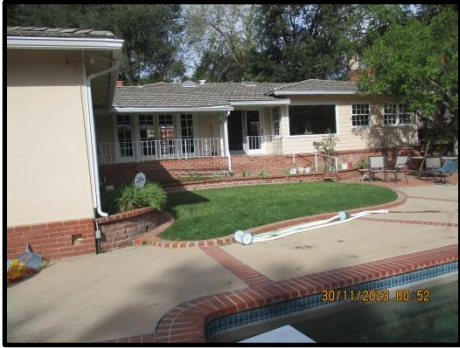
There are various plants and or bushes next to the exterior wall(s). Recommendation: Trim or prune all vegetation in such a way as to allow a minimum of six inches of clearance between the plant and the exterior wall. This is necessary in order to prevent damage to the exterior and to inhibit the ability of insects to migrate into the building structure.

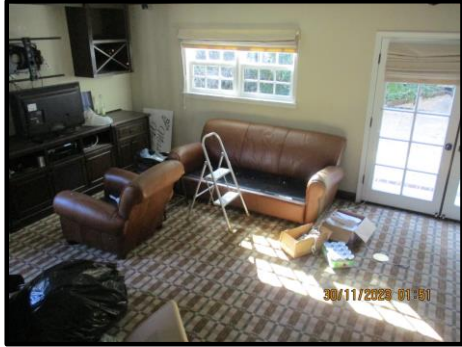
NEEDS SERVICING: Carpet stains were noted in one or more areas of the interior carpeted rooms. Recommend that the carpeting be properly cleaned and sanitized as necessary at this time by a qualified professional.

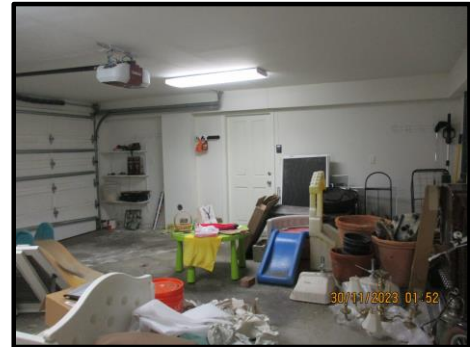
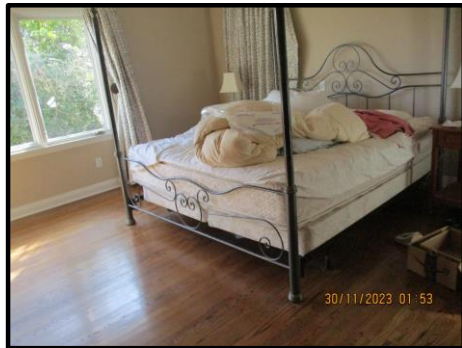
The flooring has compression (gaps between the cover and the floor sub-structure - floor joists). This softness is a condition known as 'compression set' which is very common with raised floor or multi-level

structures. Correction of this condition involves filling the gaps with epoxy filler, re-sanding and refinishing the floor or simply replacing the section of floor that exhibits this condition. Recommendation: No repairs or remediation is recommended at this time. Compression set is common and since it is overall minor in scope no action is recommended at this time.

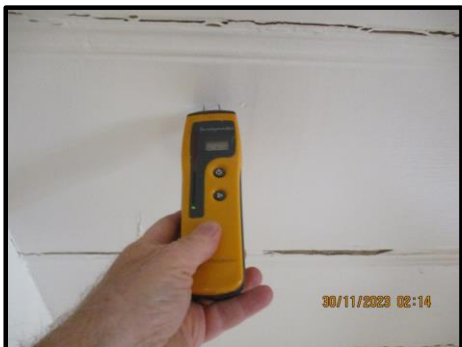
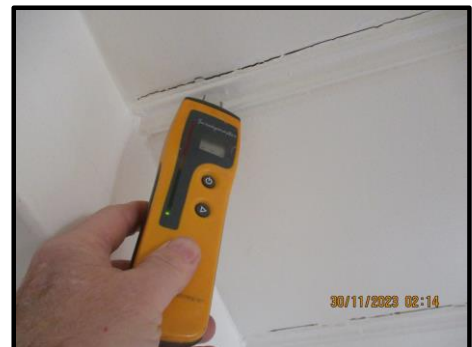
There are water-stained ceilings that appear to be the result of past water intrusion from the roof. There is no indication that the stains are the result of active leaks. It is unknown how these have affected unseen areas, and whether or not there could be structural damage caused by rot. Recommendation: Confirm from seller if the stains are related to a previously repaired problem or obtain evaluation for the source of the moisture by licensed roofing, siding or plumbing contractor and repair as appropriate (See Below).

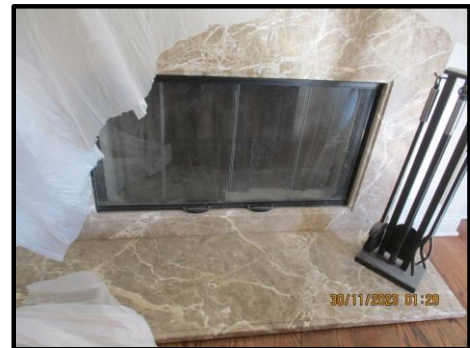
Both Fireplace Systems: There is no lockout clamp installed on the fireplace damper. This unit has been retrofitted with a gas-log set. The gas-log set uses a pilot light that is always on, therefore it is necessary to install a clamp on the damper to keep it open, in order to vent carbon monoxide and other combustion byproducts from the home. It is not advisable to use this fireplace until the lockout clamp has been reinstalled.
