LIMITLESS CONTRACTING INC  
RESIDENTIAL & COMMERCIAL ROOFING

# 21919 Fallview Dr, Sonora, CA 95370, USA (8/14/26)

Roof Inspection Report  
Cheryl Branco

# Roof Inspection Summary & Recommended Repairs

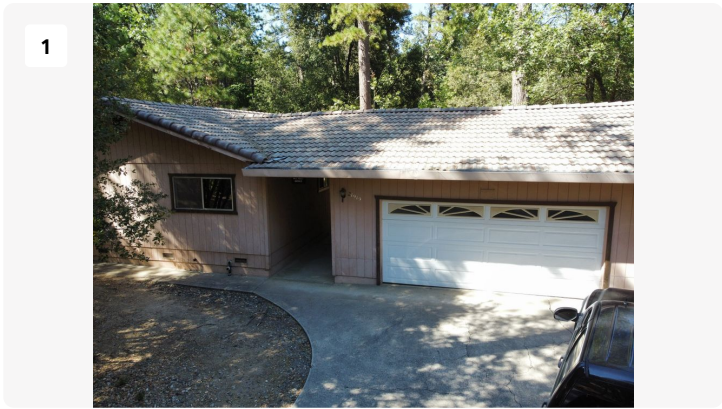
Project: 21919 Fallview Dr, Sonora, CA 95370, USA  
Date: Aug 14, 2026, 3:57 PM  
Creator: Steven Alvarez  
Tags: Discontinued - Roma Tile

4. Broken tiles were noted at:
5. Various locations (see photos).
6. 7 field tiles allotted.
7. Note: Exact tile match cannot be guaranteed as this tile has been discontinued. However, a similar style, color, and profile will be utilized to ensure the roof maintains waterproofing integrity.

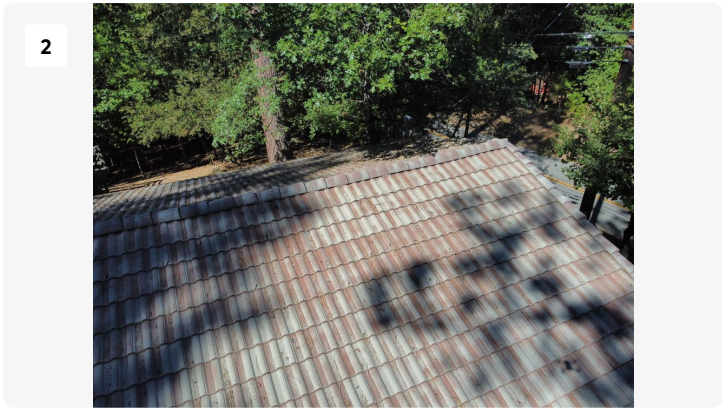
Project: 21919 Fallview Dr, Sonora, CA 95370, USA  
Date: Aug 14, 2026, 3:57 PM  
Creator: Steven Alvarez  
Tags: Roof Debris - Clean, Discontinued - Roma Tile

1. Remove all debris from the roof surface as necessary.
2. Replace all vent collars with new rubber collars as necessary.
3. Reset all slipped tiles throughout the roofing system as necessary.

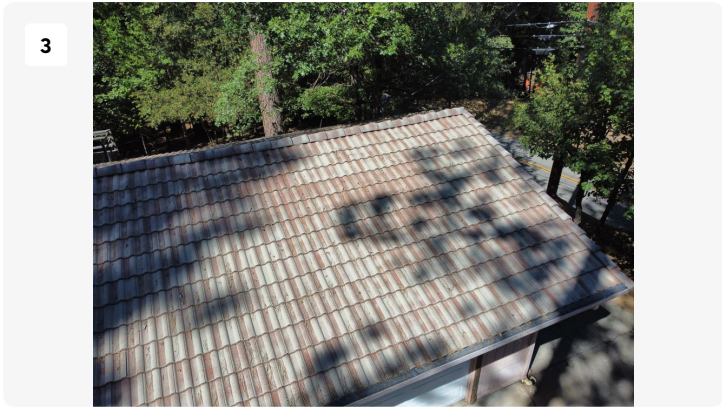
Project: 21919 Fallview Dr, Sonora, CA 95370, USA  
Date: Aug 14, 2026, 3:57 PM  
Creator: Steven Alvarez  
Tags: Roof Debris - Clean, Discontinued - Roma Tile

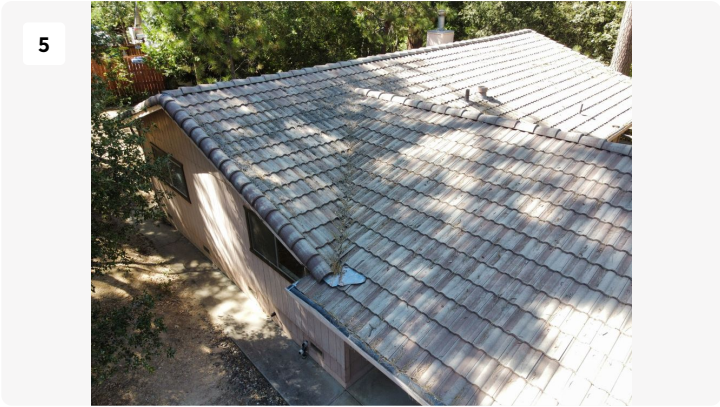
Project: 21919 Fallview Dr, Sonora, CA 95370, USA  
Date: Aug 14, 2026, 3:57 PM  
Creator: Steven Alvarez  
Tags: Valley Debris - Clean

15. \*All additional tiles to be replaced will be charged on a supplemental report at a rate of \$15/tile.
16. Debris must be removed from all critical flashings in the roofing system. This includes all valleys, sidewall flashings, and all major penetrations larger than 24" wide. All open hems in the valley and sidewall flashings are to be opened-up to allow proper water diversion off of the roofing system.

17. All valleys (2).

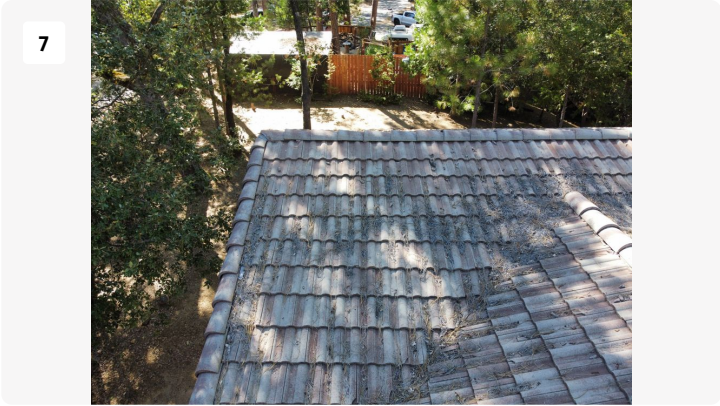
Project: 21919 Fallview Dr, Sonora, CA 95370, USA  
Date: Aug 14, 2026, 3:57 PM  
Creator: Steven Alvarez  
Tags: Roof Debris - Clean

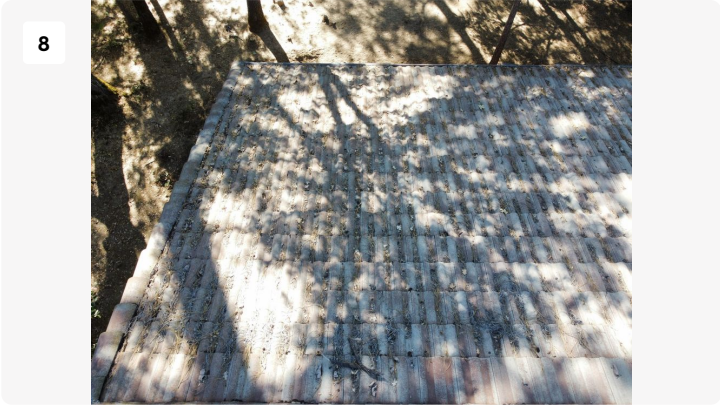
Project: 21919 Fallview Dr, Sonora, CA 95370, USA  
Date: Aug 14, 2026, 3:57 PM  
Creator: Steven Alvarez  
Tags: Roof Debris - Clean

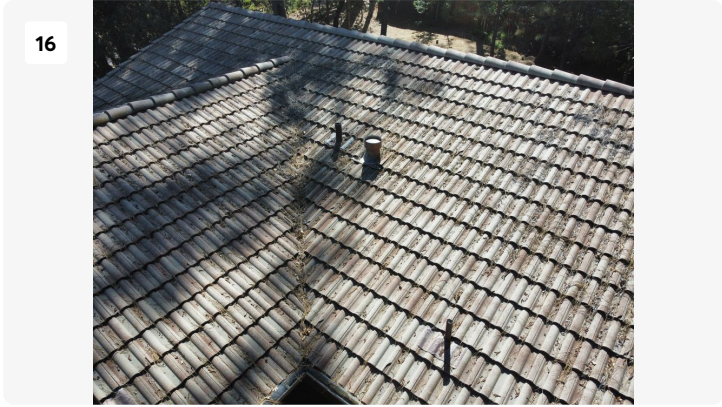
Project: 21919 Fallview Dr, Sonora, CA 95370, USA  
Date: Aug 14, 2026, 3:58 PM  
Creator: Steven Alvarez  
Tags: Valley Debris - Clean

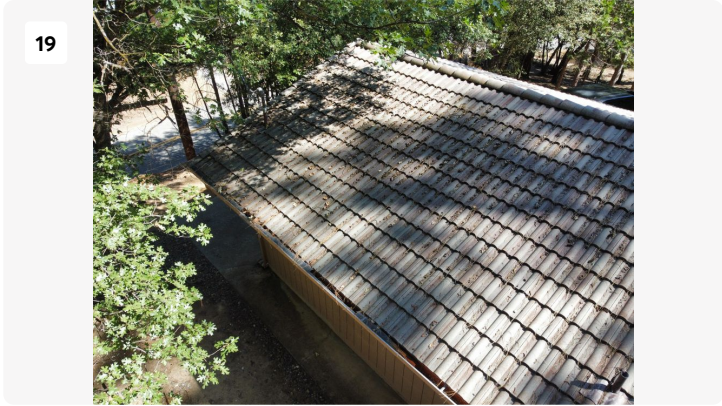
Project: 21919 Fallview Dr, Sonora, CA 95370, USA  
Date: Aug 14, 2026, 3:58 PM  
Creator: Steven Alvarez  
Tags: Discontinued - Roma Tile
