# REAL ESTATE INSPECTION REPORT

**Henry Wisch**

16256 Horace St. Granada Hills CA 91344

DATE OF INSPECTION: 04/12/2023.

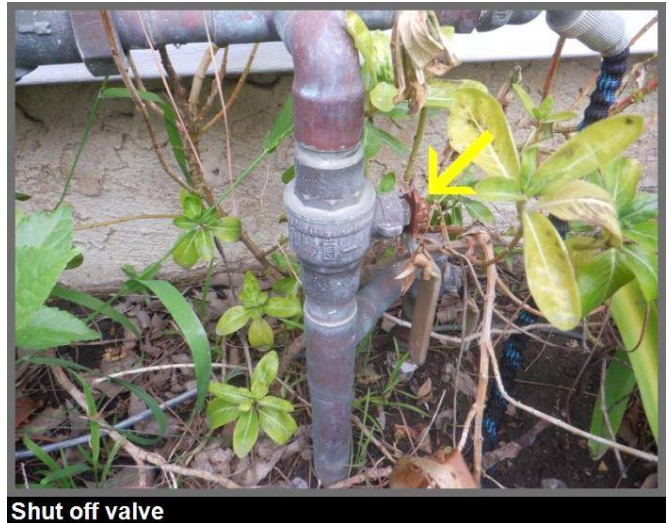
Shut off valve

**PRESENT.** During a general visual inspection valves are not operated or tested for correct operation, due to the potential of failure. Their operating condition is not determined. If more information is desired it is recommended to consult with a qualified plumber. This is located at the main water line.

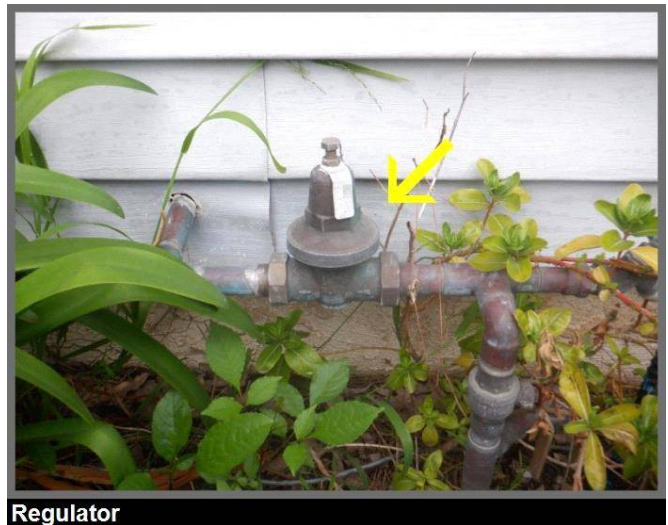
Regulator

The pressure regulator is at the front of the building.

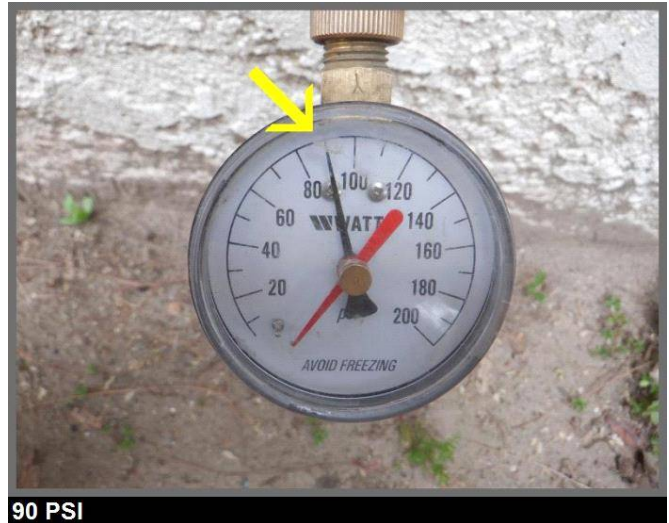
**NEEDS ATTENTION.** The pressure is over 80 psi. This is too high, it should be between 40 and 80 psi. The regulator should be adjusted and/or repaired, to bring the water pressure into proper range. The pressure tested at 90 PSI.

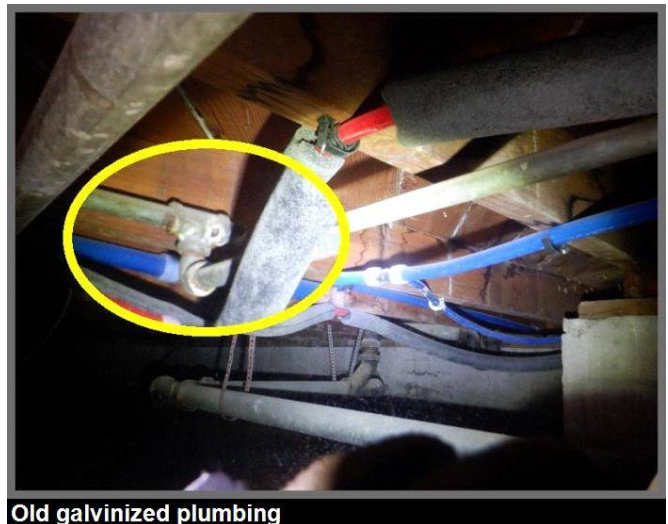
**NEEDS ATTENTION.** There are abandoned pipes still in place under the building. During a general inspection it is not possible to tell which are still connected and in use (if any), and which are removed from the system. It is difficult to tell how much of the piping system is re-piped, and how much is older and worn. A plumbing contractor should evaluate this further if desired and ideally the abandoned pipes would be removed.

Much of the lines are concealed and the condition of the materials in the walls, concealed spaces and within/under the floors, etc is unknown. For a detailed inspection of the water supply system a qualified plumber would be recommended.

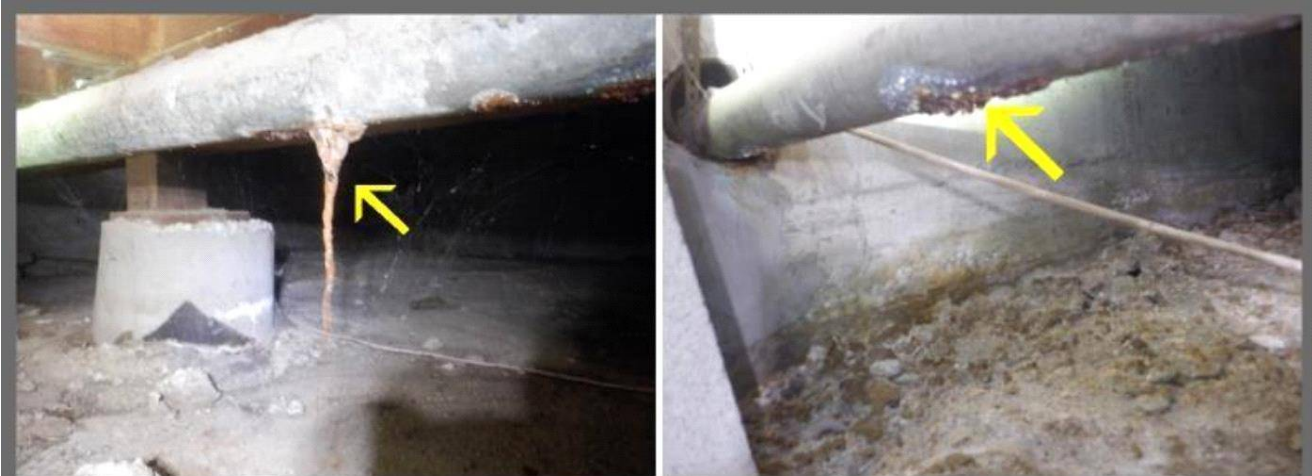
**NOT ACCEPTABLE.** There are areas of rust blistering that are now beginning to leak in the waste pipes. These lines should be further evaluated and or replaced by a licensed plumber at this time. This is seen under the kitchen and under the hallway bathroom.

**Rust blistering now leaking**

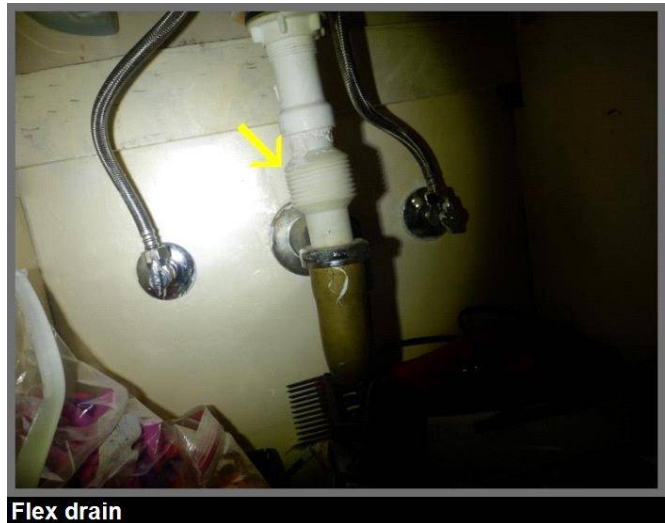
Flex drain

There are corrugated flex drain lines in use under some sink drains, such as in the master bathroom. This material is not approved for use as part of the drain system, only smooth wall drain lines can be used.

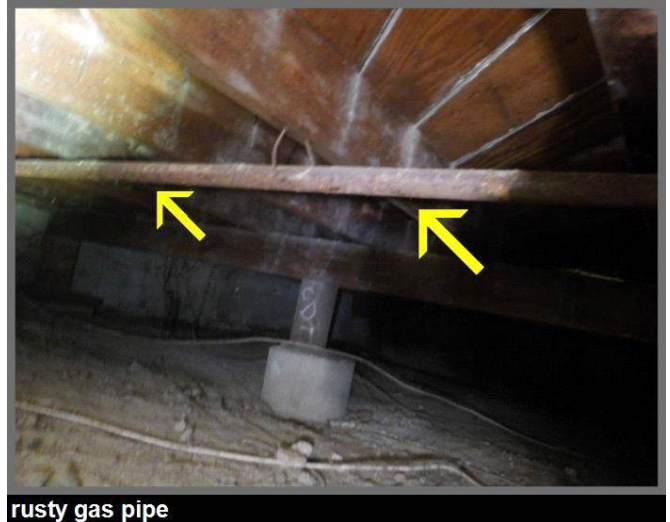
**NEEDS ATTENTION.** There are areas of rusty and deteriorated gas piping on the property. Such as in the crawl space.

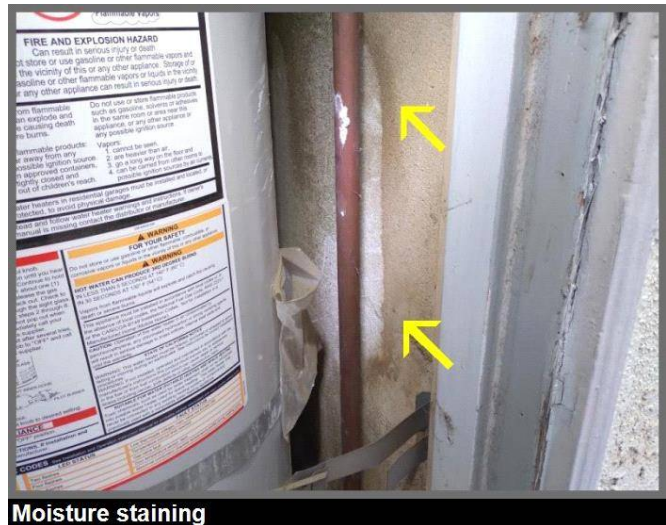
**NEEDS ATTENTION.** There is moisture staining noted in the closet. Consult with a moisture mold specialist regarding this.

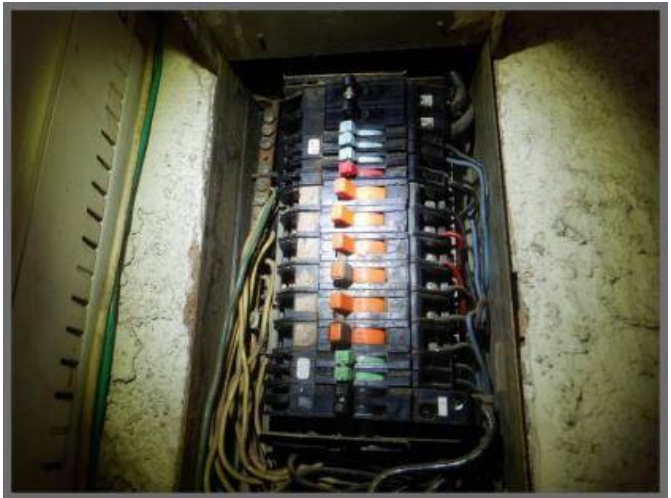
**NOTE.** This panel does not have a complete 'directory' to identify what the breakers control. This is often required for new work, and is a recommended convenience.

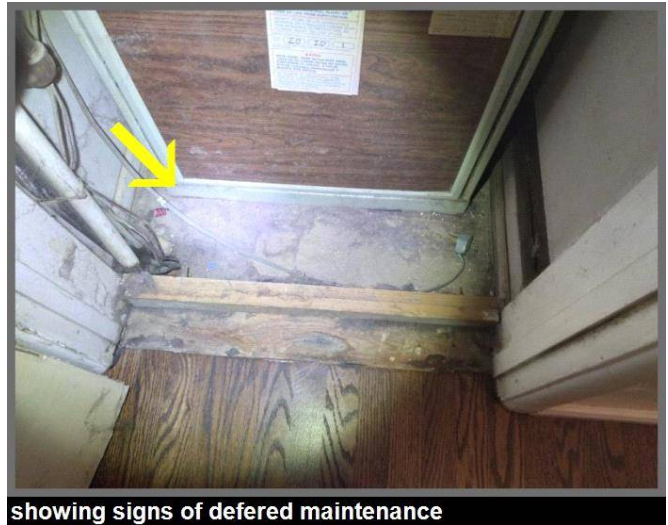
**SAFETY ALERT.** The closet area is dirty with a large amount lint and dust. This could be a potential fire hazard and should be cleaned out.

showing signs of defered maintenance

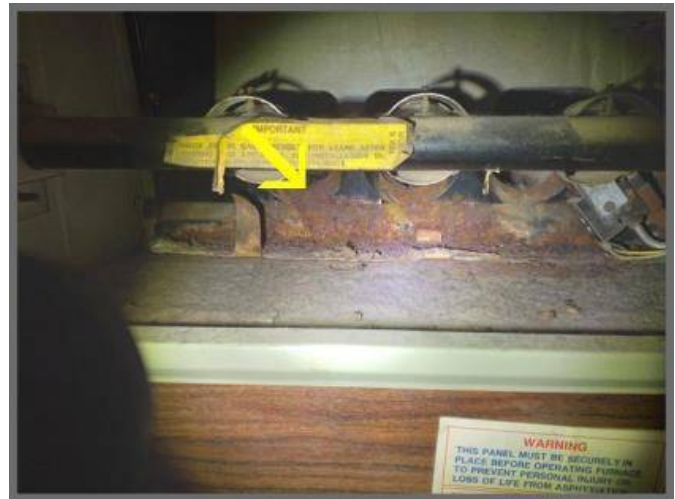
**SAFETY ALERT.** There is rust and corrosion in the burner area, this may indicate failure of the heat exchanger or other components and may lead to system failure and a potential safety concern.

**NEEDS ATTENTION.** The system is very old (likely original) and has been in the building for a long time. While is still working at this time, the system is well past its expected working life and no longer reliable and does not meet current safety standards and efficiency.

It is expected it will need to be replaced.

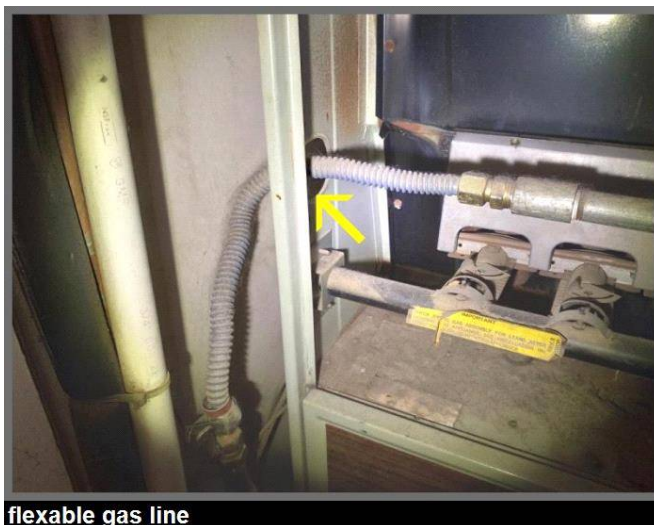
**SAFETY ALERT.** The flexible gas line passes through the outside wall of the furnace as it feeds the gas to the unit. Flexible gas lines are not supposed to pass through any walls for safety reasons and it should be a rigid metal line until it passes out of the furnace so there is no danger of it being damaged.

flexable gas line

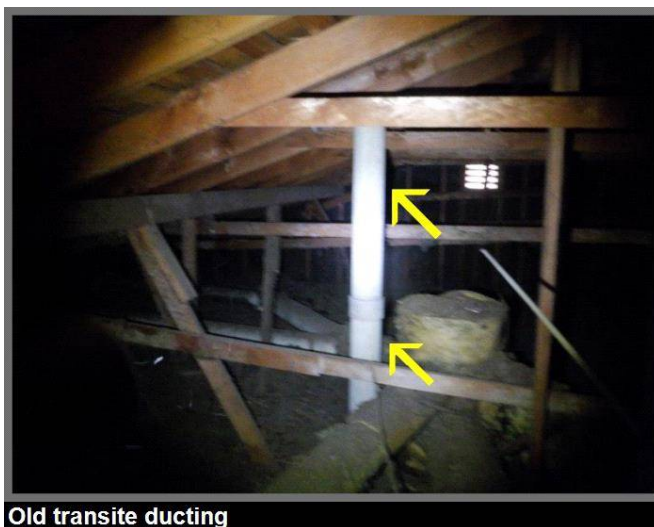
Old transite ducting

This condition should be further evaluated by a qualified contractor and corrected as needed/required.

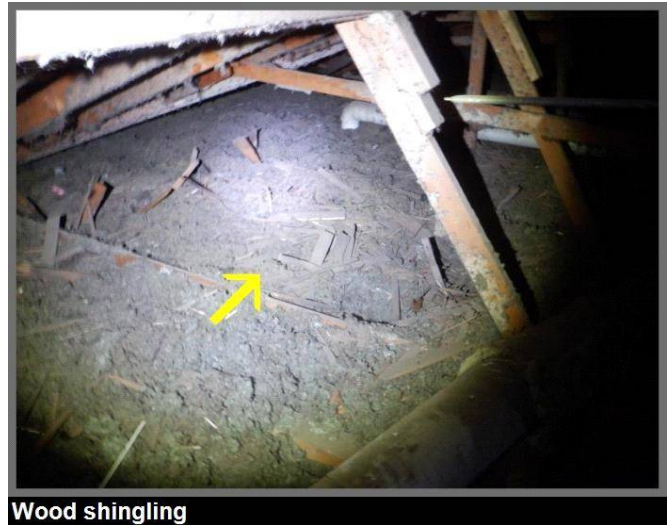
**NEEDS ATTENTION.** The attic has parts of wood shingles in it. This apparently occurred when the old wood roof was removed and pieces of it fell in the attic and were not removed.

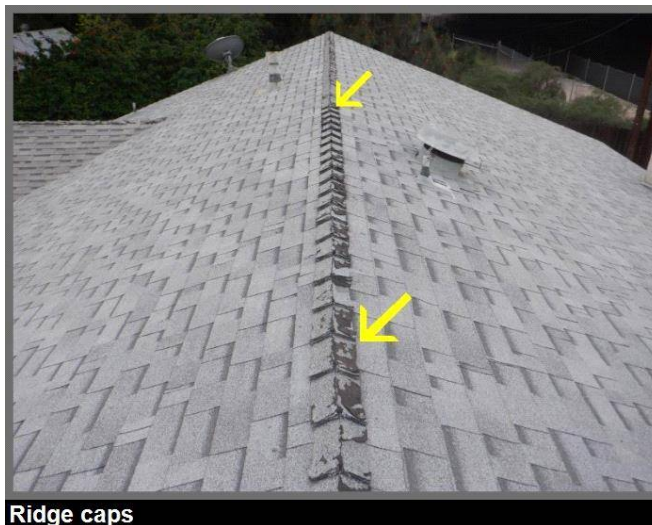
Ridge caps

**NOT ACCEPTABLE.** On the garage, the right side roof is worn out and falling apart in areas.

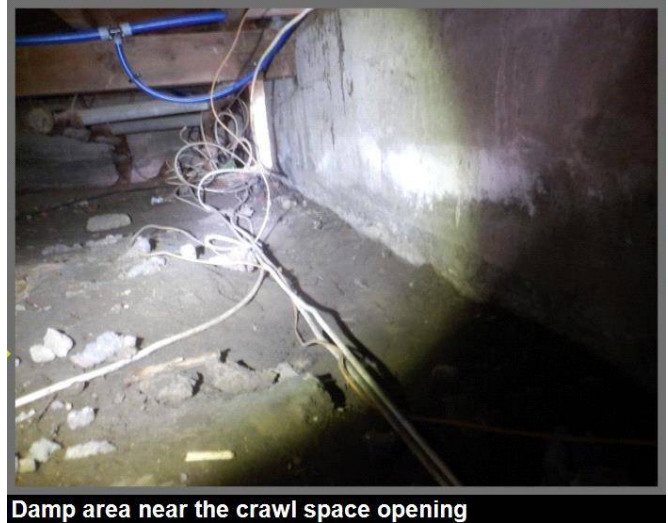
**NOT ACCEPTABLE.** There are areas of excessive damp soil under the house. This is near the crawl space opening and along the front side of the crawl space.

Damp area near the crawl space opening

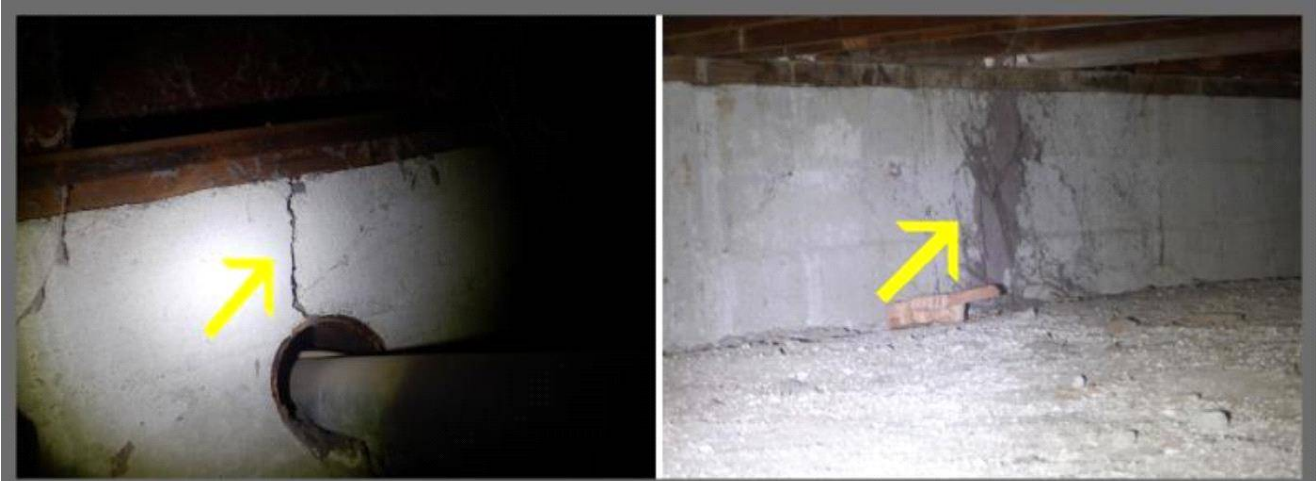
Cracks & patching

It is advised to check that permits for the past repairs were signed off for the work.

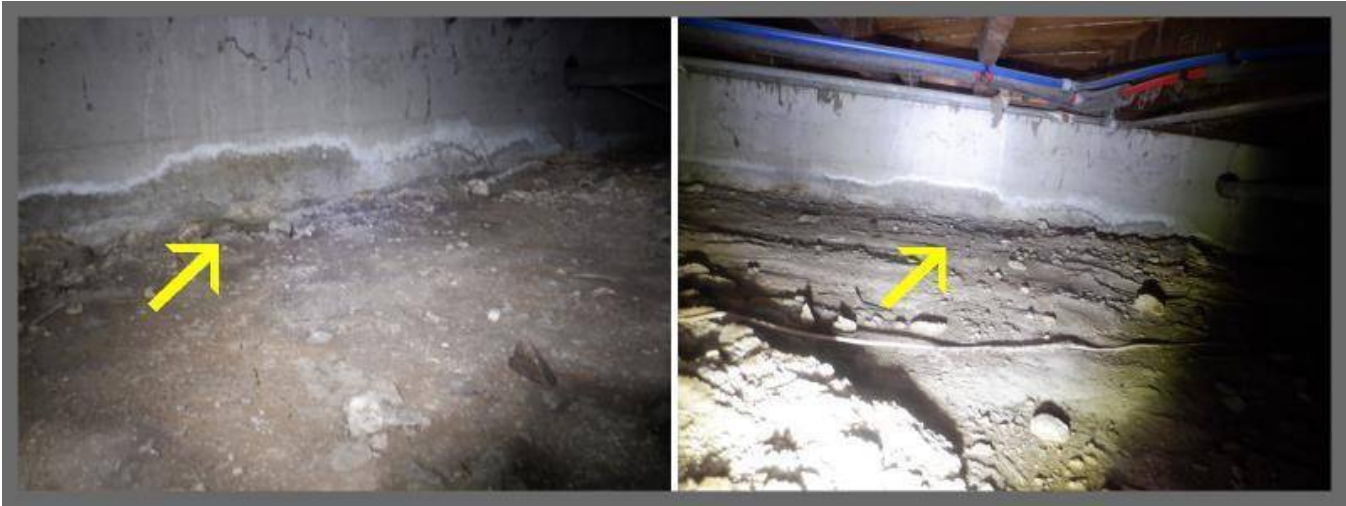
**NEEDS ATTENTION.** There is white staining and powder that may be efflorescence, indicating moisture in / through the foundation. This can damage any steel 'rebar' in the foundation and is not ideal. Consult with a grounds drainage specialist regarding this.

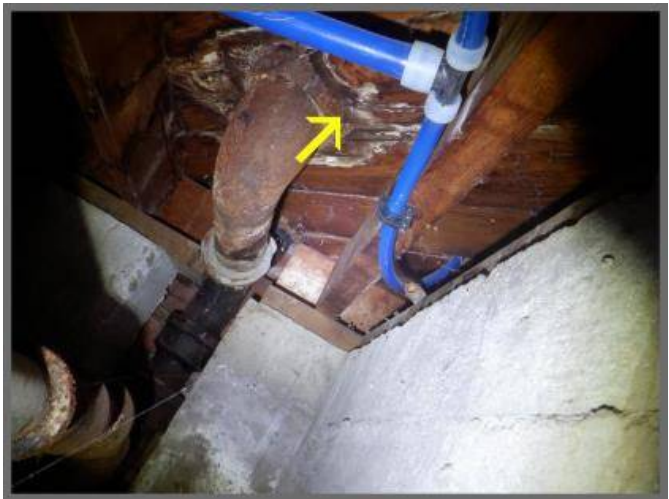
**NEEDS ATTENTION.** There is water staining and some wood deterioration under the bathroom. Consult with the structural pest control report for more information.

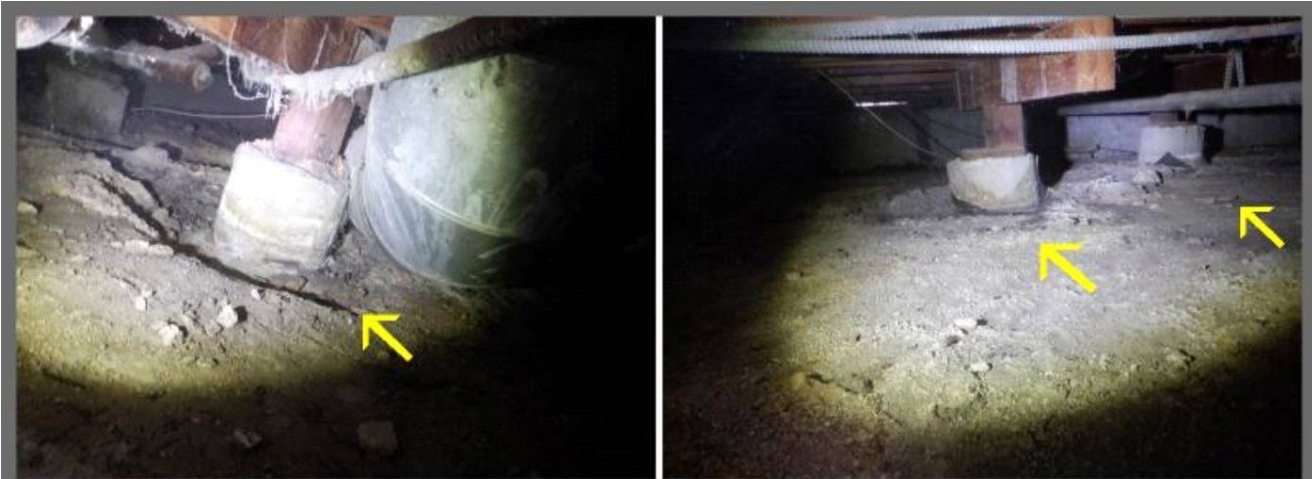
past flooding.

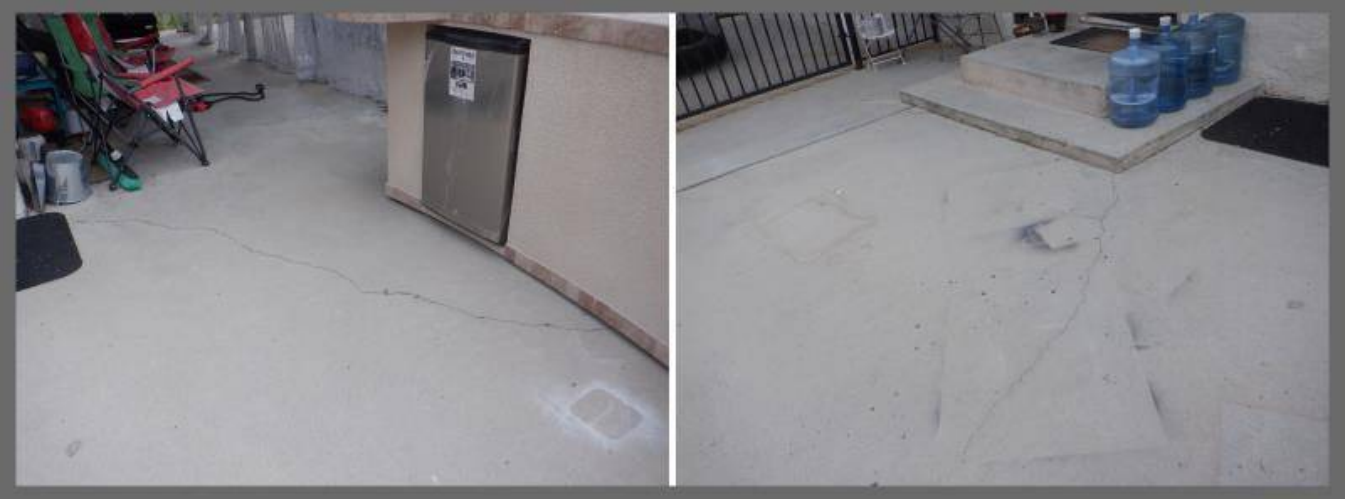
**There are cracks and shifted areas of surface that are typical for the age and type of construction.**

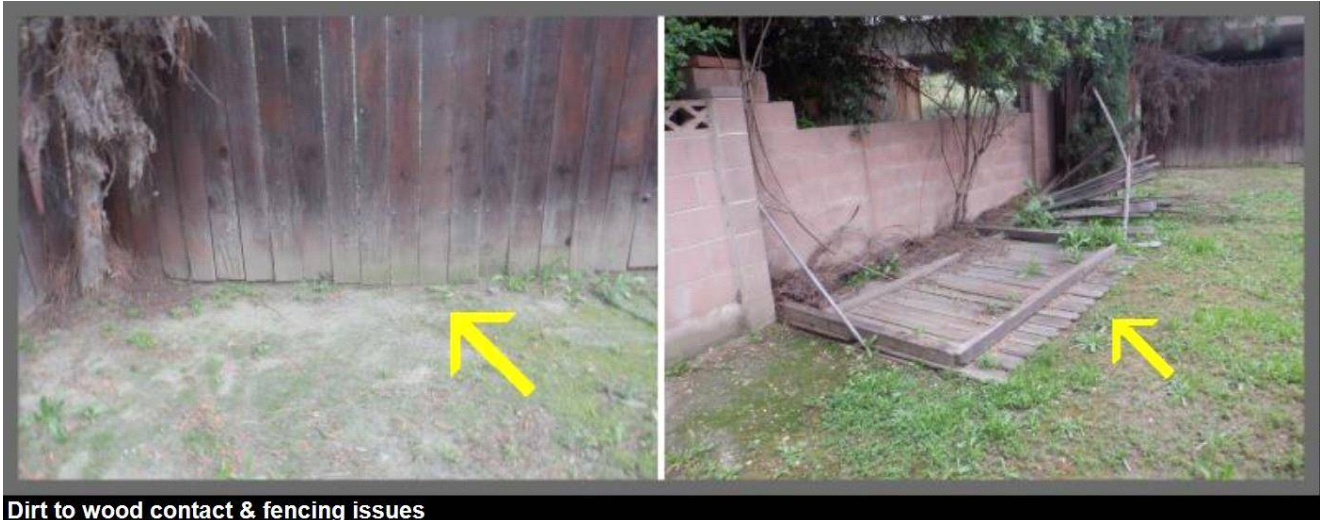
**Dirt to wood contact & fencing issues**

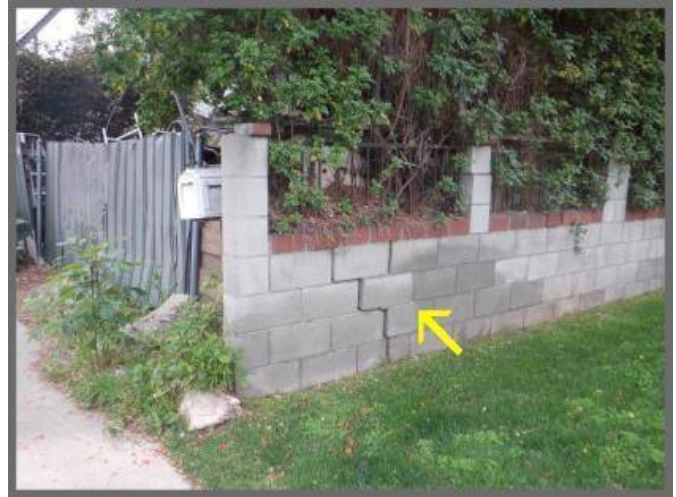
The concrete block walls are cracked and displaced in areas, they will not have their intended strength and may need repairs by a mason.

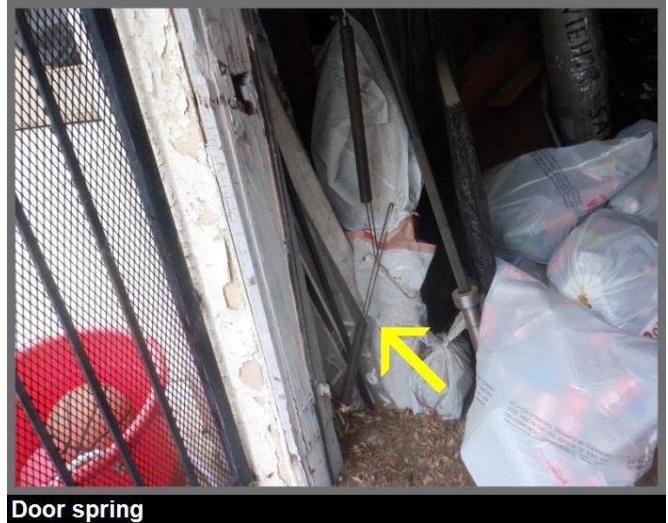
**NOT ACCEPTABLE.** The left spring for the garage door is broken and the door is unsafe to use. This will need to be replaced.

**Door spring**

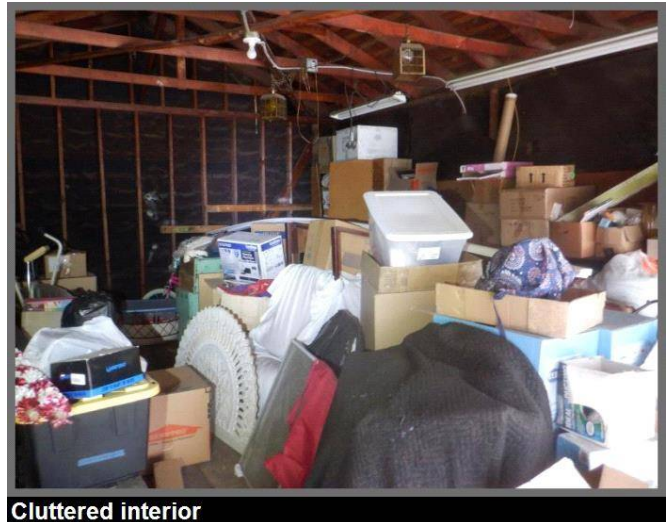
**NOT ACCEPTABLE.** There are stored items in the garage that limit the ability to do a full visual inspection.

**Cluttered interior**

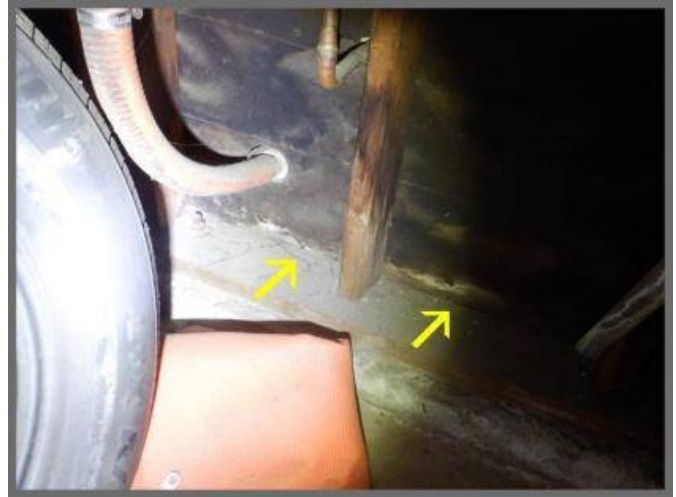
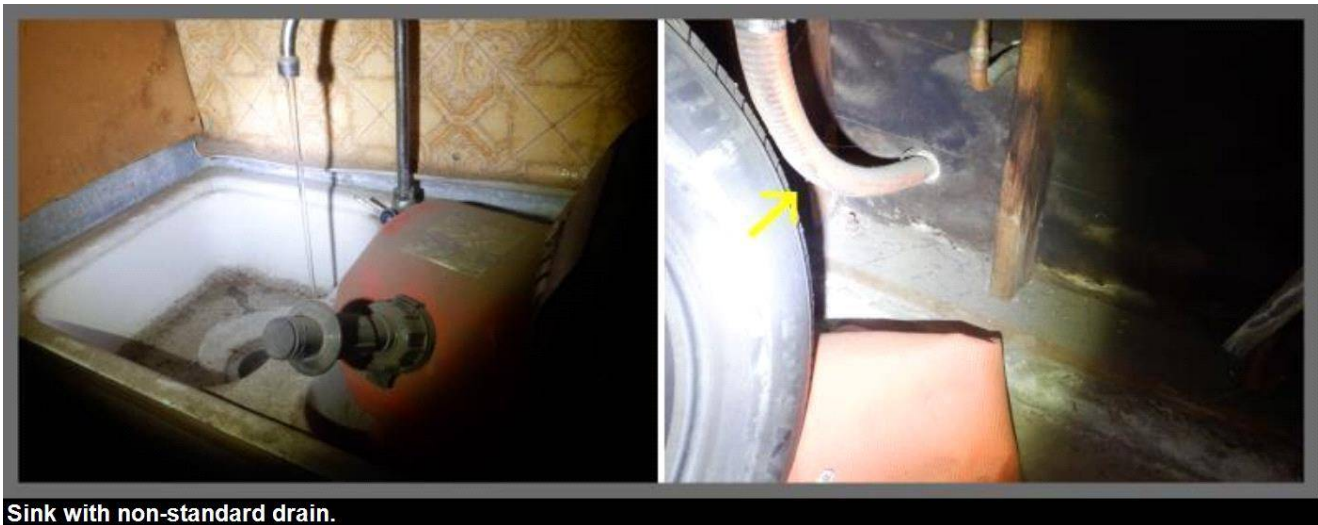
**NEEDS ATTENTION.** There is some moisture staining noted in the tarpaper, such as under the sink.

**Sink with non-standard drain.**

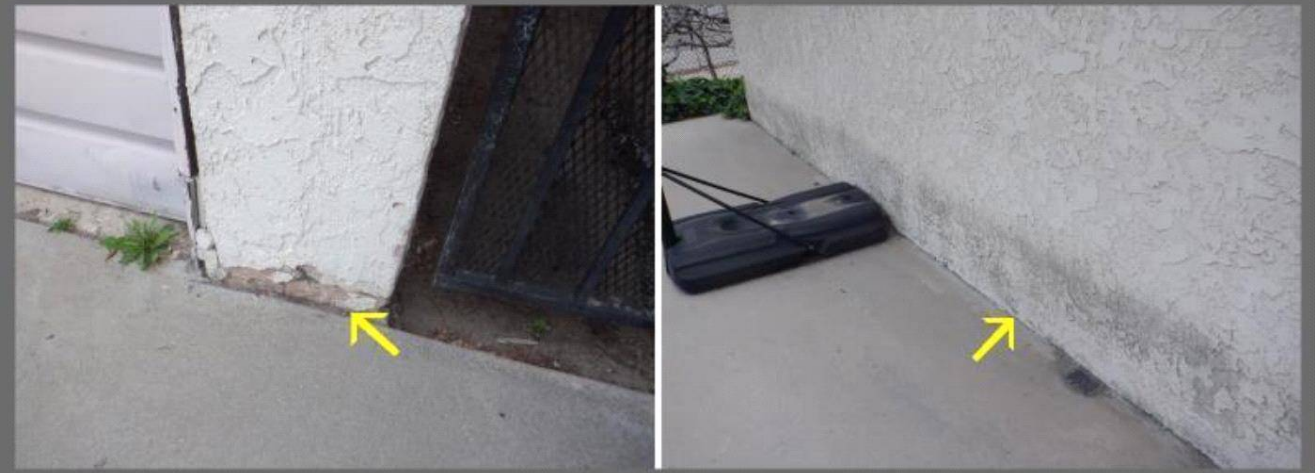
**Deterioration & splatter marks**

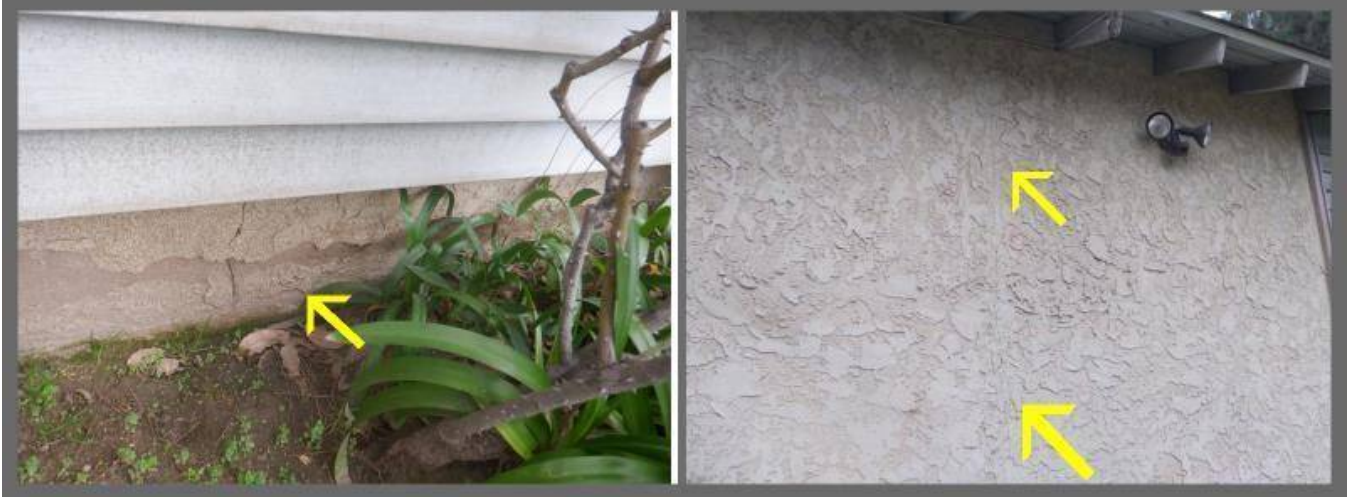
**NEEDS ATTENTION.** The stucco has minor peeling and some deteriorated in areas near the level of the soil, such as at the front and left side of the building.

There is typical cracking in the exterior stucco, such as where the office addition attaches to the building.

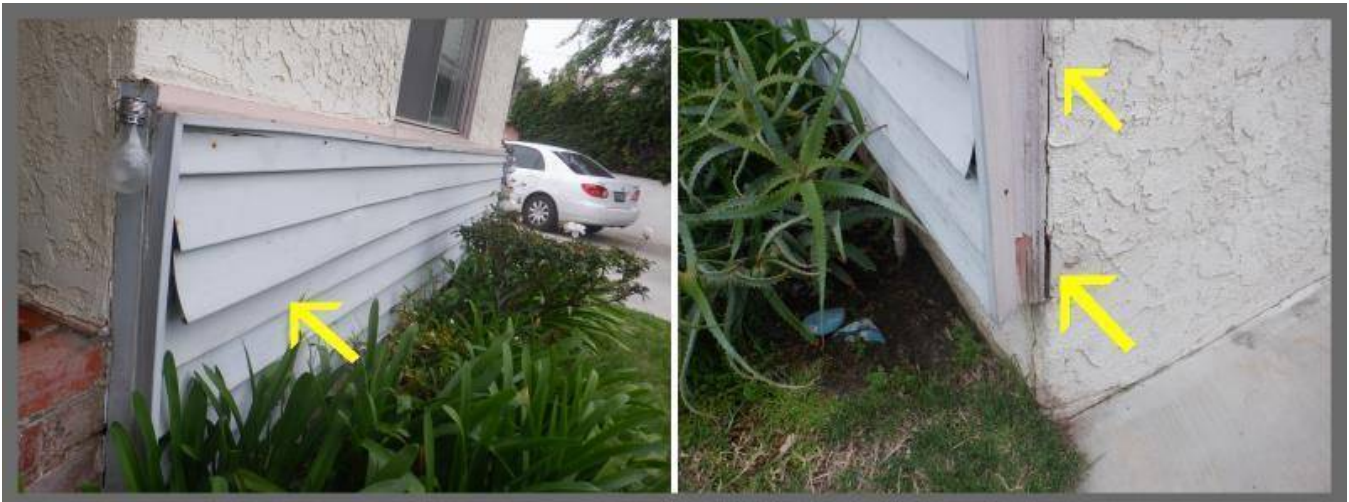
**NEEDS ATTENTION.** The siding is warped and detaching from the side of the building in areas, such as at the front.

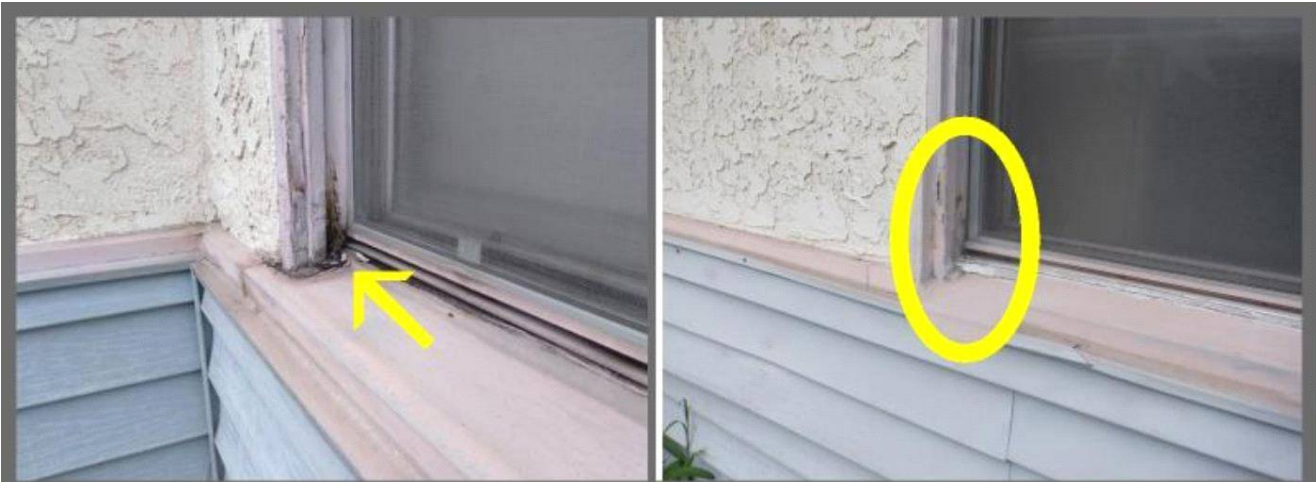
wood damage to window frames

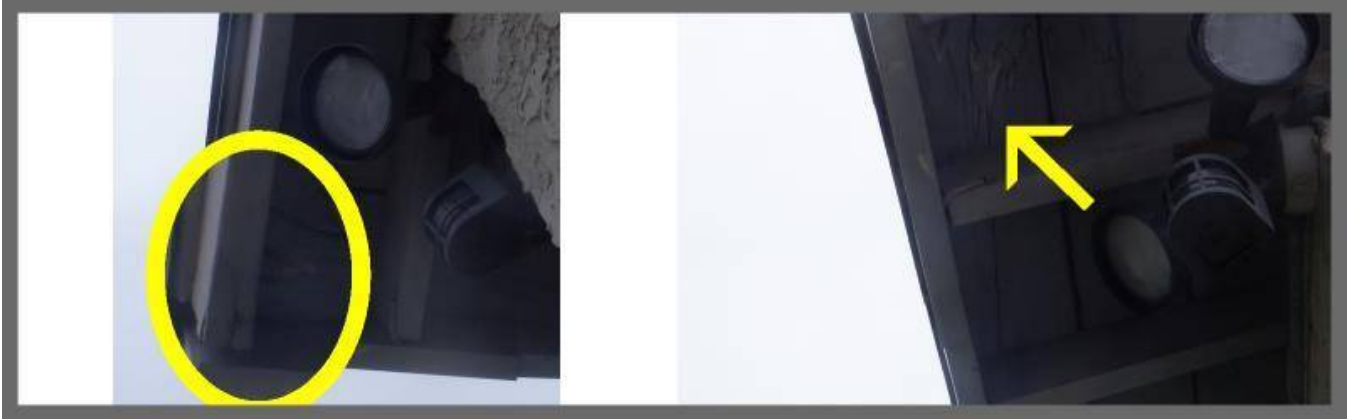
**NEEDS ATTENTION.** The trim has areas of damage, It is recommended that a structural pest control operator fully evaluate the properly and perform all needed repairs.

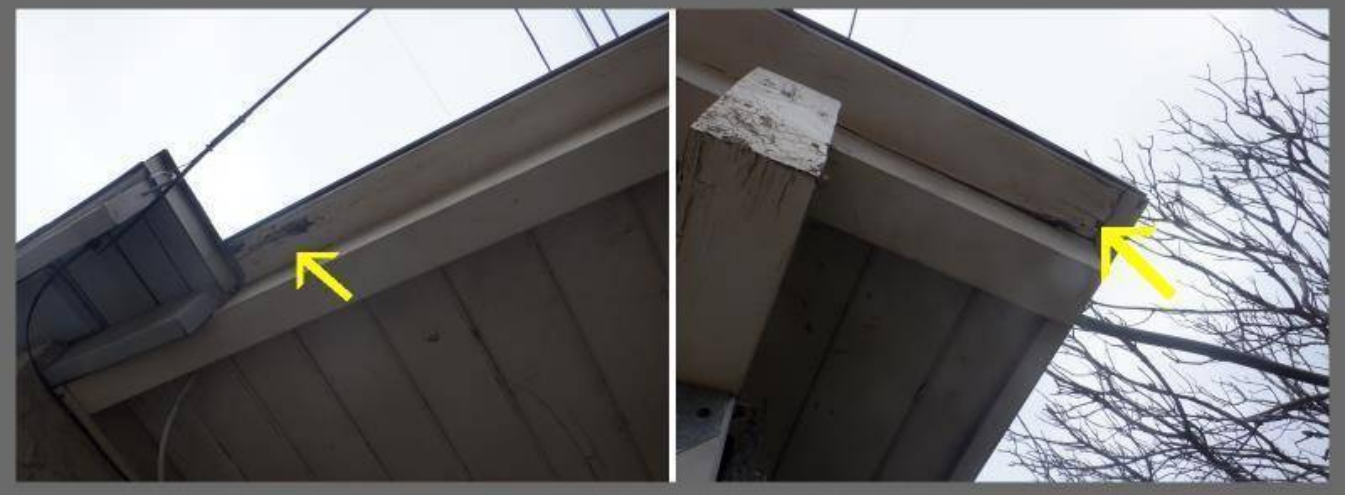
**NEEDS ATTENTION.** There are areas of damage to the wood framing.

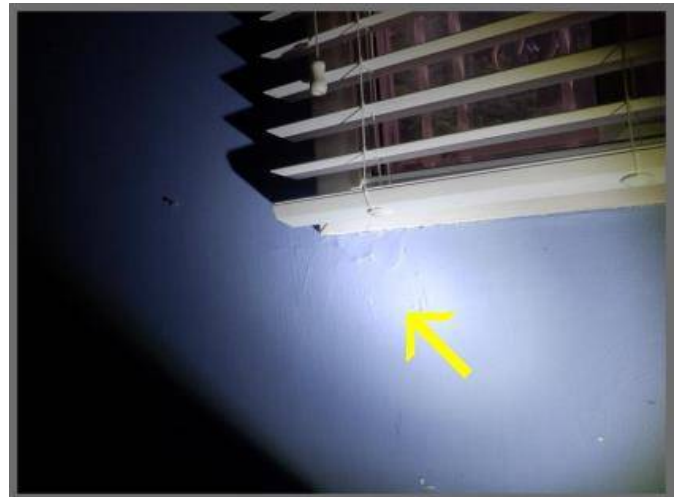
**NEEDS ATTENTION.** There are areas of patching and apparent repairs on the wall surfaces, such as at the window frame. Consult with the seller regarding this.

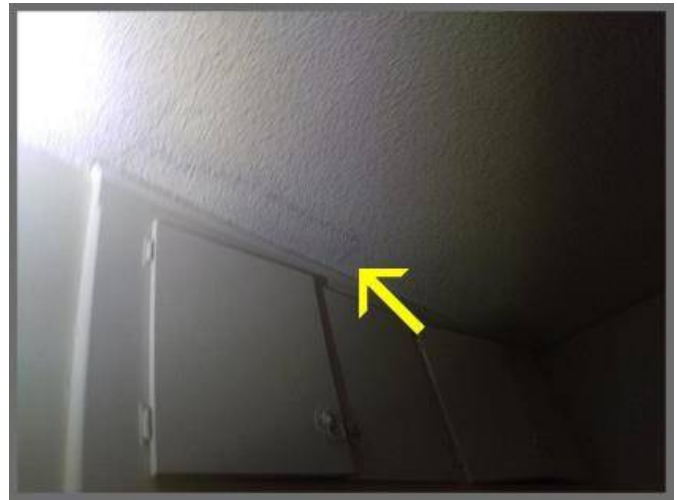
**NEEDS ATTENTION.** There are areas of stress cracks in the ceiling.

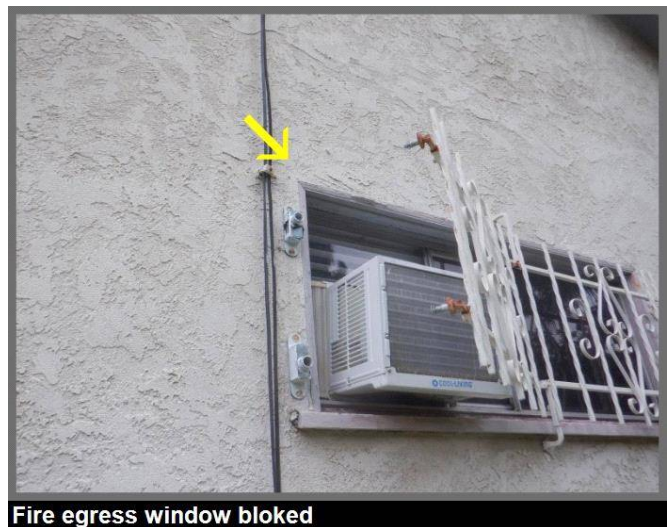
**NOT ACCEPTABLE.** The security fire egress bars/ window in the master bedroom is blocked by a window A/C unit. This window is no longer open-able for emergency exit, this is a requirement and a safety hazard if they cannot be used for egress in a fire emergency.

**NOT ACCEPTABLE.** The master bedroom window dose not meet the current emergency fire exit standards which require a second escape route out of an open-able window with the window sill no higher than 44 inches, and large enough for a fireman to safely climb through (over 5 square feet of space).

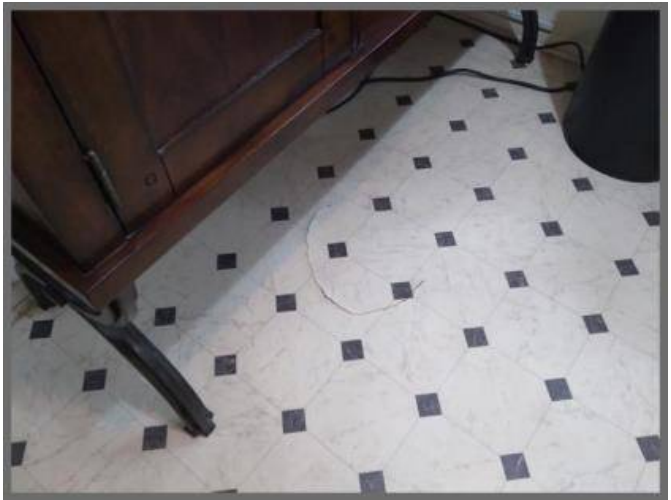
**NEEDS ATTENTION.** The linoleum is worn or damaged in areas, such as in the breakfast area.

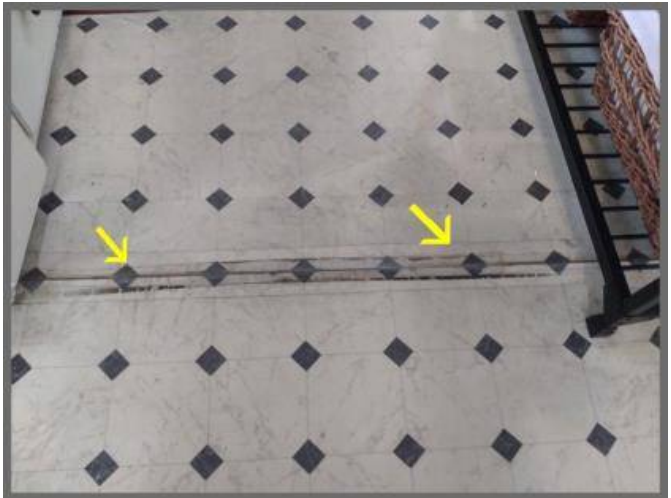
**NEEDS ATTENTION.** The kitchen linoleum flooring is worn and lifting in areas.

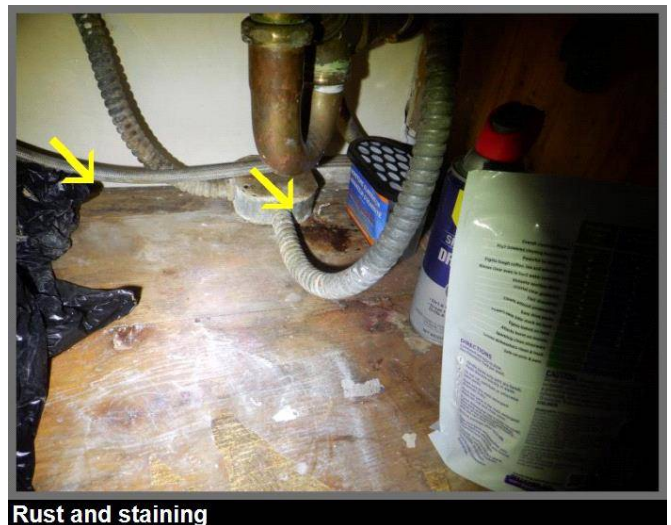
**NEEDS ATTENTION.** There is moisture / rust staining to the shelf area under the kitchen sink. Consult with a moisture mold specialist regarding this.

Rust and staining

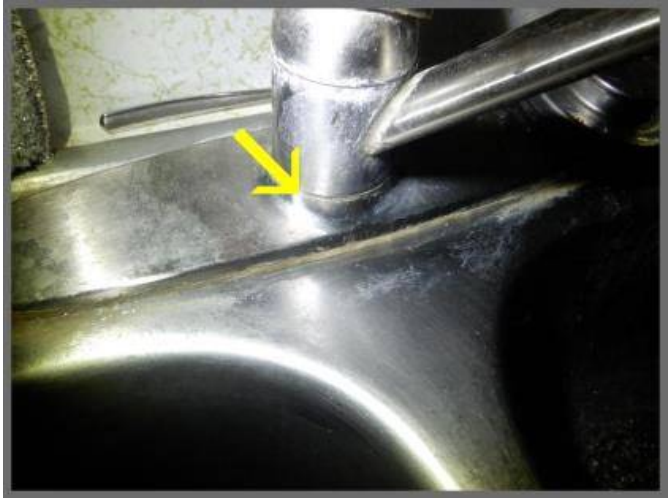
**NOT ACCEPTABLE.** The kitchen faucet leaks at the base of the spout.

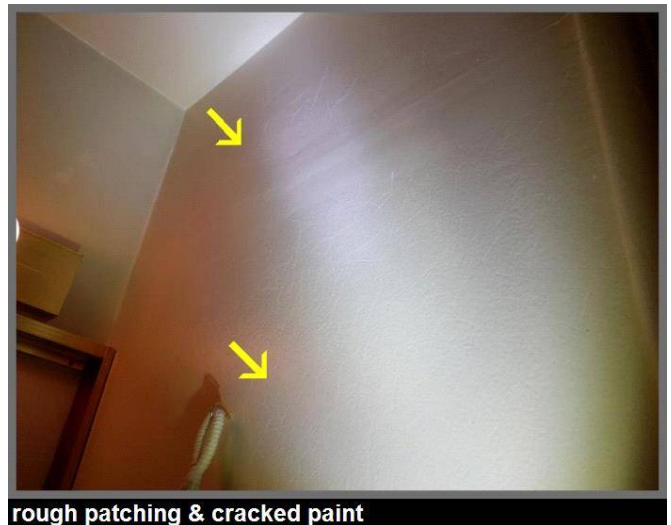
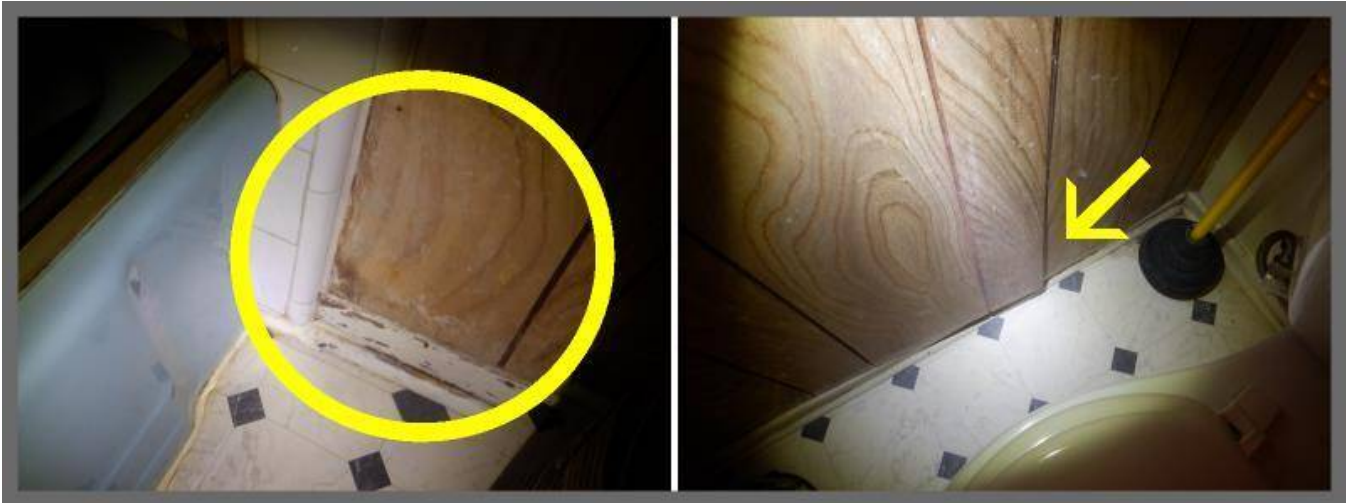
**NEEDS ATTENTION.** There is some rough patching and apparent repairs in the walls such as near the door and over the mirror. They're also appears to be peeling paint showing through the current paint consult with the seller regarding the history of this.

**NEEDS ATTENTION.** There is what appears to be damaged to the wood paneling at the wall near the tub. Consult with the seller regarding the history of this. It would also be advised to have a moisture mold specialist further investigate this area.
