Cornerstone Home Inspections

Home Inspection Report

21065 Crystal Falls Dr

Inspected on Fri, Jun 26 2026 at 7:52AM

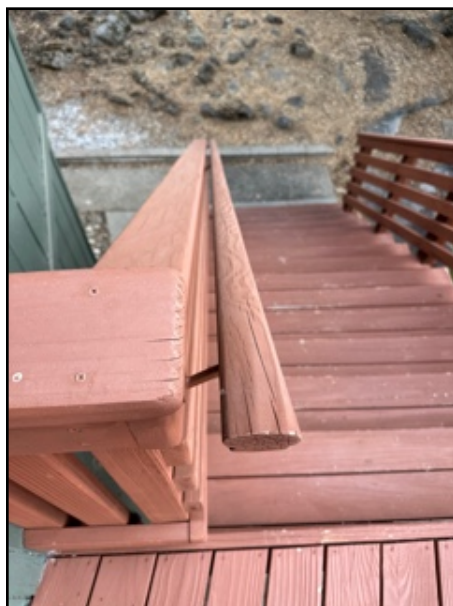
Figure 1-1

Comment 1:

Current CA building code requires hand railings to re-connect to the structure. However, since this railing is pre-existing it would only need replaced if a permit were pulled on the property.

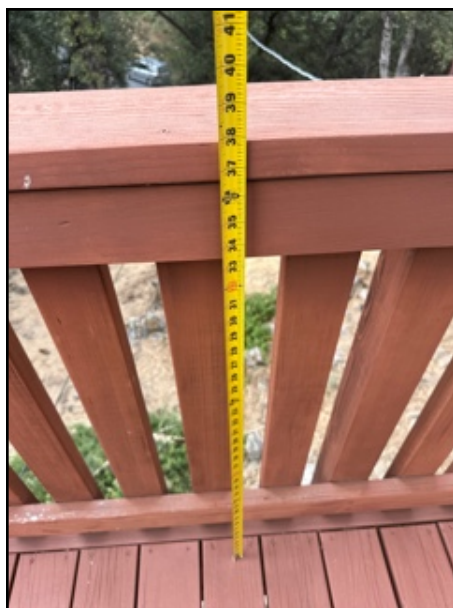
Figure 2-1

Front porch railing height is not up to code. Current CA building code requires a minimum railing height of 42". However, this height is pre-existing and would only need replaced if a permit were pulled on the property.

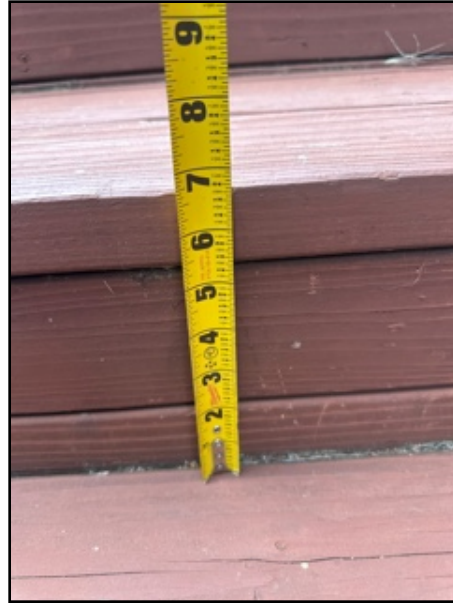
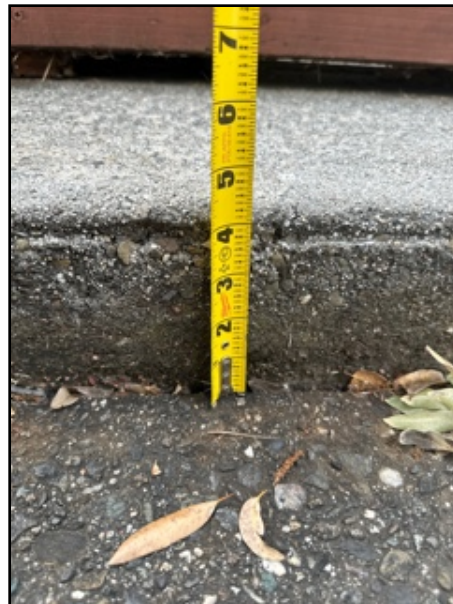
Comment 3:
Steps to front porch are inconsistent heights.

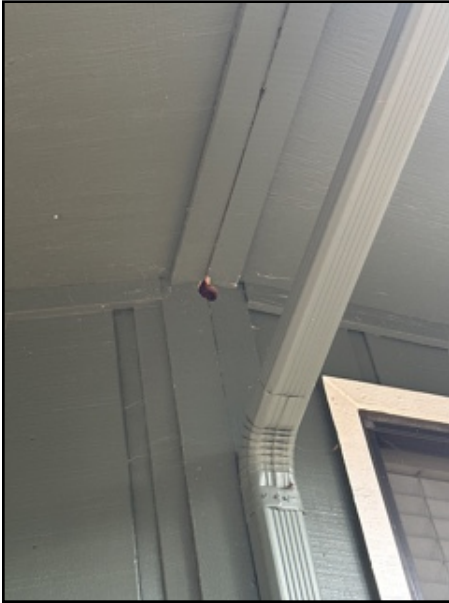
Figure 4-1

Woodpecker damage noted near window above AC condenser.

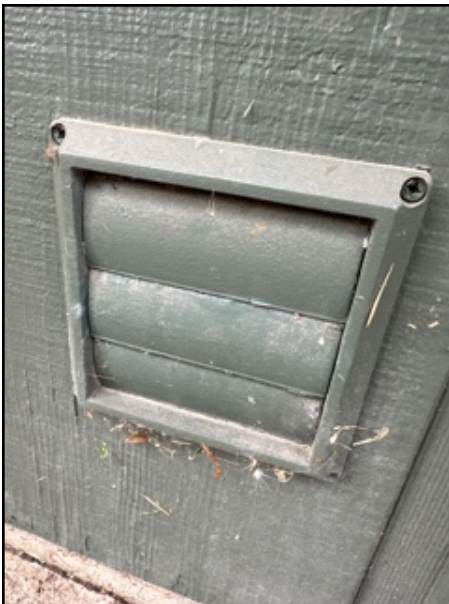
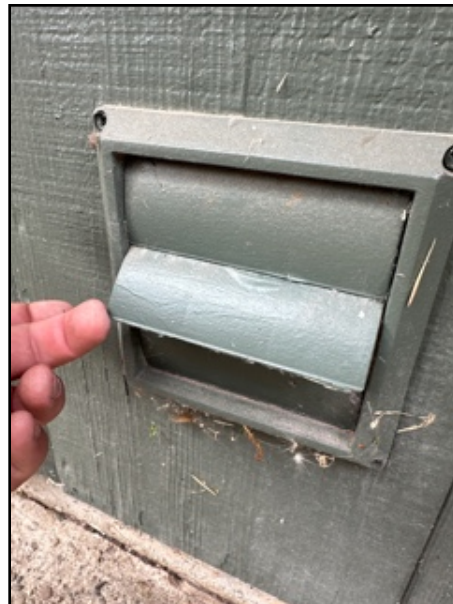
Top & bottom flap on dryer vent are stuck closed, likely from being painted over. Only the middle flap opens. Recommend repair to allow proper ventilation.

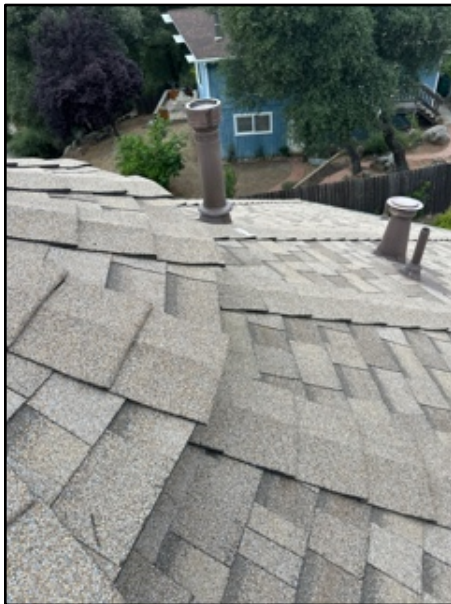
Figure 6-1

Overall roofing appears to be in like new condition with multiple years of usable life remaining.

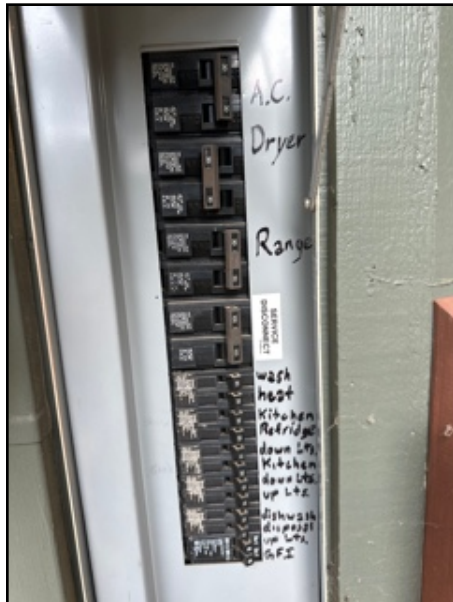
Figure 7-1

**Comment 7:**
Main service panel is properly labeled, however accurate labeling was not confirmed.

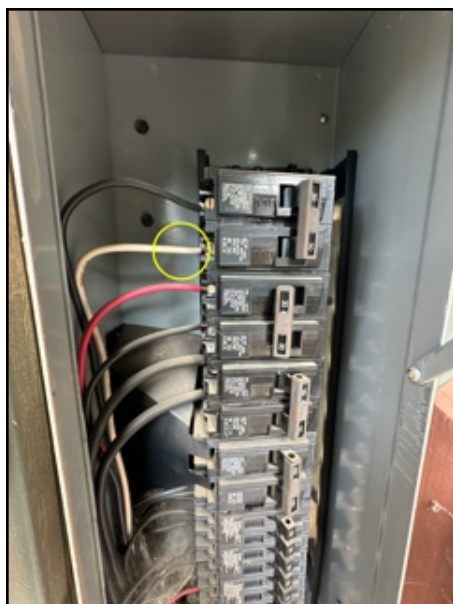
Figure 8-1

**Comment 8:**
White wires connected to breakers used to carry load are require to be labeled with black or red tape.

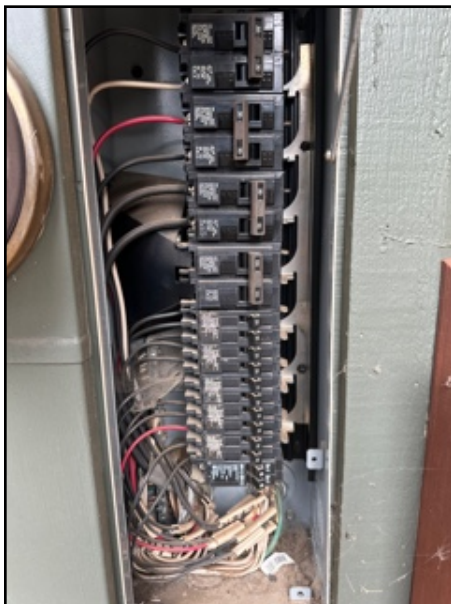
Figure 9-1

Main service panel installation & wiring appears correct.

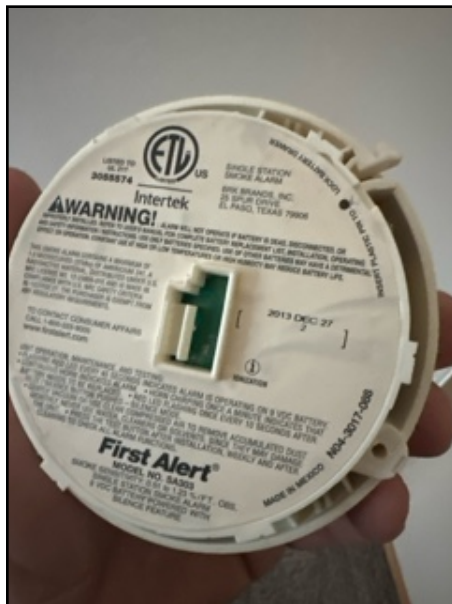
Figure 10-1

Master bedroom smoke alarm is expired & not up to current CA Fire Code Requirements.

Ca building code requires all smoke alarms to either contain 10 year non-replaceable batteries / or be hard wired in. Recommend installing as required.

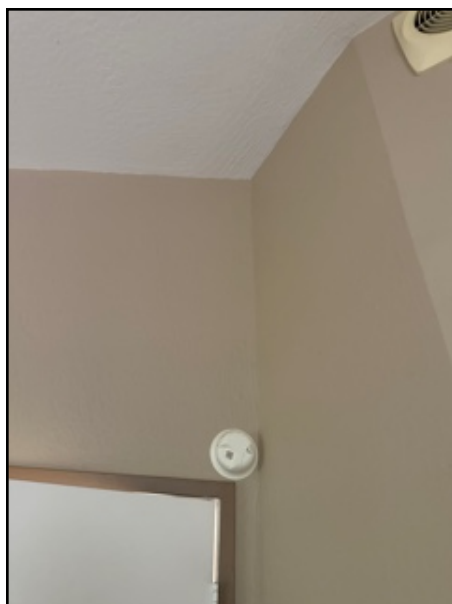
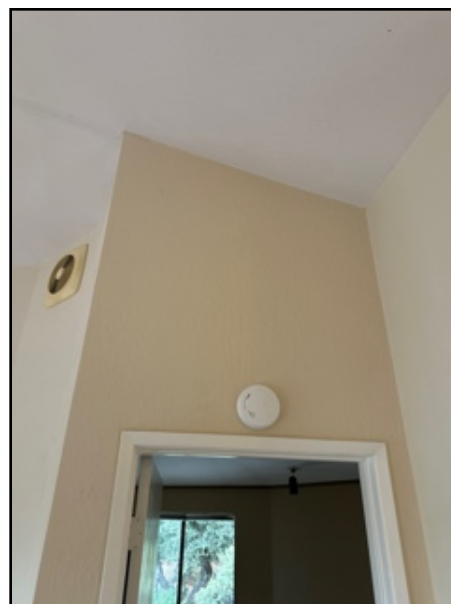
Current CA fire code states: Smoke alarms should be mounted on the ceiling 4" from the wall; wall mounts should be 4-12" from the ceiling. Do not install near draft areas (windows, vents).

Recommend to raise smoke alarms to ceiling height as required.

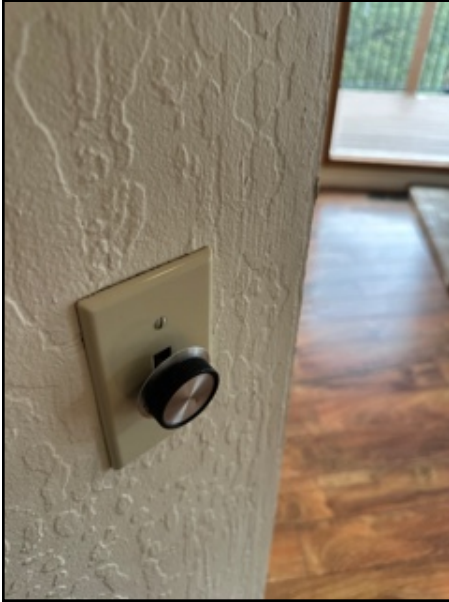
Figure 12-1

**Comment 12:**
Dimmer switch for living area lights noted as damaged. Switch still functions.
Recommend replacing.

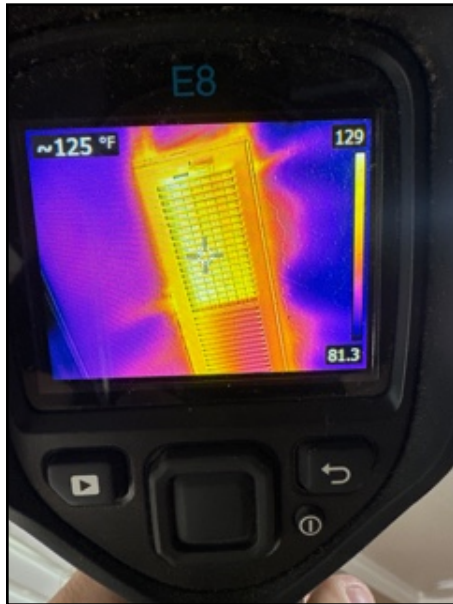
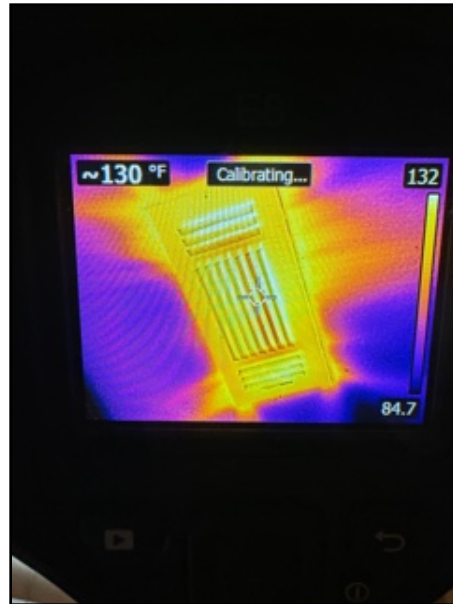
Heater tested and recorded an output of over 105 degrees at all registers (unless otherwise noted). Condition is functional.

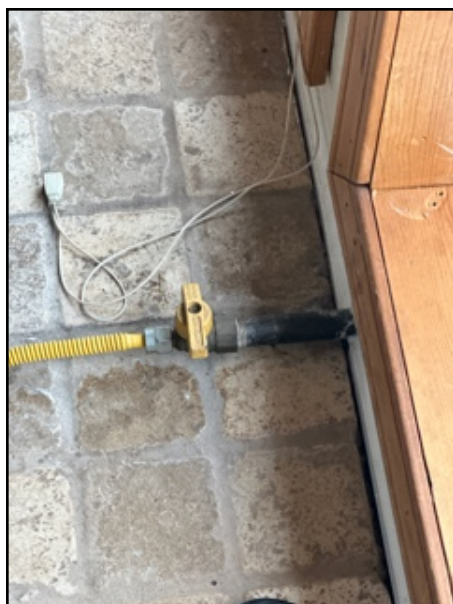
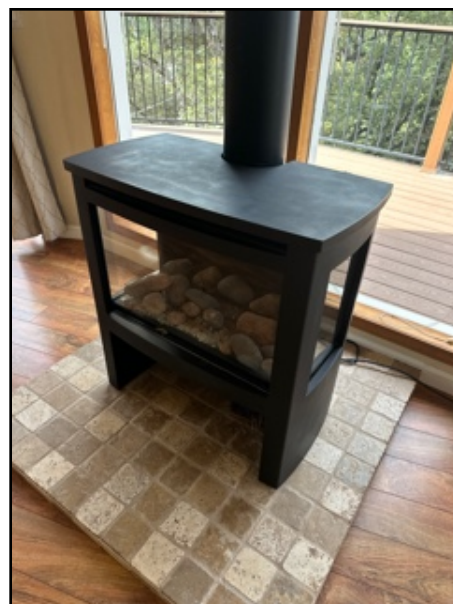
Gas was off to propane heat stove at time of inspection, therefore was not tested for function.

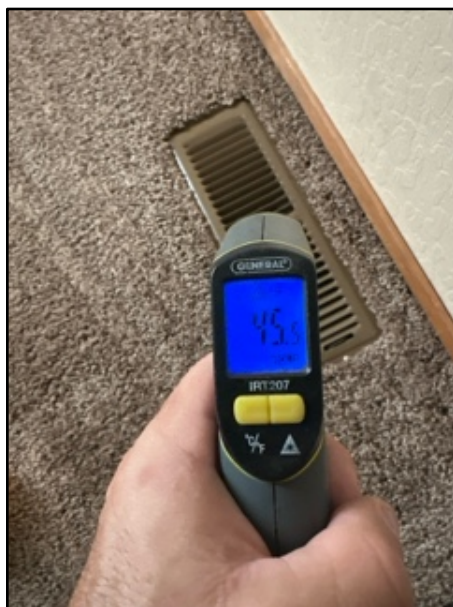
Figure 15-1

Air conditioning recorded an output of 45 degrees with an intake of 74 degrees. Condition is functional.

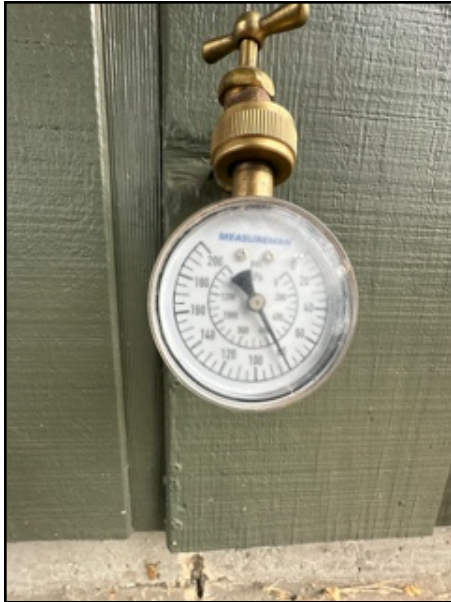
Figure 16-1

Comment 16:
Water pressure noted at 80 psi. Current CA building code allows a maximum pressure of 80 psi. Condition is functional.

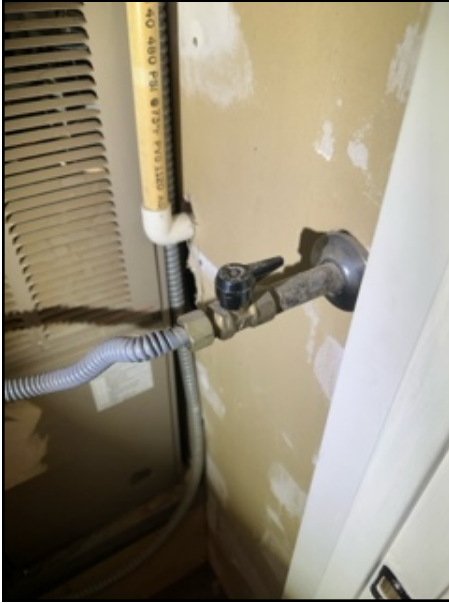
Figure 17-1

Comment 17:
No drip leg installed on furnace propane supply line. Recommend installing to catch any particles/debris traveling through the line to prevent orifices from clogging. Refer to a licensed plumber.

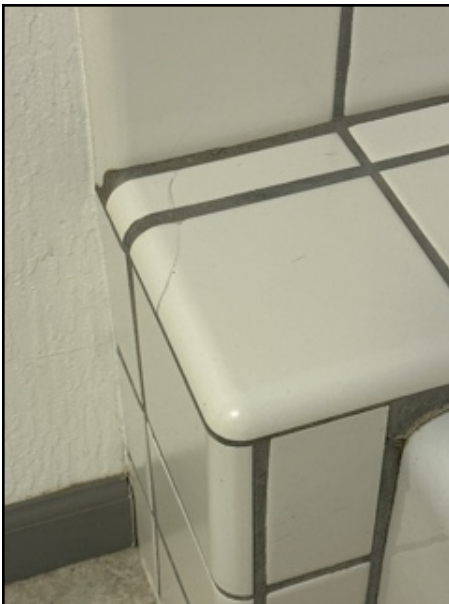
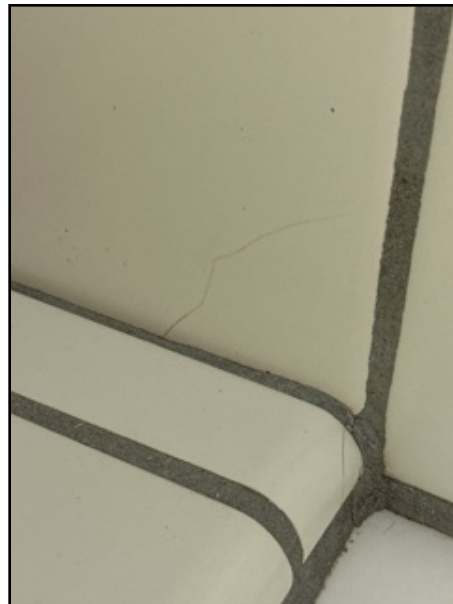
Cracked tiles noted on left side of downstairs bathroom tub.

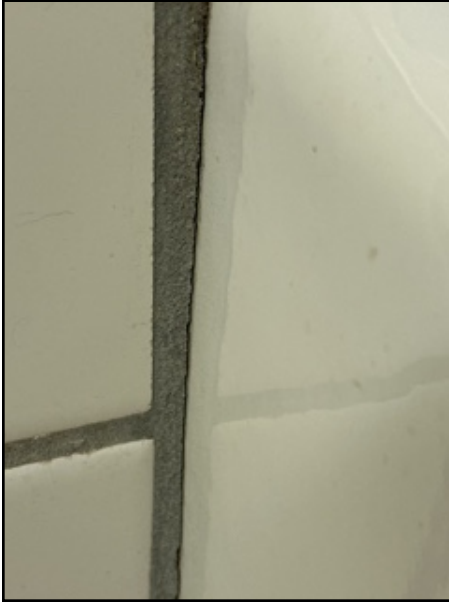
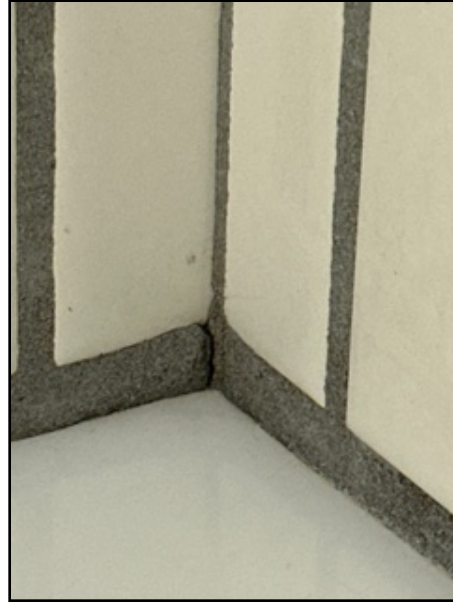
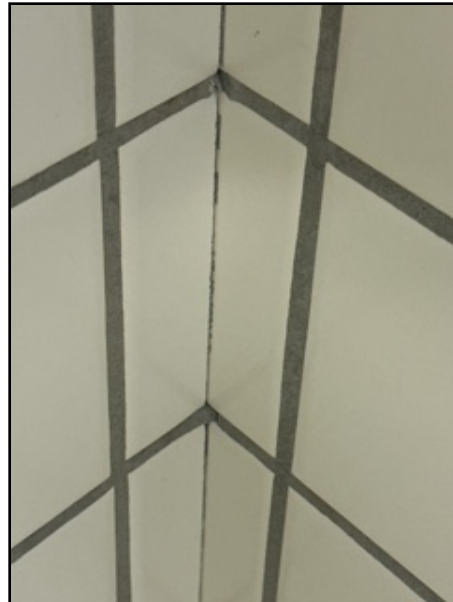
**Comment 19:**
Recommend to reseal any cracked or missing gout surrounding downstairs bathroom tub.

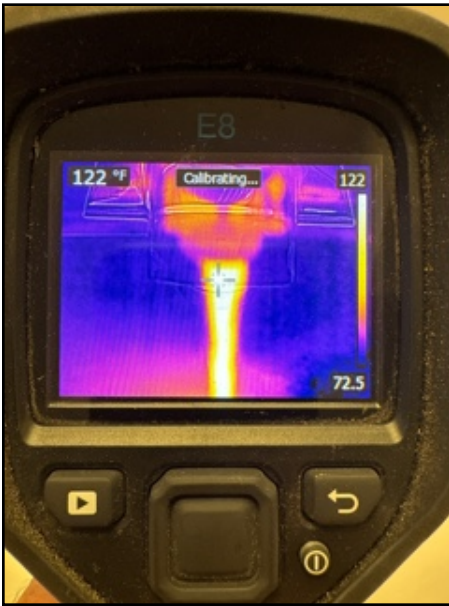
Figure 20-1

Water heater tested & determined functional & in range.

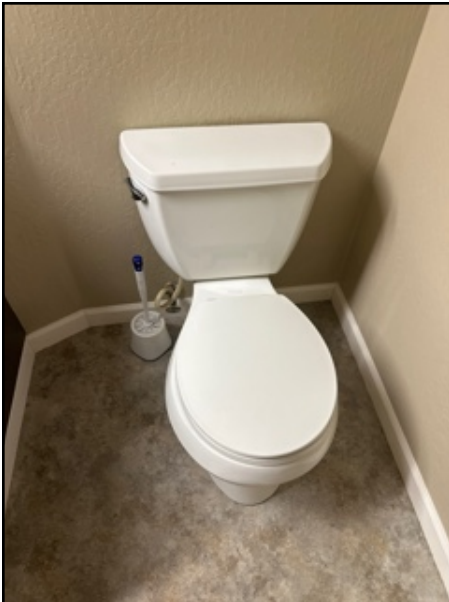
Figure 21-1

Master bathroom toilet noted as loose. Recommend tightening to prevent any future leaks.

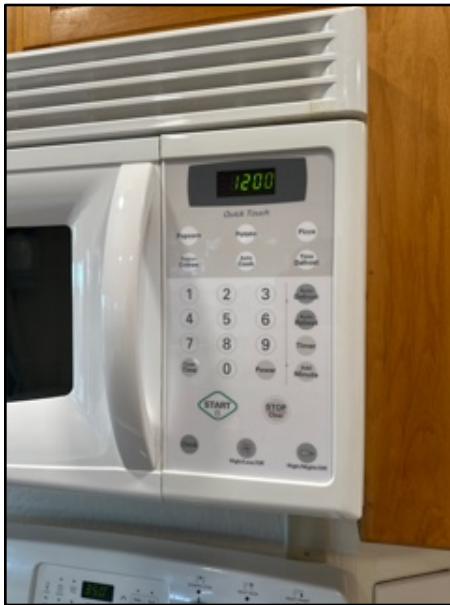
Figure 22-1

Microwave tested and determined functional, however the over the range light & vent fan failed to power on at time of inspection.

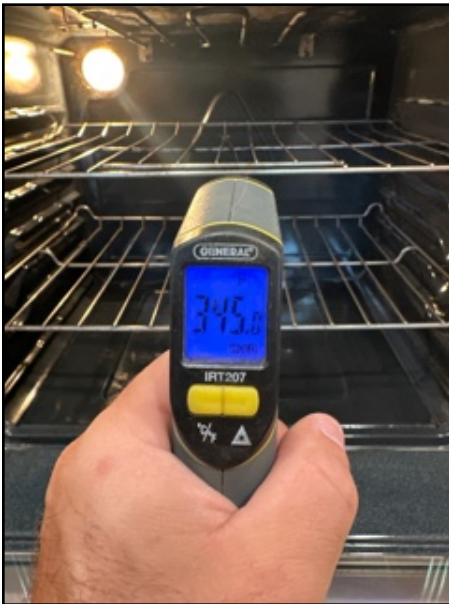
Figure 23-1

Oven set at 350 recorded a temperature of 345 degrees. Condition is functional.

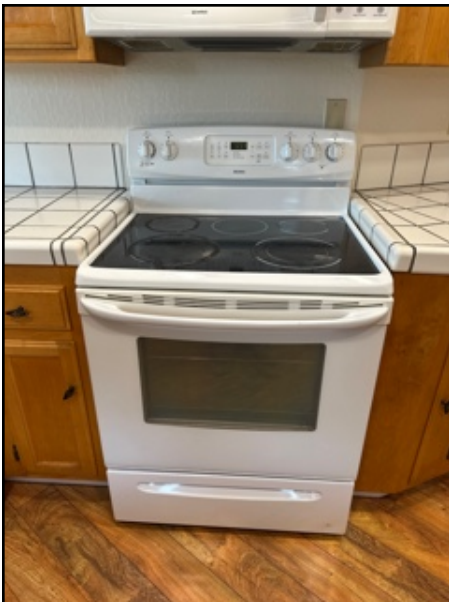
Figure 24-1

No anti-tip bracket installed on oven. Recommend installing to ensure the safety of the appliance.

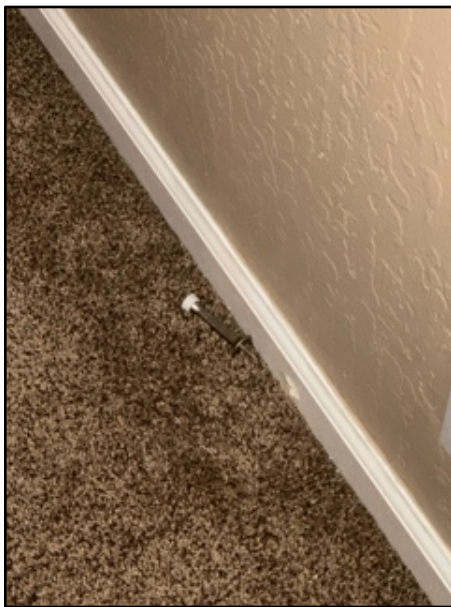
Figure 25-1

Downstairs 2nd bedroom door stop is not attached to the wall.

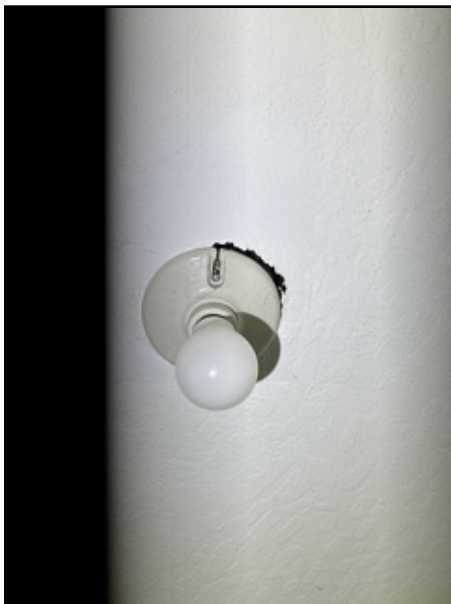
Figure 26-1

Hole around first downstairs bedroom closet light is cut too large.

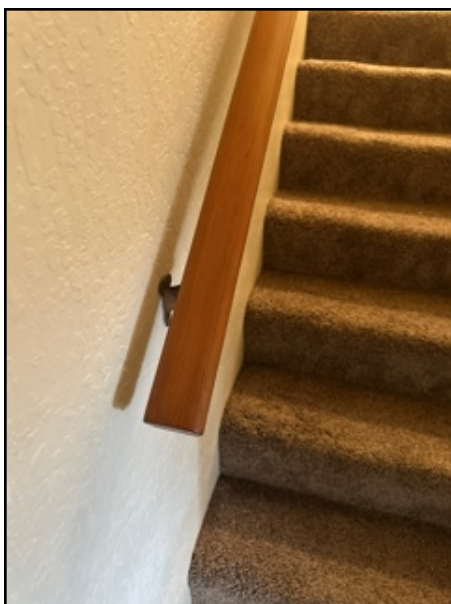
Figure 27-1

Current CA building code requires hand railings to re-connect to the structure. However, since this railing is pre-existing it would only need replaced if a permit were pulled on the property.

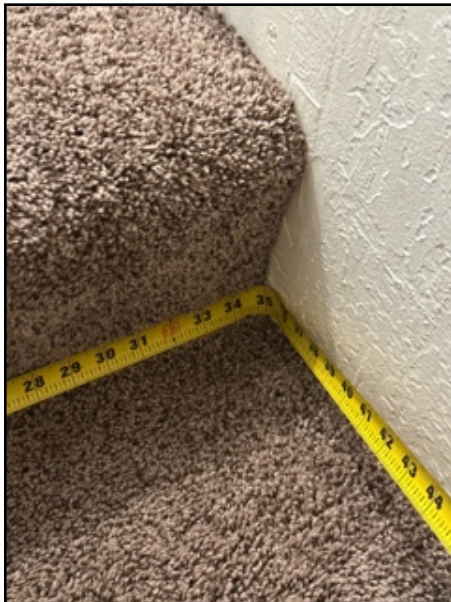
Figure 28-1

**Comment 28:**
Current CA building codes require stairways have a minimum width of 36", measured above the handrail.

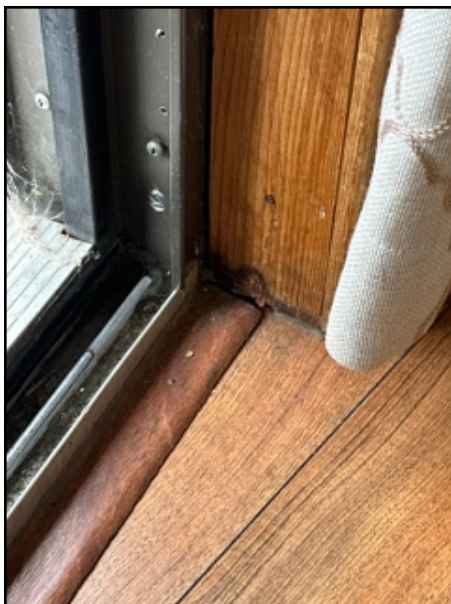
Figure 29-1

**Comment 29:**
Moisture stain noted on trim inside sliding door. This is a common find.

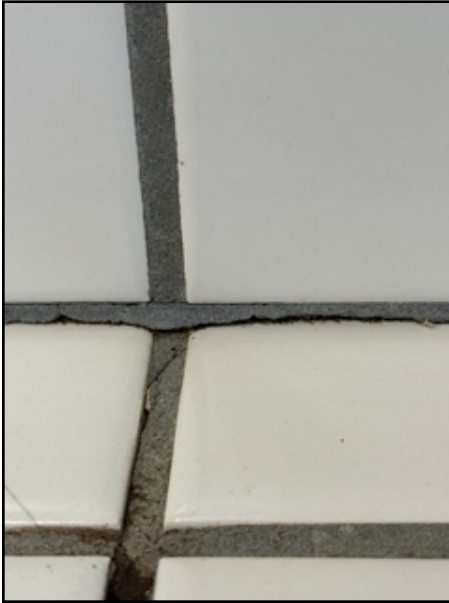
Figure 30-1

**Comment 30:**
Recommend to reseal any missing or cracked grout on kitchen counters.

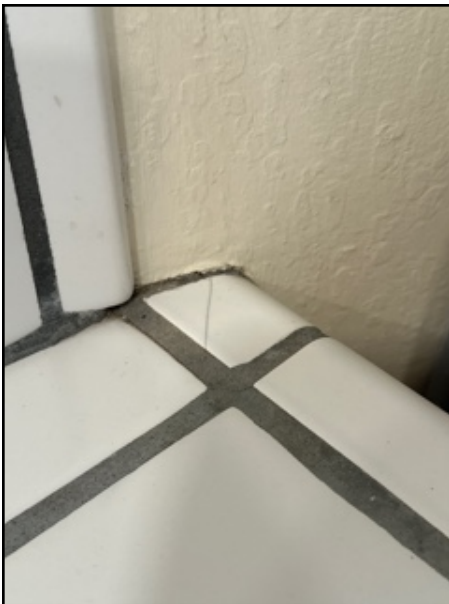
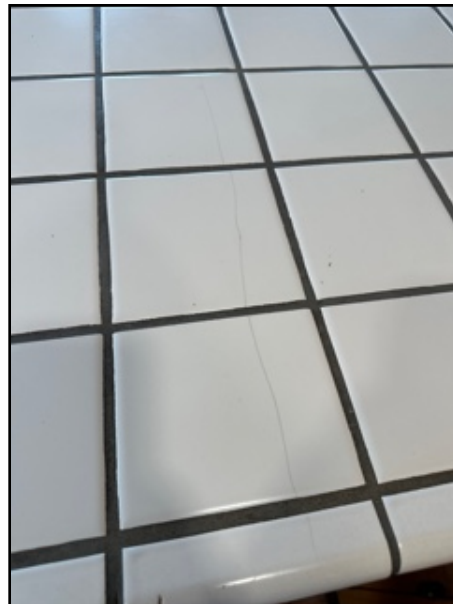
**Comment 31:**
Minor cracks noted on some kitchen counter tiles.

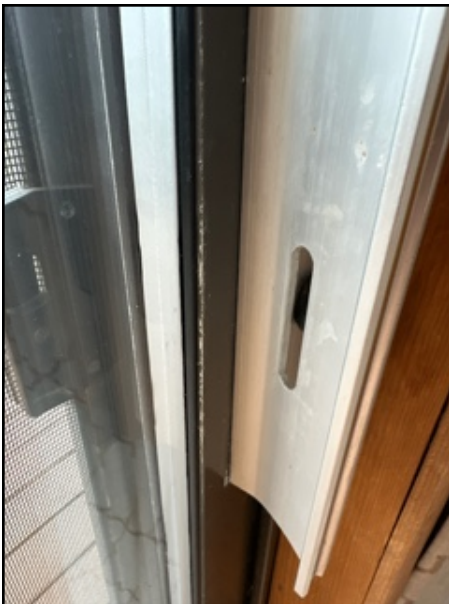
Figure 33-1

Sliding door latch is broken & fails to latch closed.

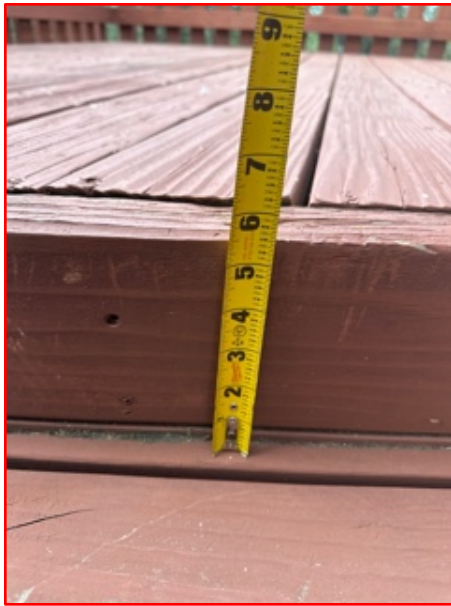
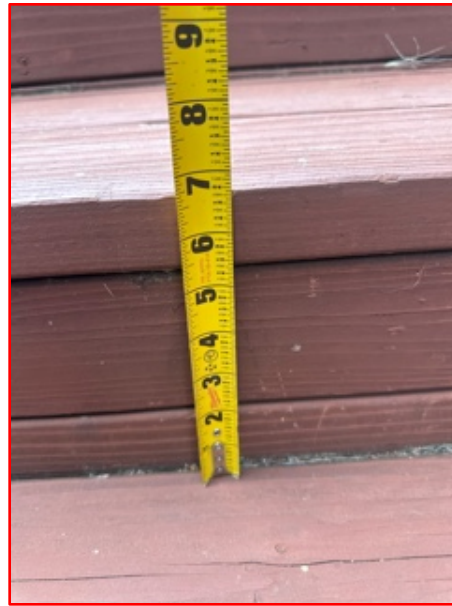
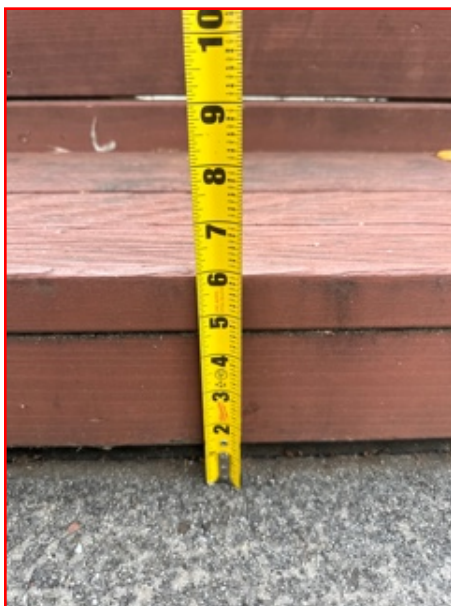
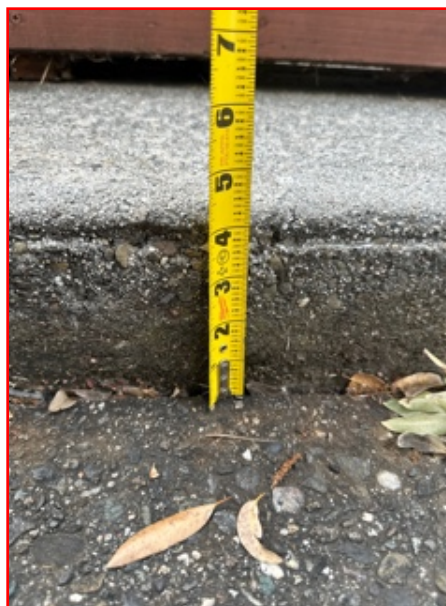
1) Steps to front porch are inconsistent heights.

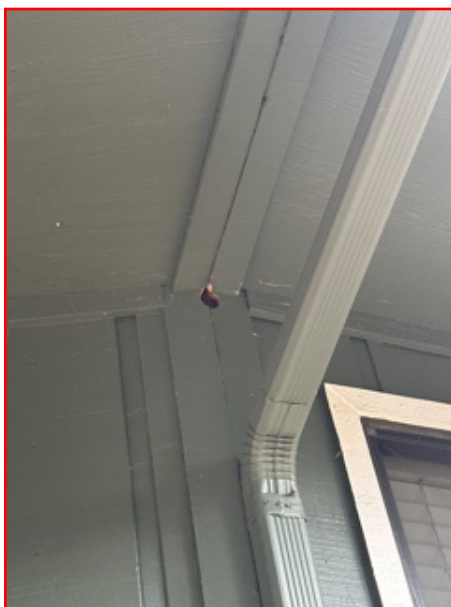
Figure 4-1

2) Woodpecker damage noted near window above AC condenser.

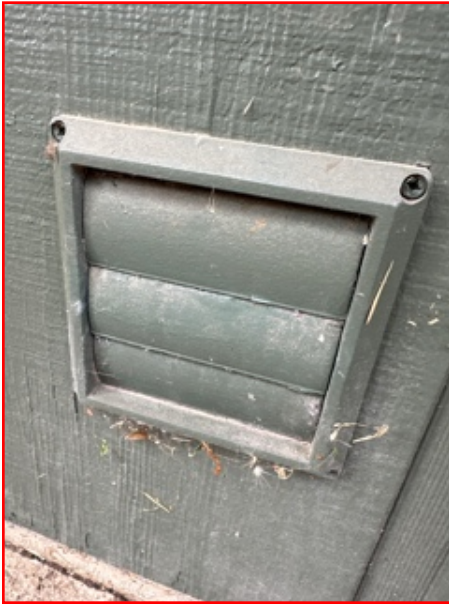
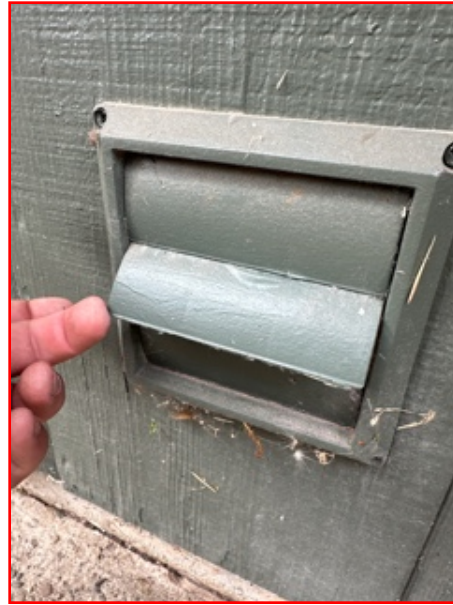
3) Top & bottom flap on dryer vent are stuck closed, likely from being painted over. Only the middle flap opens. Recommend repair to allow proper ventilation.

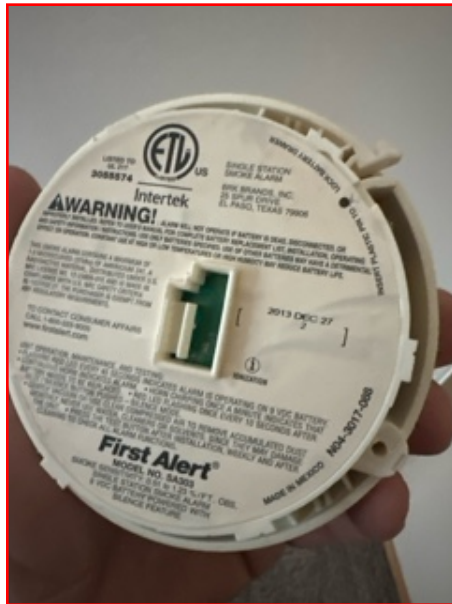
Figure 10-1

5) Master bedroom smoke alarm is expired & not up to current CA Fire Code Requirements.

Ca building code requires all smoke alarms to either contain 10 year non-replaceable batteries / or be hard wired in. Recommend installing as required.

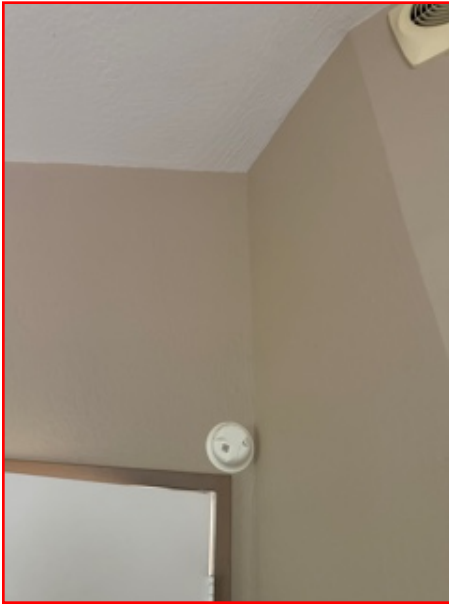
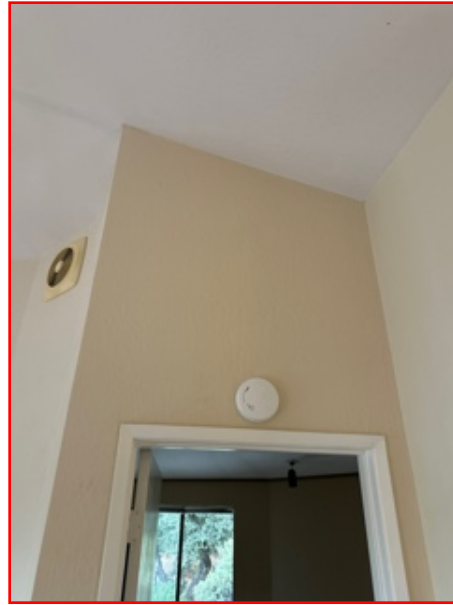
Current CA fire code states: Smoke alarms should be mounted on the ceiling 4" from the wall; wall mounts should be 4-12" from the ceiling. Do not install near draft areas (windows, vents).

6) Recommend to raise smoke alarms to ceiling height as required.

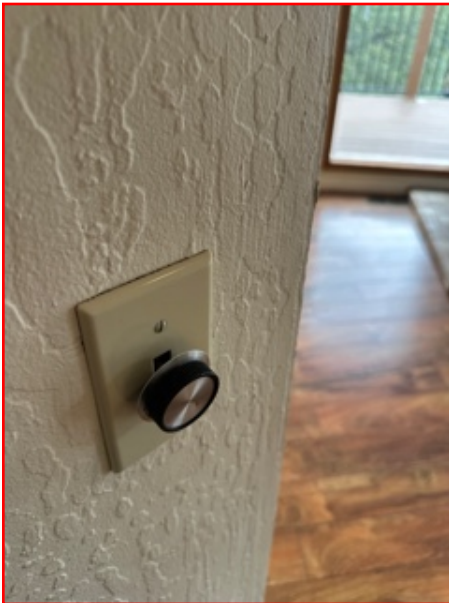
Figure 12-1

7) Dimmer switch for living area lights noted as damaged. Switch still functions. Recommend replacing.

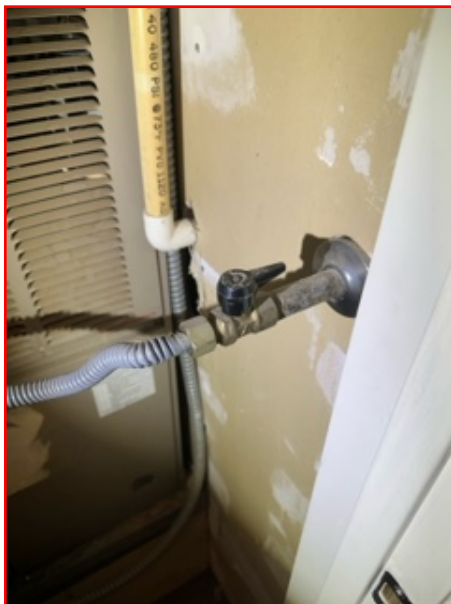
Figure 17-1

8) No drip leg installed on furnace propane supply line. Recommend installing to catch any particles/debris traveling through the line to prevent orifices from clogging. Refer to a licensed plumber.

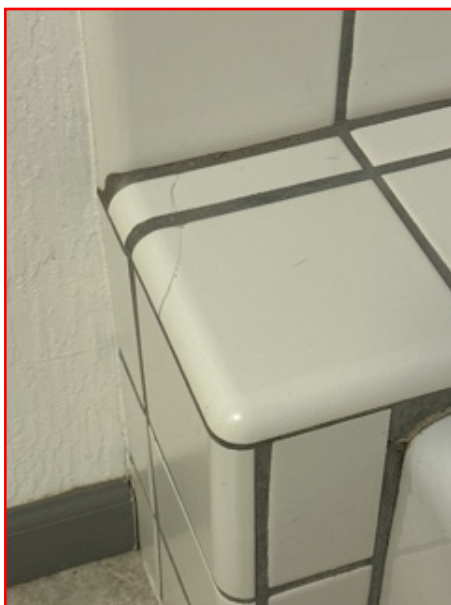
Figure 18-1

9) Cracked tiles noted on left side of downstairs bathroom tub.

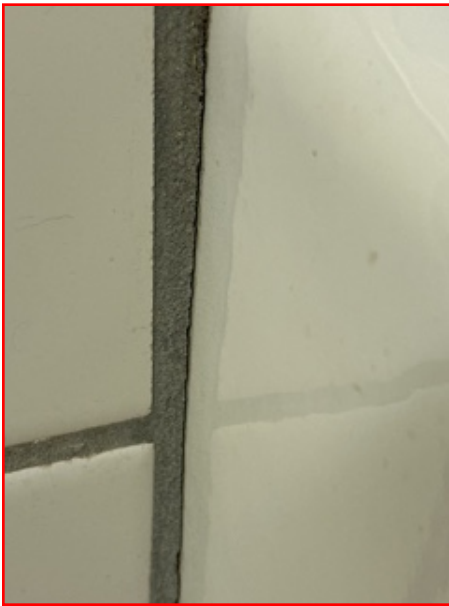
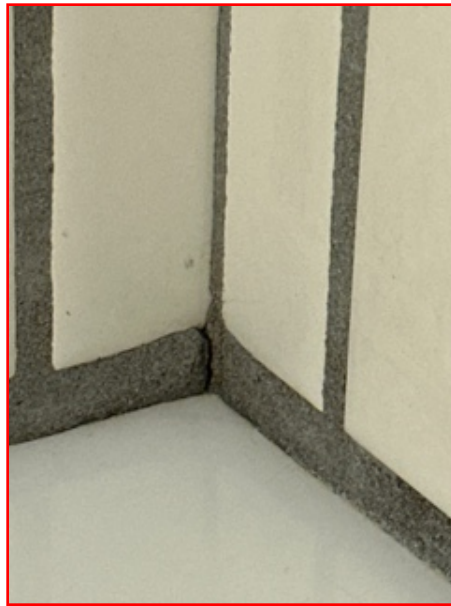
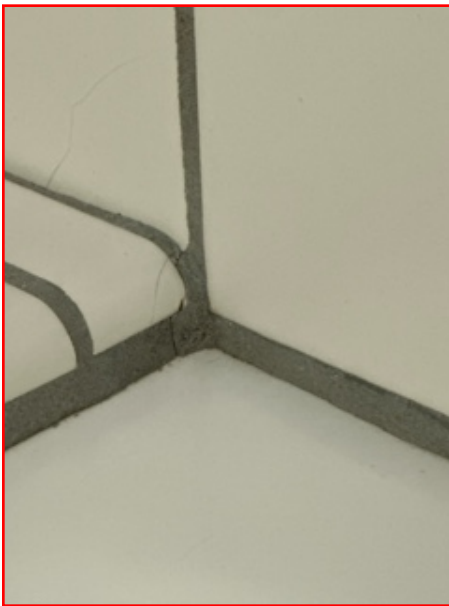
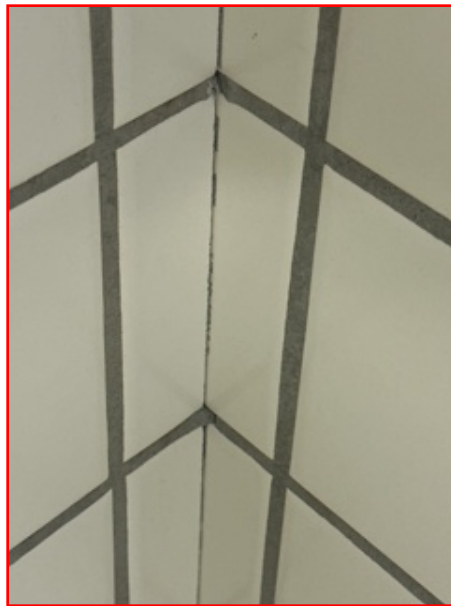
10) Recommend to reseal any cracked or missing gout surrounding downstairs bathroom tub.

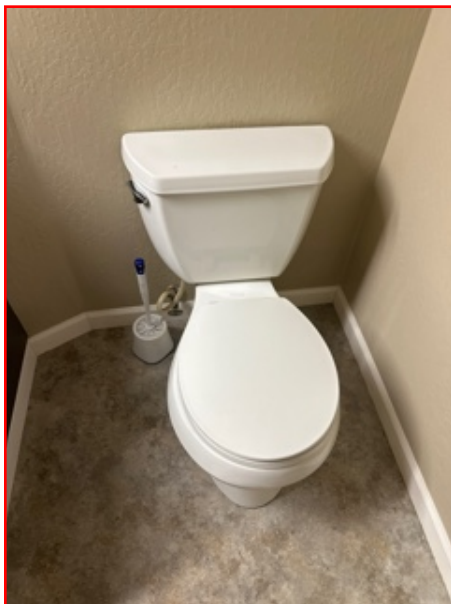
Figure 21-1

11) Master bathroom toilet noted as loose. Recommend tightening to prevent any future leaks.

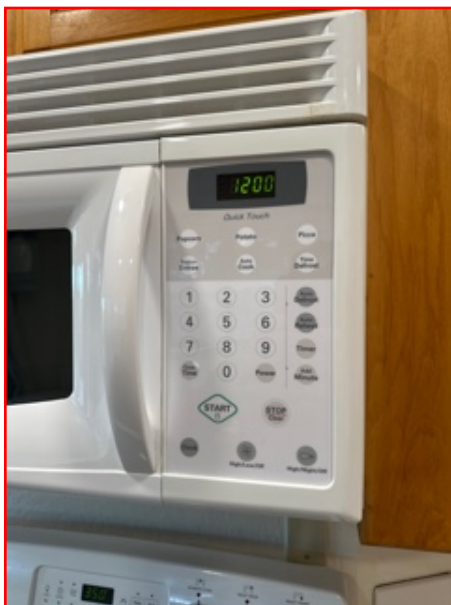
Figure 22-1

12) Microwave tested and determined functional, however the over the range light & vent fan failed to power on at time of inspection.

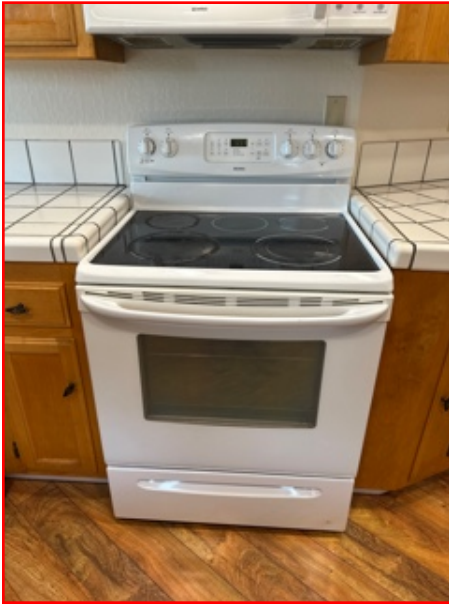
Figure 24-1

13) No anti-tip bracket installed on oven. Recommend installing to ensure the safety of the appliance.

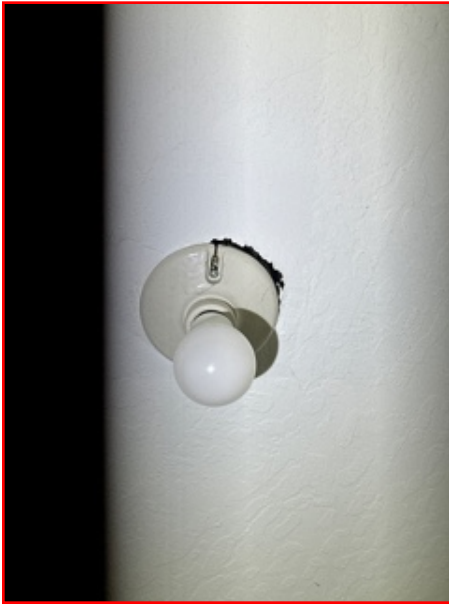
Figure 26-1

15) Hole around first downstairs bedroom closet light is cut too large.

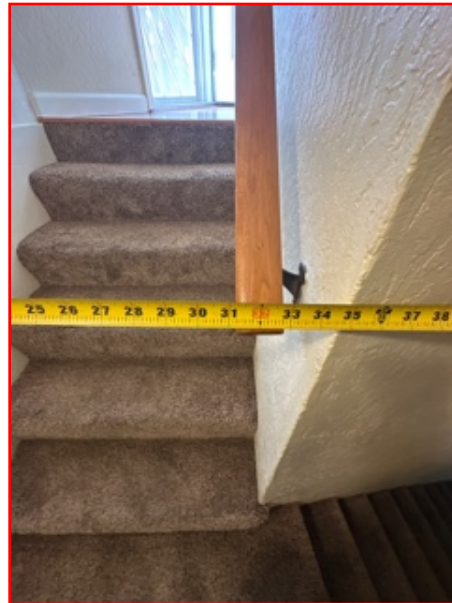
Figure 28-2

16) Current CA building codes require stairways have a minimum width of 36", measured above the handrail.

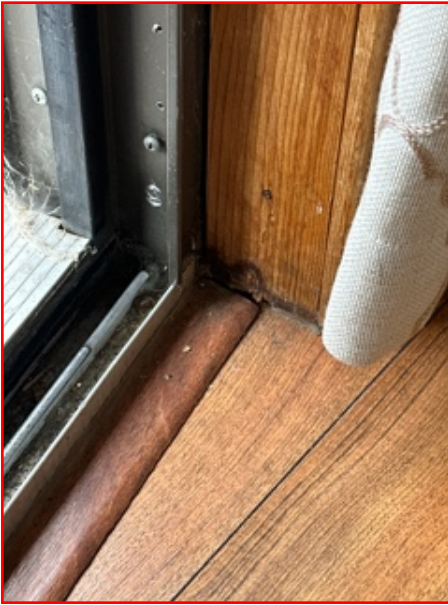
Figure 29-1

17) Moisture stain noted on trim inside sliding door. This is a common find.

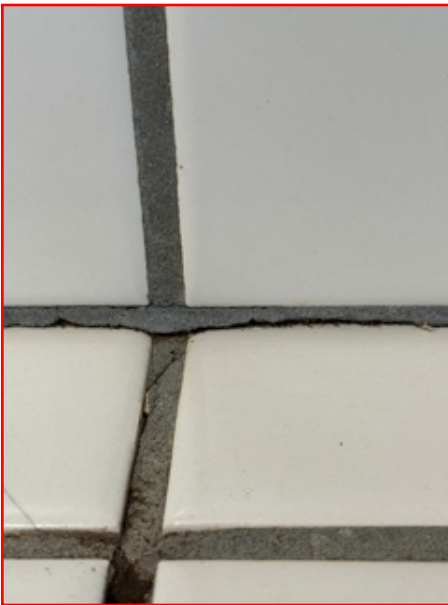
Figure 30-1

18) Recommend to reseal any missing or cracked grout on kitchen counters.

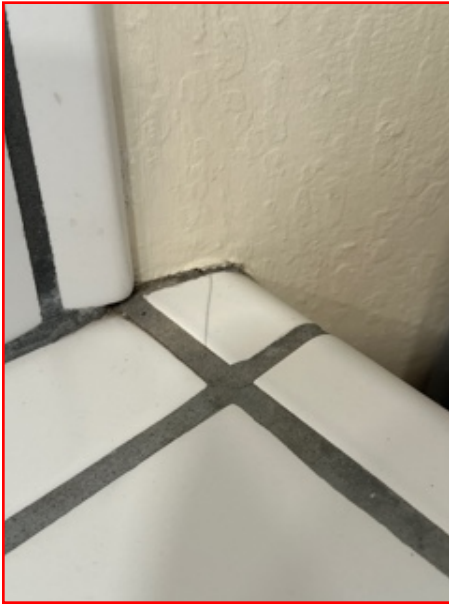
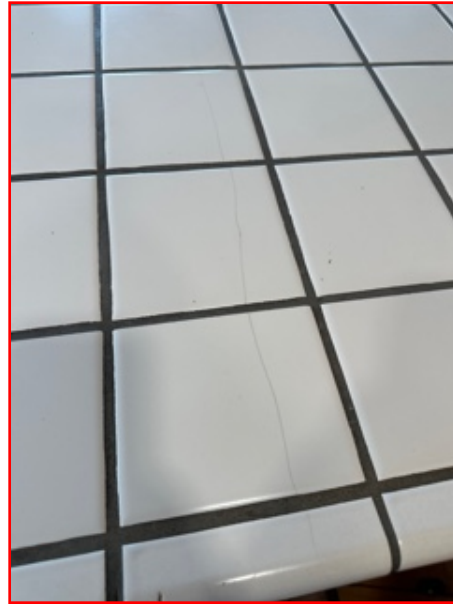
19) Minor cracks noted on some kitchen counter tiles.

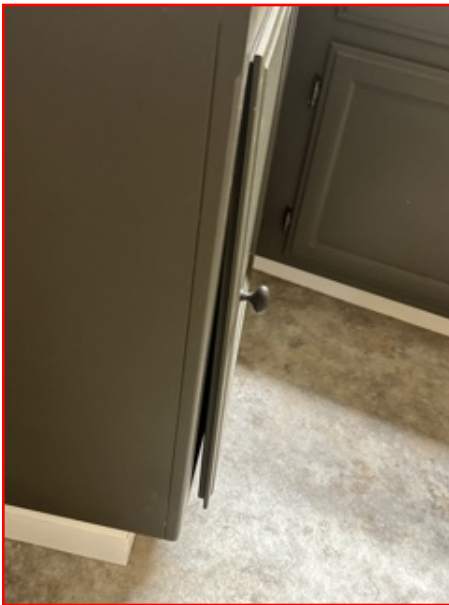
Figure 32-1

20) Master bathroom cabinet door on left side is warped.

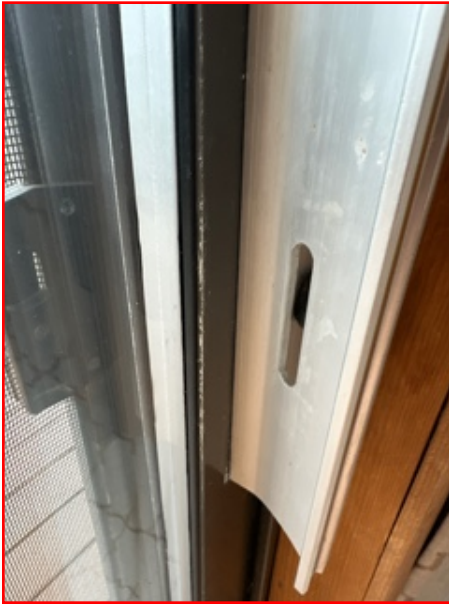
Figure 33-1

21) Sliding door latch is broken & fails to latch closed.
