WOOD DESTROYING PESTS AND ORGANISMS INSPECTION REPORT

BUILDING NO. 17355	STREET, CITY, STATE, ZIP High Grade Ln, Sonora CA 95370	Date of Inspection 4/19/2021	No. of Pages 5
------------------------------	---	--	--------------------------

General Description: ONE STORY SINGLE FAMILY RESIDENCE FURNISHED & DETACHED GARAGE	Inspection Tag Posted: SUBSTRUCTURE AREA
	Other Tags Posted: None

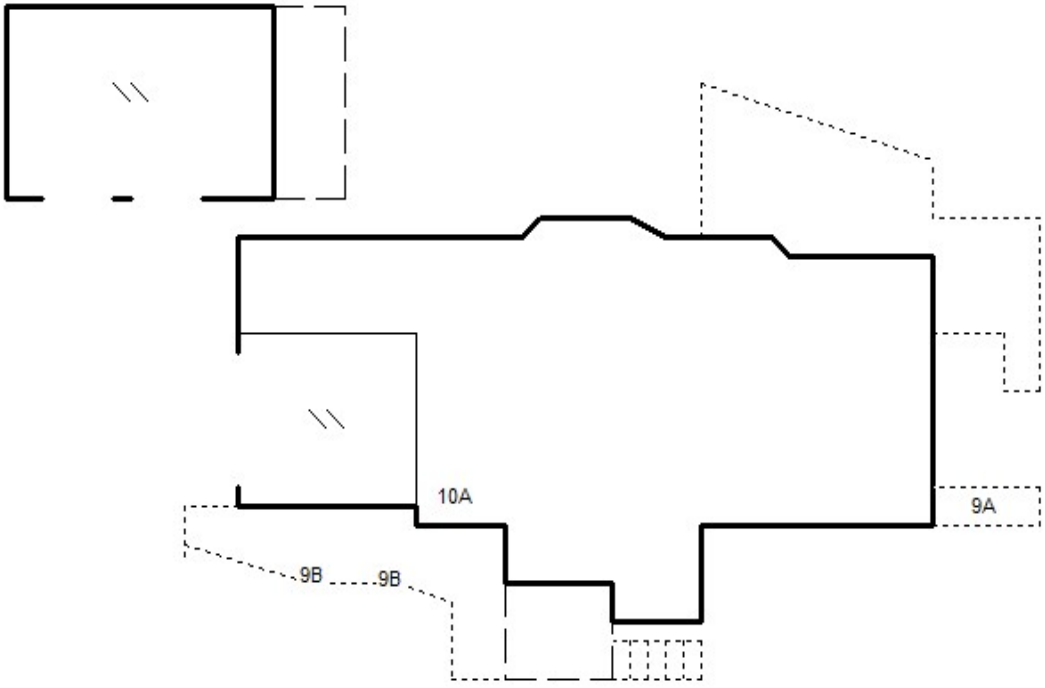
ITEM 9A Fungus damage was noted at deckboards.

ITEM 9B Fungus damage was noted at the retaining wall.

RECOMMENDATION Remove the fungus damaged wood members to allow for further inspection. If no additional damage is discovered, replace wood members with new material.
