WOOD DESTROYING PESTS AND ORGANISMS INSPECTION REPORT

BUILDING NO. / STREET 45150 CASPAR POINT ROAD	CITY CASPAR	ZIP 95420	Date of Inspection 02/20/2023	# OF PAGES 1 of 7
--	----------------	--------------	----------------------------------	----------------------

GENERAL DESCRIPTION: Two story main residence and attached garage with wood shake roofing.	Inspection Tag Posted: Water Heater Closet
	Other Tags Posted:

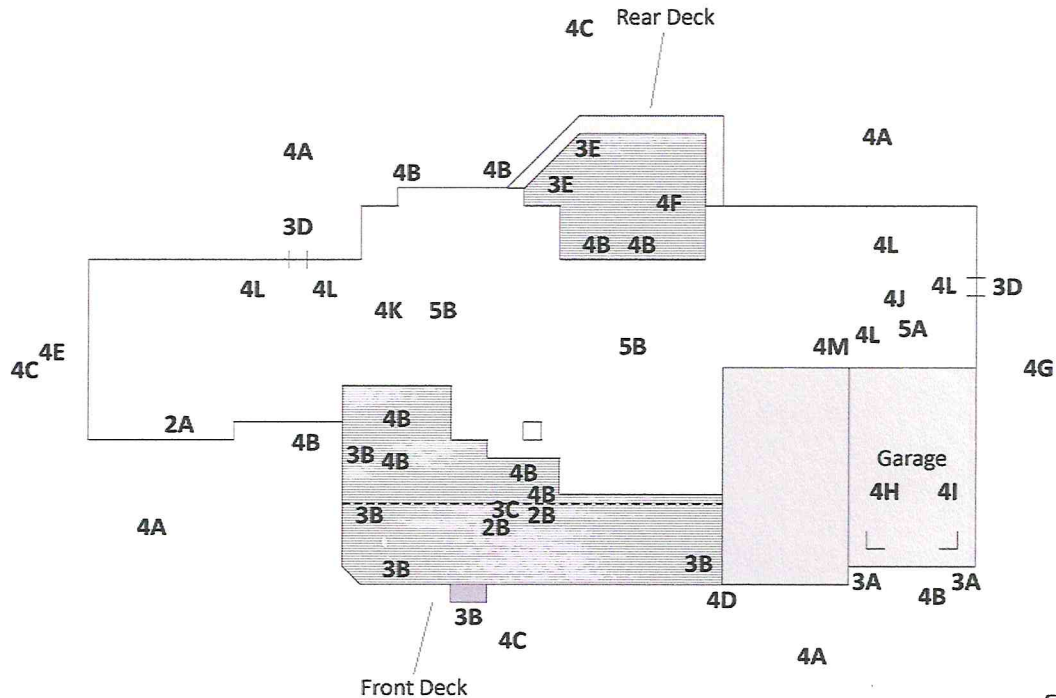
Evidence of drywood termite infestation was noted at/in interior beam in laundry room where marked on diagram.

Base of garage door jamb where marked on diagram was noted with minor fungus damage.

Wood boring beetle infestation was noted at/in select tongue and groove roof shear and rafter tails where marked on diagram. Infestation in these areas did not appear to lead to inaccessible areas.

Fence was noted abutting exterior siding where marked on diagram.

The base of exterior siding and/or skirting where marked on diagram was noted in faulty grade condition.

Fumigate the entire structure with approved fumigant Vikane for the control of drywood termites; or, as a secondary recommendation at the request of property owner in lieu of the primary recommendation, treat areas of infestation locally with approved chemical Bora-Care for the control of drywood termites. Remove or cover all accessible drywood termite fecal pellets with price to complete. NOTE: Localized treatments are not designed as whole structure treatments and may not control infestations in the inaccessible areas. NOTE: Price is for secondary treatment portion only. Fumigation price on request.

Appropriate trades to remove and replace damaged door jamb with new material. Check for further conditions and issue a supplemental report if conditions are found.

Treat areas of infestation with approved chemical Bora-Care for the control of wood boring beetles. Periodic inspection is advised.

Divorce fence from structure to prevent the trapping of moisture.

Break all faulty grade conditions. Check for further conditions and issue a supplemental report if conditions are found. Slope soil in such a manner to divert moisture.
