## HOME INSPECTION

9827 Edgar Pl  
La Mesa, CA 91941

07/27/2026

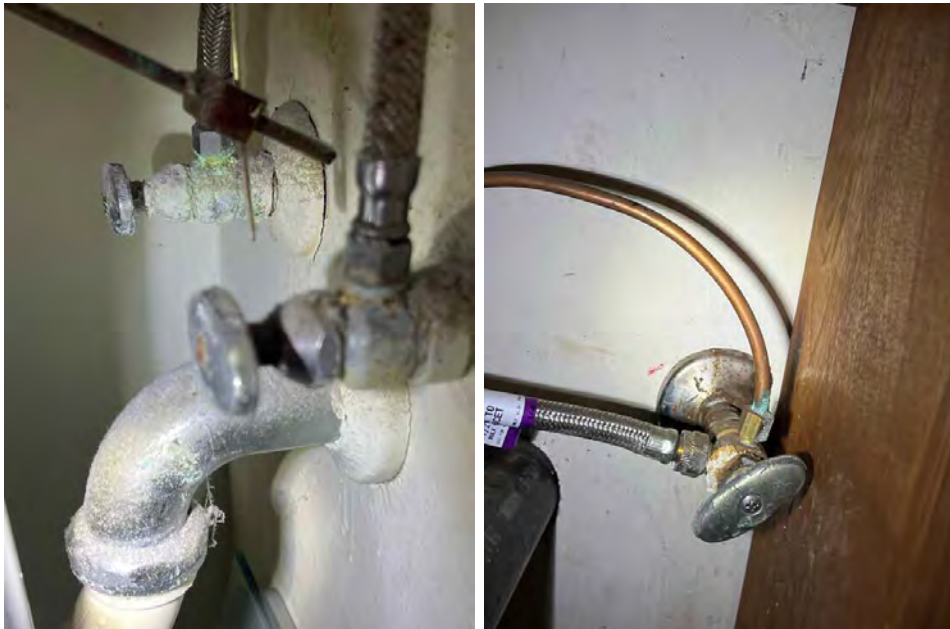
### 3.3.2 FAUCETS, VALVES AND CONNECTED FIXTURES

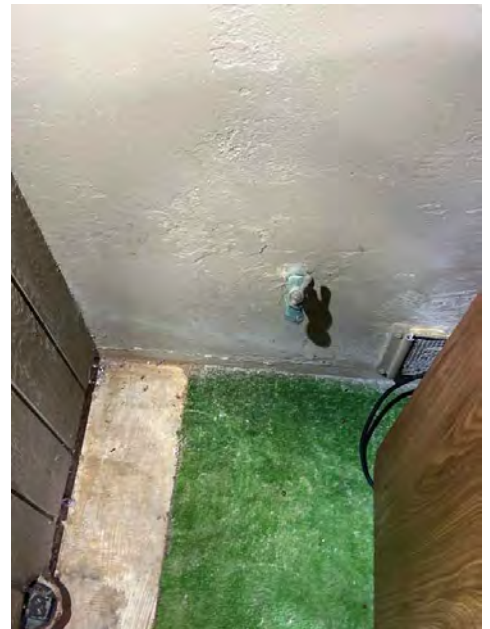
#### 3.5.1 WATER SUPPLY AND DISTRIBUTION SYSTEM

##### **WATER METER - NOT FOUND**

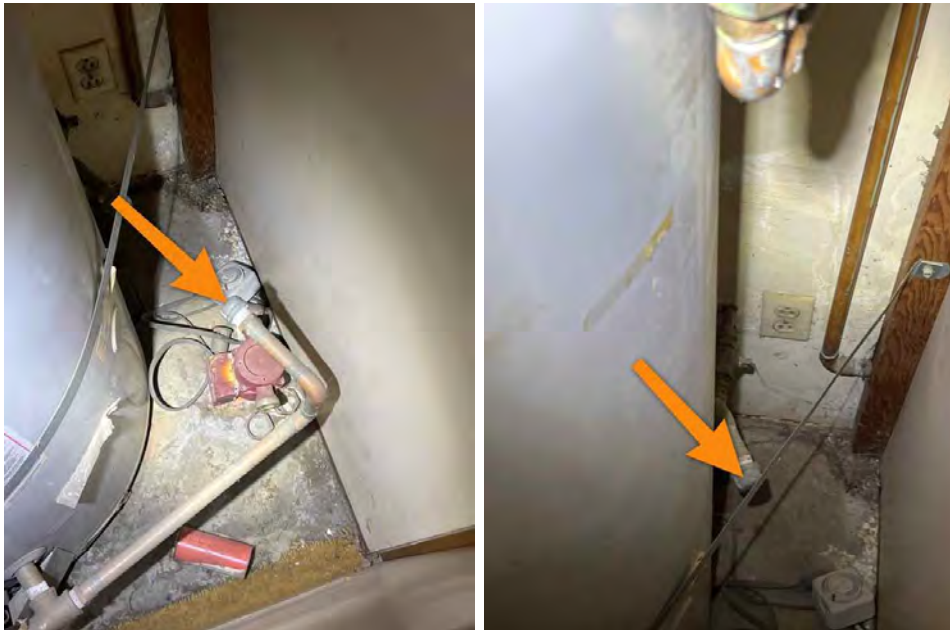
### 3.5.3 WATER SUPPLY AND DISTRIBUTION SYSTEM

#### **CORROSION - PIPING**

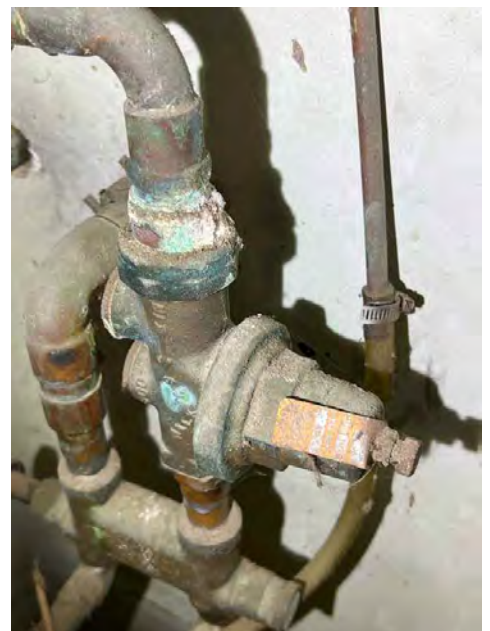
### 3.7.1 WATER HEATER(S), FLUES AND VENTS

#### **OLD WH - 20+ YEARS OLD**

Contact a qualified plumbing contractor.

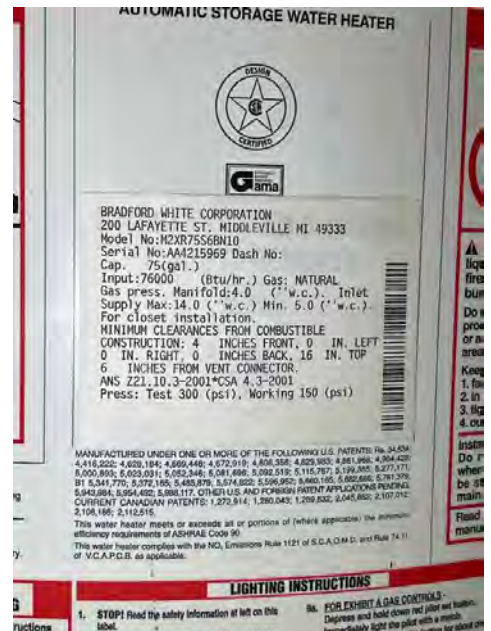
### 3.7.2 WATER HEATER(S), FLUES AND VENTS

#### NO LEAK PAN

Contact a qualified professional.

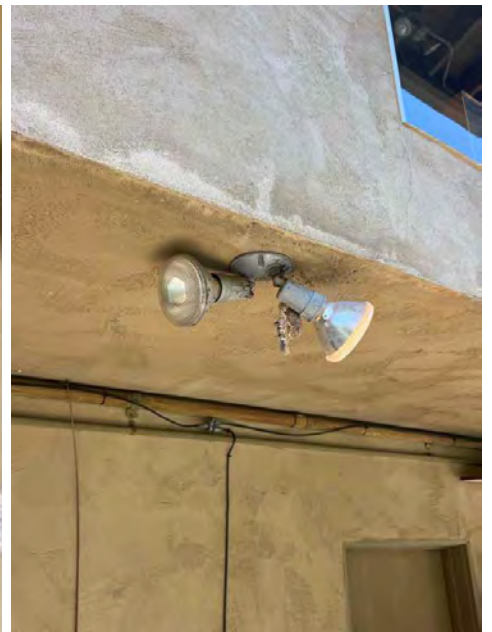
#### 4.9.2 EXTERIOR LIGHTING

##### **LIGHT COVER MISSING**

Contact a qualified professional.

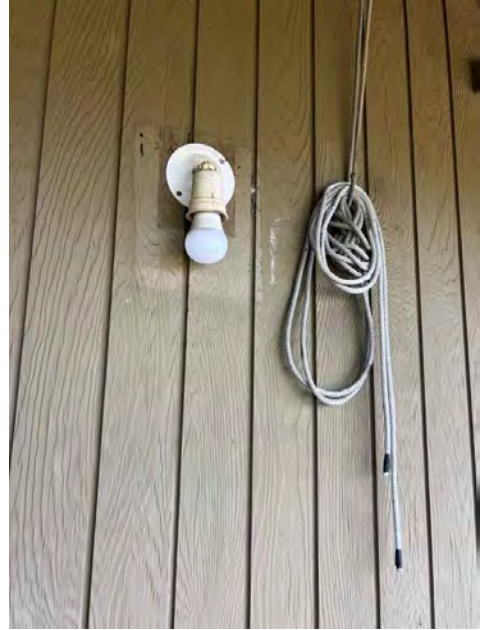
## 4.10.1 POLARITY AND GROUNDING OF RECEPTACLES

**RECEPTACLE - NO POWER**

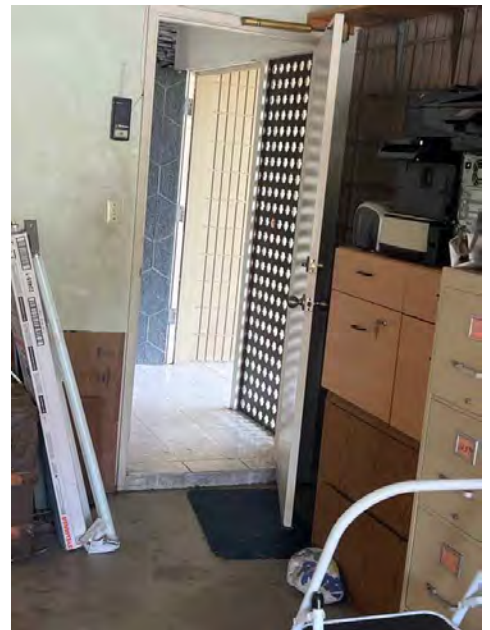
## 8.4.1 FIRE WALL

**FIREWALL BREACH**

Contact a qualified professional.

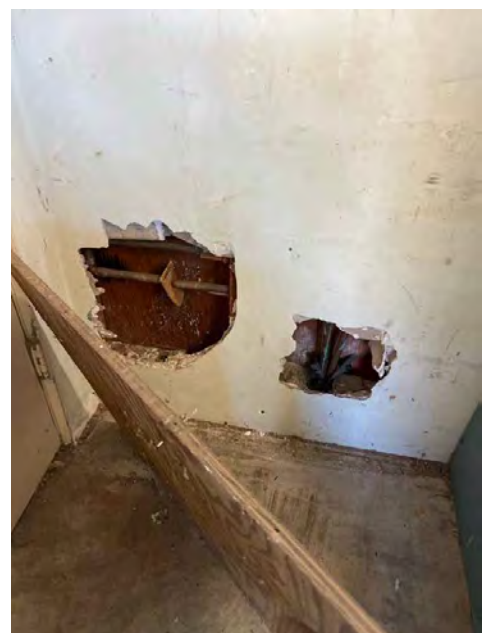
## 8.4.2 FIRE WALL

**FIRE WALL - STAIRS OPENED**

Contact a qualified professional.

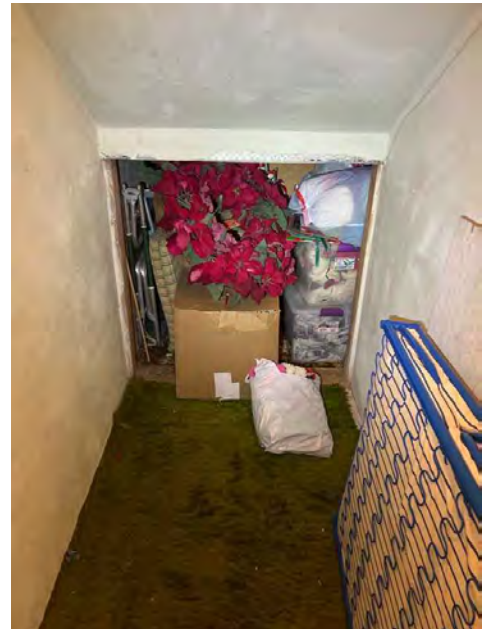
## 8.6.1 SMOKE DETECTORS

**IN HALLWAY(S) ONLY - MORE NEEDED**

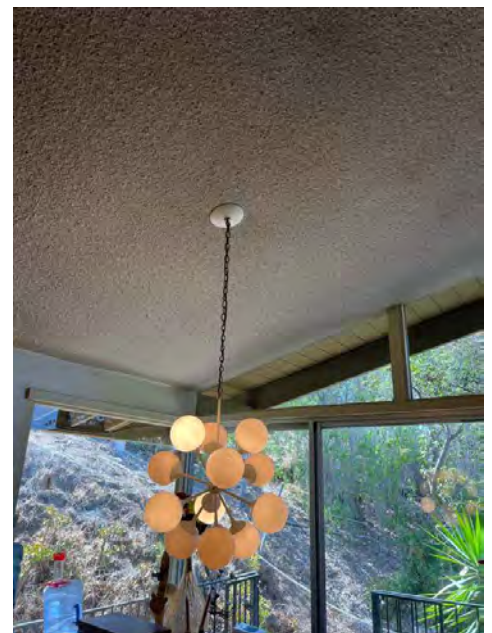
## 9.2.4 INTERIORS - General and Visual Mold Assessment

**GHOSTING**

Contact a qualified professional.

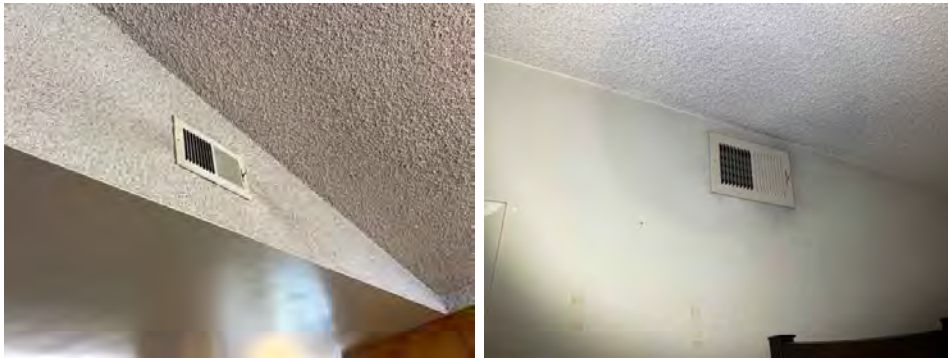
## 9.3.1 CEILINGS

**CRACKS - POSSIBLE LEAK**

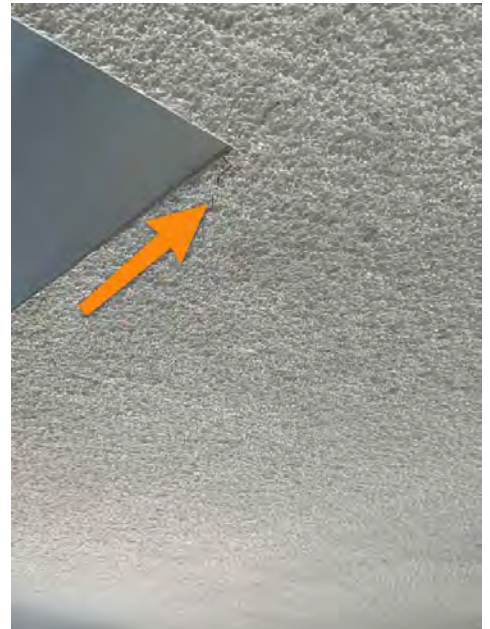
## 9.3.3 CEILINGS

**MOISTURE/APPARENT LEAK - BELOW HALL BATHROOM**

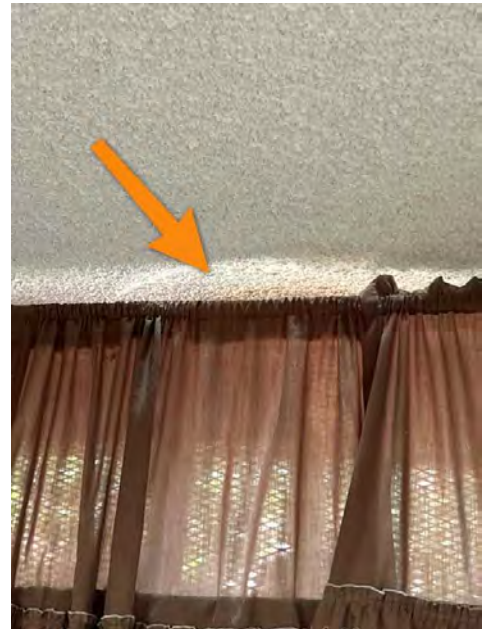
### 9.3.7 CEILINGS

#### STAINS - DRY UNDER ROOF

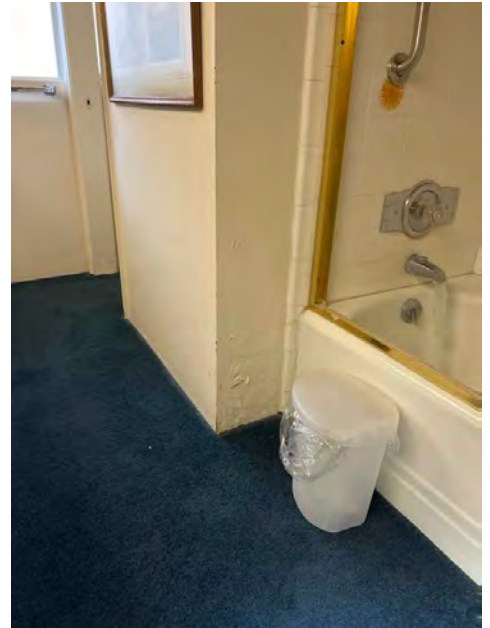
### 9.6.1 TUB/SHOWER ENCLOSURE

#### **SHOWER PAN - LEAKS OBSERVED**

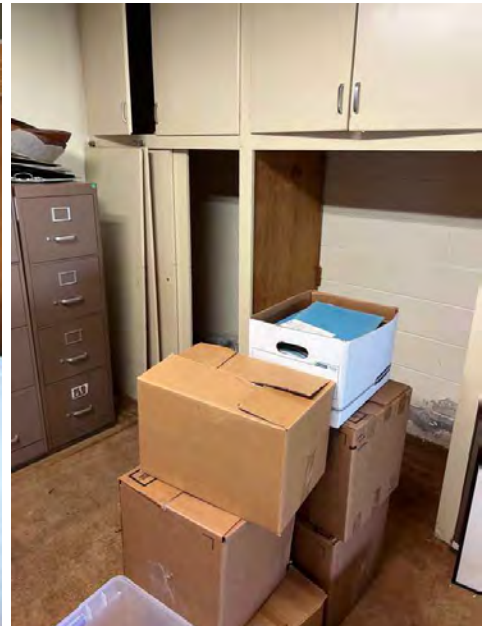
#### 9.7.3 COUNTERS AND A REPRESENTATIVE NUMBER OF CABINETS

##### **MOISTURE/SWELLING - DRY**

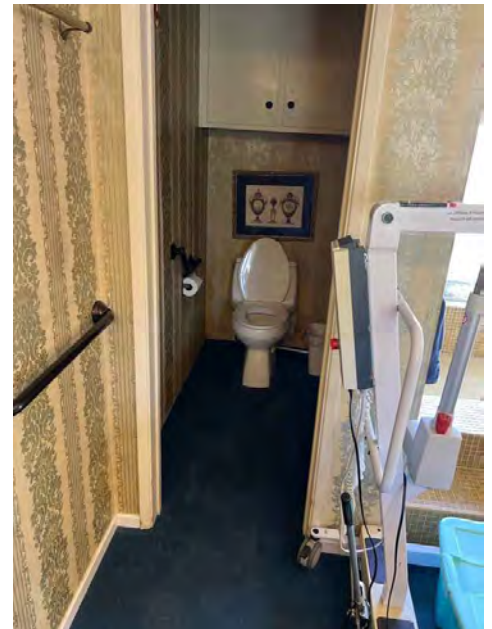
#### 9.9.2 DOORS (REPRESENTATIVE NUMBER)

##### **CLOSET ROLLERS DAMAGED**

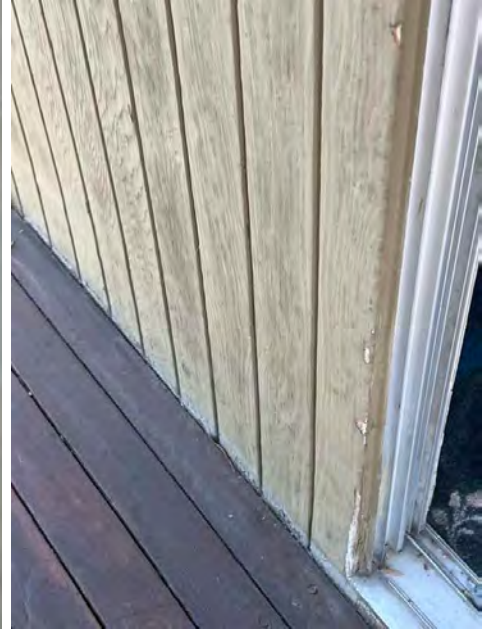
## 10.5.3 WALL SIDING FLASHING AND TRIM

**DAMAGED WOOD TRIM**

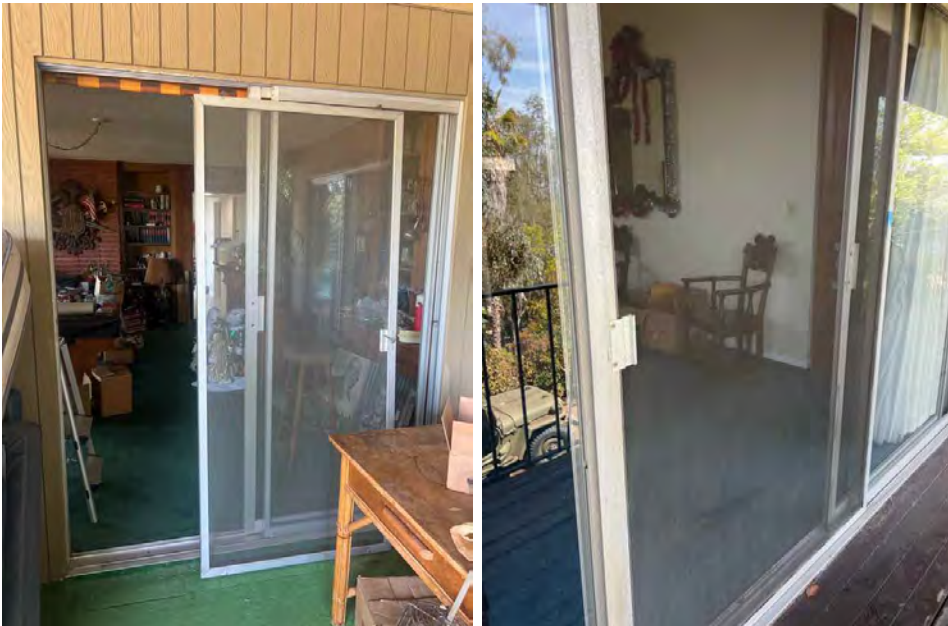
#### 10.6.3 DOORS (Exterior)

##### **SLIDER SCREEN - TORN/DAMAGED**

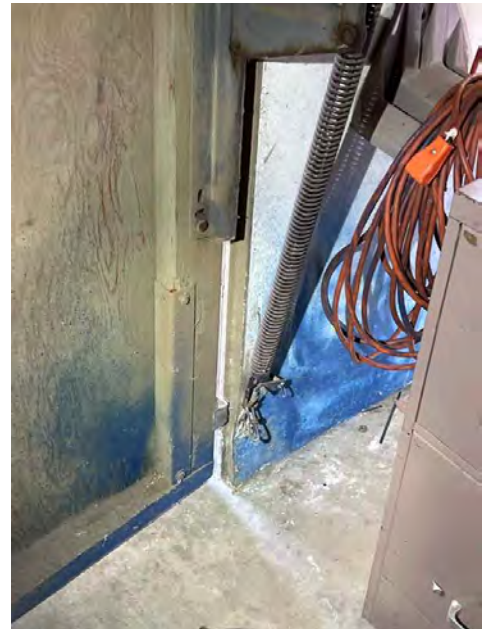
#### 10.9.1 STOOPS, STEPS, PORCHES AND RAILINGS

##### **RUSTED POST**

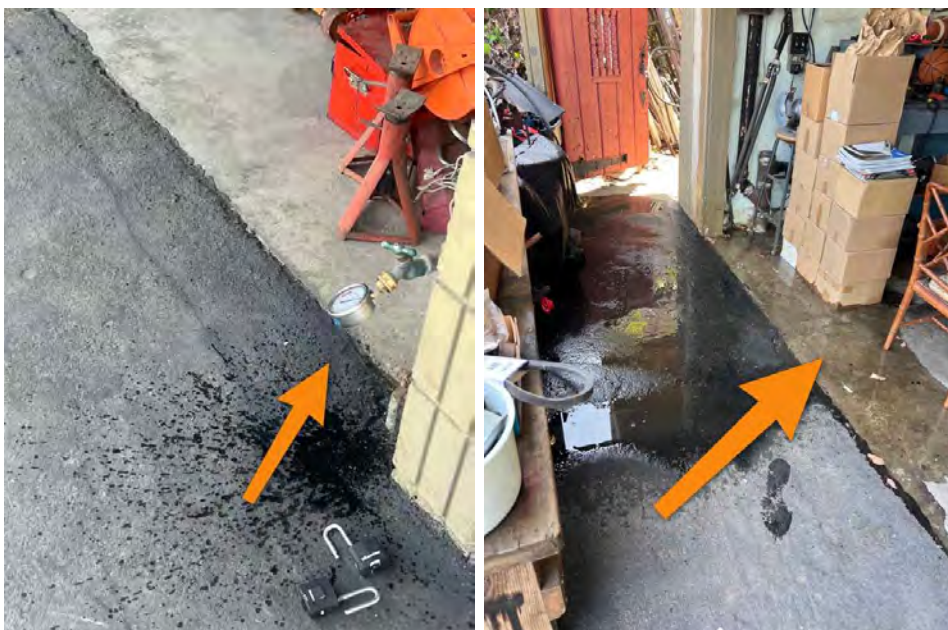
## 10.10.3 DRIVEWAYS, PATIOS, WALKWAYS

**ASPHALT DETERIORATED**

Contact a qualified professional.

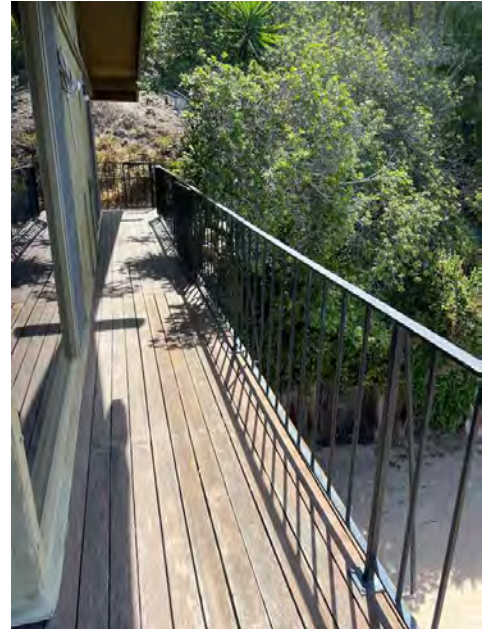
#### 11.1.4 RAILINGS

##### **DAMAGE - RAILING**

Contact a qualified deck contractor.

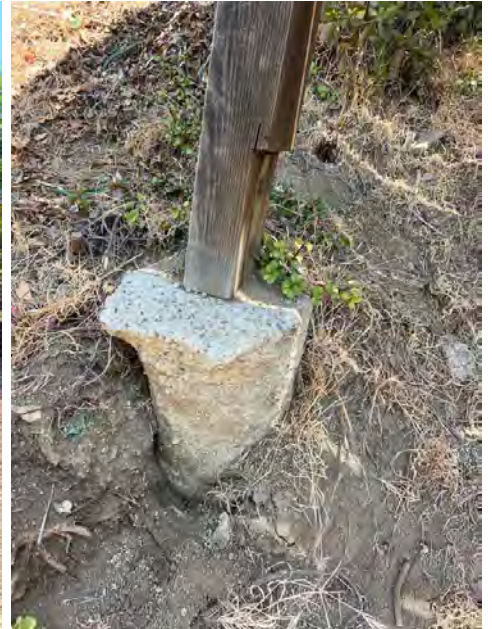
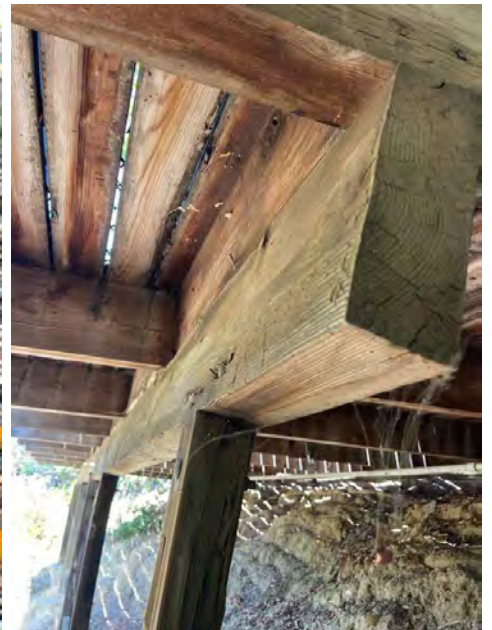
#### 11.5.1 STRUCTURE

##### **EXCESSIVE ROT - DECKS**
