INSPECTION REPORT  
5700 Baltimore Dr #39  
La Mesa CA 91942

INSPECTED BY  
Ray Salcido  
HomeSite  
Inspections - A  
Division of DeBerry  
Inspection Services

INSPECTION DATE  
📅 9/23/2024  
🕒 11:00 AM

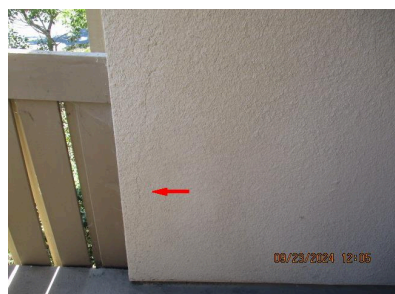
1.1 Item 1 (Picture)

Cracking noted on the stucco surface, wood siding worn and stained. Please Note: The exterior siding may be part of the Home Owners' Association: Due to height and angle restrictions, the entire exterior was not able to be fully inspected at this time.

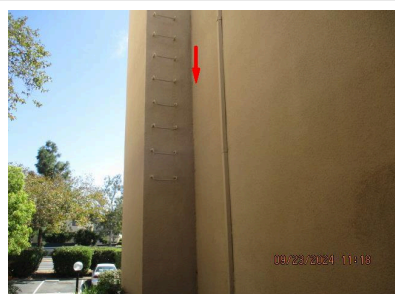
1.3 Item 1 (Picture)

Cracking noted along sides of the chimney junction to the building. The cracks should be sealed. Please Note: The exterior siding may be part of the Home Owners' Association. Items warrant attention and repair.

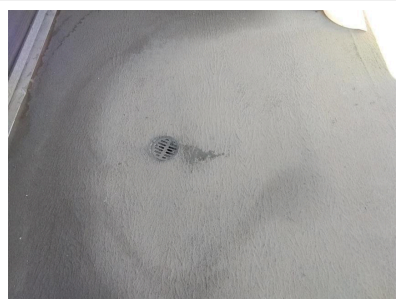
1.9 Item 1 (Picture)

Cracking and staining noted on the balcony surface, railing boards and frame loose, wood weathered and worn. Ensure that the balcony surface is kept well sealed to prevent water intrusion or damage to the inaccessible areas. Drain should be kept clean and clear to allow water to flow off. Recommend review and repairs by a licensed contractor.

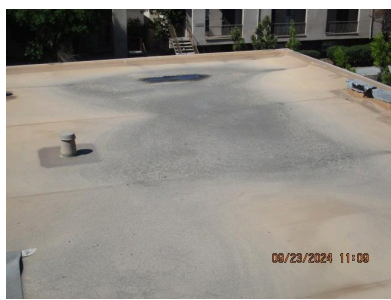
3.0 Item 1 (Picture)

Roof surface is stained, signs of poor drainage. This type of roof requires regular maintenance to prevent water intrusion. Ensure all roof penetrations are kept well sealed. Please Note: Roof may be part of the Home Owner's Association. The entire roof was not fully inspected at this time.

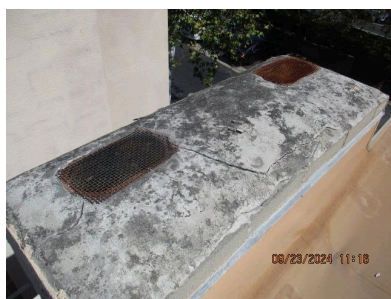
3.3 Item 1 (Picture)

Cracking noted on the chimney cap, missing proper spark arrestor/rain cap.  
Recommend further evaluation, and/or repairs by a certified chimney sweep.

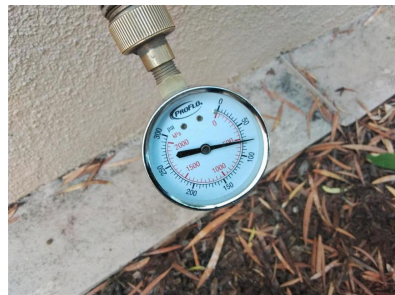
4.2 Item 1 (Picture)

Please note: The water pressure reading was taken from a common area hose faucet. The water pressure reading is only reflective of water pressure to the building at this particular faucet fixture and does not necessarily reflect the water pressure throughout the dwelling. Recommend client routinely monitor water pressure throughout the dwelling.

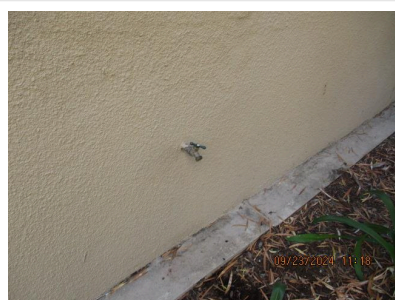
4.3 Item 1 (Picture)

Common area faucet only noted.

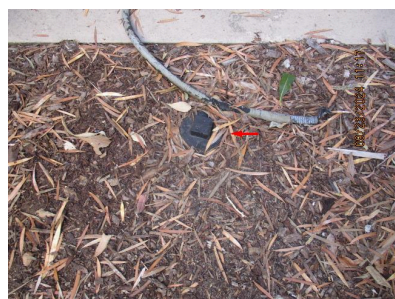
4.6 Item 1 (Picture)

Drain clean-out noted at ground level common area only.

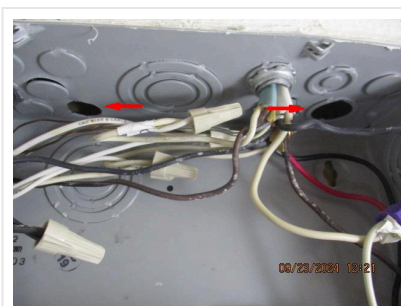
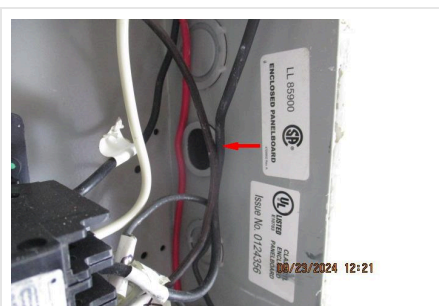
(1) Open "knock-out" holes noted. This is a safety hazard. Insert caps to close off openings. Recommend review and repairs by a licensed electrical contractor.

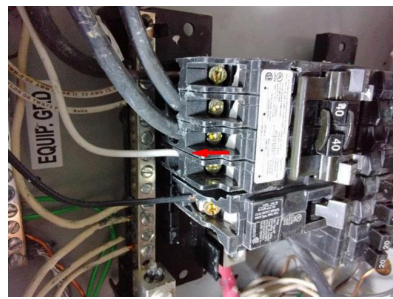
6.2 Item 1 (Picture)

White wire used as "hot" wire. The wires should be properly marked as "hot" with black or red tape. Recommend review and repairs by a licensed electrical contractor.

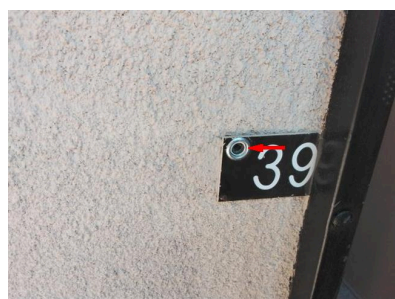
7.2 Item 1 (Picture)

The doorbell did not function, button damaged. Item warrants attention and repair.

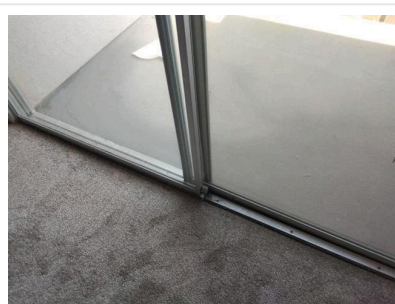
7.3 Item 1 (Picture)

Rollers bounce, track and rollers need to be cleaned and lubricated and or repaired. Screen door does not latch. Sliding glass door installed backwards. The fixed section of the door situated on the inner track, leaving the sliding door on exterior track.

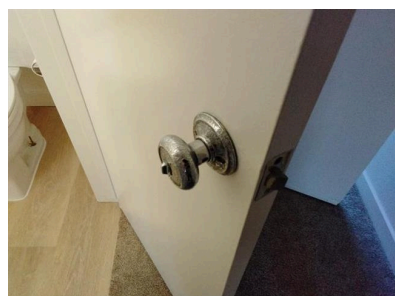
7.4 Item 1 (Picture)

1/2 bathroom door does not lock, also rubs on strike plate. West facing bedroom door rubs on frame. Items warrant attention and repair.

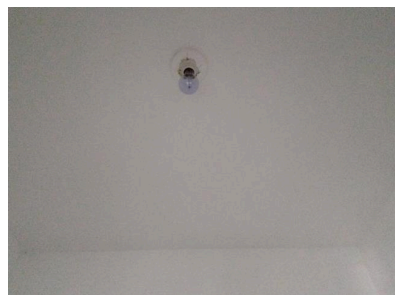
7.9 Item 1 (Picture)

(2) Lights inside closets would be considered improper and potential fire/safety hazards by today's standards. Missing protective cover over light fixtures.

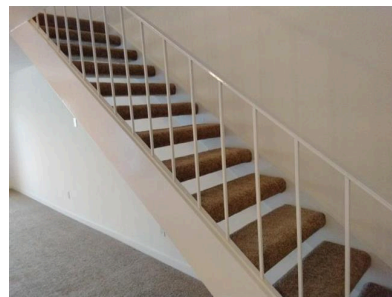
7.13 Item 1 (Picture)

Baluster spacing @ railings too wide by today's standards. This is a potential safety hazard. Client may consider installation of a protective barrier along the railings and/or replacement. Height of the railings would be considered too low by today's current standards. Although typical for age of home, modern handrails are 42 inch minimum height for increased safety.

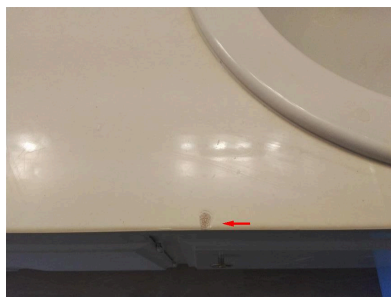
**8.2.A Item 1 (Picture)**

Chipped spot, scratches noted on the counter top. Wear to cabinetry.

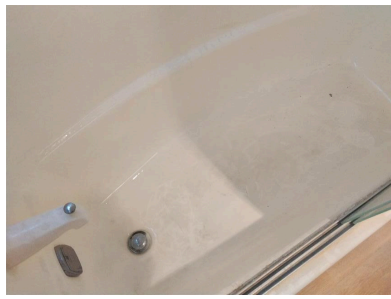
8.6.A Item 1 (Picture)

Small quantity of water dispenses from tub spout when shower is in use. Shower diverter does not fully seal. Water leaking from underside of spout. Tub surface stained. recommend review and repairs by a licensed plumbing contractor. Ensure that the fixtures and surrounding areas are kept well sealed to prevent water damage.

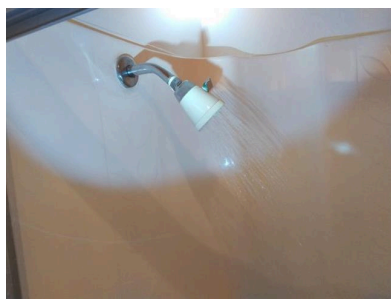
8.7.A Item 1 (Picture)

Ensure that the fixtures and surrounding areas are kept well sealed to prevent water damage.

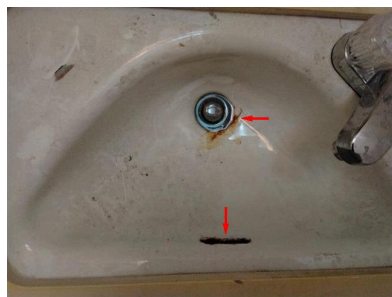
8.0.B Item 1 (Picture)

Rust staining and cracking noted on the surface. Recommend review and repairs by a licensed plumbing contractor.

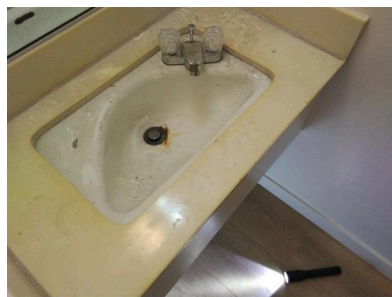
8.2.B Item 1 (Picture)

Wear to the counter tops. Corrosion spots noted on the mirror.

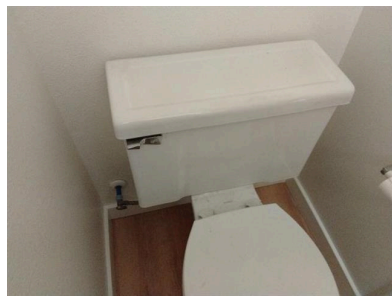
8.4.B Item 1 (Picture)

Toilet tank loose & needs to be secured. Item warrants attention and repair.

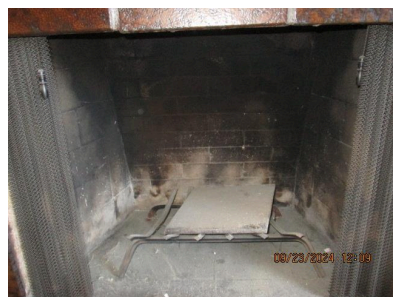
9.0 Item 1 (Picture)

Soot staining in fireplace interior.

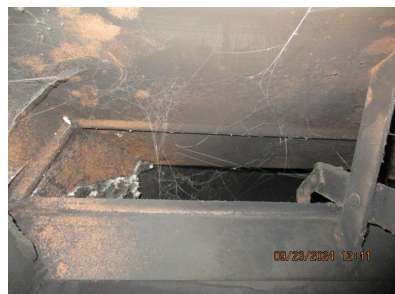
9.1 Item 1 (Picture)

Please Note – Limited visual inspection of the flue and interior firebox due to angle and height restrictions.  
 Recommend safety inspection by a certified chimney sweep.

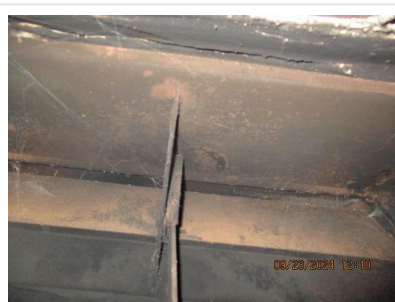
9.2 Item 1 (Picture)

Rust noted on the damper.

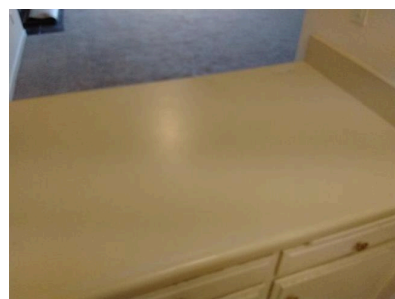
10.0 Item 1 (Picture)

(1) Wear to the counter tops.

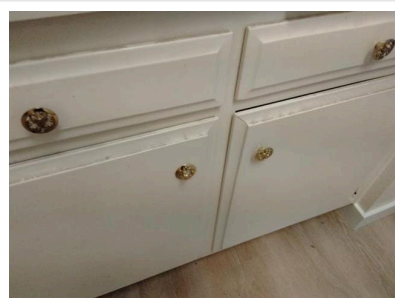
10.1 Item 1 (Picture)

(1) Wear noted to the cabinets.

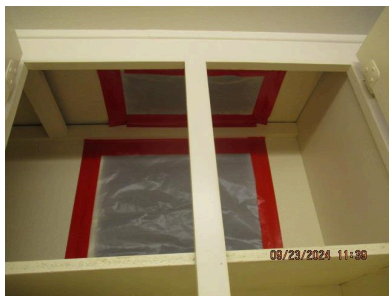
10.1 Item 2 (Picture)

(2) Holes noted on the walls and ceilings in the cabinets, reason for holes not known, plastic covered.

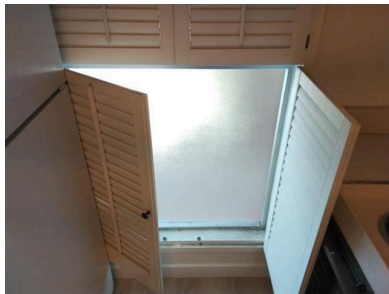
10.2 Item 1 (Picture)

If windows are replaced, lower window would possibly require glass to be tempered.

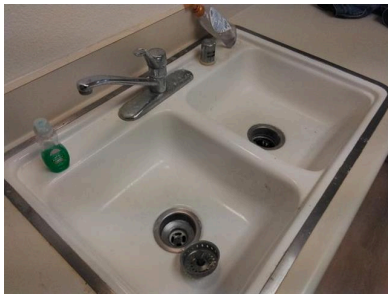
10.6 Item 1 (Picture)

Wear noted to sink basins. Ensure sink kept well sealed.

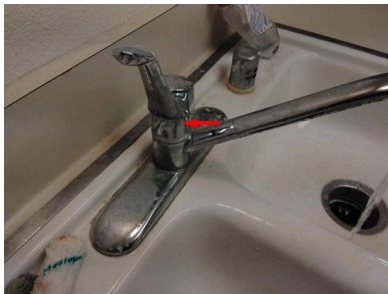
10.7 Item 1 (Picture)

Corrosion noted on the faucet,

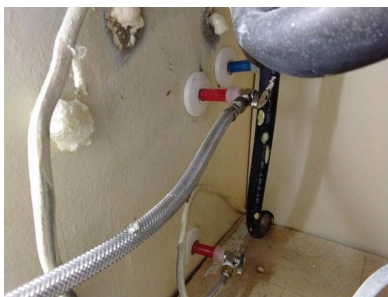
10.8 Item 1 (Picture)

Pipes have been replaced. PEX type pipes visible.

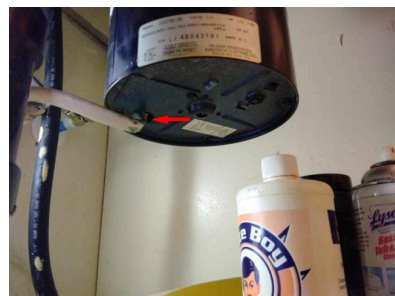
10.9 Item 1 (Picture)

Disposal unit is functional however it is wired directly to the switch. Expose Romex noted, missing clamp at wire going into the disposal. Recommend review and repairs by a licensed electrical contractor.

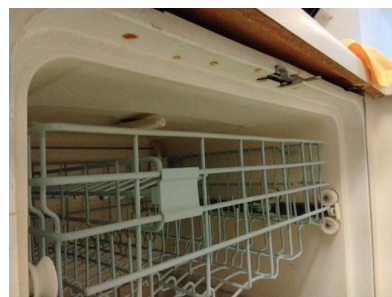
10.10 Item 1 (Picture)

Dishwasher not adequately secured to the cabinetry / countertop. Unit did not function properly, it would start but stop and go into fault mode. Recommend review and repairs by a licensed contractor.

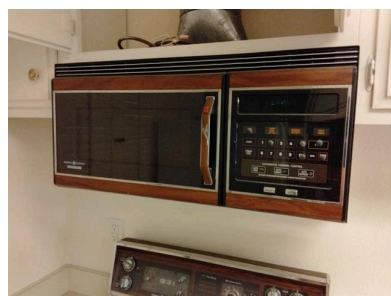
10.12 Item 1 (Picture)

Microwave did not operate properly. Unit failed to heat. This unit would be considered to be at the end of its life. Replacement may be necessary. Exposed wiring in cabinet above microwave, this is improper and potential safety hazard. Recommend evaluation and repair by a licensed electrical contractor.

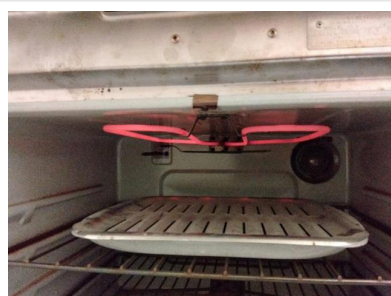
10.14 Item 1 (Picture)

Oven elements are functional however it is missing an anti-tip bracket. This is a safety hazard. Item warrants attention and repair.

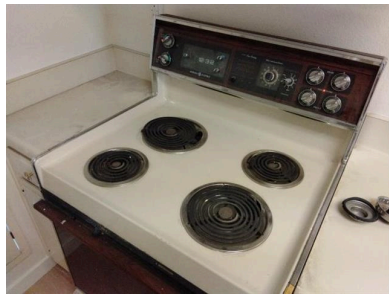
10.15 Item 1 (Picture)

All elements are functional at the stove top, unit is worn.

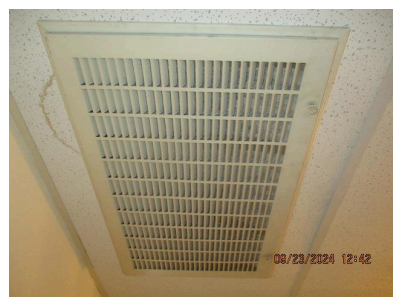
11.0 Item 1 (Picture)

(1) Heating unit is functional. Stain noted on the ceiling tile, unable to determine cause, no moisture detected at this time.

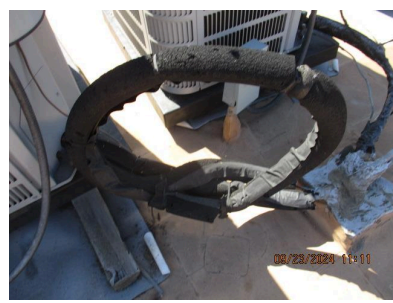
12.2 Item 1 (Picture)

Deteriorated insulation on the refrigerant line needs to be repaired / replaced @ the exterior.

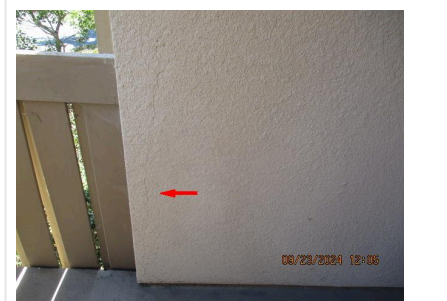
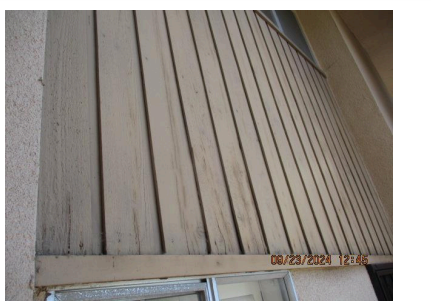
Cracking noted on the stucco surface, wood siding worn and stained. Please Note: The exterior siding may be part of the Home Owners' Association: Due to height and angle restrictions, the entire exterior was not able to be fully inspected at this time.

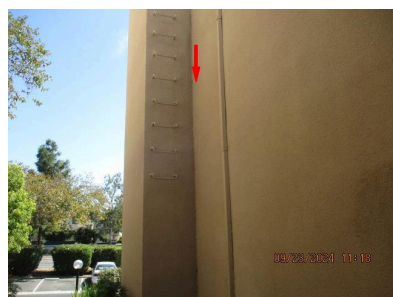
1.3 Item 1 (Picture)

Cracking noted along sides of the chimney junction to the building. The cracks should be sealed. Please Note: The exterior siding may be part of the Home Owners' Association. Items warrant attention and repair.

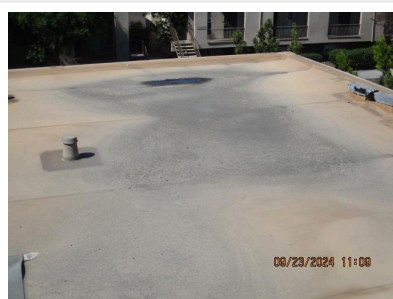
3.0 Item 1 (Picture)

Roof surface is stained, signs of poor drainage. This type of roof requires regular maintenance to prevent water intrusion. Ensure all roof penetrations are kept well sealed. Please Note: Roof may be part of the Home Owner's Association. The entire roof was not fully inspected at this time.

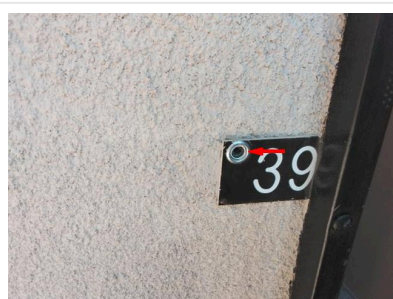
7.2 Item 1 (Picture)

The doorbell did not function, button damaged. Item warrants attention and repair.

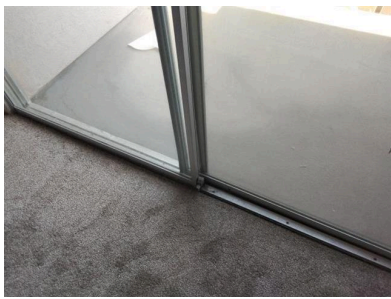
7.3 Item 1 (Picture)

Rollers bounce, track and rollers need to be cleaned and lubricated and or repaired. Screen door does not latch. Sliding glass door installed backwards. The fixed section of the door situated on the inner track, leaving the sliding door on exterior track.

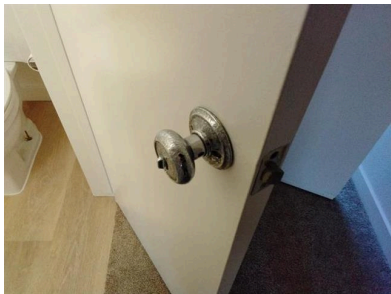
7.4 Item 1 (Picture)

1/2 bathroom door does not lock, also rubs on strike plate. West facing bedroom door rubs on frame. Items warrant attention and repair.

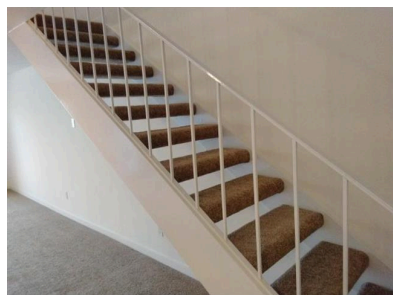
7.13 Item 1 (Picture)

Baluster spacing @ railings too wide by today's standards. This is a potential safety hazard. Client may consider installation of a protective barrier along the railings and/or replacement. Height of the railings would be considered too low by today's current standards. Although typical for age of home, modern handrails are 42 inch minimum height for increased safety.

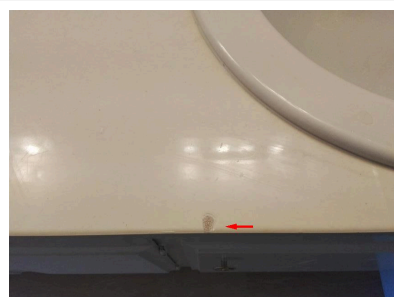
8.2.A Item 1 (Picture)

Chipped spot, scratches noted on the counter top. Wear to cabinetry.

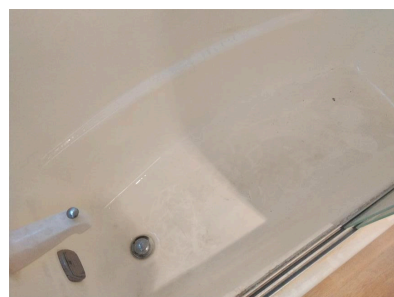
8.6.A Item 1 (Picture)

Small quantity of water dispenses from tub spout when shower is in use. Shower diverter does not fully seal. Water leaking from underside of spout. Tub surface stained. recommend review and repairs by a licensed plumbing contractor. Ensure that the fixtures and surrounding areas are kept well sealed to prevent water damage.

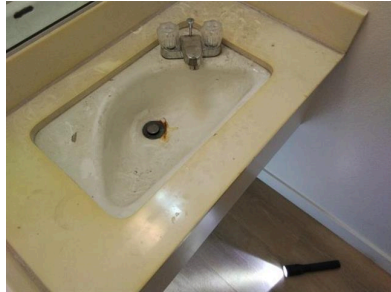
8.2.B Item 1 (Picture)

Wear to the counter tops. Corrosion spots noted on the mirror.

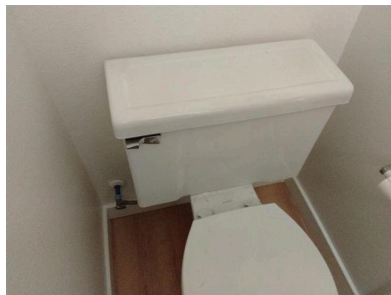
8.4.B Item 1 (Picture)

Toilet tank loose & needs to be secured. Item warrants attention and repair.

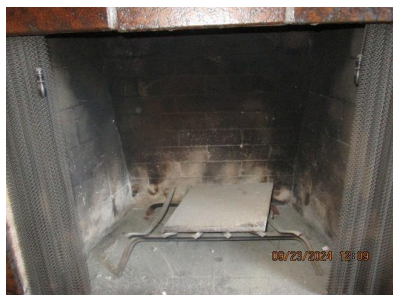
9.0 Item 1 (Picture)

Soot staining in fireplace interior.

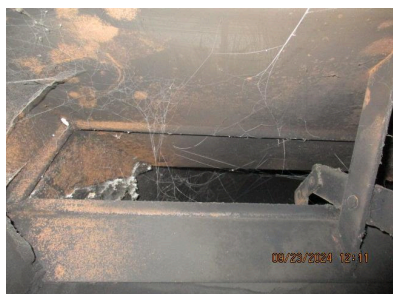
9.1 Item 1 (Picture)

Please Note – Limited visual inspection of the flue and interior firebox due to angle and height restrictions. Recommend safety inspection by a certified chimney sweep.

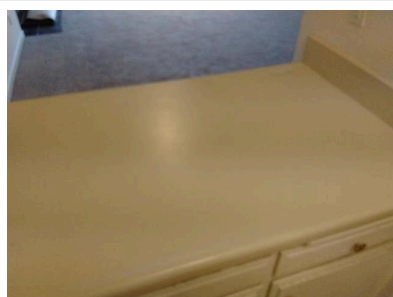
10.0 Item 1 (Picture)

(1) Wear to the counter tops.

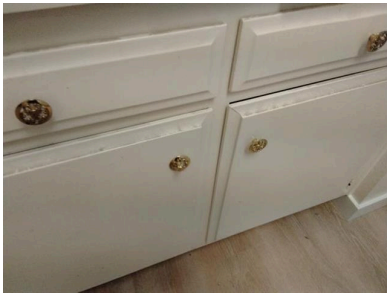
10.1 Item 1 (Picture)

(1) Wear noted to the cabinets.

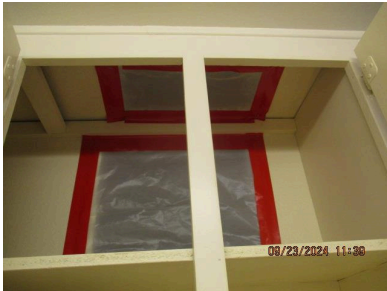
10.1 Item 2 (Picture)

(2) Holes noted on the walls and ceilings in the cabinets, reason for holes not known, plastic covered.

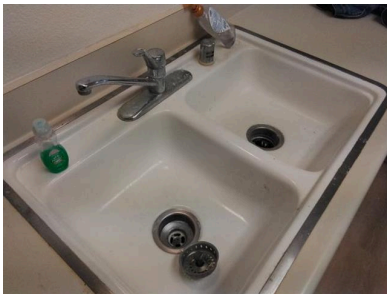
10.6 Item 1 (Picture)

Wear noted to sink basins. Ensure sink kept well sealed.

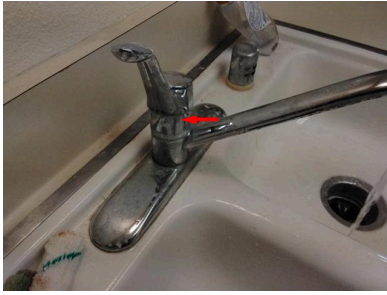
10.7 Item 1 (Picture)

Corrosion noted on the faucet,

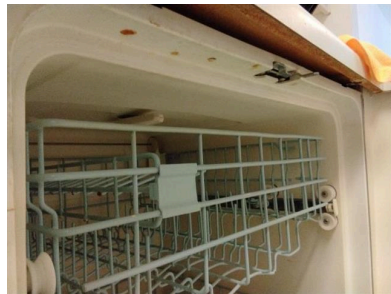
10.10 Item 1 (Picture)

Dishwasher not adequately secured to the cabinetry / countertop. Unit did not function properly, it would start but stop and go into fault mode. Recommend review and repairs by a licensed contractor.

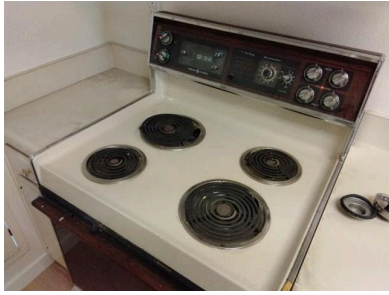
10.15 Item 1 (Picture)

All elements are functional at the stove top, unit is worn.

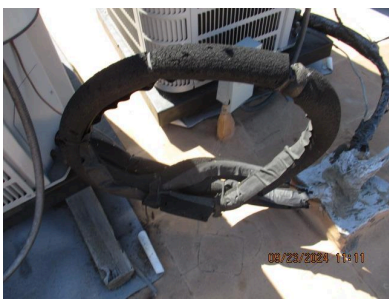
12.2 Item 1 (Picture)

Deteriorated insulation on the refrigerant line needs to be repaired / replaced @ the exterior.

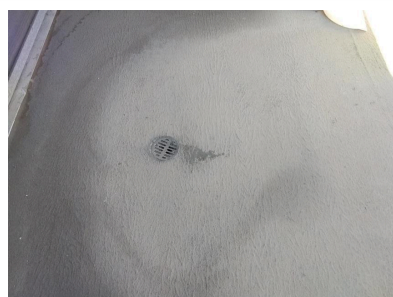
1.9 Item 1 (Picture)

Cracking and staining noted on the balcony surface, railing boards and frame loose, wood weathered and worn. Ensure that the balcony surface is kept well sealed to prevent water intrusion or damage to the inaccessible areas. Drain should be kept clean and clear to allow water to flow off. Recommend review and repairs by a licensed contractor.

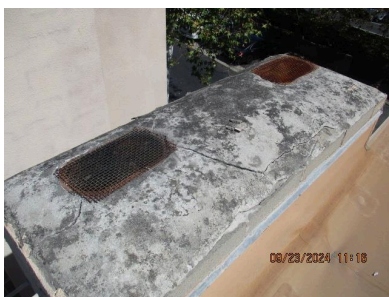
3.3 Item 1 (Picture)

Cracking noted on the chimney cap, missing proper spark arrestor/rain cap.  
Recommend further evaluation, and/or repairs by a certified chimney sweep.

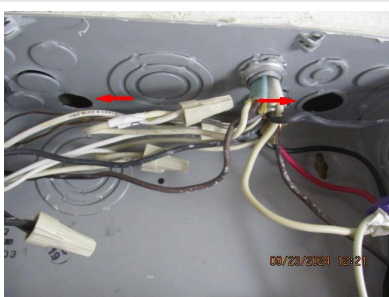
6.0 Item 1 (Picture)

(1) Open "knock-out" holes noted. This is a safety hazard. Insert caps to close off openings. Recommend review and repairs by a licensed electrical contractor.

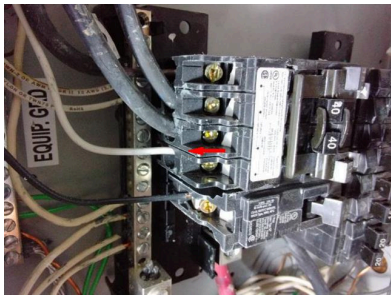
6.2 Item 1 (Picture)

White wire used as "hot" wire. The wires should be properly marked as "hot" with black or red tape. Recommend review and repairs by a licensed electrical contractor.

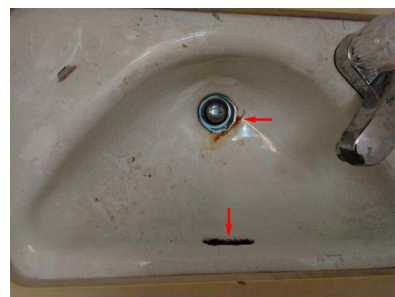
8.0.B Item 1 (Picture)

Rust staining and cracking noted on the surface. Recommend review and repairs by a licensed plumbing contractor.

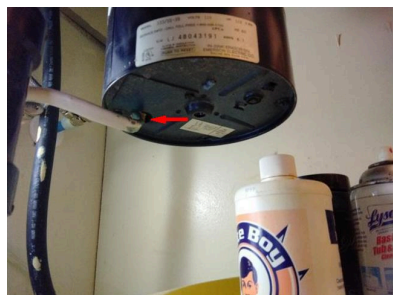
10.9 Item 1 (Picture)

Disposal unit is functional however it is wired directly to the switch. Expose Romex noted, missing clamp at wire going into the disposal. Recommend review and repairs by a licensed electrical contractor.

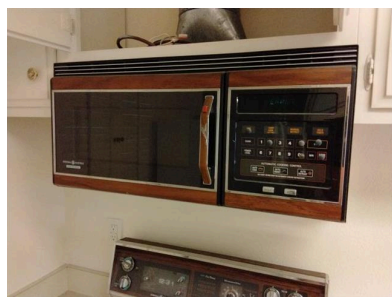
10.12 Item 1 (Picture)

Microwave did not operate properly. Unit failed to heat. This unit would be considered to be at the end of its life. Replacement may be necessary. Exposed wiring in cabinet above microwave, this is improper and potential safety hazard. Recommend evaluation and repair by a licensed electrical contractor.

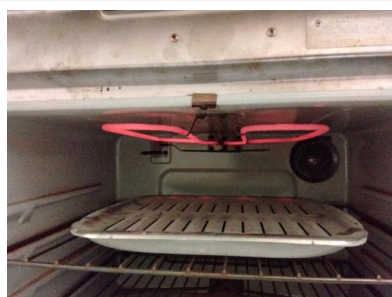
10.14 Item 1 (Picture)

Oven elements are functional however it is missing an anti-tip bracket. This is a safety hazard. Item warrants attention and repair.
